VSI: TECHNART 2023 selected papers

# The “Black Panther”: A multi-analytical study on the statue of the football player Eusébio da Silva Ferreira

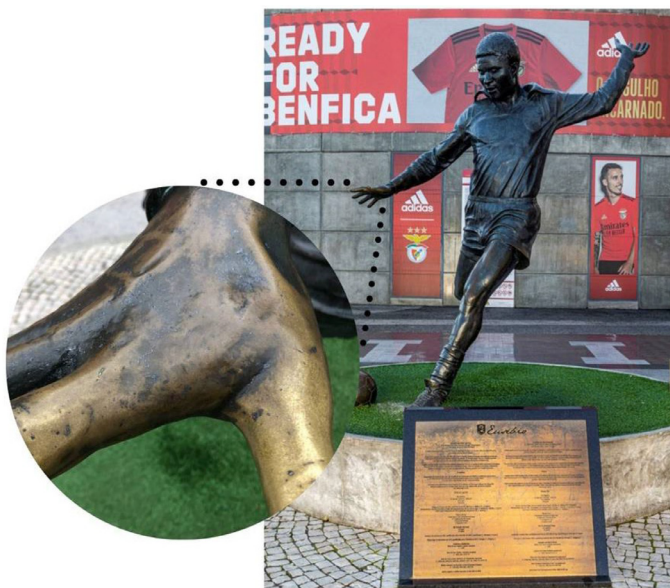
**Fig. 1.** Eusébio da Silva Ferreira Statue, located at Praça Centenário at Sport Lisboa e Benfica stadium. The statue's right hand is frequently touched by fans and clearly shows the effects of this action (adapted from a photograph by João Freitas).

The patina is wearing off in the most touched areas (Fig. 1), as a consequence of the public interaction and there are localised signs of possible corrosion products with green/blue, orange and white colouration visible in specific locations (Fig. 2a and b, Fig. 5).

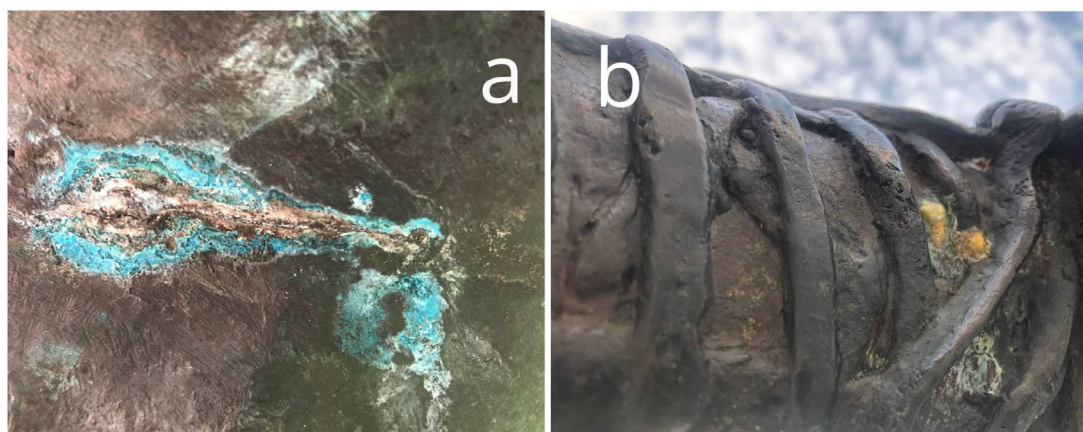
**Fig. 2.** a and b- The left leg presents greenish-blue deposits, and the right foot has developed rounded orange ones. See Fig. 4 for their locations (B and I, respectively). (For interpretation of the references to color in this figure legend, the reader is referred to the web version of this article.)

Regarding structural stability, and as already mentioned, moving and repositioning the statue to its present location may have added mechanical stresses to the left leg that anchors the statue to the ground. These mechanical stresses could accelerate the deterioration of the connection (welding point) between the leg and the torso and be responsible for the alterations visible in Fig. 2a, with accumulation of oxidation products. Since the statue is out-

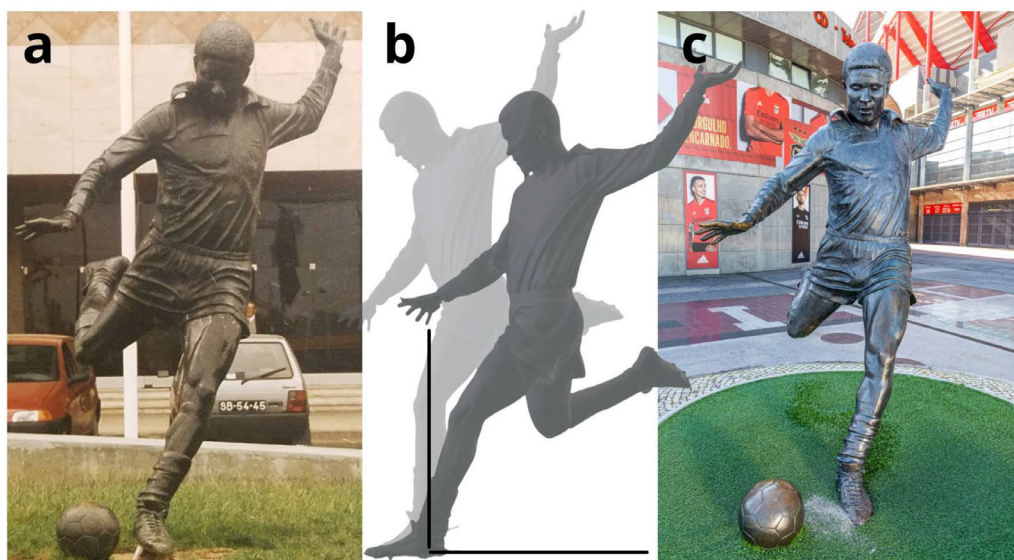
Adding to the possible corrosion products observed and unknown alloy composition (relevant to discerning the best possible conservation treatments going forward and fully understanding the corrosion patterns), the statue may also be suffering from mechanical stress caused by a shift from its original position in the old Sport Lisboa e Benfica stadium. Designed to be displayed in a pre-determined state of equilibrium, with Eusébio in a kicking position, the statue was first installed at the former Estádio da Luz, which met its demise in 2003. The statue then found a new home at the entrance to the new stadium in 2002, only to be moved again in 2008 to its current location at Praça Centenário within the modern stadium complex. These relocations have resulted in a noticeable change in the player's posture, now reclining, and a shift in the direction of his gaze, no longer fixed on the ball, as shown in Fig. 3a, b and c.

**Fig. 3.** a) Photography of the statue in the original position, determined by the artist in the former Sport Lisboa e Benfica stadium (reference: Artist Duker Bower); c) photography of the statue in the current location in the new Sport Lisboa e Benfica stadium (author of the photography: João Freitas); b) Between the two photographs, a composition depicting the original (light grey) and the current (dark grey) position of the statue. This schematic representation was obtained from the 3D model of the statue. (For interpretation of the references to color in this figure legend, the reader is referred to the web version of this article.)

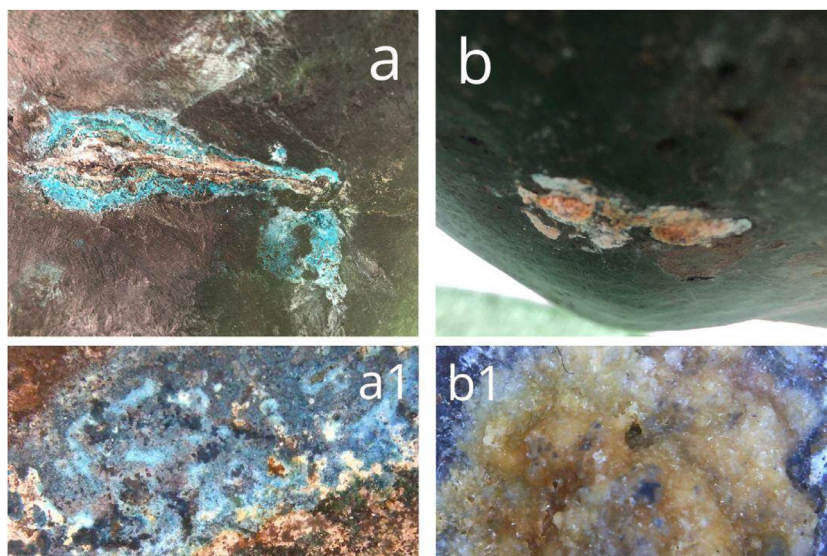
**Fig. 5.** a and b) Coloured deposits on location B and D, respectively (see Fig. 4); a1 and b1) Expanded view (magnification 12x) of the deposits using a portable microscope. (For interpretation of the references to color in this figure legend, the reader is referred to the web version of this article.)

A digital microscope is a valuable tool to better visualize and understand the morphology of the coloured deposits. Fig. 5a refers to location B and Fig. 5b to location D in Fig. 4. Fig. 5a1 and b1 refer to the enlarged versions of these locations and these help in the process of sample retrieval. These deposits exhibit green, orange and white hues. The composition of these hues was later investigated through analytical methods.

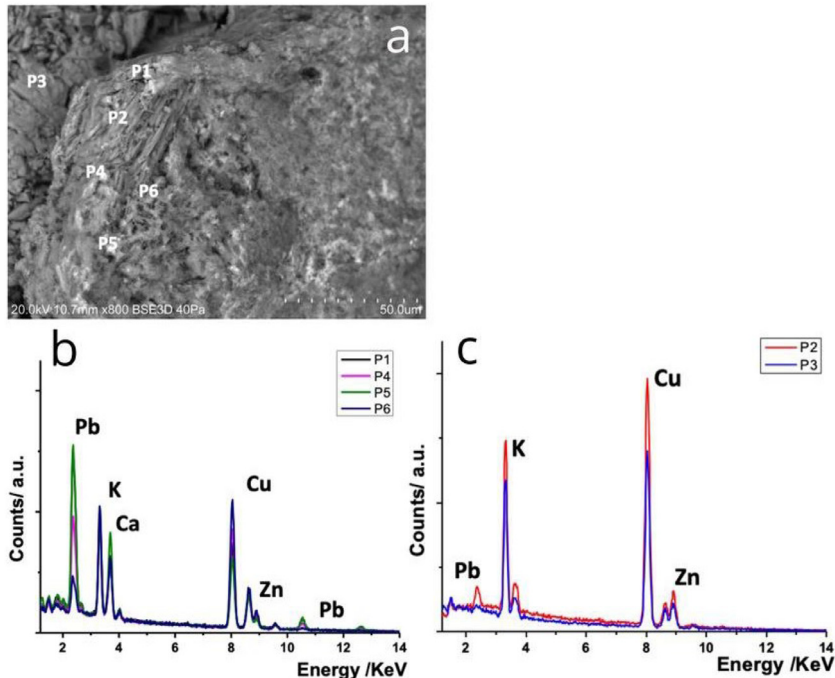
VP-SEM-EDS observations of the turquoise-coloured deposits allowed the observation of laminar-shaped crystals (Fig. 7, P2 and P3) and other crystals which appear lighter coloured in BSE (Fig. 7a) due to the presence of Pb (identified by EDS - Fig. 7c). The sampled area appears to be a welding area, where the leg and torso of the statue were joined. The presence of Pb in this area seems to confirm the  $\mu$ XRF results and the use of this metal to join the two parts together.

Both areas showed Cu and Zn, the main constituents of the bulk metal, which suggests that these deposits have their origin in the corrosion of metal or patina. In both cases potassium (K) was de-

**Fig. 7.** Turquoise blue deposits accumulated close to a welding area: a) BSE image displaying the selected points for EDS analysis; b) EDS spectra of P1, P4, P5 and P6; c) EDS spectra of P2 and P3. This sample was collected from the location represented in Figs. 2a, 5a and 5a1.

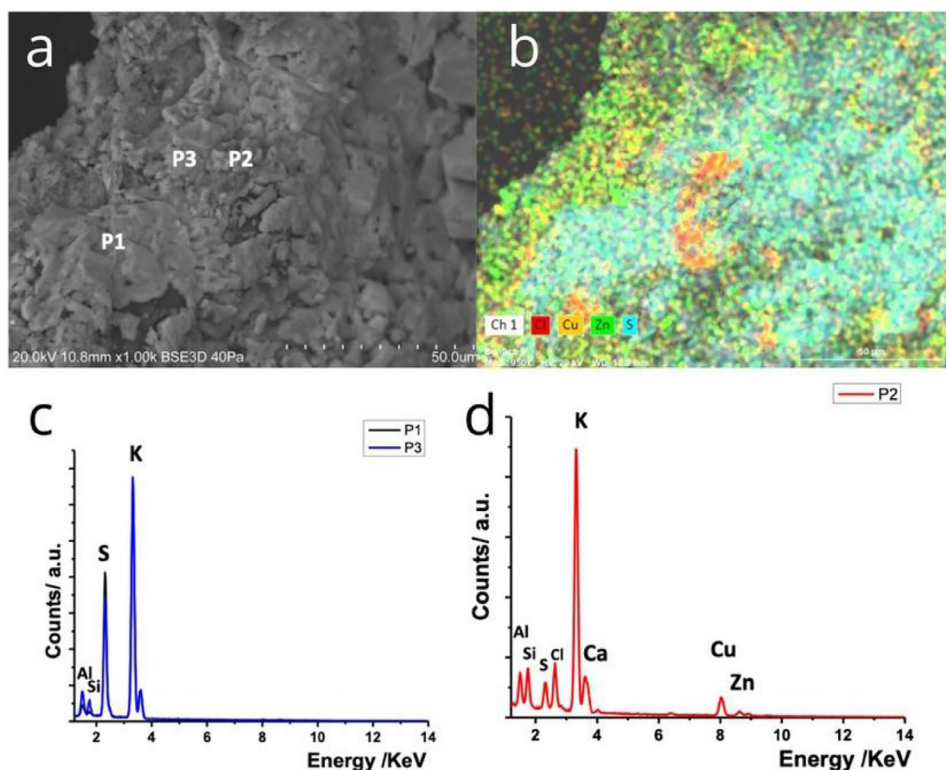
**Fig. 8.** Turquoise blue deposits: a) BSE image; b) EDS map with Cl, Cu, Zn and S; c) EDS spectra of point P1 and P3; and d) EDS spectra of point P2. (For interpretation of the references to color in this figure legend, the reader is referred to the web version of this article.)

Observations of another turquoise-coloured deposit (location E in Fig. 4) under VP-SEM-EDS allowed the observation of different structures (Fig. 8). One of the areas had Cu and Zn, which are the main constituents of the bulk metal reinforcing that some deposits are corrosion products (Fig. 8c and d), being the presence of Chloride (Cl) and Sulphur (S) also detected. Another structure presented no metal, only potassium (K), S, aluminium (Al) and silicon (Si). The presence of K, as in the previous example, might suggest the use of a K-rich compound to produce the dark-coloured patina [20], but could also be present in atmospheric particles.

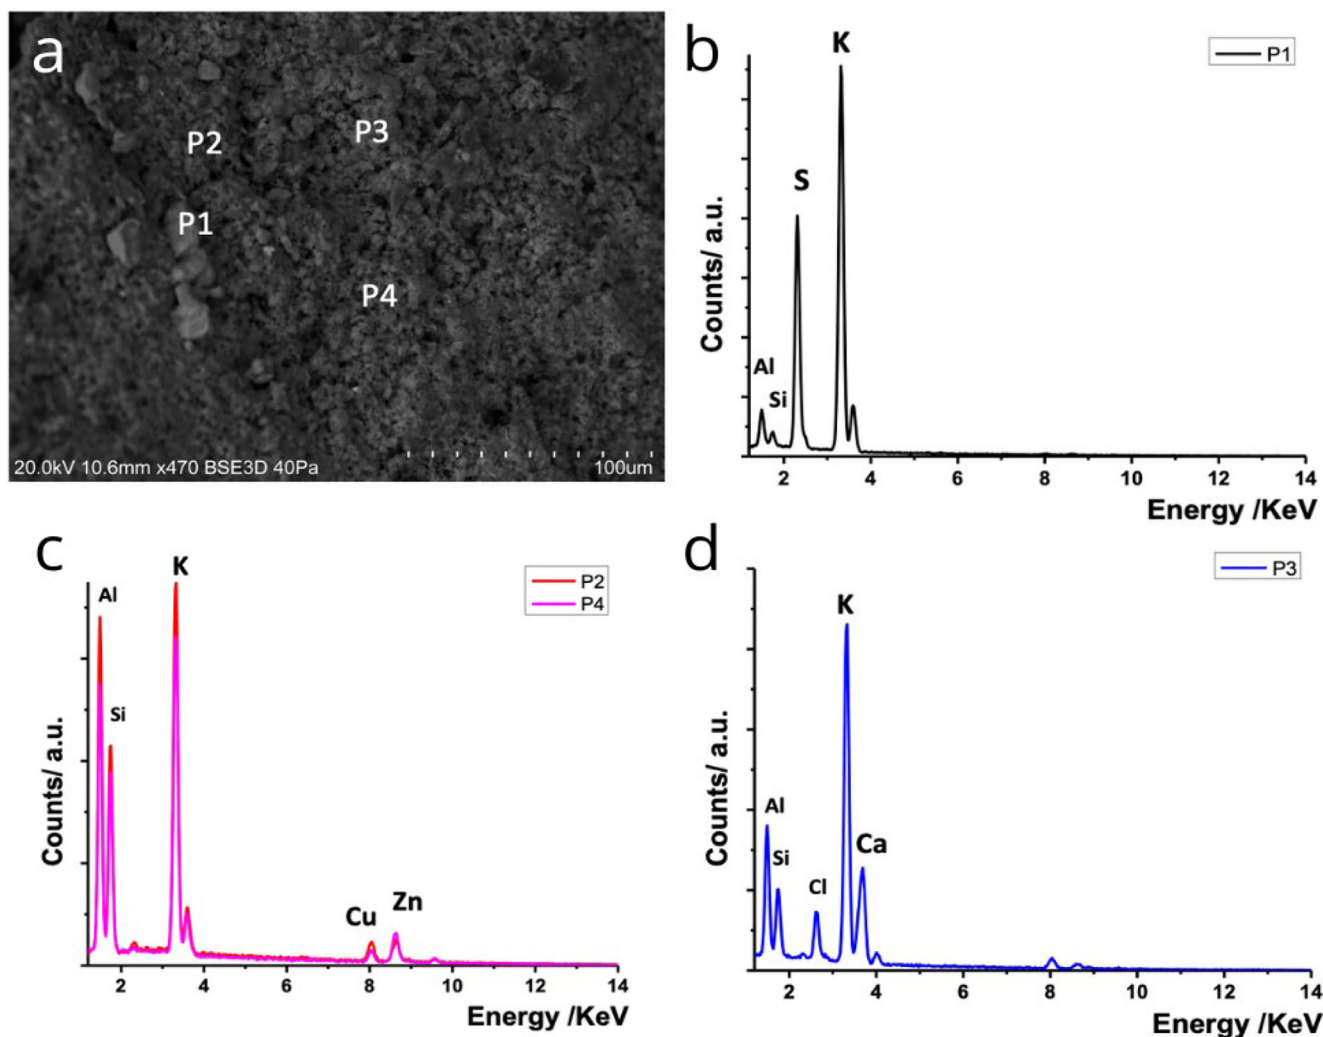
Observations of the white/orange deposits in location I (right foot, see Fig. 2b and Fig. 4) under SEM allowed the identification of structures with three different compositions (Fig. 9). This is the same location where the presence of hydrated zinc sulphate was determined by  $\mu$ XRD (see Table 1). In one of the points analysed (P1), there were K and S-rich crystals similar to the ones observed in the previous sample. In P2 and P4 the result was rich in Al, Si and K and Cu and Zn were also detected. Finally, a third combination, this one rich in Al, Si, Cl, K and Calcium (Ca), appeared in P3.

**Fig. 9.** White/orange deposits: a) BSE image displaying the different points where EDS measurements were performed; b) EDS spectra of point P1; c) EDS spectra of points P2 and P4 and d) EDS spectra of point P3. (For interpretation of the references to color in this figure legend, the reader is referred to the web version of this article.)

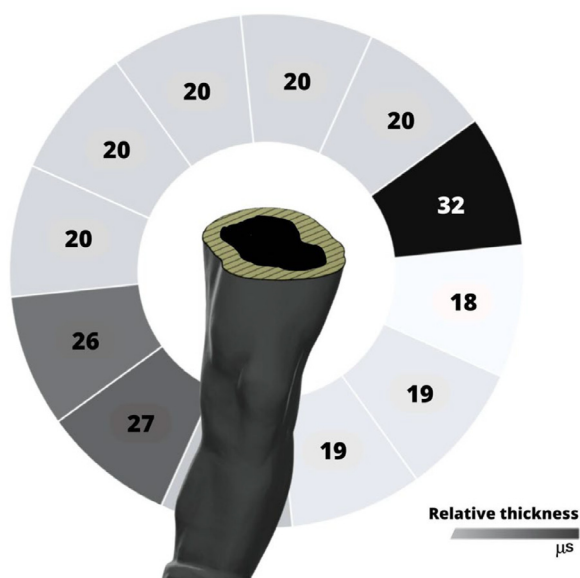
**Fig. 10.** Thickness results as obtained with the ultrasound technique. The areas where the tone is darker are the thicker ones. The results are consistent with the possible presence of an inner rod in contact with the areas considered thicker.

The results obtained for the leg *thickness* were translated from wave speed and do not correspond to the exact thickness value but do mean that different transmission times were obtained in different areas of the statue leg. This difference indicates that there is a section of the interior and a section of the external area that poses higher resistance to the propagation of the wave. There is, of course, the already mentioned degree of variability in terms of thickness when creating a statue. However, it is also true that if a metallic rod does extend to the upper leg (to sustain the statue as seen in other examples [22]) the locations where this rod is attached to the inner statue may be indicated by the darker regions depicted in Fig. 10. Regardless, there is no way of determining if the condition of this rod is pristine or if the current position of the statue has shifted the internal rod's position and further studies (X-ray radiography and/or boroscopy) [23] are scheduled.

side, accessible to the public, it is essential to evaluate the structural stability and state of conservation of its interior to mitigate the evolution of degradation processes and for obvious safety reasons. The first methodological approach to this pressing issue did not deliver enough conclusions. Further studies are warranted and loading tests, applied at specific points (points that generate the greatest physical deviation from the statue's centre of gravity like the hands and the left foot), with the recording of angle deviation and recovery to the initial position are scheduled. A video endoscopy/boroscopy is also being proposed.
