# Conservation of the historical render in the Church of Nossa Senhora da Assunção in Elvas

## *Conservação dos rebocos históricos na Igreja de Nossa Senhora da Assunção em Elvas*

In this paper we present a practical case of conservation of the historical renders in the pyramidal tower of the Church of Nossa Senhora da Assunção in Elvas (Portugal), carried out by the former IPPAR (Portuguese Institute of Architectonic Heritage), now Regional Direction of Culture of Alentejo. Awareness of the value and of the risks facing these renders points towards the necessity to safeguard their material authenticity.

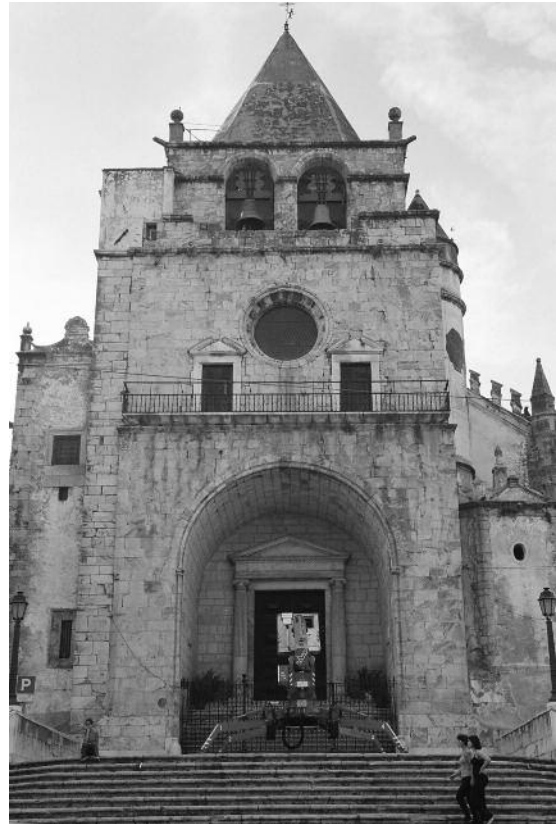
The façade was undoubtedly one of the most problematic situations, due to the state and degree of alteration of the stone material and the non-functionality of the joints and also due to the architectural meaning of the façade for the whole monument and for the image of the city (fig. 1). The axial tower composes the imposing and symbolic main façade of the Church of Nossa Senhora da Assunção. The large dimensions of the tower define, almost in

Fig. 1 Church of Nossa Senhora da Assunção before the works of conservation.

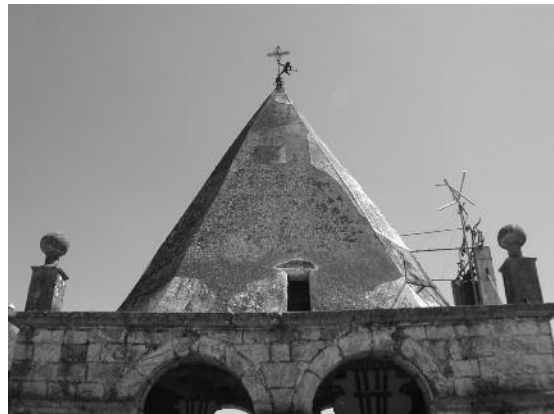
During the works on the site we discovered, on the top of the tower, in the pyramid part, under the finishing layer of the non decorated render, a previous decorated render that simulates stone masonry with raised joints (figs. 3-7). In fact, when preparing the conservation project for the restoration of the façade we used mechanical elevators for a prior study of the conservation and materials' diagnosis but, at that time, with this equipment and weather conditions, it was not possible to observe any traces of the existence of this historical render.

Fig. 3 Initial state of conservation of the pyramidal tower.

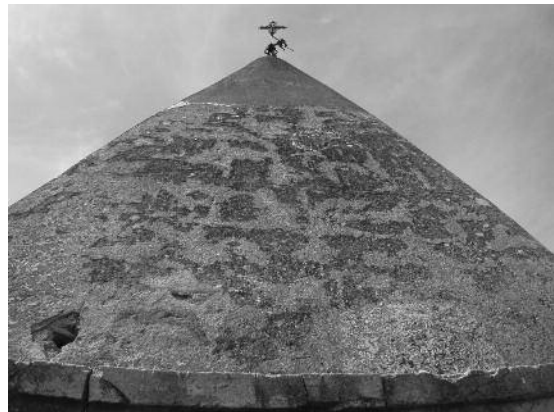
Fig. 4 Detail of the initial state of conservation.

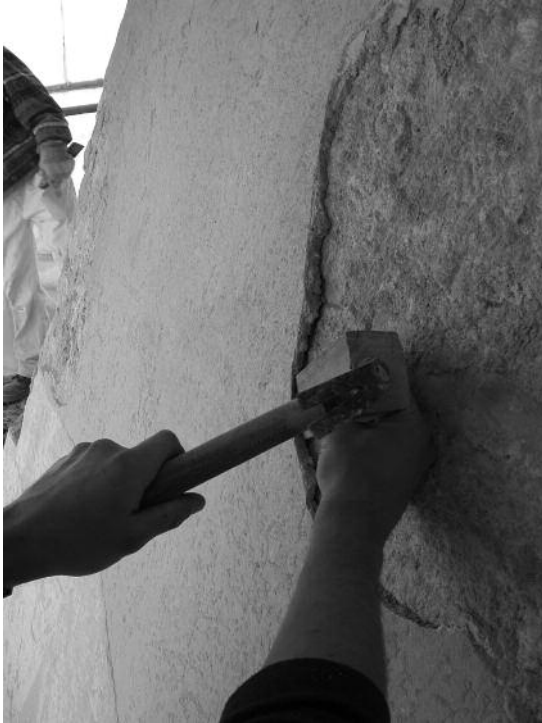
Fig. 5 Removal of the non decorated recovering render.

- Removal of previous non-decorative and non-functional render. After removal, we could identify evidence of different types of uncovered decorated historical renders. There were renders where we could see the aesthetic appearance and formal techniques in spite of some material degradation. There were also uncountable

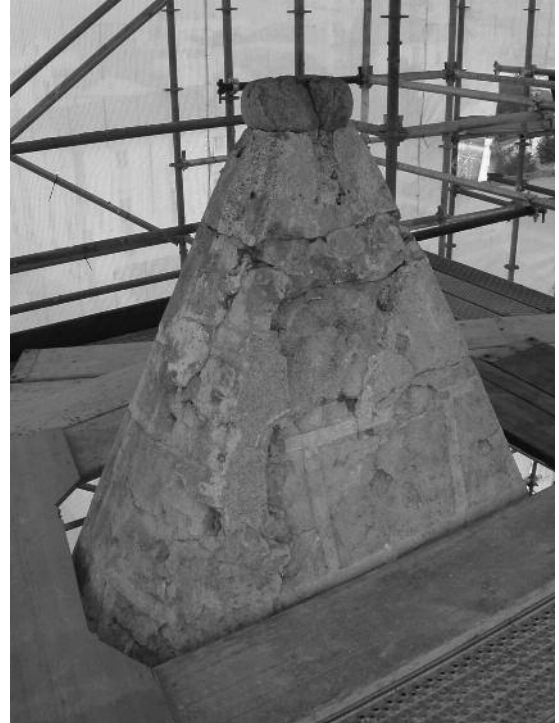
Fig. 7 Detail of the previous decorated render.

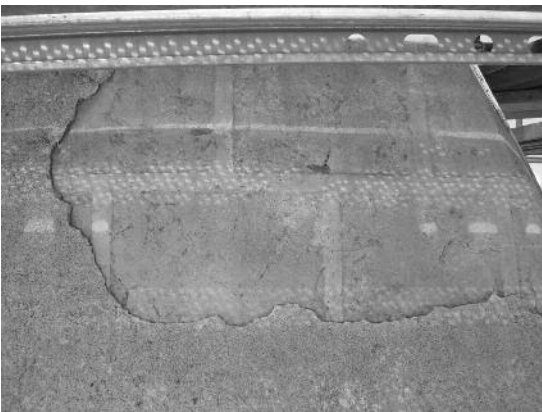
Fig. 6 The previous decorated render discovered under the layers of non decorated recovering render.

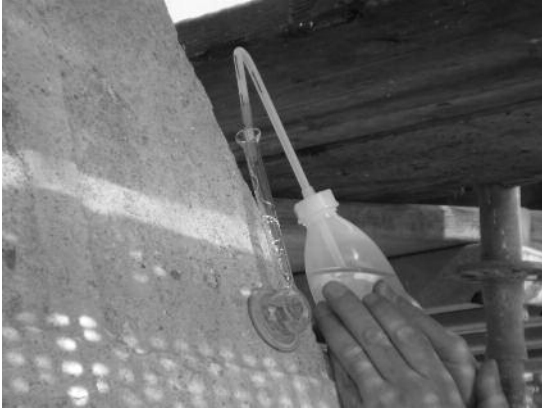
Fig. 8 In loco, water absorption experimental tests were made to characterise the original materials.

- Characterization of the original materials, with *in loco* experimental tests, to define the restoration mortars' properties (figs. 8-9);

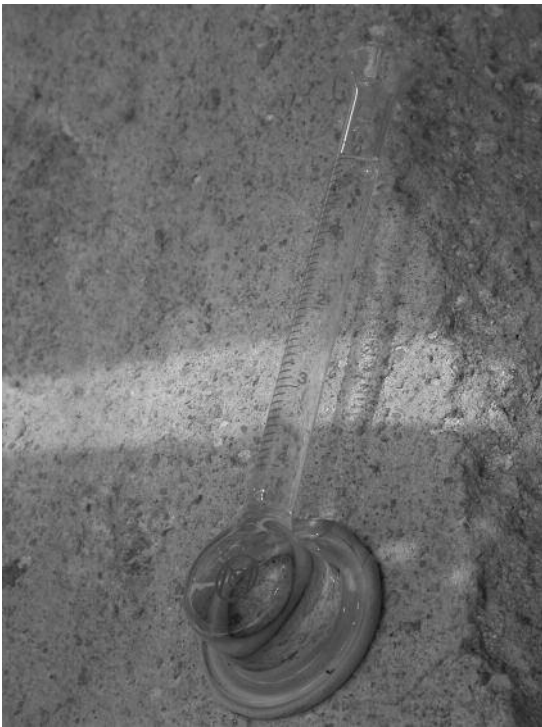
Fig. 9 Detail of the experimental tests.
