## Industrial heritage: Atarazanas Market's squares in Málaga

S. Palomares Alarcón  
*University of Jaén, Jaén, Spain*

**ABSTRACT:** The commercial activity is and has been fundamental for the development of the society in our cities. Though this labor is present from the ancient history, it is in the Middle ages when it has got in the urban design a major incident on having done the own streets of markets. We cannot forget that the medieval city was a market in itself, that with the passage of time will derive in market's squares, in complementary buildings of commercial nature and finally in the new typology of markets arisen after the industrial revolution. This abstract tries to make known one of the first attempts to recuperate the buildings heritage at the end of the 19<sup>th</sup> century in Spain: It's called Atarazanas Market's squares in Málaga, a marvellous Joaquin Rucoba's architect work. It is one of the first examples in iron architecture in Spain which opted preservation building heritage from the respect of the place memory even in his last restoration.

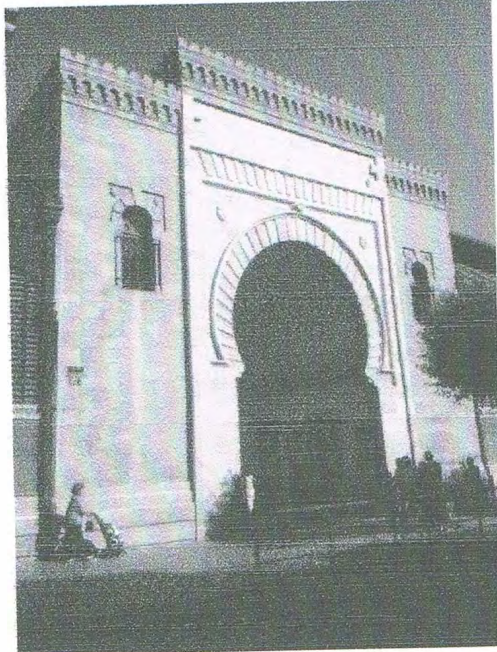
Figure 2. Arab door. Nowadays.

Rucoba looked for a tripartite composition to integrate the door. He added two bodies on both sides of the old gate, more discounted and with two horseshoe arch windows, columns with slim

capitals and shutters, star-shaped wooden enclosure. We have another attempt to whole integration, appreciated even in ornamental details. These new modules, as well as the cornice, are made by Alicante stone in contrast with the original marble and the jaspon. The economic reason given the difficulty of finding new material was probably decisive in the election.

During the process of the demolition of the dockyards, the arch was dismantled and the stones remained guarded and numbered for his later restoration and incorporation in the new building. In order to avoid that the segments composing the arc above the door disappeared, the architect stressed that the reconstruction speed's was fundamental, requesting the segments to be placed in the hollow of the arc door, closing it with a zither for avoiding disappeared pieces.

The door was in a lamentable condition, fruit of the successive works throughout the times.. His intervention is described in two levels, the first was the restoration of the gate itself and the second its adaptation to a new place: a metal structure market's.

According to the final settlement document written by Rucoba, (Ordieres, 2002) the arch mounting process was described in this way: first of all they would tear down the wall attached to the Arabic arc, they would take apart the arc ashlar and later, they would probably add new jason ashlar in the lintel as well as Alicante stones in the straight and padding style on the main body. In addition, the patina would be eliminated to return the monument its old appearance. Twenty-six new stones were described probably used in the jamb arcs. His own tonality is the best reference to differentiate the new stones from the original. Moreover, it would be the most worn part that had been buried nearly a meter from the ground level, although this can only be considered as a hypothesis.

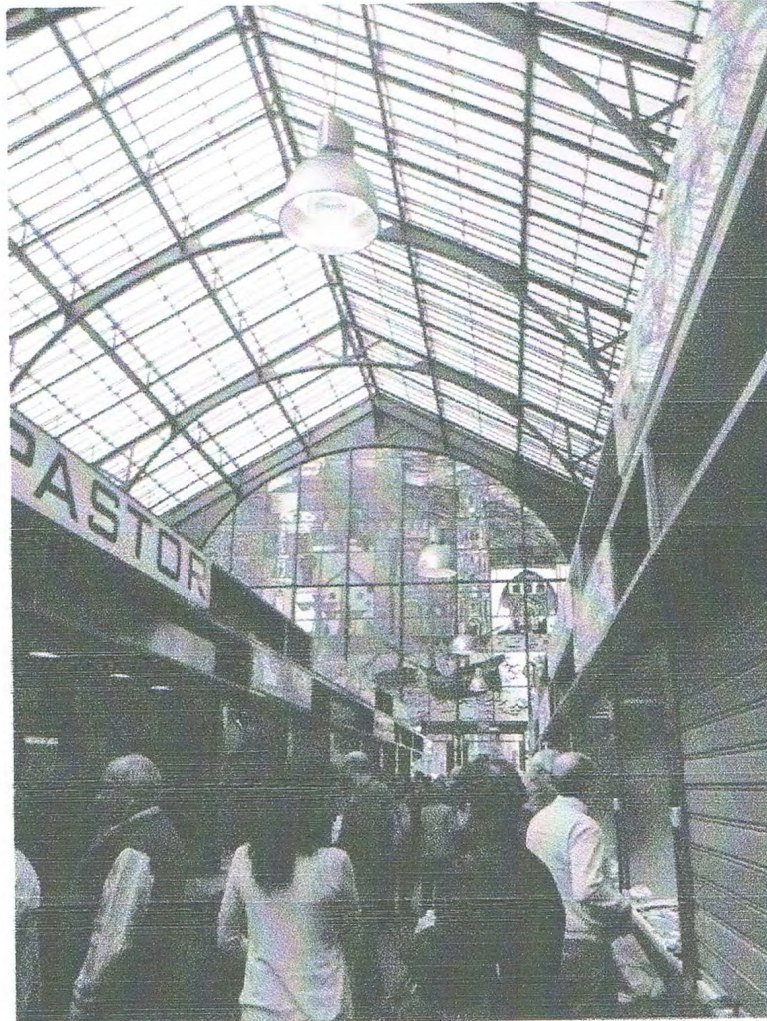
Figure 3. Stained glass window. Central nave.

In 1973 the market was again rehabilitated by the architects César Olano and Carlos Verdú who entrusted to the brothers Atienza the production of a great window on the history of Malaga in the arch of later front in substitution of the blind of Rucoba's crystal. Cesar Olano and Carlos Verdú's architects, who order the development of a large stained glass window on the history of Malaga in the back wall arch instead of Rucoba blind glass from Atienza's brothers.

They will clean and rehabilitates the big window to its original state, as well as the lattice of glass blades that all the glasses would be replaced.

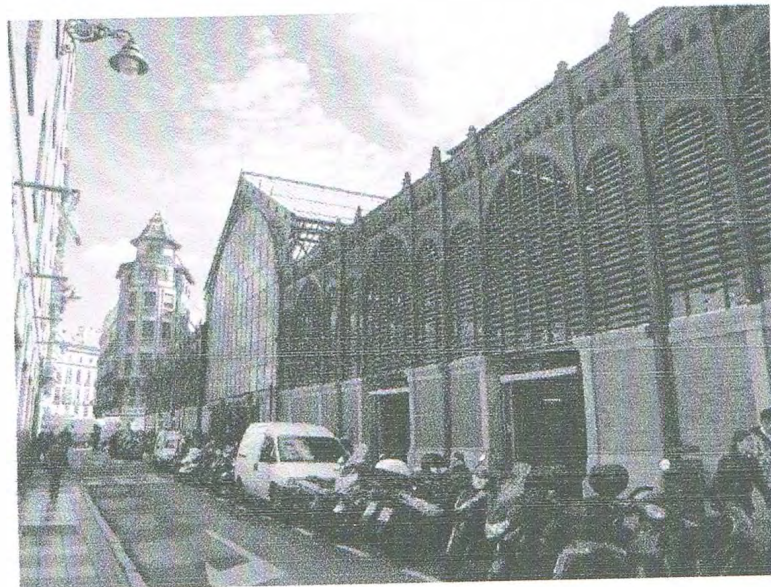
Figure 4. Back façade.

In the facade they cleaned stonework, dry, with sandblasted projection, sealed the cracks and joints and repaired the most damaged areas like joining hollows with the structure.

They reinstated the volume of natural stone with stones of similar characteristics to the original fixed by anchors, and they restored the lost mass with epoxy mortar. The possible efflorescence from stone would be treated and the facades would be shored up increasing hardness stone.

They recovered the brick, in that moment hidden with tile, so once demolished the tile, on the hidden brick would provide a brick masonry face, smooth, that would recover the original design.

There are new facilities such as plumbing, electricity or air conditioning. The new toilets are located on the ground floor next to the back façade.

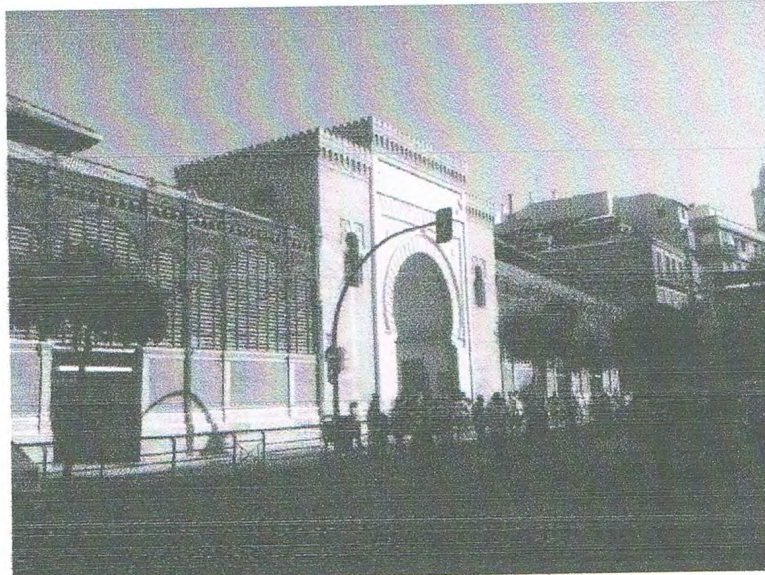
Figure 5. Main façade.

The façades are divided into thirds vertically: the first, a base of stone and brick, the second iron Arab arcs having placed three in each arcade, and the third, the tympanum arcades, also made with Arabic ornamentation and openings in the upper part to facilitate ventilation.

In each arcade, the central arc is double light the other two, and small columns which separate them resting on the socket. Large arcs are closed by fixed wooden blinds and small doors hinged stained glass at the bottom that can be opened.
