Geomaterials and decay forms of the coastal towers of Piscinni and Foghe, Weastern Sardinia

Abstract

3.1 Torre di Piscinni

3.2 Torre di Foghe

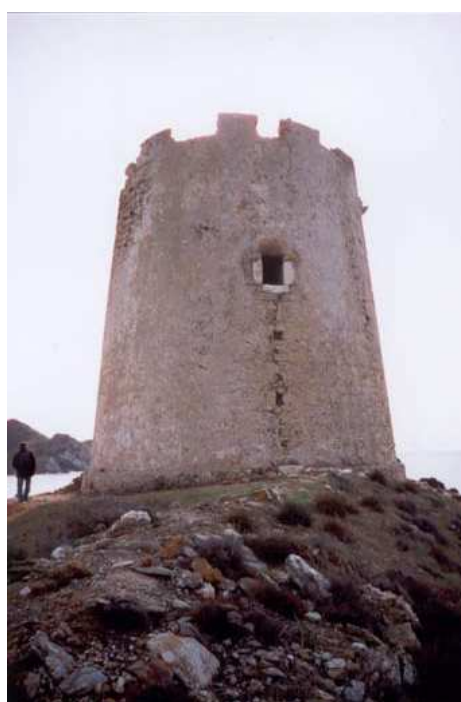
Fig. 1- Torre di Piscinni

The tower is truncated-cone shaped, topped by battlements and embrasures. The diameter of the base is 10 m, and the height of 9 m. The accommodation, located about at 4 m from the ground, is a single circular small-sized room ($d = 5.5$ m), closed by a dome vault supported by a central column. The openings are represented by a *troniera*, on the opposite side of the entrance, the fireplace, on the left, and the stairwell, on the right. On the parade gunboats, parapets and battlements are well preserved.

The entrance of the tower is oriented towards North.

The tower walls consist of sandstone blocks extracted from an ancient quarry, found in the underlying coast, which still preserves evident signs of the past mining works. Even shale was used as building stone, to level laying plans of sandstone ashlar.

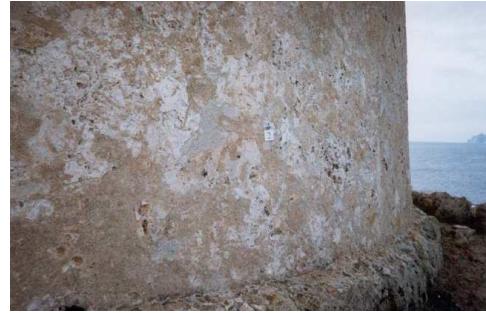
The aggregate-binder ratios of lime mortars range from 1:1 to 4:1. Calcareous shells of lamellibranchia and foraminifera are recognizable inside the aggregate. The binder fraction shows abundant bio-alveolar structures and fossils (foraminifera and bivalves) principally inside the putty lime, where structures related to an original organogenic limestone still occur. The plaster is virtually absent in the surfaces facing the sea; in the protected side, towards the inland, tafones and

flakings, partially restored in the past, frequently occur.

Fig. 3 - Northern side of the tower: wall covering partially restored

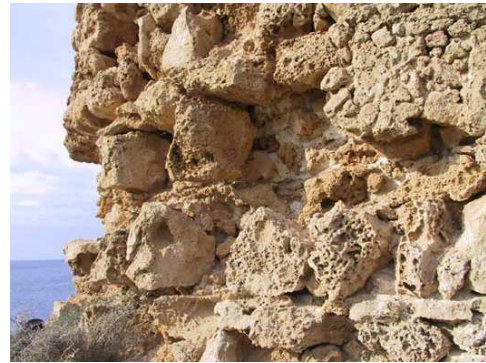
The dominant building lithotype is sandstone, characterized by the presence of macroscopic carbonatic/silicatic grains. Cement of the sandstone is carbonatic. Atmospheric agents easily attack sandstones. In particular, the dissolution phenomena of the carbonate cement, causing loss of cohesion among ashlar, frequently occur.

Fig. 4 - Inland side of the tower: evidences of tafones and flakings

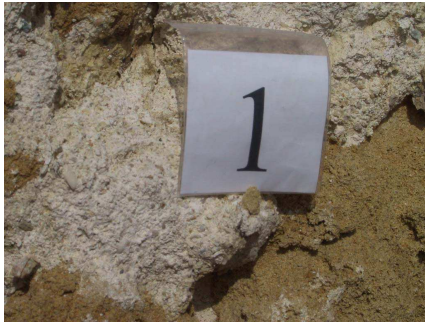
Fig. 6 - PSC-M1 sample – bedding mortar. The mortar is easy to breakage, whitish in color and full of shells inside.

Sample PSC-M1

The mortar is made up of lime-based binder and quartz-feldspathic aggregate, with sub-rounded rock-fragments. Fossiles are mainly bivalves and gastropods. The aggregate-binder ratio is approximately 4:1.

Mineral composition of the mortars, by XRPD data, is composed by several mineral species. Sample PSC-M1 mainly consists of calcite, quartz and halite; plagioclases, K-feldspars and hematite occur as minor phases. Sample PSC-M2 shows a similar composition, but without halite and hematite occurrences. Sample PSC-M3 composition is different from the previous mortars, being simpler: only calcite and quartz are detectable.

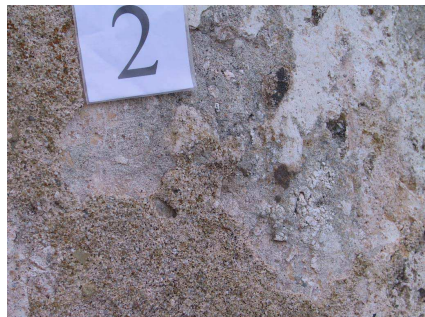
Fig. 7 - PSC-M2 sample – Plaster

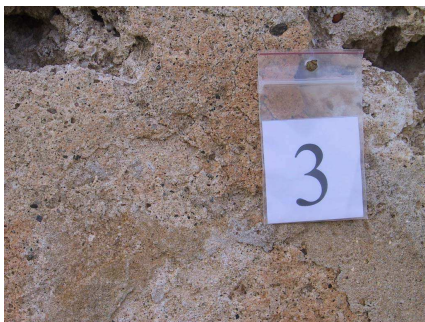
Fig. 8 - PSC-M3 sample - Plaster

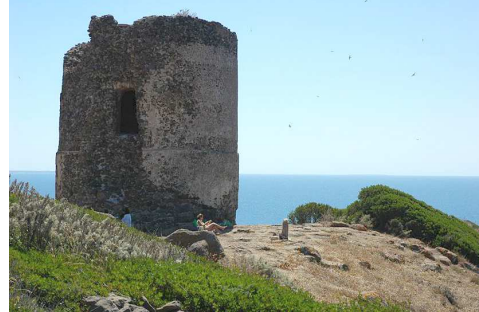
Fig. 12 –Torre di Foghe

The shape of the tower is like-cylindrical, and its small size, 8.60 m in diameter and 9.60 m in high, confirms the function of watchtower. The room, located about at 4 m above the ground, is covered by a dome vault (Fig. 13). In the room, a fireplace and a staircase, for the access to the terrace, are present.

Therefore, the decay of structure is mainly due to the removal of plaster and bedding resulting in detachment of the blocks. These damages are particularly evident at the base, and severely compromise the statics of the tower.

Rare patches of plaster still occurring, are in a severe state of decay because affected by alveolization, tafones and spalling.

In this context it is emphasized, therefore, the need to operate with extreme skill and caution in selecting the correct mix-design of the repair mortar, as regards the binder and, to a same extent, the nature and the particle size distribution of the aggregates. Due to the poor mechanical performance of the original mortars, made with lime and local aggregates, the presence of the coating mortar would provided protection against the strong aggression of the coastal environment. These operational choices thus have repercussions on the programming of maintenance that, if not implemented, encourages decay phenomena to be developed and accelerated.

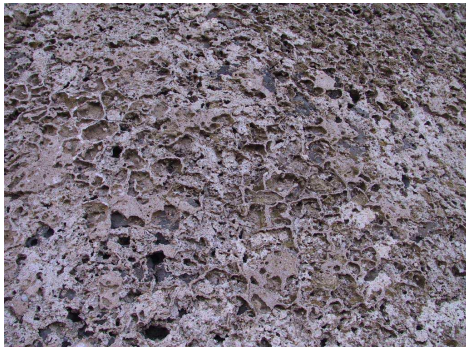
Ashlars mainly consist of basalt, rock resistant to the action of weathering agents; rhyolitic and sandstone ashlar locally occur, especially in the vaulted room. Ashlars forming the structure are not affected by significant alteration phenomena, except the presence of locally *micro-tafones*, generally affecting the surface of the tower exposed towards NW.

Fig. 14 – Torre di Foghe, tafones like-honeycomb in the exposed NO surface of the tower

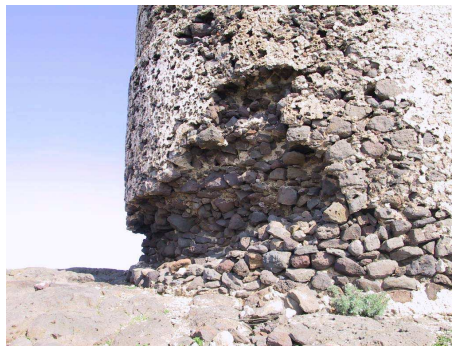
Fig. 15 – Torre di Foghe, erosion at the base

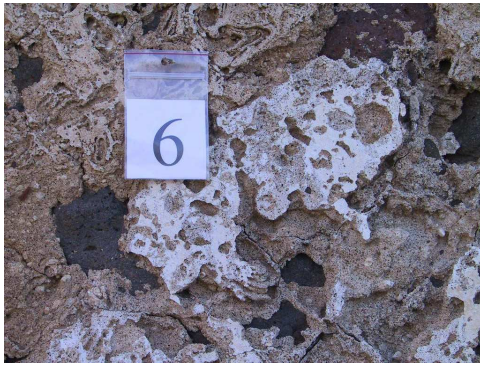
Fig. 17 - FOG-M6 sample – Plaster

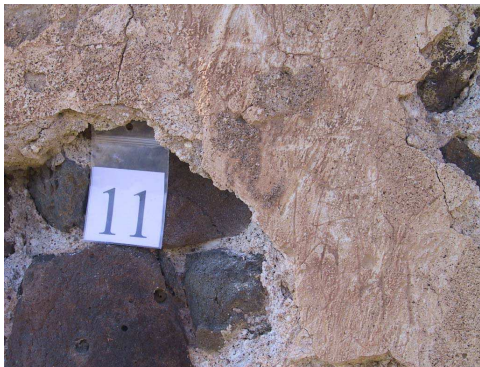
Fig. 18 - FOG-M11 sample – external finish coating

Finish coating have an aggregate/binder ratio 1:1. The aggregate consists of quartz, plagioclase, K-feldspar sub-angular elements. The clastic fraction is abundant and mainly given by volcanic fragments and minor quartz. Fossils are seldom recognized.
