Article

Modern Muralists in the Spotlight: Technical and Material Characteristics of the 1946–1949 Mural Paintings by Almada Negreiros in Lisbon (Part1)

Abstract: This paper presents the first insight into how Almada Negreiros, a key artist of the first generation of modernism in Portugal, created his mural painting masterpiece in the maritime station of Rocha do Conde de Óbidos in Lisbon. This set of six monumental mural paintings dates from 1946 to 1949 and is considered Almada's artistic epitome. As part of the ALMADA project: Unveiling the mural painting art of Almada Negreiros, the murals are being analyzed from a technical and material perspective to understand his *modus operandi* and the material used. This is the first study of this nature carried out on site and in the laboratory using standard and more advanced imaging, non-invasive analysis, and microanalysis techniques. This article reports the results obtained with visual examination, technical photography in visible (Vis), visible raking (Vis-Rak), complemented by 2D and 3D optical microscopy (OM), scanning electron microscopy with energy-dispersive spectrometry (SEM-EDS), and Fourier transform infrared micro-spect

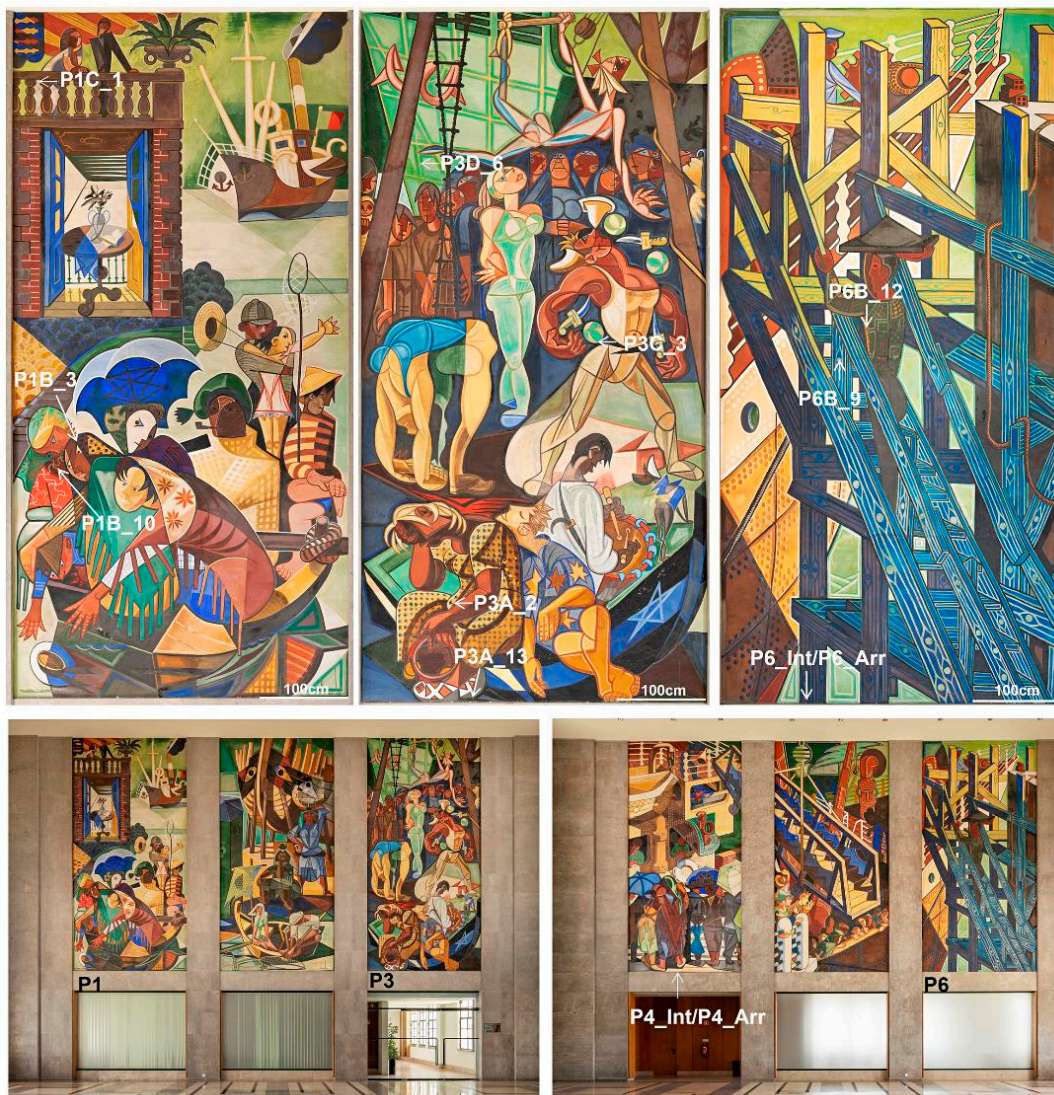
Figure 1. Overview of the mural paintings in the east and west of walls of the main shipping hall and of the murals named P1, P3, and P6, which were presumably the first, third, and last to be painted. The indication of the sampling location discussed in this paper is given in the three murals. The letters in the samples reference the name of the painting (P) and the different areas analysed (A, B, C, and D). Photos by M. Ribeiro 2022.

The six paintings located in the main departure hall on the first floor of the maritime station of Rocha do Conde de Óbidos are organised in two triptychs (Figure 1). On the west side of the room, the murals are dated 1946–1949, and on the opposite side, 1947–1949 (Figure 1). These dates are not indicative of the time it took Almada to paint them but rather of how the whole administrative process unfolded. Almada Negreiros only signed the contract on 17 February 1947 and began painting in the hall in 1949, after more than two years of preparatory work in his studio [16,17]. By then, the maritime station had already been inaugurated, and temporary plasters had been put on both walls [18]. These plasters were supposedly removed so that Almada Negreiros could paint the six murals measuring 7.80 m × 3.80 m. Using the demanding fresco technique, one would believe that the paintings had taken the eight months foreseen in the timetable set by the artist in December 1948 [17]. But it was Almada himself, in an interview with a newspaper [Diário de Lisboa] in 1950, who revealed that it took him three years to learn the fresco technique, but only 29 days to do this painting set, sometimes working 10 h a day [19]. This remarkable piece of information is particularly relevant for understanding the work performed if we consider that Almada painted alone, occasionally with the help of an assistant on site [8,17,20].

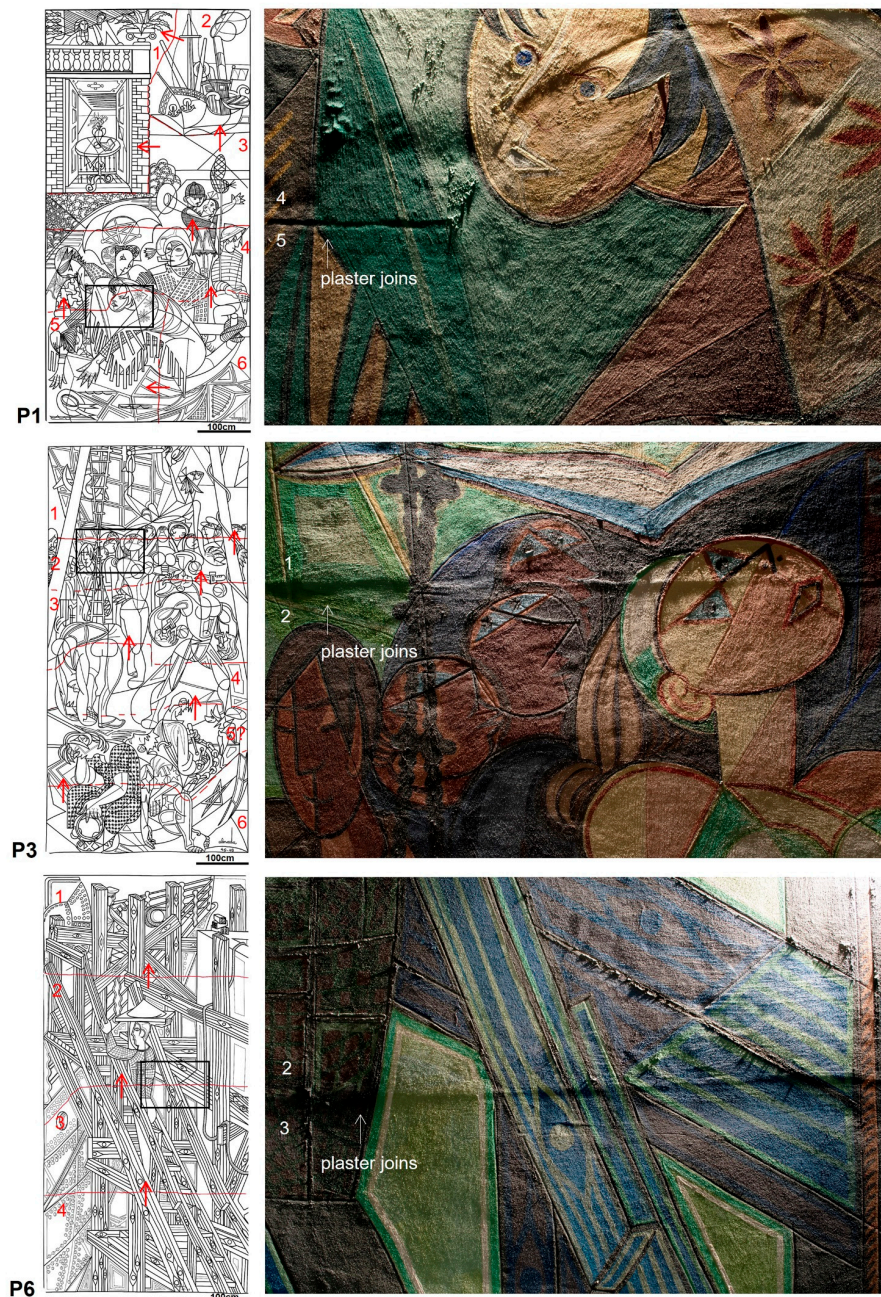
Figure 2. On the right, mapping showing the location, the number, and the laying order of the plasters in P1, P3, and P6. The work proceeded from top to bottom and from left to right as indicated by the number and arrows. The dashed lines indicate the areas where the joints are not clearly visible by Vis-Rak. On the right, detailed images by Vis-Rak of the plaster joints showing the method of leaning the mortars against each other (photos by M. Ribeiro 2022; drawings by K. Rix/M. Gil 2022/24).

the mortar is still damp. This was no easy feat, and any defect in the materials or method used could compromise the final work [12]. Figure 2 shows the number and the location of the patches of plaster found by Vis and Vis-Rak light in the murals P1, P3 and P6. The number of patches appears to vary with the complexity of the decoration, being higher on P1 and P3, which had more figures and decorative details to paint (Figures 1 and 2). Vis-Rak highlights the joining areas between the different plaster sections, and it can be perceived that each new layer of plaster stops along the edge and leans against the previous one rather than overlapping it. Sometimes, the joints between the different patches are well disguised and covered with thick paint layers, making them difficult to detect.

The shape of the patches of plaster also varies within and between the murals (Figure 2). On P1, horizontal and vertical plaster joins are visible, while on P3 and P6, only horizontal joins are found, suggesting the presence of what is known as *giornata* and *pontata*. These are two Italian terms commonly used in technical studies of mural paintings to appoint two types of working methodologies [12].

In the paintings from the maritime station of Rocha do Conde de Óbidos, the distinction between the two methodologies is not always straightforward due to the position, shape, and dimensions of the mortar sections (Figure 2). In the detailed analysis of the three murals, only in P6 is it clear that Almada proceeded by *pontate*, with each painted section corresponding to a story of the scaffolding. In P3, he seems to have used both types, although only horizontal joins are seen, and in P1, most of the mortar sections are unusually large for *giornate*. In this painting, some sections have more than 2 m × 1.5 m and have certainly surpassed a story of scaffolding (for example, the patch n°1, Figure 2).

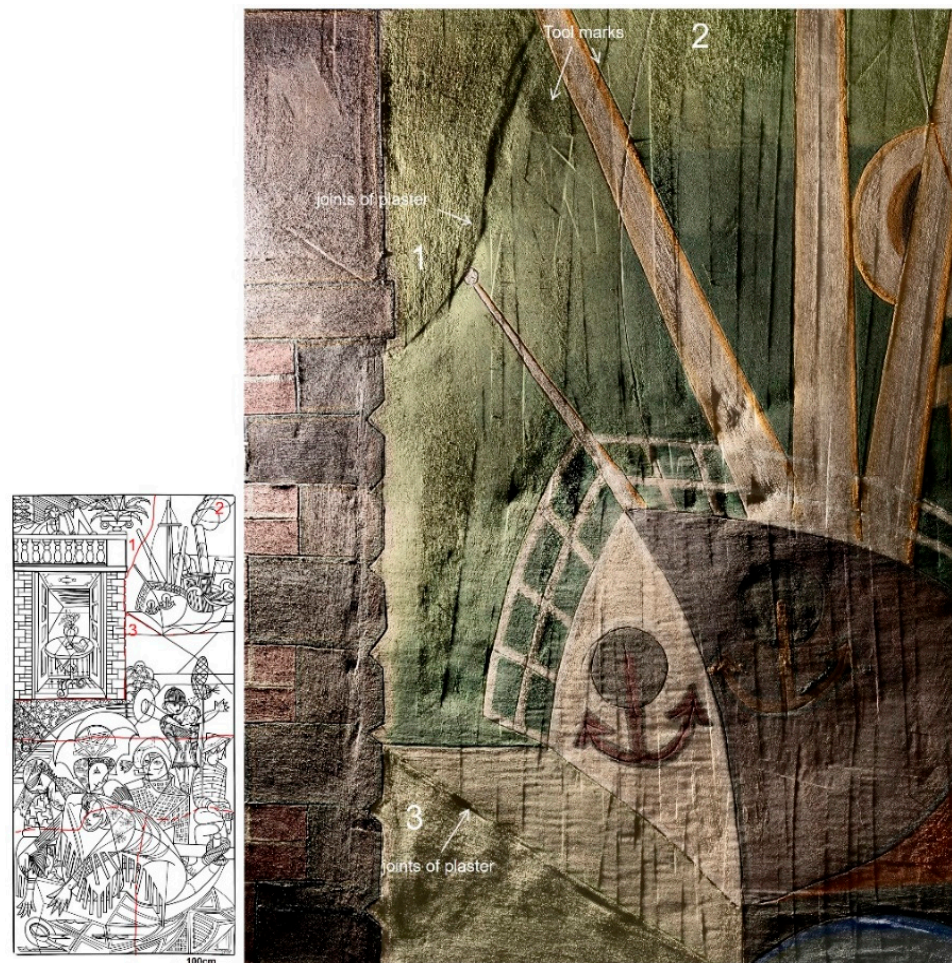
Figure 3. On the left, location of the plaster patches observed in mural P1. Patch n°2 is in the top left corner. On the right, details in Vis-Rak of patch n°2 and adjacent areas of patches n°1 and n°3, showing the intense presence of tool marks on the former when compared to the surface of the other two. The marks were made by repeated pressure movements exerted vertically, presumably after the painting was done, as evidenced by the differences in the texture of the paint on the green background and on the mast of the boat (photo by M. Ribeiro, drawing by K. Rix 2022).

The marks of the instruments used to lay the mortars and smooth the surface can only be clearly seen by Vis-Rak on one of the larger sections of the upper part of P1 (Figure 3). On the rest of the surface and on the other murals, depressions can mainly be seen, which may have been caused by irregularities in the underlying masonry and the pressure exerted on the damp surface when the full-scale drawing sheets were transferred to the walls. Figure 3 shows a detailed image by Vis-Rak of the patch n°2 in P1. This patch with intense tool marks was placed on Almada's second day of work at the maritime station and may indicate a defect that occurred during the drying of the mortar. Several large shrinkage cracks are clearly visible in this area, suggesting that there may have been some deficiency in the preparation and/or placement of the plaster. It is possible that Almada noticed the phenomenon during the course of painting—it should be noted that he could work up to 10 h a day—and tried to remedy it by further compressing the mortar with a float to save that day's work. This would explain why this situation only occurred once in the full set of paintings.

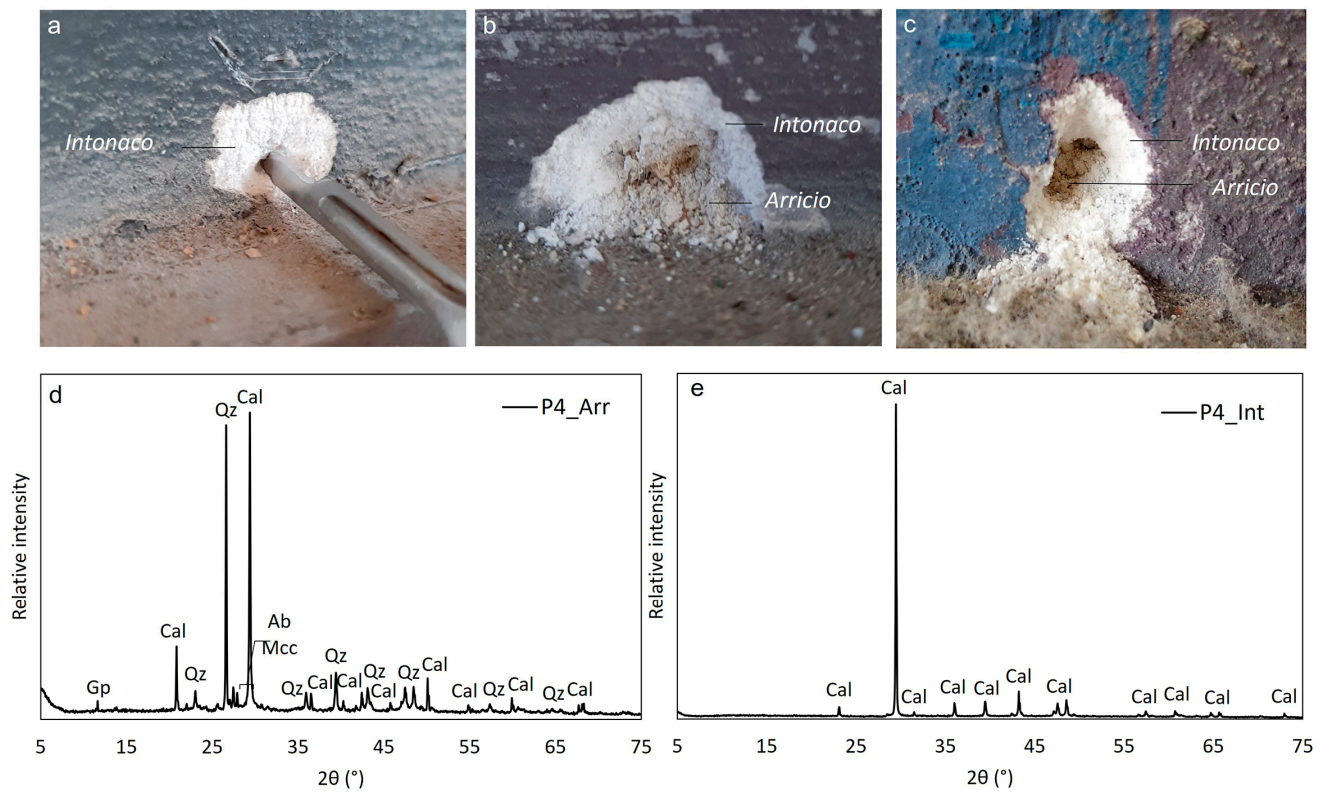
Figure 4. Above, details of the sampling location of samples P3A_13 (a), P4_Int and P4_Arr (b), and P6_Int and P6_Arr (c) collected from lacunae of approximately 1.5 to 3 cm long at the edges of P3, P4, and P6. Below, diffractograms of P4_Arr (d) and P4_Int (e), representative of the four powdered mortars samples analysed by XRD.

XRD and SEM-EDS data from samples collected from P3, P4, and P6 are summarised in Table 1 and in Figures 4 and 5. The results confirm that both plasters are made of calcium-based mortars. The two samples of *arricio* analysed by XRD are identical in terms of their mineralogical composition. Both consist of calcite with siliceous aggregates and potassic and sodic feldspars (microcline and albite) (Table 1, Figure 4d). Gypsum was only detected in P4_Arr in a small amount and may be present due to water infiltration. The presence of calcite is related to the use of calcitic aerial lime as a binder.

On the other hand, the two samples of *intonaco* are essentially composed of calcite (Table 1, Figure 4e). SEM-EDS analysis of the *intonaco* of the P3A_13 cross-section also shows heterogeneous fragments of crushed carbonates around 400 μm to 50 μm long embedded in a Ca matrix (Figure 5). This material was used as a binder and as an aggregate, which explains the white colour observed in the lacunae. The quartz detected by XRD in sample P4_Int is associated with siliceous aggregates (sands). No gypsum was found in the two samples of *intonaco* analysed by XRD (Table 1).

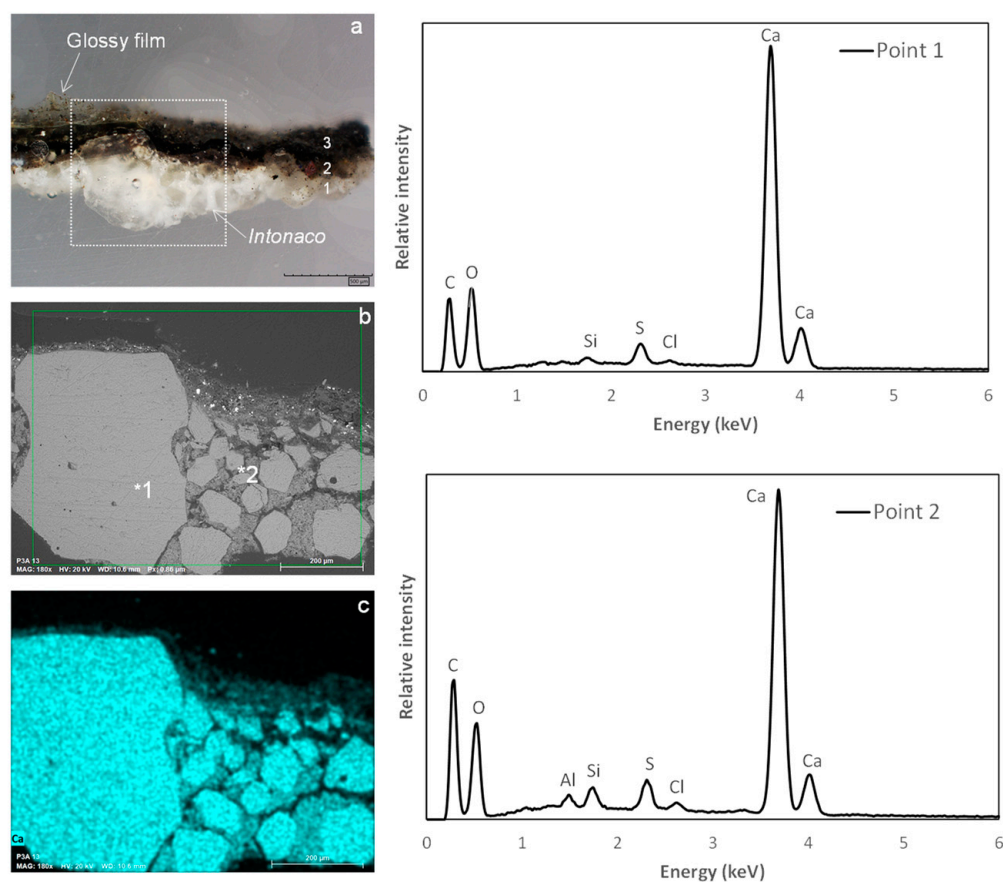
Figure 5. On the left, from top to bottom; (a) P3A_13 cross-section in MO-Vis at 200 \times , indicating the three visible layers (1 is the *intonaco*, 2 and 3 are paint layers); (b) SEM backscattered image; and (c) SEM-EDS elemental distribution map of calcium showing the widespread presence and quantity of this element in the *intonaco*. On the right, SEM-EDS analysis of the *intonaco* aggregates and matrix. The results of the point analyses 1 and 2 (marked as *1 and *2 in the backscattered image) are given in Table 1.

By OM-Vis, PVA can clearly be seen as a translucent shiny layer on the surface of paint layers P3A_13 and P1B_3 in Figures 5 and 13, respectively, and as a carbon-rich layer on SEM-EDS elemental map distribution in P1B_3, Figure 13. The identification of PVA by FTIR on the surface of the paint layers is straightforward since almost all the absorption bands displayed in the spectrum obtained are attributed to this compound. In layers with other materials, such as calcium carbonate, gypsum, or others, their bands overlap with most of the PVA bands in the infrared spectrum. Even so, their presence can be identified by the shape of the CH elongation band at around $2940\text{--}2944\text{ cm}^{-1}$, as in the case of the green layer of sample P3C_3 (Figure 14).

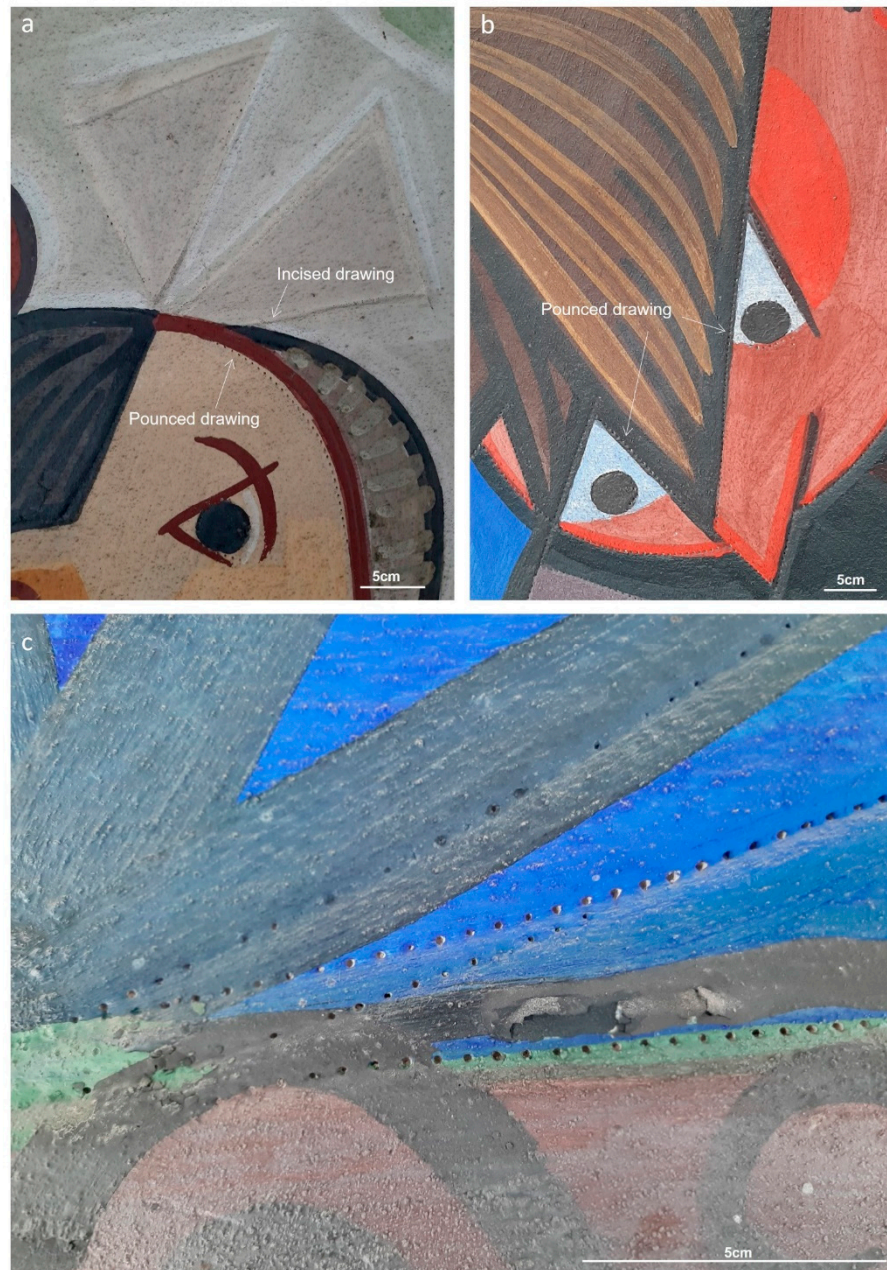
Figure 6. Detailed images in Vis of the incised lines (a) and of pounced drawings (b,c) used by Almada to transfer the full-scale drawings to the wall in P1. In (c), details of the Ø1 mm printed holes made by piercing the drawing's outlines directly into the fresh mortar (photos by M.Gil 2022).

used by Almada, and it was usually followed by incisions made on top with the handle of the brush to link the dots together [4,8]. In the upper part of P1, there are still traces of such black dots. On the bottom half onwards, and on the remaining painted murals, Almada has pierced the paper with the drawings directly in the fresh mortar, leaving the holes imprinted on the surface. Figure 6a,b shows, by Vis-Rak, the two types of techniques used, and in Figure 6c, the detail in Vis of the imprinted holes, circa 3 mm apart, strongly suggesting that a round-tipped instrument was used for the purpose. By Vis-raking light, a slight rounded groove linking the holes can also be noticed, caused by the pressure exerted to pierce the drawings through the paper on the wet plaster (Figures 6c and 7a,c).

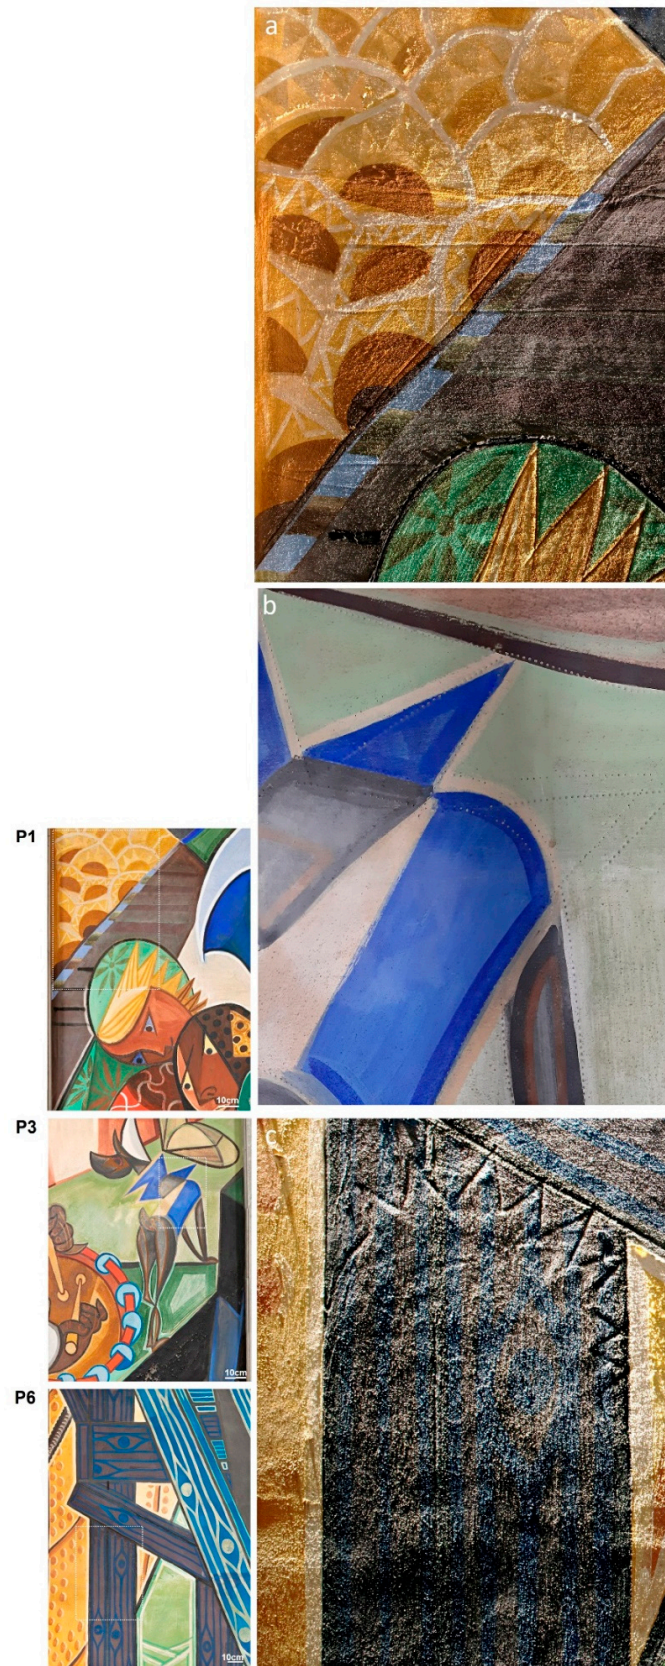
Figure 7. Three examples in Vis-Rak (a,c) and Vis (b) of the variations found between the pounced drawings and the final painting on P1, P3, and P6 (photos by M. Ribeiro 2022).

The imprinted holes are seen in all the murals in the outlines of the figures and in some decorative and anatomic details. Even in the geometric motives in P6, this was the method most followed instead of the traditional beaten rope or incised lines with a pointed instrument. Not only did this method speed out the transfer process, but the marks left on the surface of the *intonaco* were visible enough to guide the artist in the next stages of the painting's execution. Overall, Almada followed the drawings imprinted. Only a few variations and *pentimenti* are visible in all murals. Figure 7 shows some of the most obvious observed in P1, P3, and P6.

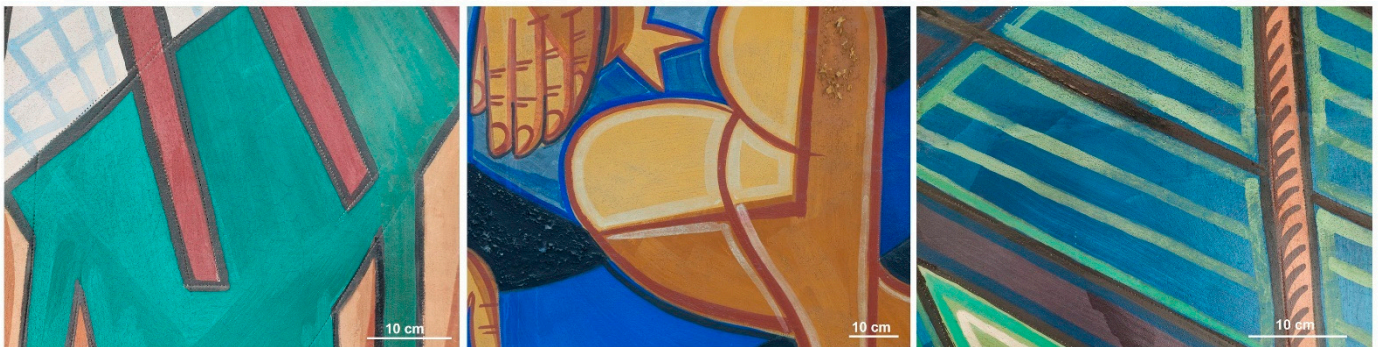
Figure 8. Detailed images in Vis of coloured backgrounds in P1, P3, and P6. In all, the different paint brushstrokes used to model the garments, flesh tones, and geometric motives can be observed (photos by M.Gil 2022).

The first noticeable feature is that Almada does not seem to have used the white *intonaco* as white paint ground or as a reflective layer. All the white paint grounds are achieved with another layer of calcium carbonate over the *intonaco* [5]. The other backgrounds of assorted colours, from light to dark, are generally very opaque, the brushstrokes being clearly visible on the thicker paint surfaces (Figure 8). The coloured backgrounds are also fairly homogeneous (Figure 8). The colour variations noted are given by (a) successive paint brushstrokes of the same pigment more or less diluted, (b) with a mixture of pigments, or (c) by increasing the white or black pigments in the composition (Table 2, Figure 8). The width of the different brushstrokes varies between 0.5 cm and 6 cm, revealing a wide use of brushes for different purposes, with the larger ones reserved mainly for the backgrounds and the thinner ones for the anatomic or decorative details (Figure 9).

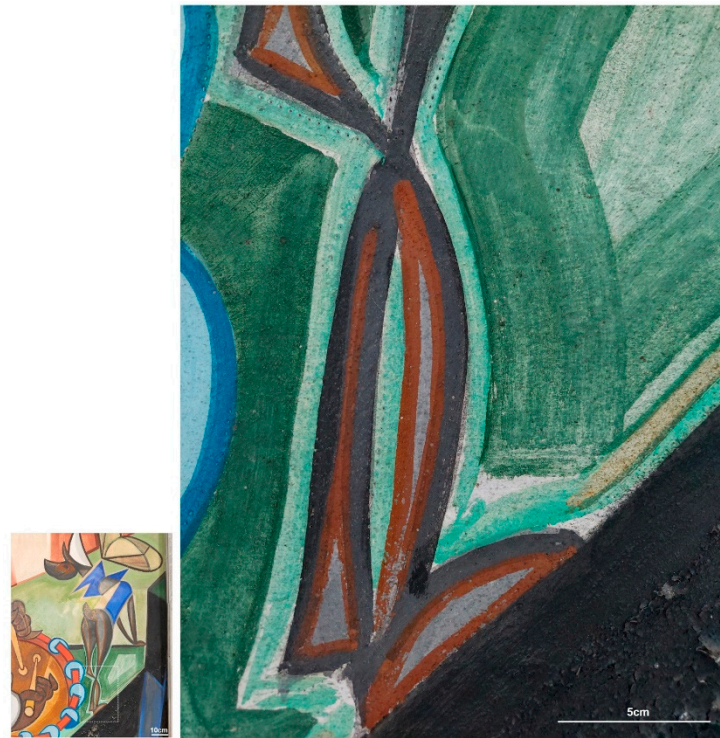
Figure 9. Details of the different types of brushstrokes used on the green background and to shape the dog leg in P3. The strokes are made in such a way as to outline the shape so that it is clearly visible from a distance (photo by M.Gil 2022).

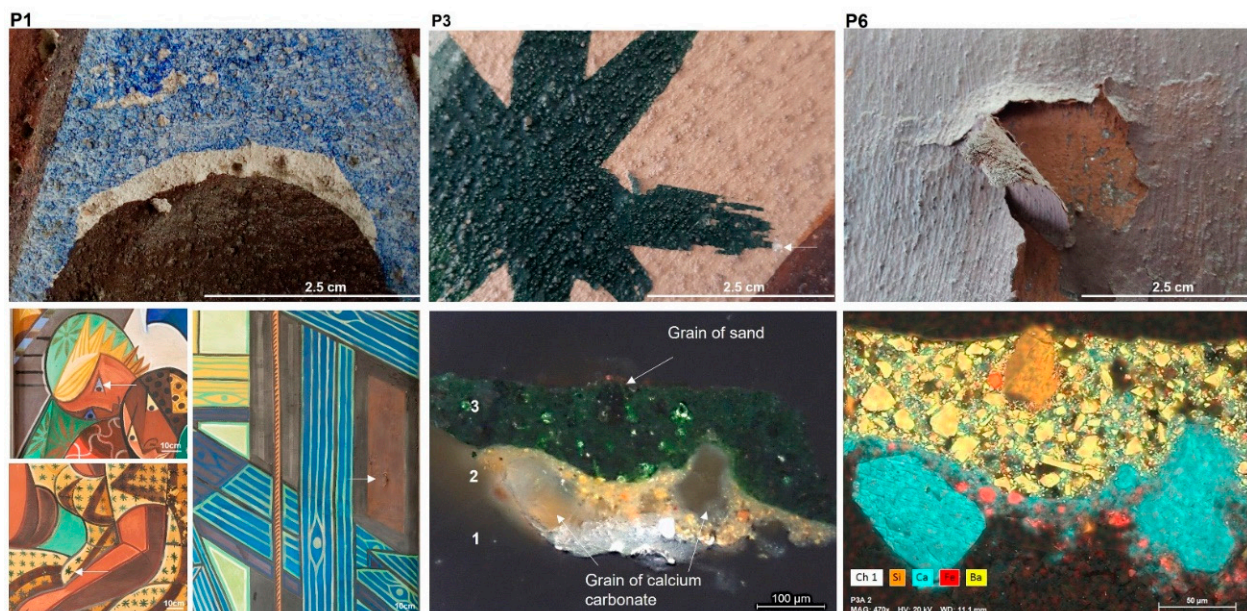
Figure 10. On top, macro images of textured paint layers on murals P1, P3, and P6, with the sampling location of sample P3A_2 marked with a white arrow. On the bottom left, OM-Vis at 200 \times and SEM-EDS elemental map of the P3A_2 cross-section, showing the presence of aggregates grains of calcium (in blue) and silicium (in orange) in the yellow and green paint layers (2 and 3). Layer 1 is the *intonaco*. The SEM-EDS data of the paint layers are reported in Table 2.

The paint layers, particularly the backgrounds, are generally very textured, and grains of aggregates can often be seen through the paint and even on the paint surface (Figure 10). In addition to the texture conferred by the granulometry of the top plaster and pigments used, it is possible that grains of calcium carbonates and sands were occasionally added to the paints, as is suggested on the flaking paint layers and on the cross-section in Figure 10.

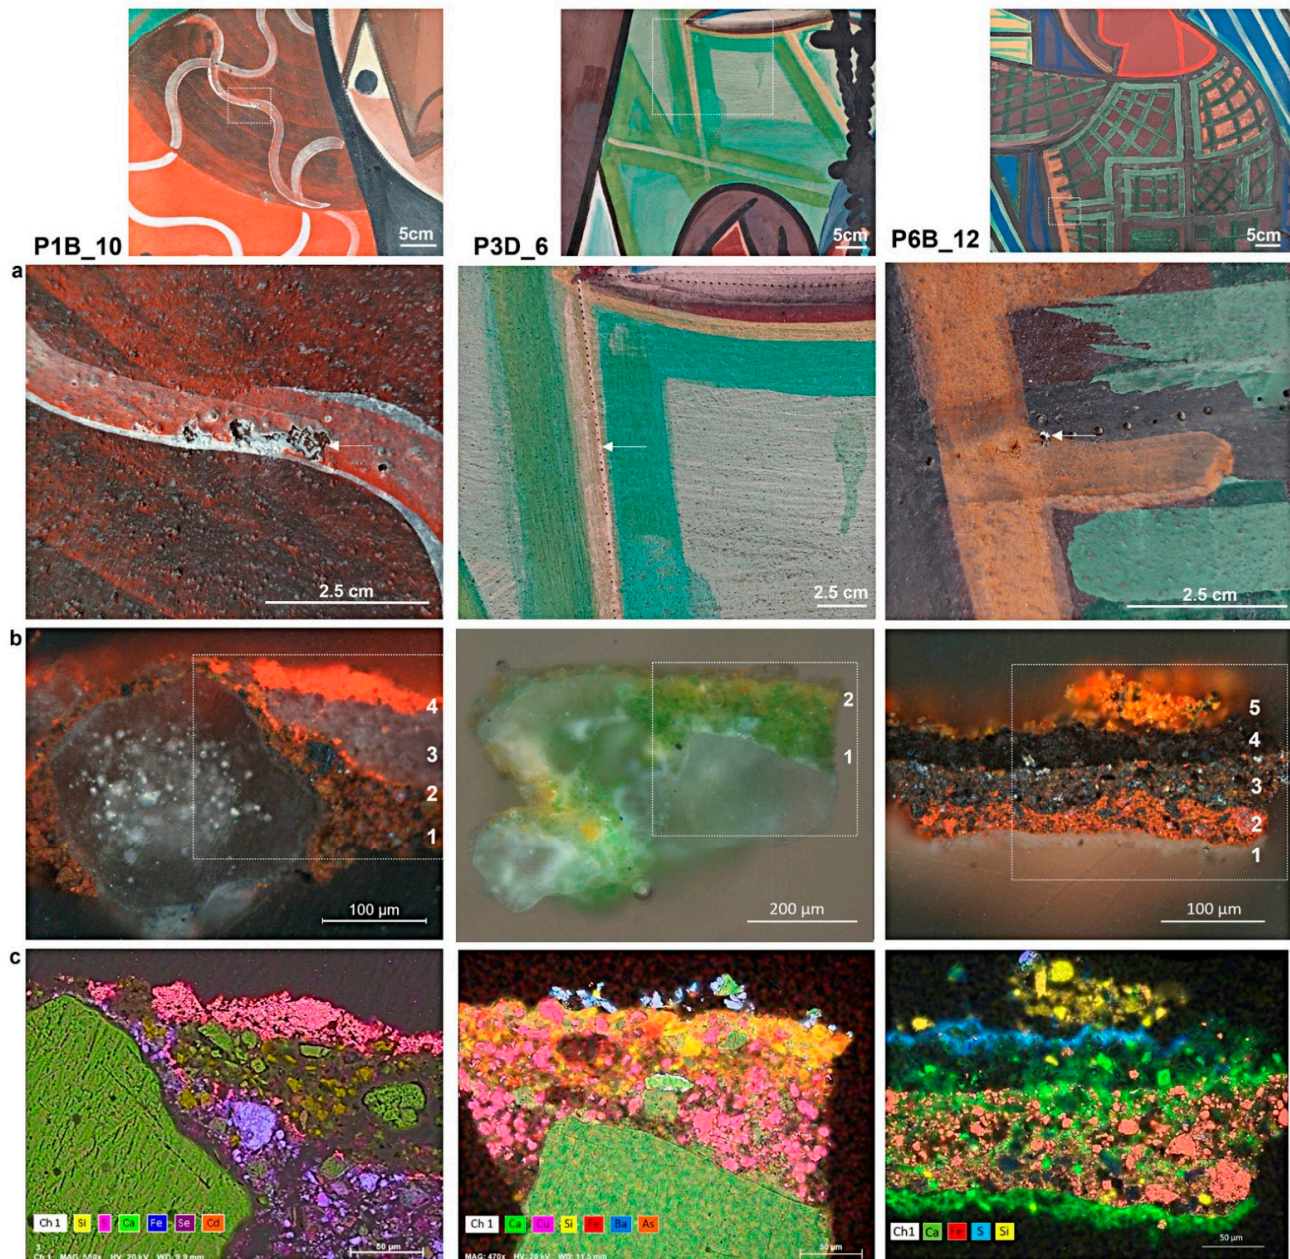
Figure 11. From top to bottom, (a) details and macrophotography of the sampling places of samples P1B_10, P3D_6, and P6B_12; (b) OM-vis 200× of the paint layers cross-sections with the indication of the number of layers identified; (c) SEM-EDS elemental maps of the paint layers revealing the presence of Ca-, Fe-, Cd-Se-, and Cu-As-based pigments. The stratigraphic description of the paint layers and SEM-EDS data are reported in Table 2.

he left or not enough time for the paint to dry between each layer. Figure 11 shows three examples of paint layers applied wet on wet and on a drier paint surface on P1, P3, and P6. The macro images reveal pigment contamination (and muddying), the cross-sections, the varying number of layers of paint placed, and their thickness.

colour palette present in all the murals, the artist did not confine himself to iron-based pigments, traditionally used in fresco mural paintings, as already reported in a previous study [5]. He has also resorted to the synthetic ultramarine blue and cadmium-based pigments, as well as the exotic but toxic copper (II)-acetoarsenite, commonly known as emerald green (Table 2). These pigments were used pure, mixed, and overlaid, as can be seen by OM-Vis in the paint layers of Figure 11.

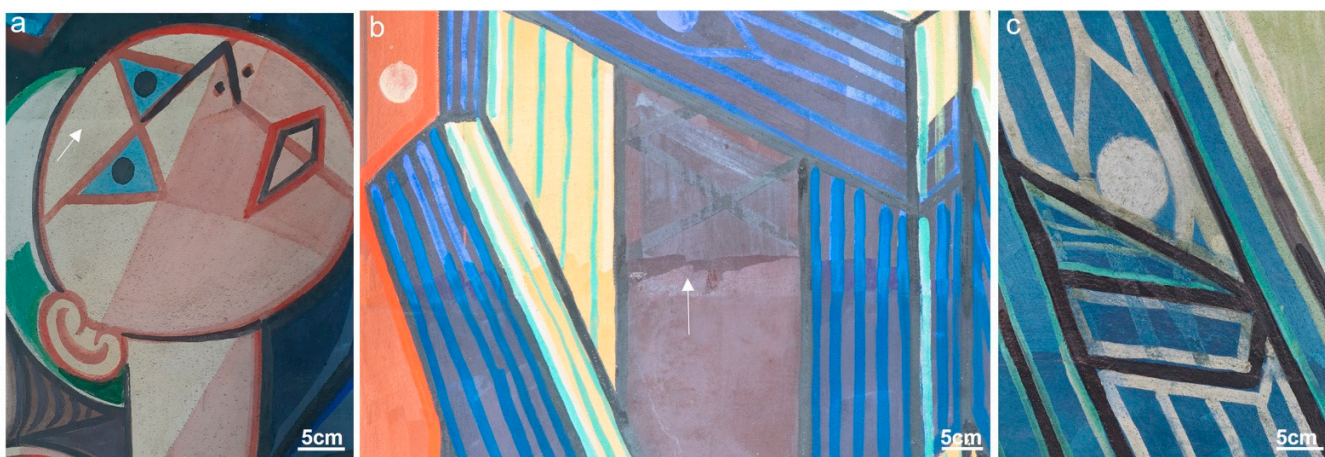
Figure 12. Detailed images with the indication of the plaster join areas in P3 (a) and P6 (b) and details of the change in composition during the painting work in P6 (c). The figure's face spans over two plaster sections and was painted with fluid brushstrokes over an opaque yellow background. The light pink layer and the anatomic details were made at the end to match the colour and disguise the plaster joins. On P6, this concern did not always occur, and colour differences are seen at the plaster joins (photos by M. Ribeiro and M. Gil 2022).

Almada painted fast and with confidence and only seemed to leave for the next day the layers of paint and final black outlines that spanned over two (or more) patches of plaster. This procedure not only ensured the colour uniformity of the figuration/motifs carried out on different working days but also disguised the mortar joins, guaranteeing the visual continuity of the paint work (Figure 12). This work method is visible in P1, and particularly in P3, on the faces of the figures in the upper half of the composition (Figure 12a). In mural P6, there seem to have been exceptions in this regard that were left visible (Figure 12b). Moreover, changes were made to the composition during the painting work, and several drops of paint are also visible on the paint surface, sometimes poorly disguised (Figure 12c). Another difference found in P6 was the lack of transparent and semi-transparent paint layers compared to P1 and P3. The simultaneous use of fluid and more opaque brushstrokes creates optical differences and effects that visually enrich the composition. In P6, the paint layers are mostly opaque and rather thick, from the backgrounds to the final touches, giving the impression that Almada ran out of time and had to speed up the painting execution.

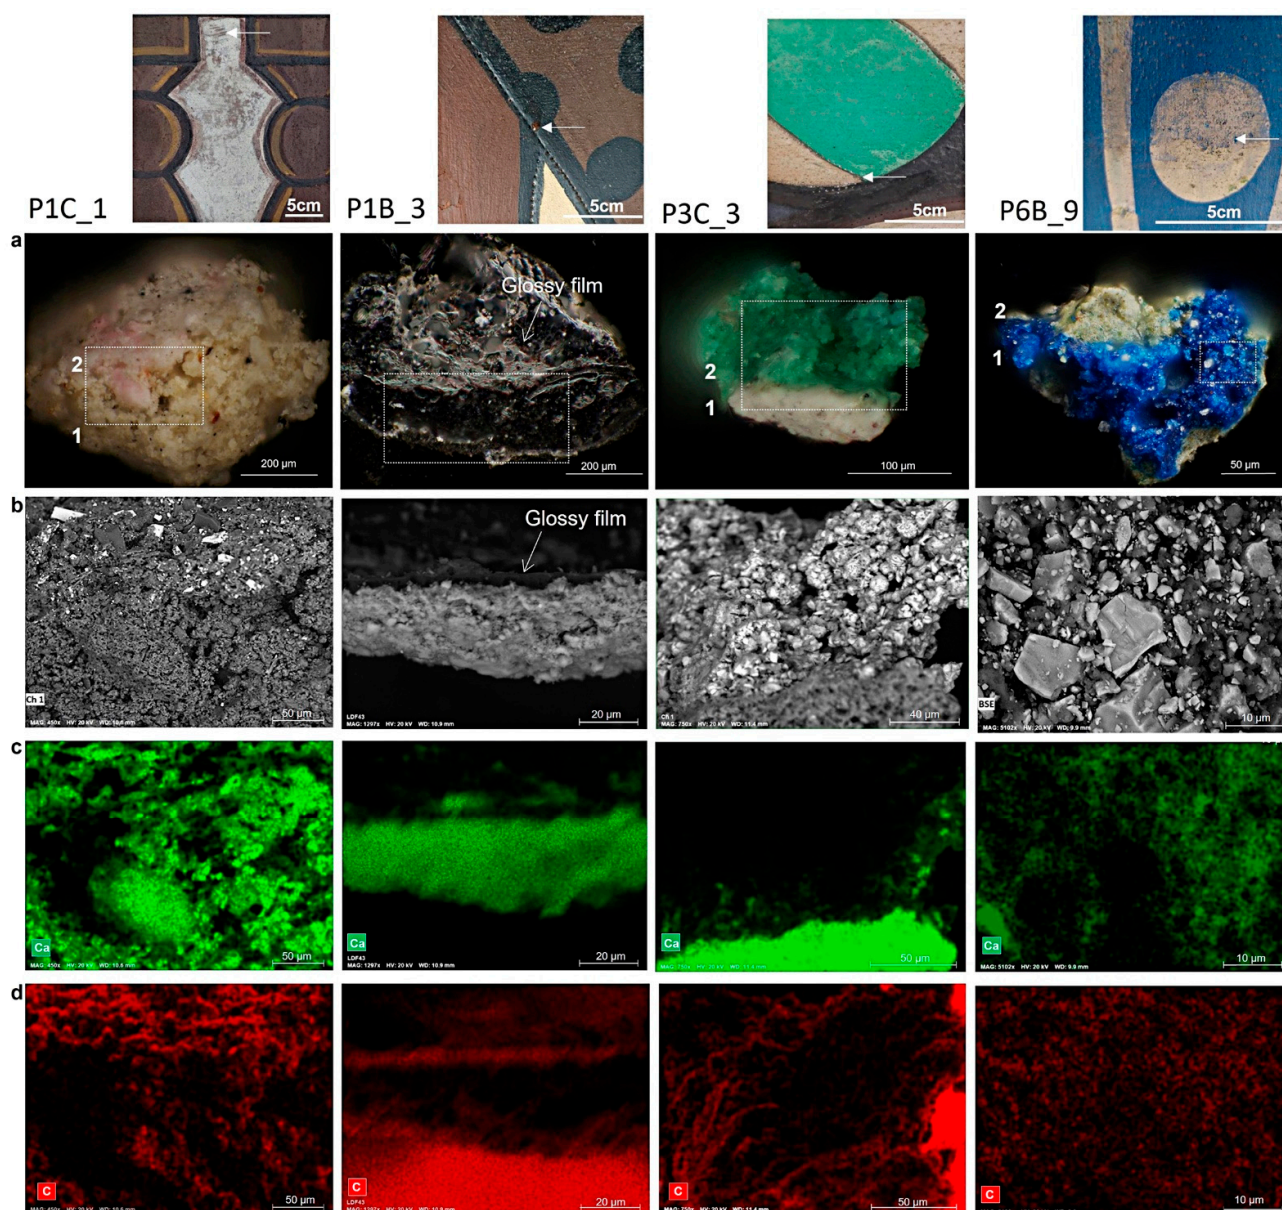
Figure 13. From top to bottom, (a) Image details of the sampling places of samples P1C_1, P1B_3, P3C_3 and P6B_9 and OM-vis 400 \times of the paint layers, with the indication of the number of layers identified; (b) SEM backscattered images of the paint layers and constituents; (c,d) SEM-EDS elemental maps distribution of calcium (in green) and carbon (in red) confirming the presence of both elements in the paint structure. Stratigraphic description of the paint layers and SEM-EDS data are reported in Table 2.

The first feature noticed by OM is the number of layers of paint, up to four, with thickness reaching 155–180 μm in the green P3C_3 and black P1B_3 of Figure 13. In general, the structure of a *fresco* painting on its own tends to be simple because the colours have to be applied while the substrate is still fresh so that the pigments are bound by the carbonation reaction that occurs between the calcium hydroxide contained in the *intonaco*

Given the large patches of mortar identified by Vis-Rak on P1, P3, and P6, it is likely that Almada only had time to paint at *fresco* the white and the coloured flat backgrounds, with the pigments previously mixed with lime in the thicker paint layers (example of P3A_2 in Figure 10). The overlapping layers of paint were most likely laid down at a later stage, with pigments mixed with lime milk (example of the pinkish and white layer of P1C_1 and of the black outline of P1B_3, Figure 13) or with an organic material (probably the green layer of P3C_3, Figure 13).

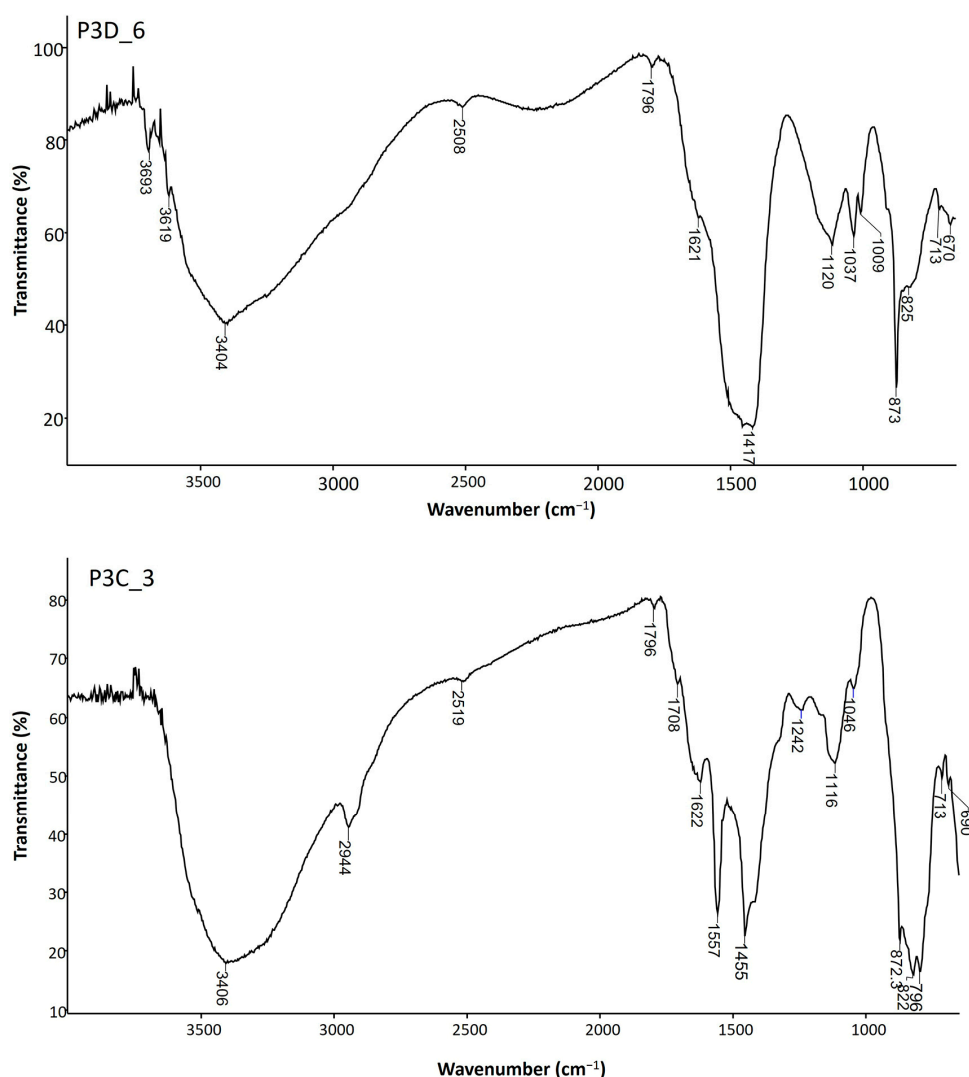
Figure 14. On top, FTIR spectrum of the green layer of sample P3D6. The absorptions in the spectrum allowed the identification of kaolin group minerals (3693, 3619, 1037, 1009 cm^{-1}), calcium sulphate dihydrate (3404, 1621, 1120, 670 cm^{-1}), and calcium carbonate (2508, 1796, 1417, 873, 713 cm^{-1}). The band at 825 cm^{-1} may be assigned to AsO or CrO elongations. On the bottom, FTIR spectrum of the green layer of sample P3C3. The absorptions in the spectrum allowed the identification of calcium sulphate dehydrate (3406, 1622, 1116 cm^{-1}), calcium carbonate (2519, 1796, 1455, 873 and 714 cm^{-1}), polyvinyl alcohol (2944, 1708, 1242 cm^{-1}), silicates (1046 and 690 cm^{-1}) and emerald green (1557, 1455, 822, 796 cm^{-1}).

The use of organic binders in this set of paintings should be particularly considered for pigments that, according to the technical literature, must not be applied at *fresco*, such as emerald green, as it could turn to a yellowish-green copper arsenite when in contact with lime [35]. Emerald green was found in samples P3D_6 and P3C_3, but, to date, the only organic material identified by μ -FTIR in these paint layers was polyvinyl alcohol (PVA) (Table 2, Figure 14).
