Green Mortars for Conservation: Utilizing agricultural and industrial waste for sustainable restoration.

A research paper submitted in partial fulfilment of the requirements for
the Master Of Science Degree In Archaeological Material Science
(ARCHMAT)

December, 2024.

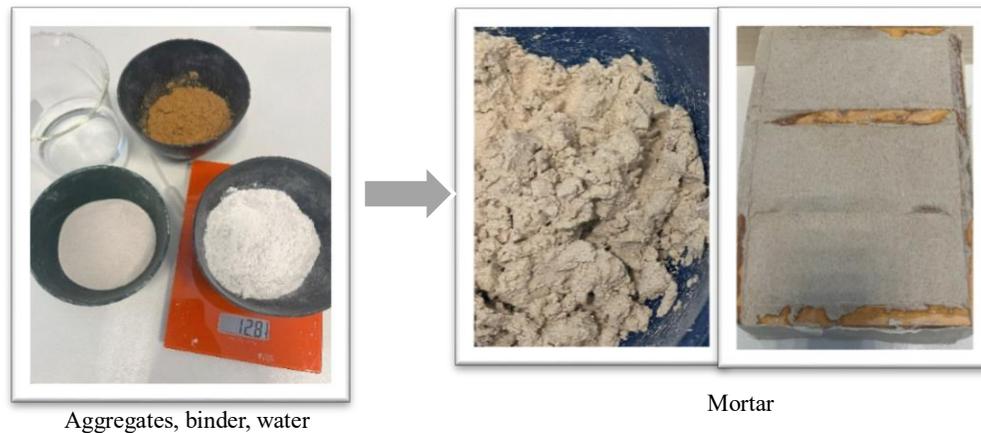
Figure 1: Mortar composition

The basic constituents of mortars are aggregates, binder and water, sometimes with some additives.

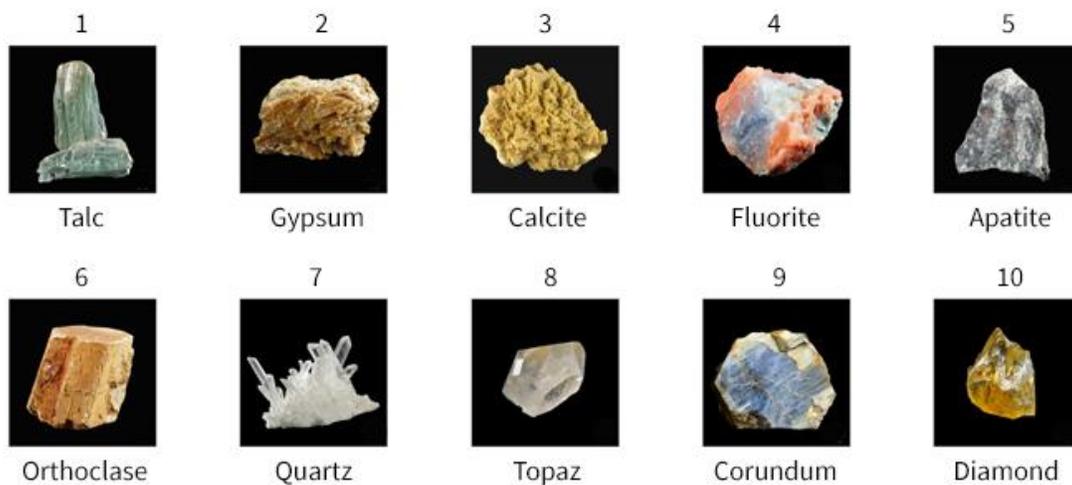
Figure 2: Moh's scale of hardness. Retrieved from: <https://www.jewelrycult.com/jewelry/what-is-the-mohs-scale-of-mineral-hardness>

one of the hardest common minerals, rated at 7 on the Mohs scale. Because of its resistance to scratches and fractures, chemical stability, and its resistance to high temperatures, quartz can be used in a wide range of applications that require longevity and durability [17].

This makes aggregates containing quartz highly resistant to mechanical wear, contributing to the durability of the mortar. Feldspar minerals which include orthoclase and plagioclase, have a hardness level of 6 on the Mohs scale.

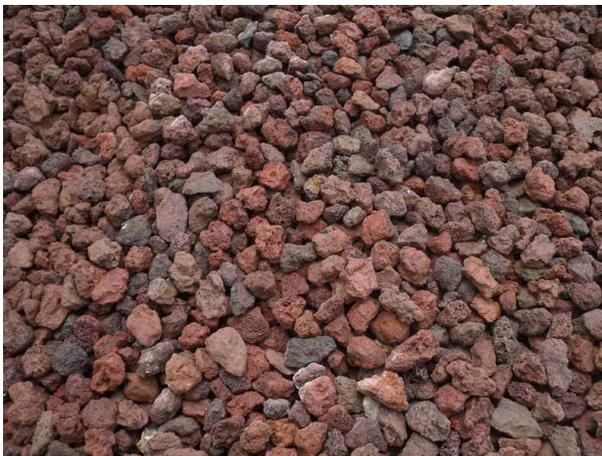
Figure 4: Pozzolana. Retrieved from <https://www.archeoflegrei.it/pozzolana-la-polvere-puteoli/pouzzolane15-20-03-z-c340-c491/>

The term "pozzolana" is derived from the Italian town of Pozzuoli, near Mount Vesuvius, where extensive fine-grained volcanic ash deposits were the principal source of natural pozzolan [26]. The Romans realized that combining volcanic ash, lime, and water resulted in a strong and durable building material. Roman engineers also recognized the hydraulic properties of pozzolanic materials which made them ideal for underwater construction [27]. Pozzolans, such as volcanic ash, react with calcium hydroxide ($\text{Ca}(\text{OH})_2$) in wet conditions to form calcium silicate hydrate (C-S-H), the main binding phase responsible for strength and durability in cementitious materials. Since pozzolanic reactions; ($\text{Ca}(\text{OH})_2 + \text{H}_4\text{SiO}_4 \rightarrow \text{CaH}_2\text{SiO}_4 \cdot 2\text{H}_2\text{O}$) which can also be represented as C-S-H (Calcium silicate hydrates) occur in wet conditions, it for instance allowed the Romans to build harbours, piers, and other maritime structures that have survived for millennia. However in cases where natural pozzolans from volcanic activities are unavailable, other materials such as crushed bricks and tiles can be utilized. Examples of other artificial "pozzolanic" materials include industrial by-products such as fly ash, silica fume, ground granulated blast-furnace Slag (GGBS) and sugarcane bagasse ash. Rice husk ash and calcined clay such as metakaolin are other examples of pozzolanic materials utilized.

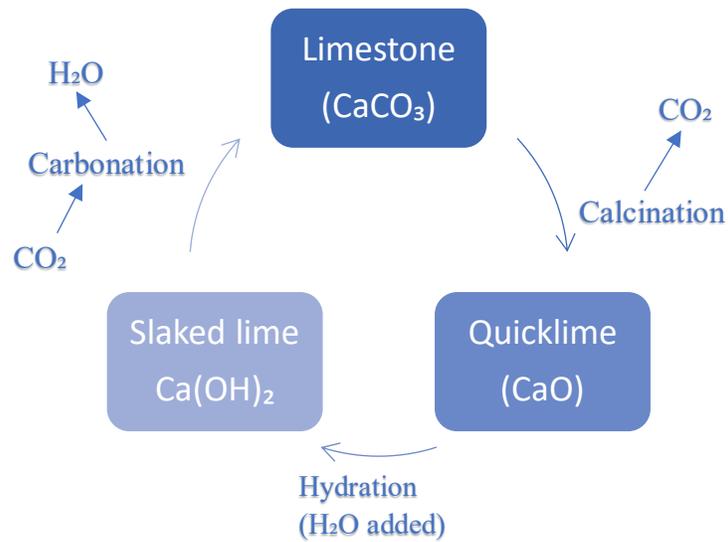
Figure 5: The lime cycle

The raw material for lime production is limestone, mainly made of calcium carbonate (CaCO_3). The limestone is then converted into lime through the processes of calcination, hydration and carbonation. These make up what is known as the “lime cycle” (Figure 5).

Processes involved in the lime cycle;

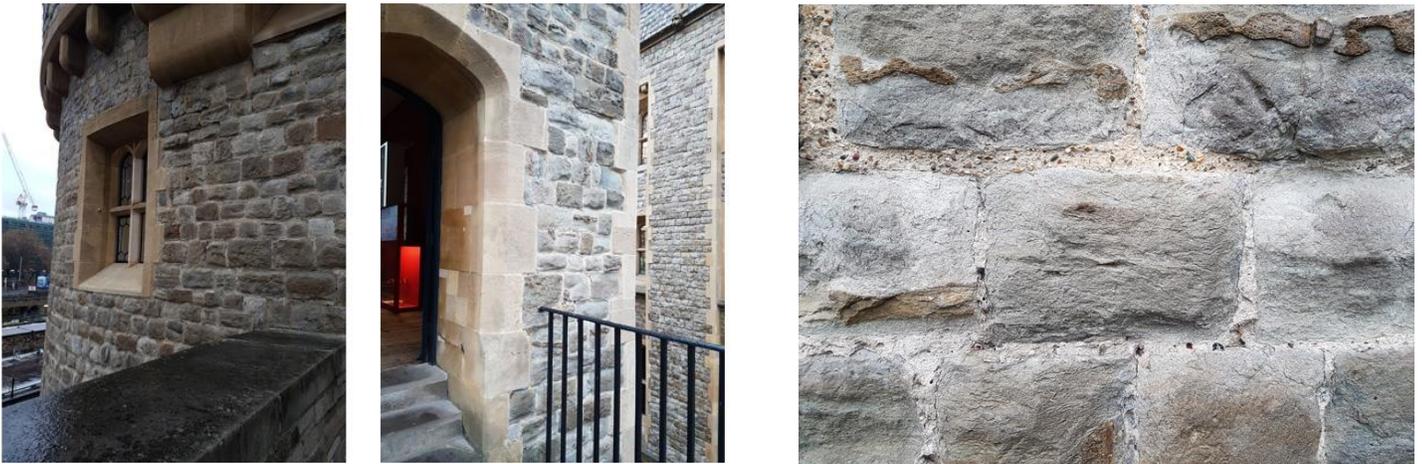
Figure 6: Repair mortars incorporating a blended coarse stuff lime putty mixture applied in the restoration of the bell tower at the Tower of London, UK. Retrieved from: <https://www.limestuff.co.uk/blog/tower-of-london>

The Tower of London, a UNESCO World Heritage site, underwent significant restoration using lime mortars to match the materials used in its original 11th-century construction. The restoration sought to ensure long-term durability while preserving historical integrity. Extensive testing led to

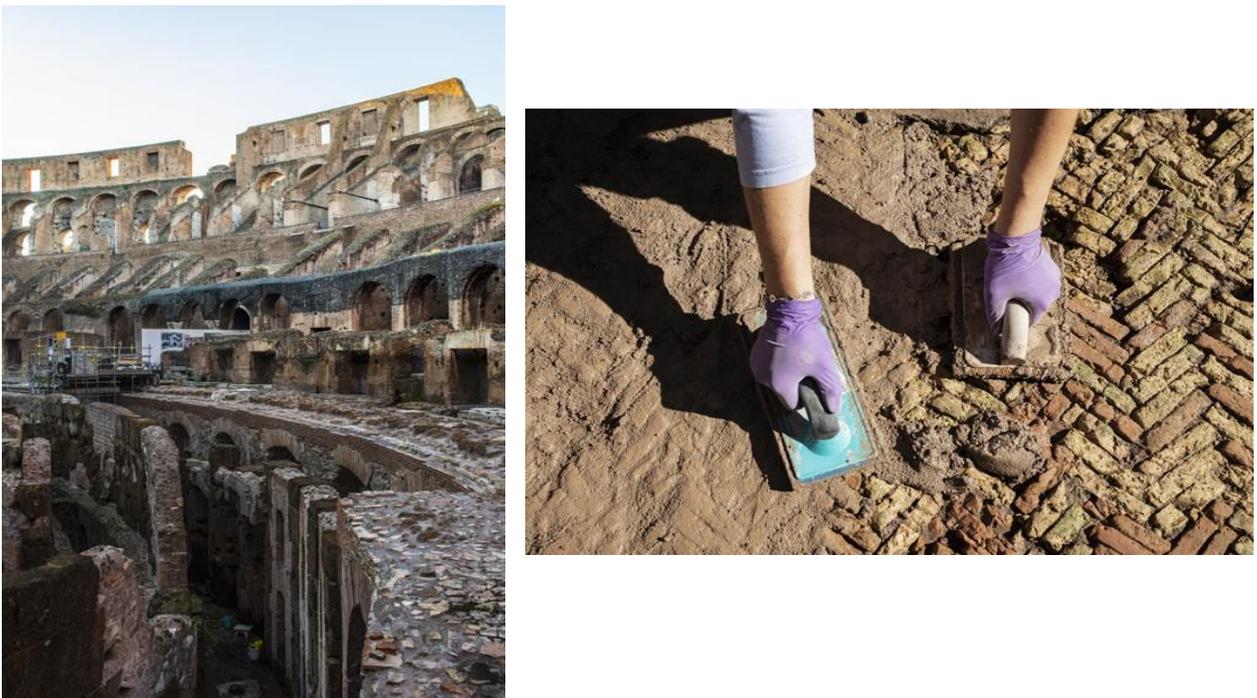
Figure 7: The restoration of the Colosseum's hypogea. Retrieved from <https://www.todsgroup.com/en/sustainability/colosseum-restoration-hypogea>

The Flavian's amphitheatre popularly known as the Colosseum, the monumental Roman amphitheatre, has undergone several restoration phases to repair damage caused by pollution, weathering, natural disasters, human activities and time. Central to these efforts has been the application of traditional lime mortars in the repair of its stone and brickwork, effectively

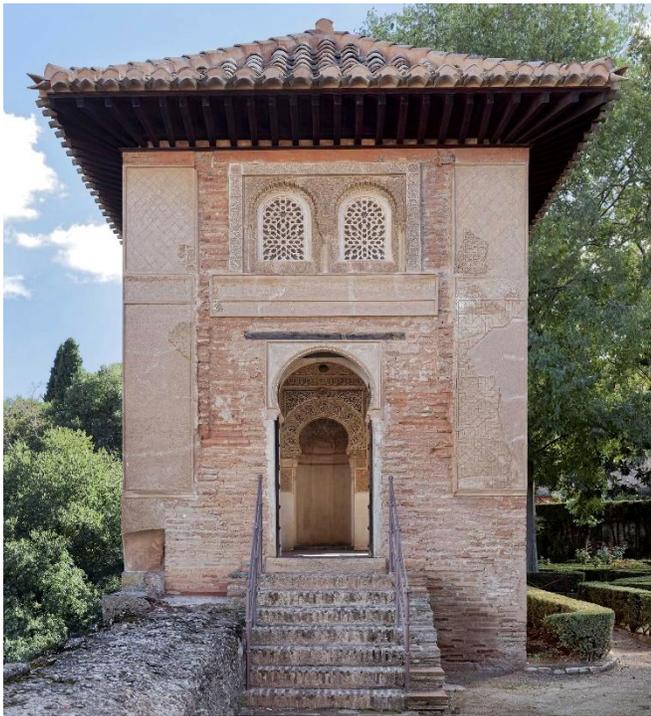
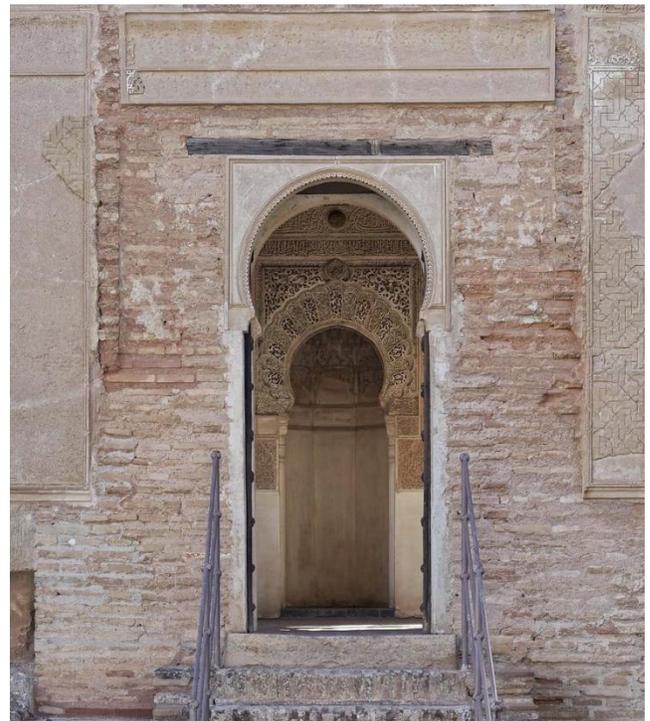
Figure 8: Repairs and restorations of the Oratory of the Partal Palace in The Alhambra, Spain. Retrieved from <https://www.europeanheritageawards.eu/winners/oratory-partial-palace-alhambra-spain/>

The Alhambra, a prime example of Nasrid architecture and one of the best-preserved Islamic palatine complexes from the medieval period, remains a significant heritage site in the Iberian Peninsula, constructed during the Islamic era (711–1492) [51]. Ongoing restoration initiatives have focused on safeguarding its intricate Islamic and mudéjar elements. A notable restoration was completed in 2017 on the Oratory of the Partal Palace, where lime mortars were employed to stabilize the original structure. Lime mortar stripes were applied along accessible edges to reinforce the brick wall fabric, while hydraulic mortar was injected into critical points prone to potential detachment [51].

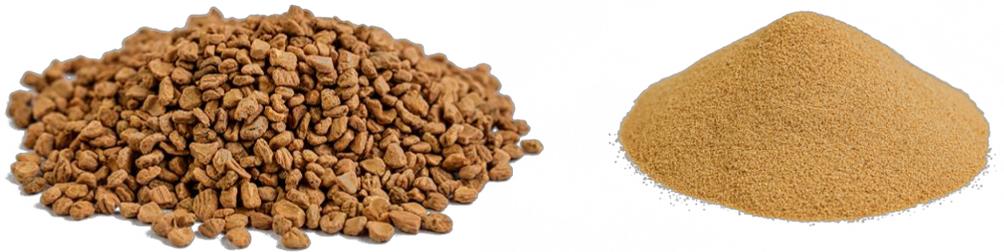
Figure 9: Left- Unmilled olive stones, Right- Ground olive stone (100-300microns). Retrieved from: www.bio-powder.com/en/olive-pit/

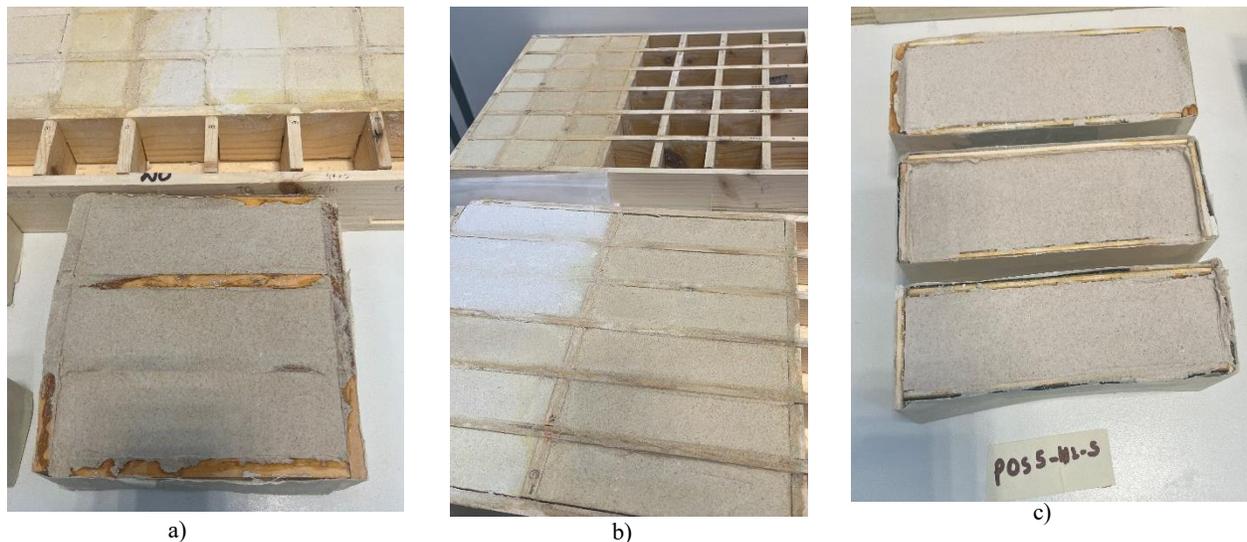
Figure 10: Curing of mortar samples - (a) – wet mortar mixture in a prism mould, (b) – dried mortar samples in cube and prism moulds, (c) – labelled wet mortar in prism moulds

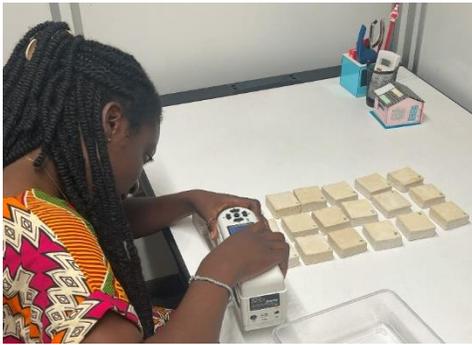
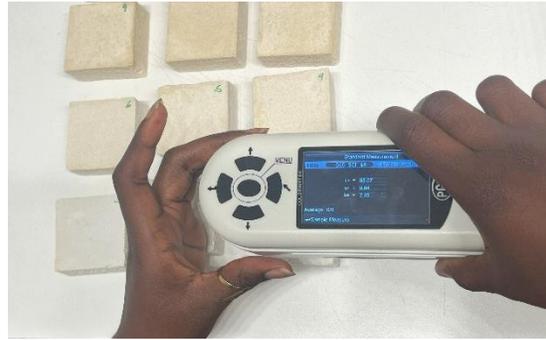
The colour measurements were conducted using a PCE-CSM 7 portable colorimeter. For each sample, data were collected from five distinct points: the top left corner, the top right corner, the bottom left corner, the bottom right corner, and the centre. The average values of the L*, a*, and b* coordinates were then calculated from these five points to evaluate the colour change in the samples with varying concentrations of GOS. The total colour difference (ΔE) of the specimens in the CIELAB colour space was evaluated by $\Delta E = \sqrt{(\Delta L^2 + \Delta a^2 + \Delta b^2)}$.

In the CIE colour space, the L* value represents the lightness component, ranging from 0 (black) to 100 (white). The a* value denotes the red-green axis, where positive values indicate a shift towards red and negative values indicate a shift towards green. The b* value represents the yellow-blue axis, with positive values indicating a shift towards yellow and negative values indicating a shift towards blue.

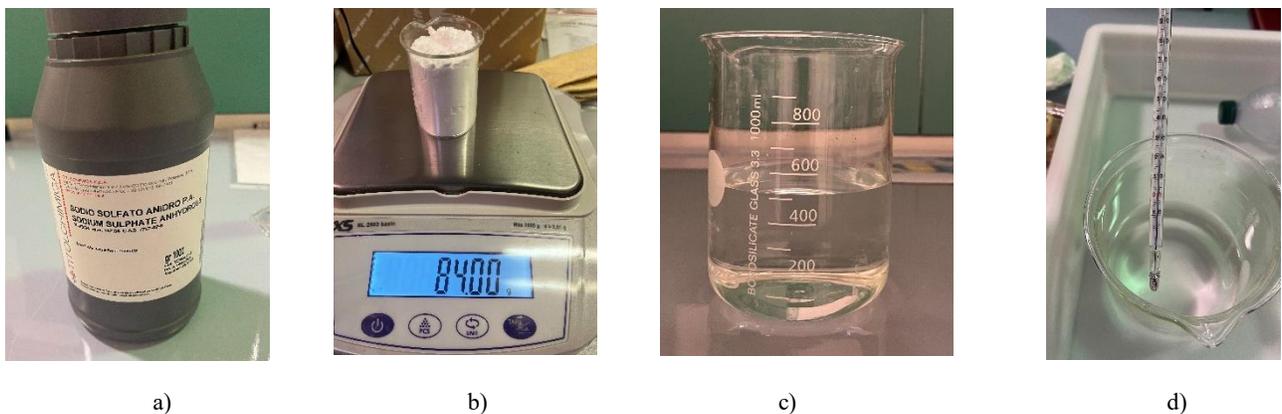
Figure 12: Preparation of a solution of sodium sulphate – (a) - Sodium Sulphate (Na_2SO_4), (b) – 84 grams of Na_2SO_4 , (c) – 516 ml of distilled water, (d) – Solution of Na_2SO_4 in a water bath

After drying to a constant mass, the samples were measured again before the start of the first cycle. A sodium sulphate solution (Na_2SO_4) was prepared by dissolving 84 grams of sodium sulphate in 516 millilitres of distilled water, mixing it with a magnetic stirrer until all the salt was completely dissolved. The solution was then placed in a water bath to maintain the temperature at $(20 \pm 0.5)^\circ\text{C}$.

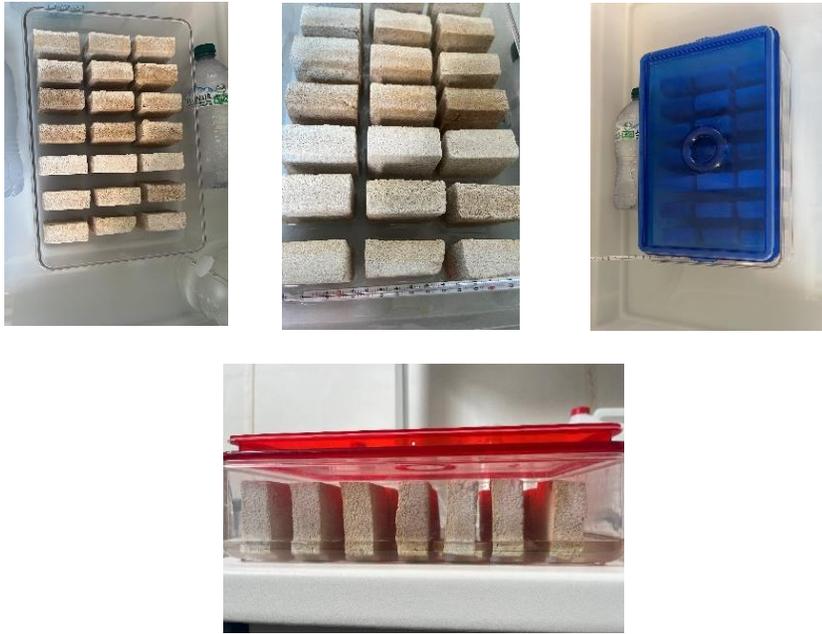
Figure 13: Representation of how the specimen were contaminated with the sodium sulphate solution while maintaining the temperature of the solution in a water bath

The dried samples were then carefully placed in a plastic container positioned within a water bath to maintain the solution's temperature at $(20 \pm 0.5)^\circ\text{C}$. The solution was carefully poured into the container until it covered approximately 10% of the height of the samples from the bottom. This was done to ensure contamination by capillary absorption of the salt solution from the bottom surface, following the recommendations of RILEM TC 271-ASC. The container was then covered to minimize evaporation, and the specimens were left to soak for 2 hours.

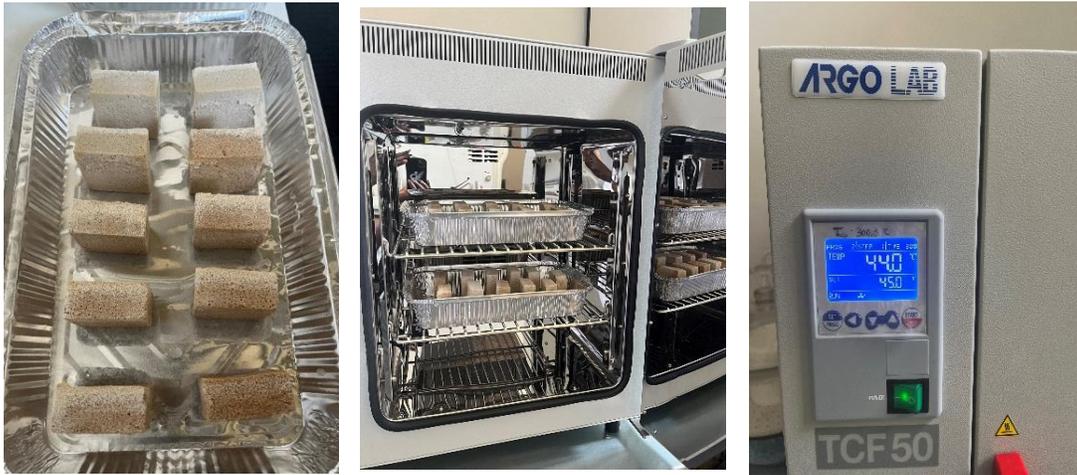
Figure 14: Drying of the specimens after immersion

After soaking for 2 hours, the specimens were removed and then dried in an oven at 45°C for 8 hours. Subsequently, they were allowed to cool to room temperature for 12 hours, after which they were weighed and photographed. A new solution was prepared, and the cycle was repeated 15 times, except for specimens that broke before the fifteenth cycle. The results, which is the relative mass difference ΔM (mass loss or gain) are expressed as a percentage of the initial dry mass M_d and the number of cycles required to induce failure in cases where the specimen has disintegrated or has broken into two or more pieces before the final drying, in the equation $\Delta M = \frac{M_f - M_d}{M_d} \times 100$. Where M_f is mass of the dried specimen in grams, after the 15th cycle, or the number of cycles required to induce failure in cases where the specimen has broken into two or more pieces before the final drying, and M_d is the mass of the dried specimen with label before first cycle, in grams.

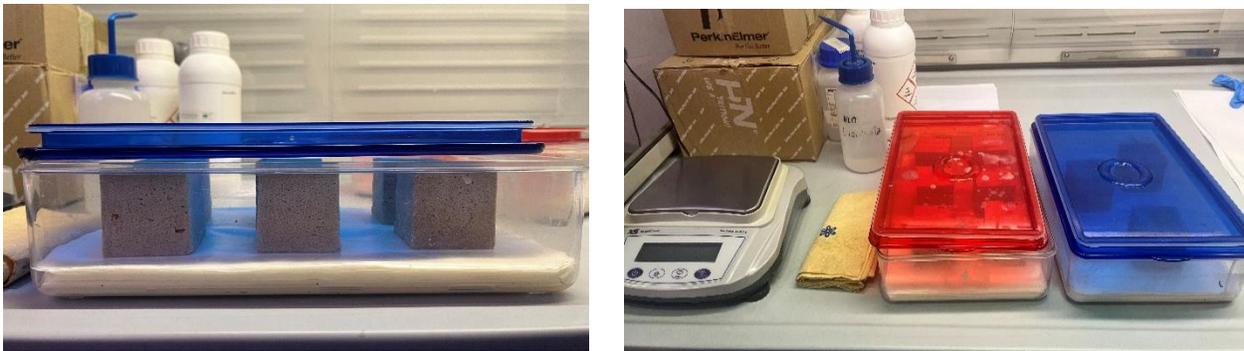
Figure 15: Set up for water absorption by capillarity test

In this research, the samples were first dried to a constant mass in an oven at a temperature of 60 ± 2 °C until their mass change was less than 0.1% after two successive measurements in 24 hours to ensure that the test starts with a completely dry sample. Once the samples were dried and cooled to room temperature in a desiccator, they were weighed to determine the mass of the dried specimen, which is the initial mass (m_0) of the samples. The dried samples were then placed on a saturated layer of absorbent paper about 1 ± 0.5 cm thick, which was placed at the bottom of a flat bottomed container filled with distilled water.

The samples were left in this position and later weighed after 10, 20, 30 and 60 minutes and after 4, 6, 24, 48, 72, 96, 128, 152 and 176 hours. After the immersion time has elapsed, the samples were removed from the saturated layer of paper, surface water was then removed using a damp cloth, and the samples were weighed immediately. This is the wet mass (M_i) of the sample. The amount of water absorbed by the specimen through capillary action, calculated by the difference between the wet mass at time (t_i) and the initial dry mass of the sample (m_0) as a function of time in relation to the samples' surface area in contact with the water was expressed as $Q_i =$

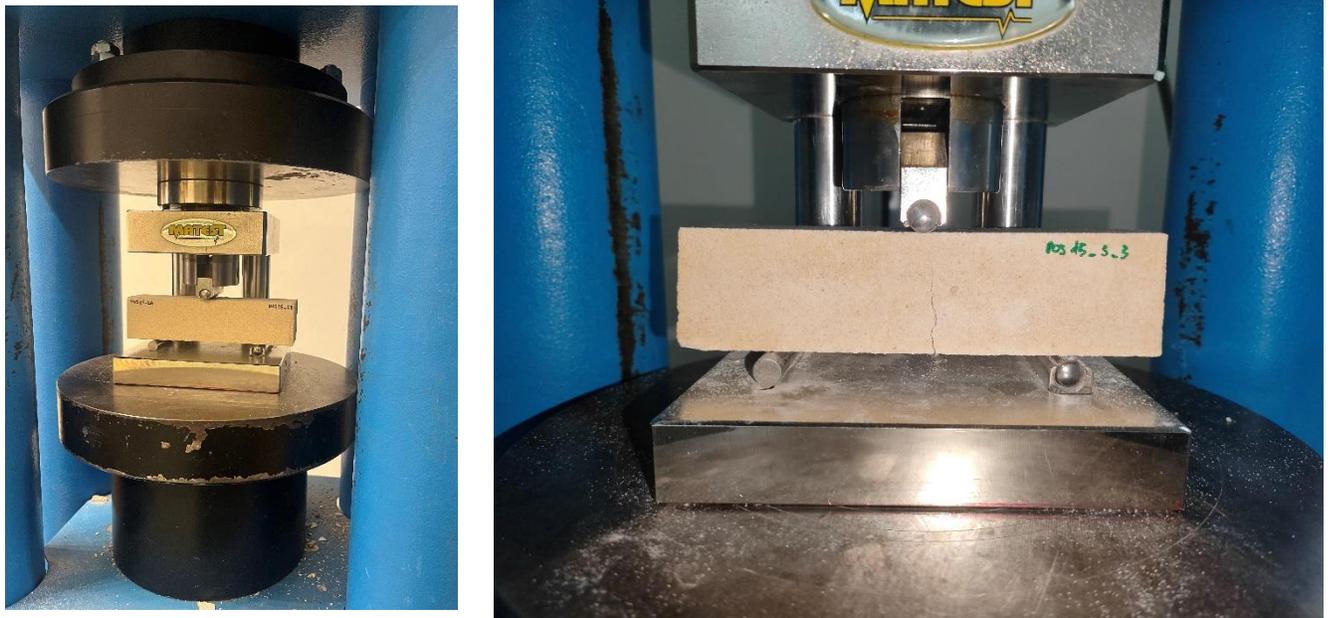
Figure 16: Loading arrangement for flexural strength test

The flexural strength (f) corresponds to the maximum force recorded by the machine, and it was determined with the equation: $f = 1.5 \times \frac{(F.l)}{b.d^2}$. Where F is the maximum load applied to the specimen, in kilo newton (KN), l is the distance between the support rollers, in millimetres (mm), b is the width of specimen, in millimetres (mm), and d is the depth of the specimen, in millimetres (mm).

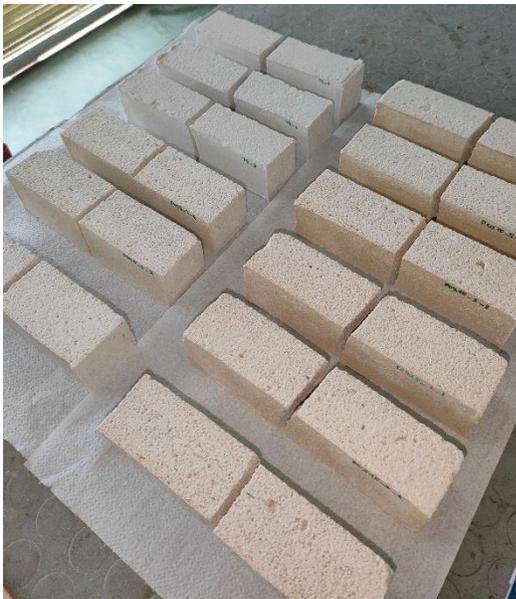
Figure 18: Halved specimens after flexural strength test

In this research, the compressive strength of the specimen was determined using the half remains of the samples after the flexural strength test according to the EN 1015-11:2019 [85], standard. During the test, each sample was placed in the testing machine and compressed, with a load applied at a rate of 0.20 MPa/s to ensure that failure occurred within a time frame of 30 to 90 seconds. The compressive strength was then determined by dividing the maximum load recorded during the test by the compressed area of the sample expressed in the equation; $f = \frac{F}{A}$, where F is the maximum the maximum load applied to the specimen, in Kilo newtons (KN), and A is the area of the compressed sample surface.

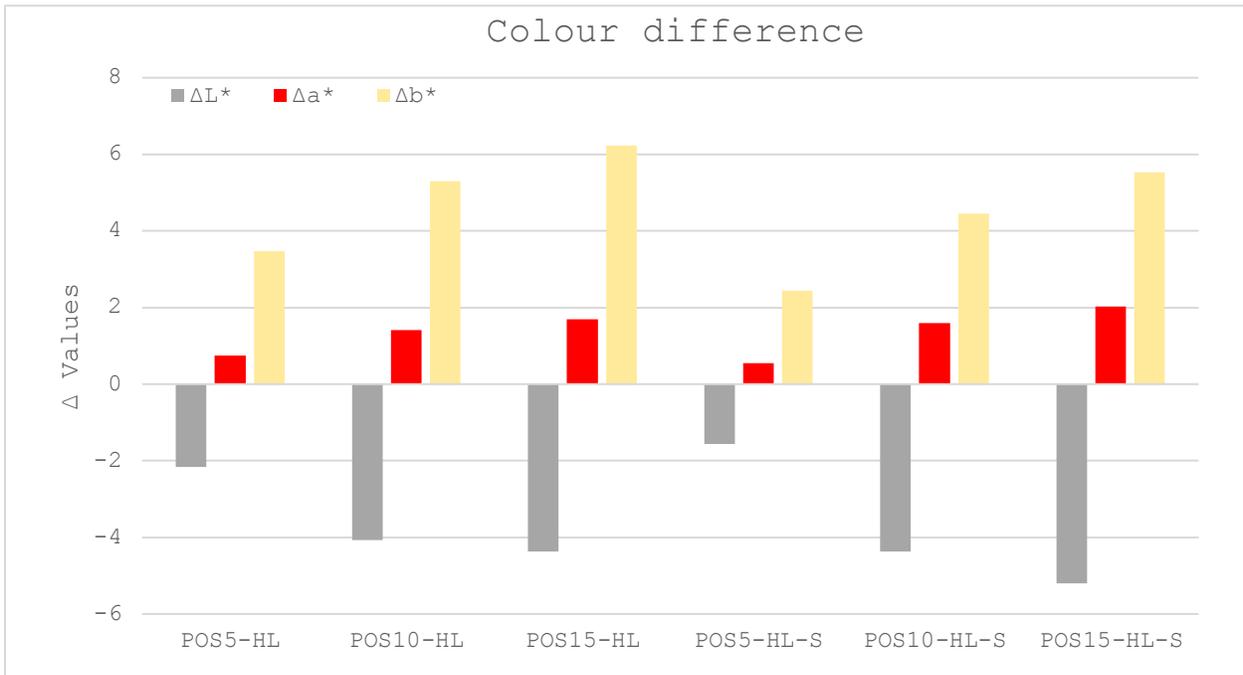
Figure 19: Graphical representation of the colour difference

From the data above, it is observed that all specimens have negative ΔL^* values, indicating that they are darker than the reference sample. The darkening effect increases as GOS content increases. For example, POS15-HL (-4.37) is darker than POS5-HL (-2.15). Meanwhile the nano silica-modified specimens (POS-HL-S series) generally show a smaller reduction in lightness compared to the POS-HL. For example, POS5-HL-S has a ΔL^* of -1.57, which is lighter than POS5-HL at -2.15.

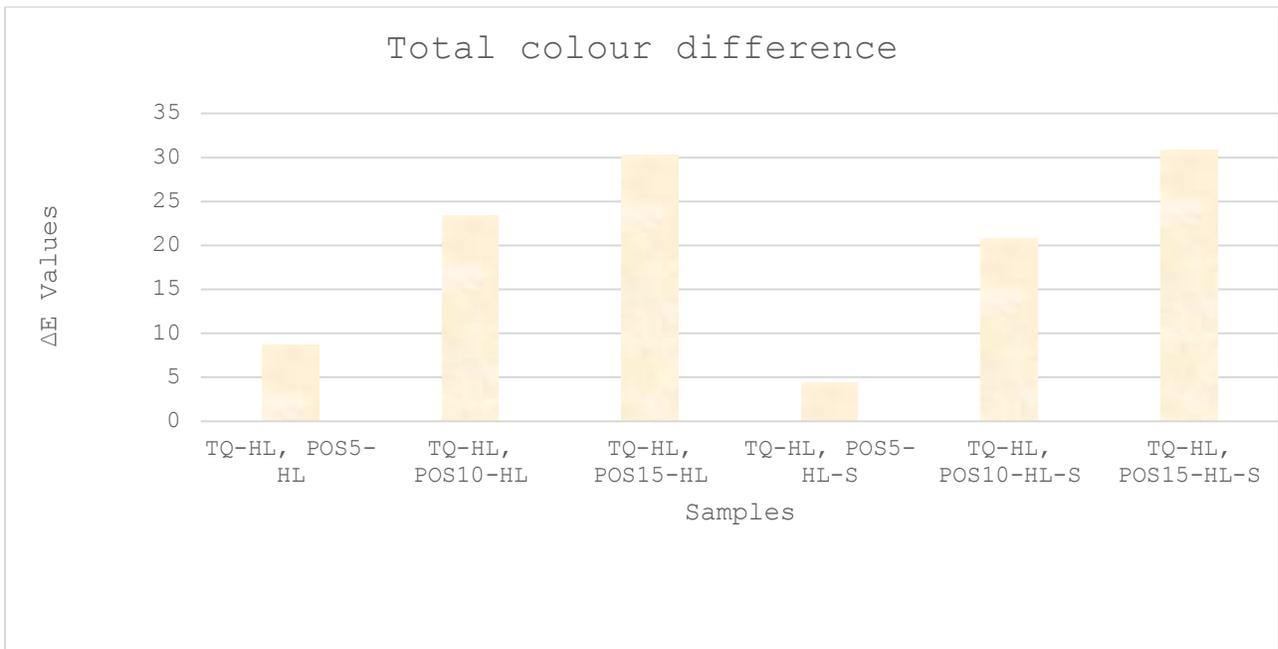
Figure 20: Graphical representation of the Total colour difference ΔE

From the data in Table 9 and Figure 20 above, it is observed that as the GOS content increases from 5% to 15% in the POS-HL series, the total colour difference (ΔE) increases significantly. For POS5-HL, the ΔE is 8.63. The value jumps to 23.34 for POS10-HL and the highest value at 30.32 in the case of POS15-HL. The POS-HL-S series however, tend to have lower ΔE values compared to their unmodified counterparts, especially for lower GOS content. For example: POS5-HL-S has a ΔE of 4.37, which is significantly lower than the 8.63 of POS5-HL. POS10-HL-S has a ΔE of

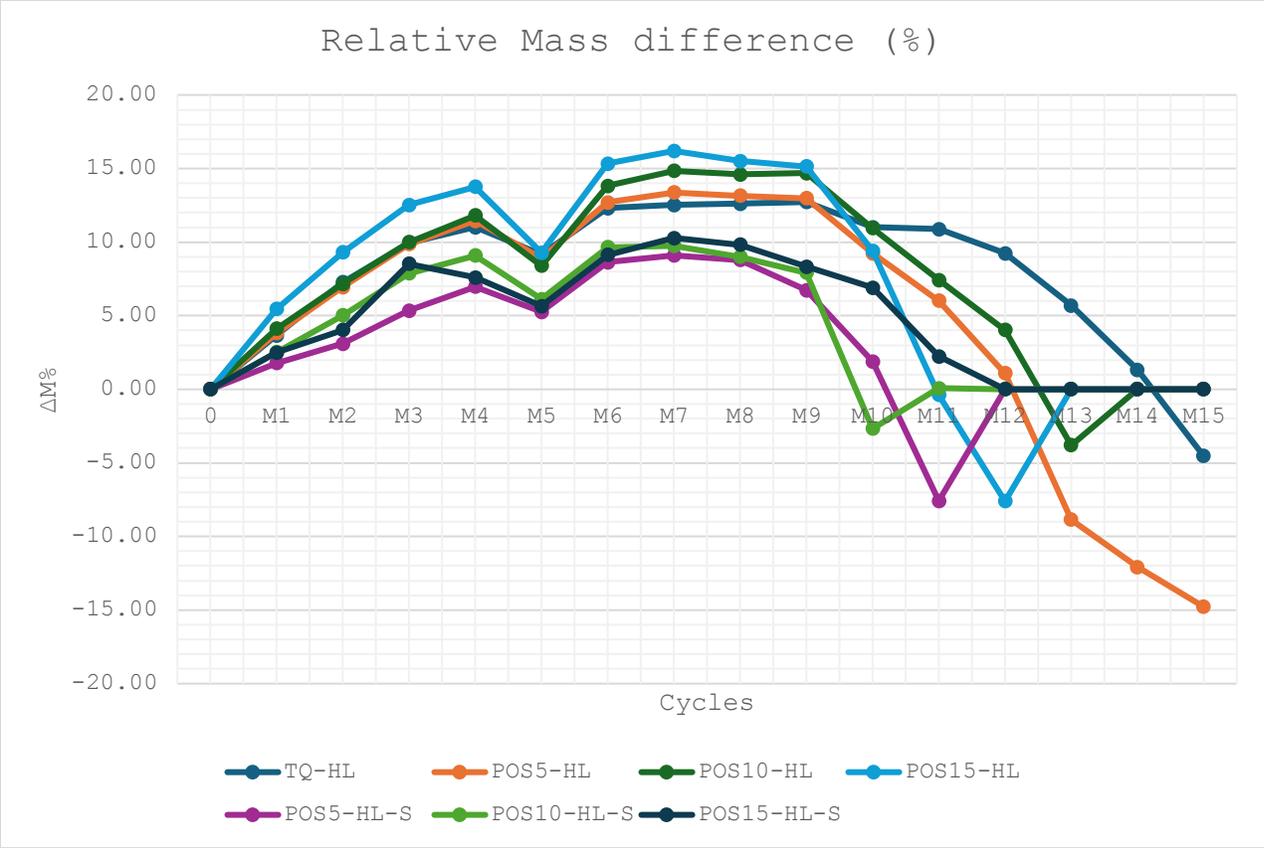
Figure 21: Graphical representation of the relative mass difference (%)

It can be observed that even though the TQ-HL sample survived all 15 cycles, it suffered considerable damage, dropping from 12.73% (cycle 9) to 11.02% (cycle 10), ending at -4.53% by the 15th cycle. POS5-HL, with only two intact samples, also experienced significant mass loss, dropping from 12.98% (cycle 9) to 9.23% (cycle 10), and eventually to -14.77% by the 15th cycle. Specimens containing higher GOS content like the POS10-HL and POS15-HL, and all nano silica-modified samples disintegrated before the 15th cycle. These trends are graphically presented Figure 21 below.

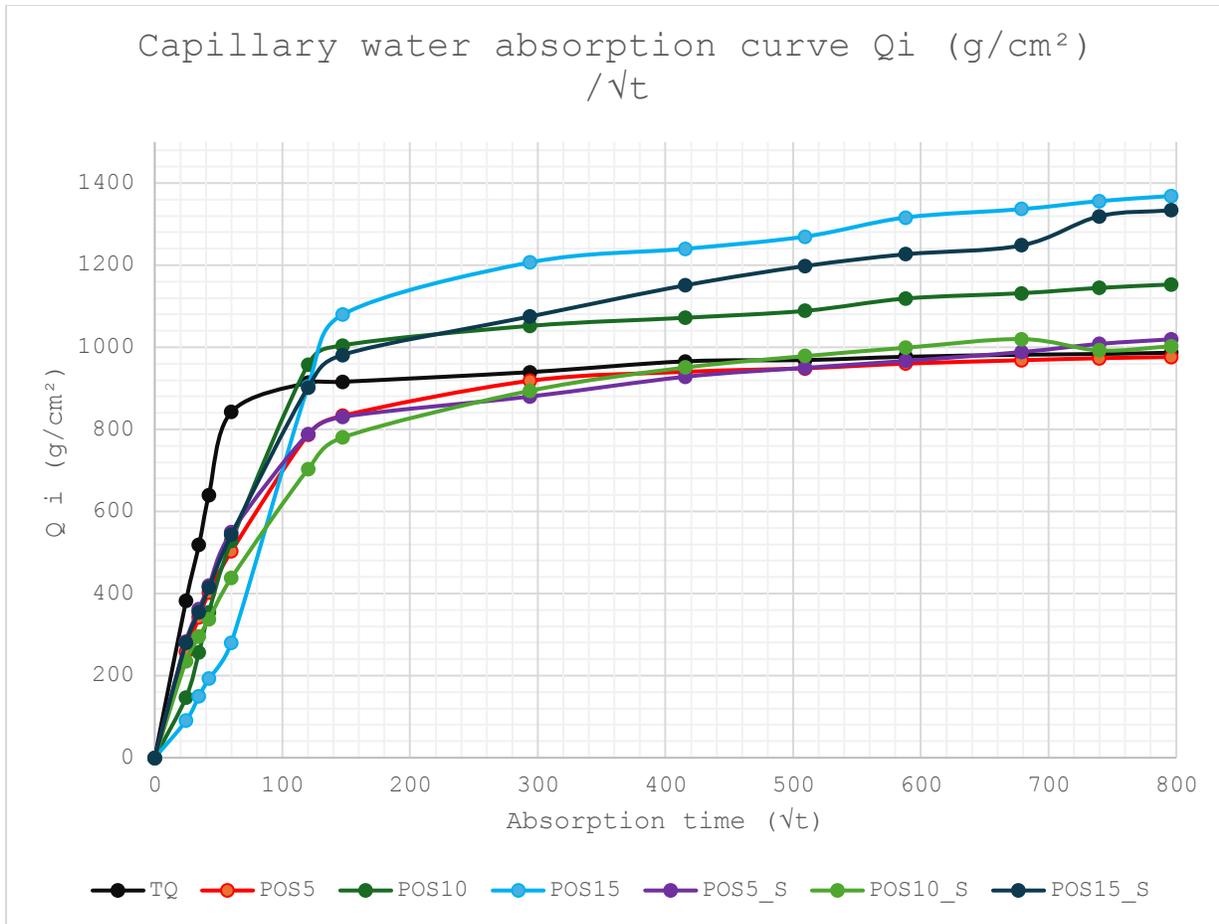
Figure 22: Graphical representation of the capillary absorption curve

The TQ-HL reference sample has the highest initial water absorption rate at $382.13 \text{ g}/\text{cm}^2/\sqrt{t}$, while the GOS-modified samples show lower initial absorption rates. POS5-HL with a value of $258.40 \text{ g}/\text{cm}^2/\sqrt{t}$, POS10-HL with $146.80 \text{ g}/\text{cm}^2/\sqrt{t}$ and POS15-HL with $90.00 \text{ g}/\text{cm}^2/\sqrt{t}$. This indicates that as the GOS content increases, the initial water absorption decreases, with the highest GOS content POS15-HL showing the lowest water absorption initially.

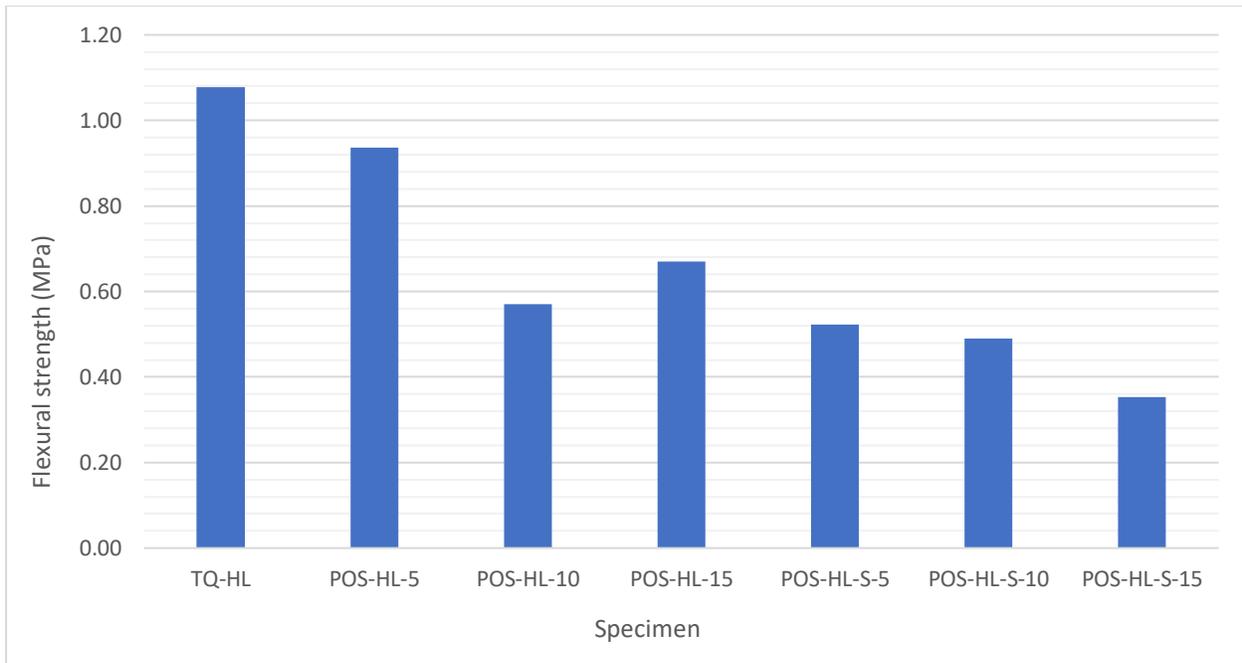
Figure 23: Graphical representation of the flexural strength test

<i>Samples</i>	<i>Flexural strength (MPa)</i>	<i>Stand. Deviation</i>
<i>TQ-HL</i>	1.08	0.13
<i>POS5-HL</i>	0.94	0.13
<i>POS10-HL</i>	0.57	0.17
<i>POS15-HL</i>	0.67	0.04
<i>POS5-HL-S</i>	0.52	0.09
<i>POS10-HL-S</i>	0.49	0.00
<i>POS15-HL-S</i>	0.35	0.04

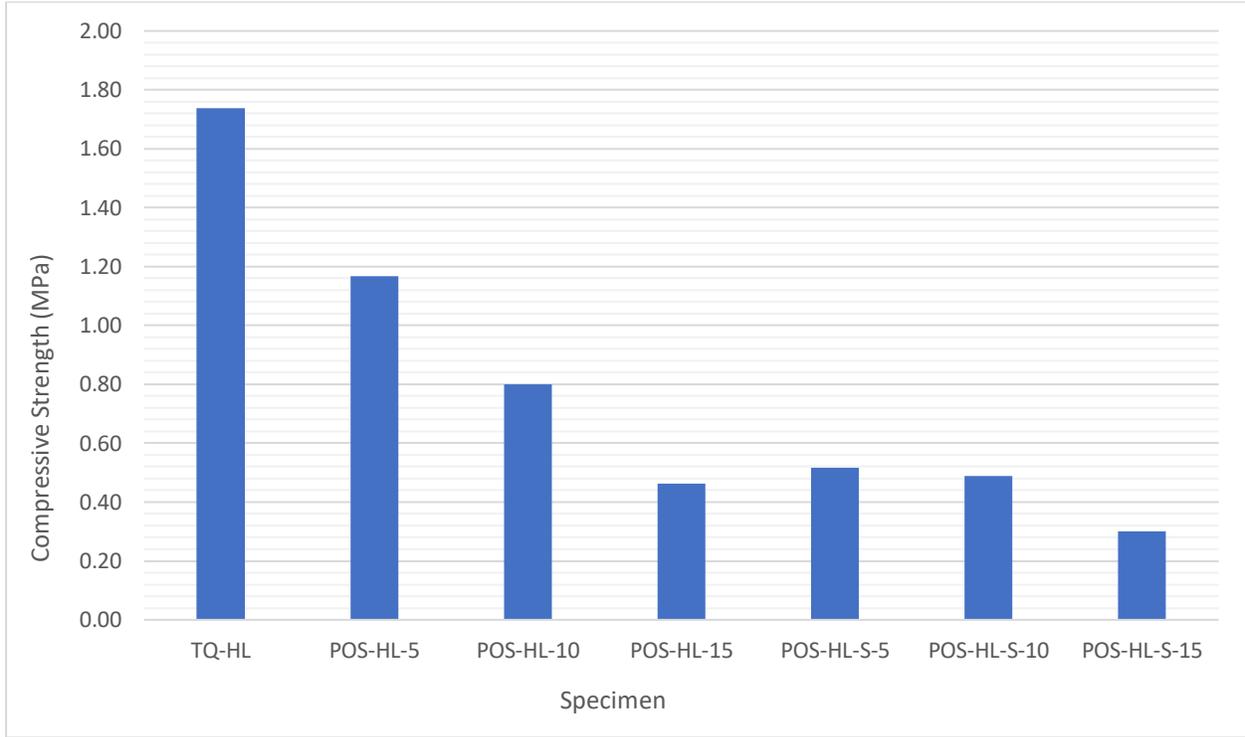
Figure 24: Graphical representation of the Specimens' compressive strength

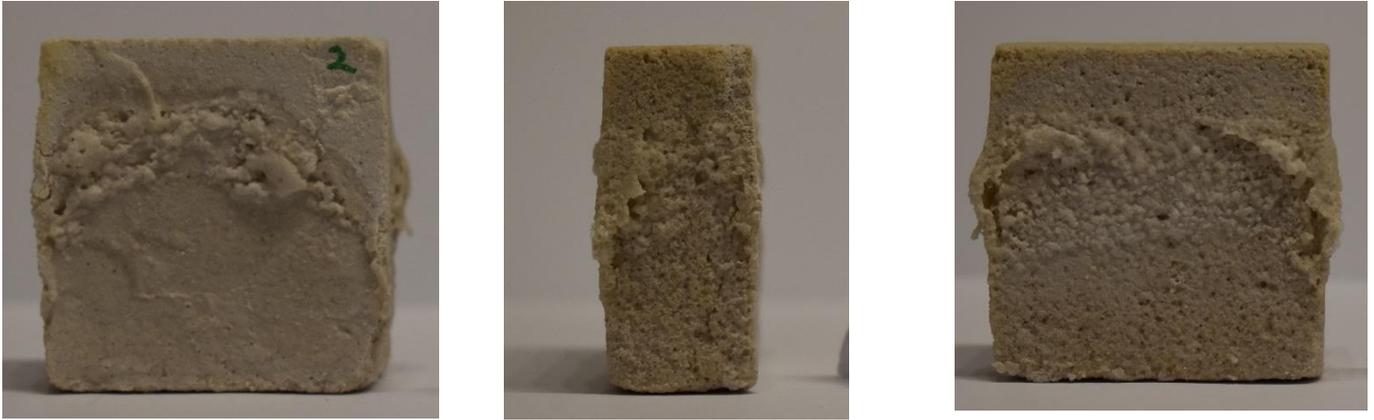
Figure 26: TQ samples after the 10th cycle showing signs of exfoliations

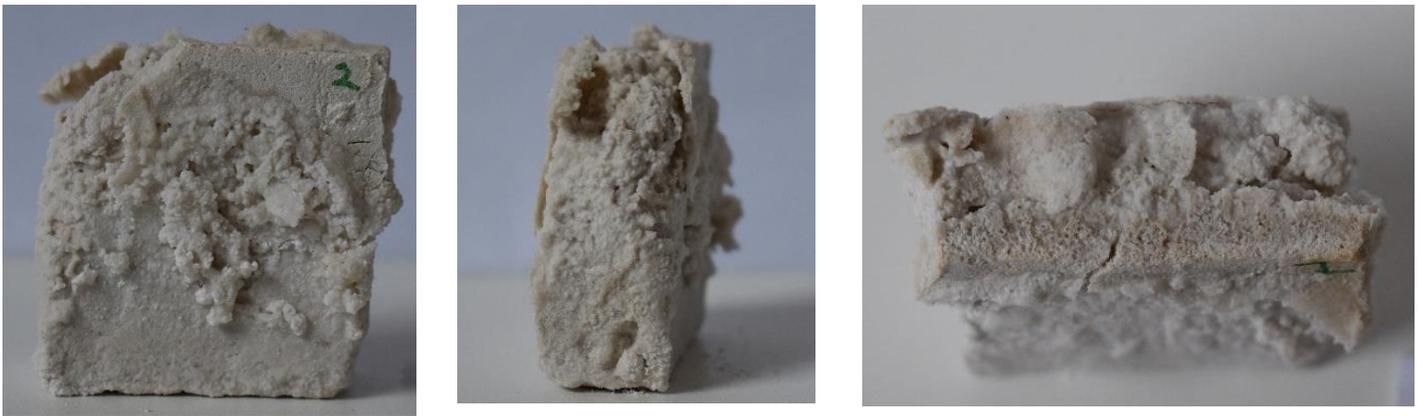
Figure 25: TQ samples after the 15th cycle showing significant material loss at the end of the test

In a 15-cycle salt crystallization test, mortars modified with GOS and nano silica were evaluated against a reference sample (TQ-HL) to assess durability under wet-dry conditions. The reference mortar (TQ-HL) showed initial mass gain but significant mass loss after the 10th cycle as indicated in Figure 26, maintaining structural integrity despite an average -4.53% mass difference by the 15th cycle (Figure 25), highlighting its relative durability.

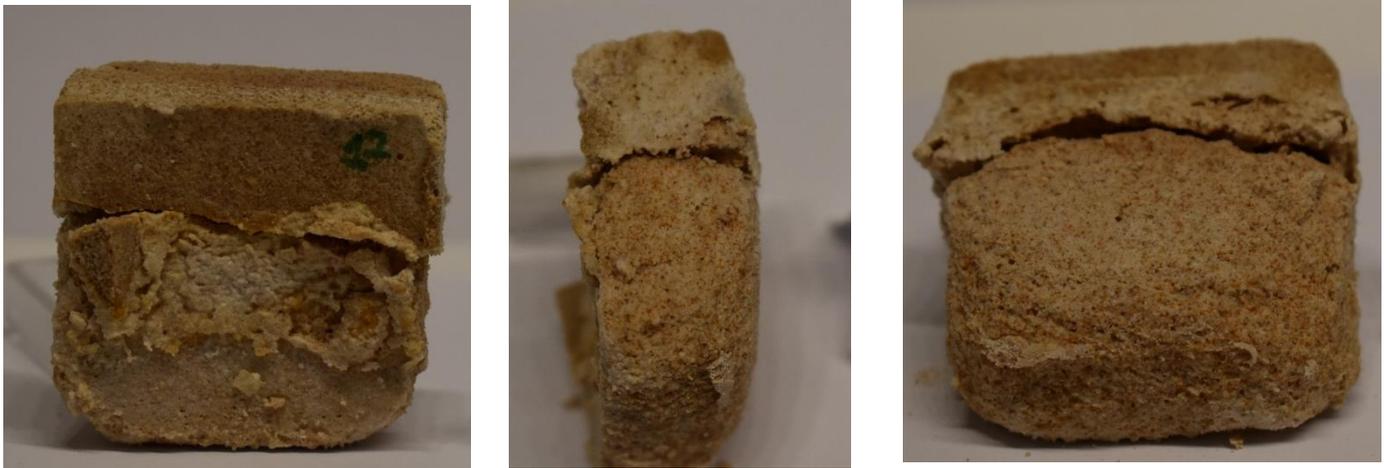
Figure 27: POS-15-HL after the 12th cycle showing a complete disintegration

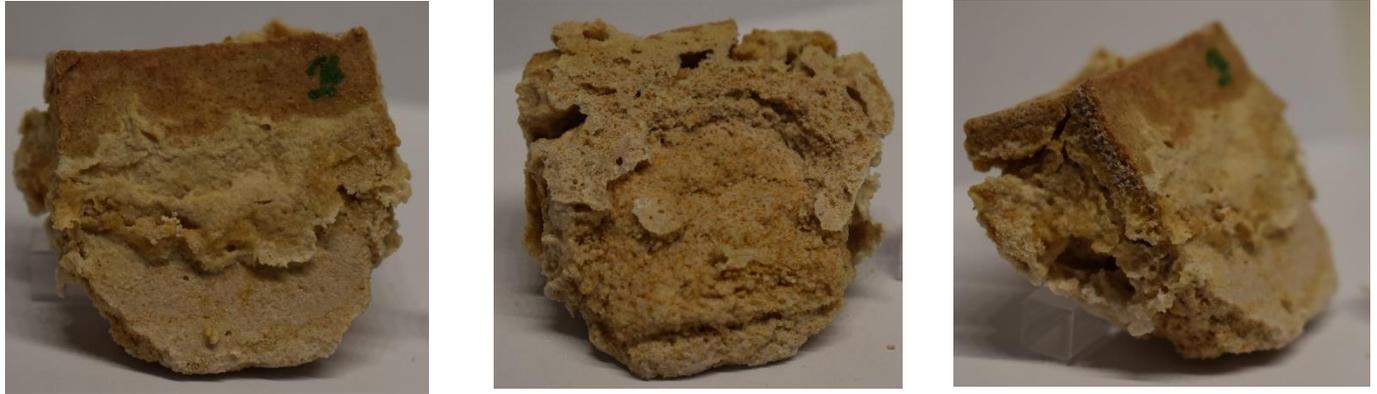
Figure 29: POS-10-HL-S after the 12th cycle completely disintegrated

Despite this, none survived past the 11th cycle without disintegration of some of its samples; POS10-HL-S, for instance, showed an average mass loss of 0.07% by the end of the 11th cycle with the last of its sample disintegrating after the 12th cycle (Figure 29). While POS-5-HL-S with an average mass loss of -7.58 after the 11th cycle with the last of its sample completely disintegrating at the end of the 14th cycle (Figure 28).

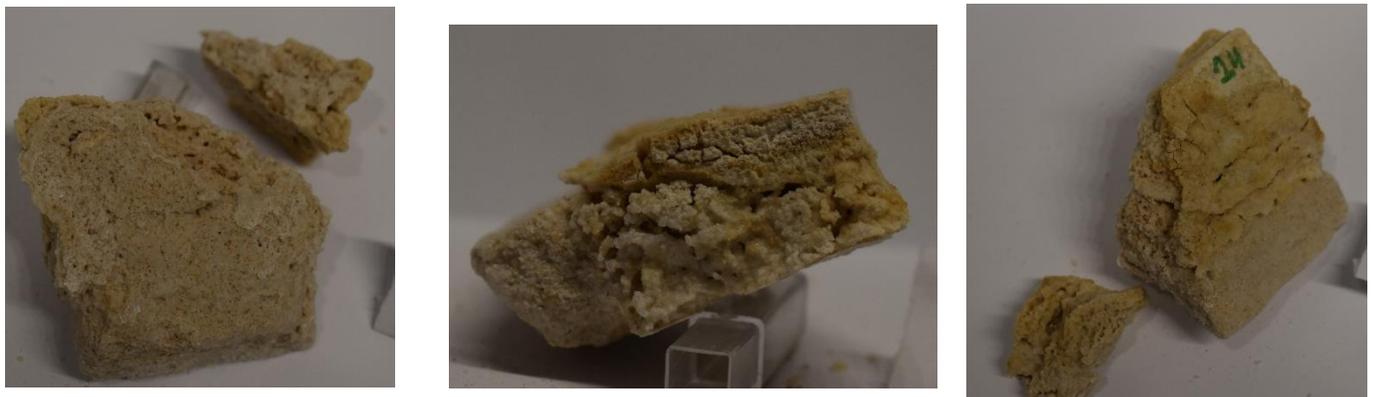
Figure 28: POS-5-HL-S after completely disintegrated after the 14th cycle

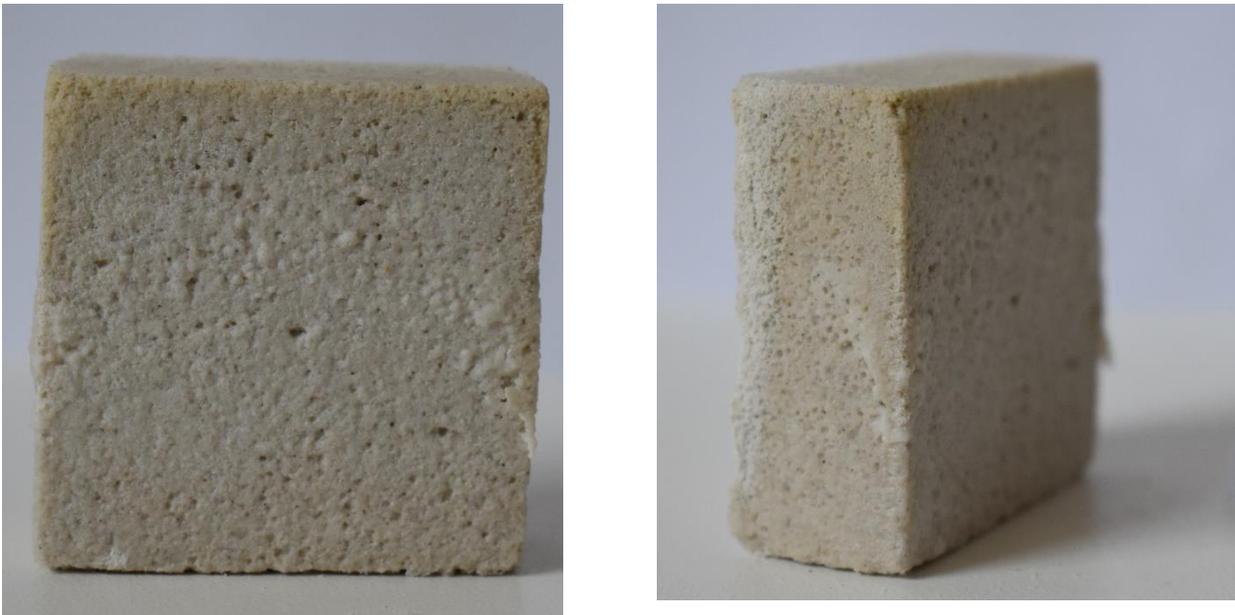
Figure 30: TQ samples showing signs of minor blistering and tiny salt crystals on its surface after the 3rd cycle of the salt crystallization cycle

With the TQ-HL serving as the baseline for comparison, the results indicate it experienced consistent mass gain during the initial cycles while showing early signs of tiny salt crystallisation on the surface (efflorescence) and minor blisters as early as after the 3rd cycle (Figure 30) , peaking at around 12.73% after the 9th cycle just before it starts to lose weight after the 10th cycle.

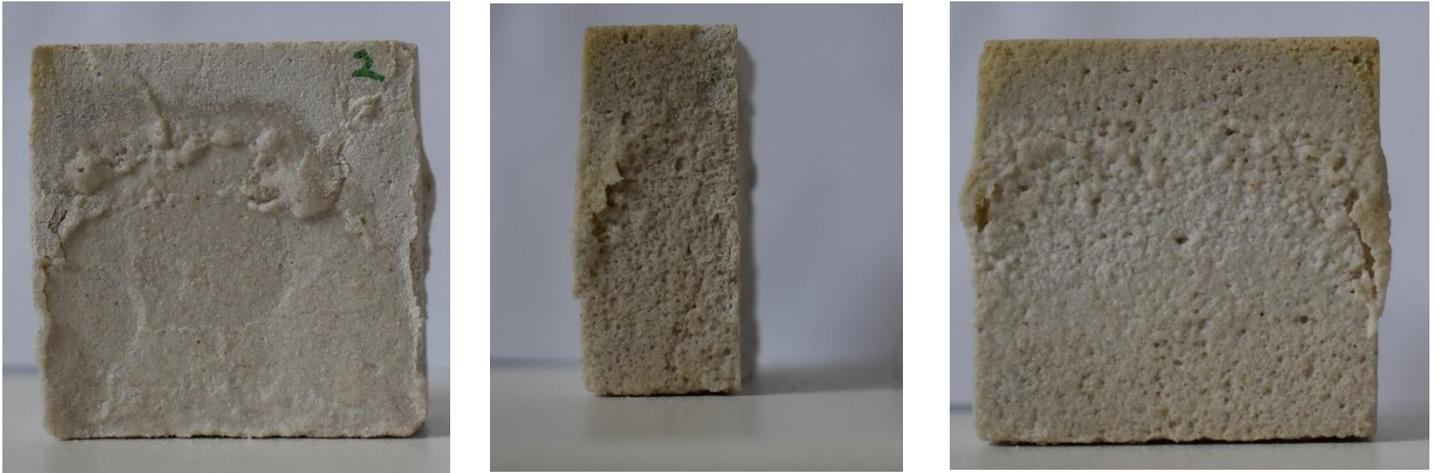
Figure 31: Visible detachment on the TQ-HL samples after the 5th cycle of the salt crystallisation test

due to material loss. This suggests that even traditional mortar is vulnerable to prolonged salt crystallization, leading to structural weakening.
