Green Mortars for Conservation: Utilizing agricultural and industrial waste for sustainable restoration.

A research paper submitted in partial fulfilment of the requirements for
the Master Of Science Degree In Archaeological Material Science
(ARCHMAT)

December, 2024.

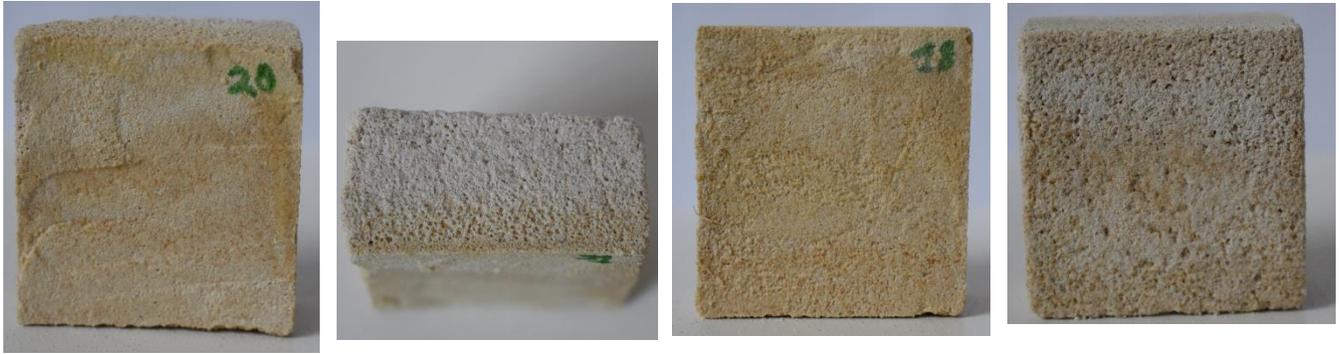
Figure 32: POS-HL-S series showing no signs of suffering the salt weathering test after the 3rd cycle as compared to the TQ-HL below

The POS-HL-S series, modified with both GOS and nano silica, showed improved initial performance compared to the GOS-only specimens, but they also ultimately disintegrated before completing all 15 cycles. The nano silica-modified specimens exhibited lower initial mass gain compared to their non-modified counterparts. For example: POS5-HL-S gained only 1.77% after the 1st cycle, compared to 3.81% for POS5-HL. Similarly, POS10-HL-S and POS15-HL-S showed less mass gain in the early cycles, suggesting that nano silica helps limit the absorption of moisture and salts in the initial stages. Unlike the reference samples, the POS-HL-S series did not show early signs of tiny salt crystals on the mortar surfaces and showed no signs of blisters in the early cycles.

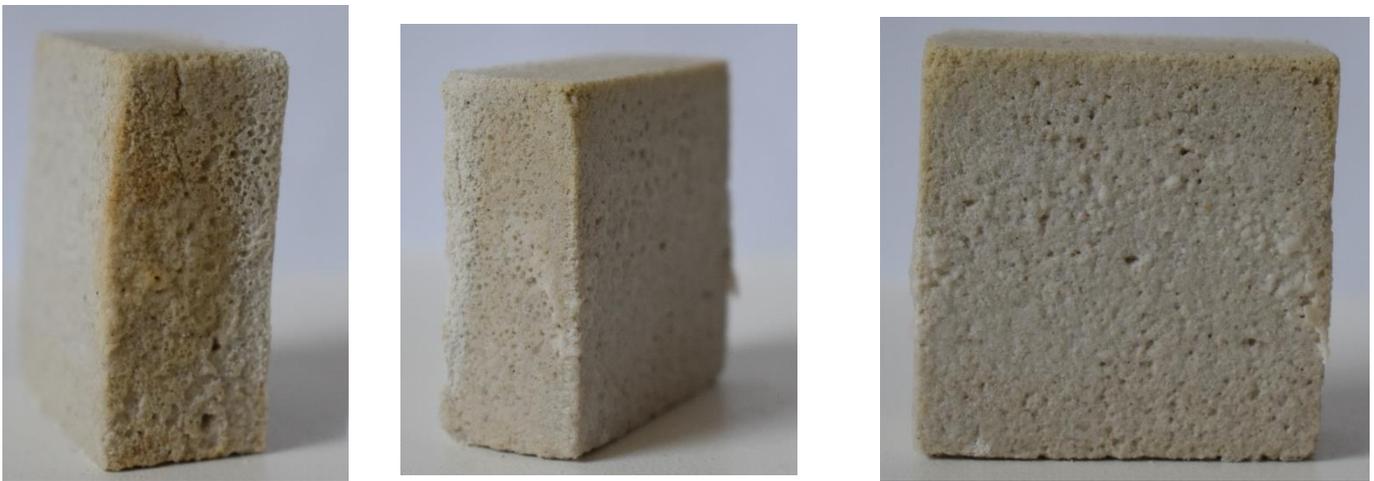
Figure 33: TQ-HL showing early signs of blistering after the 3rd cycle.

Despite their improved performance in the initial cycles, the POS-HL-S specimens eventually began to lose mass.

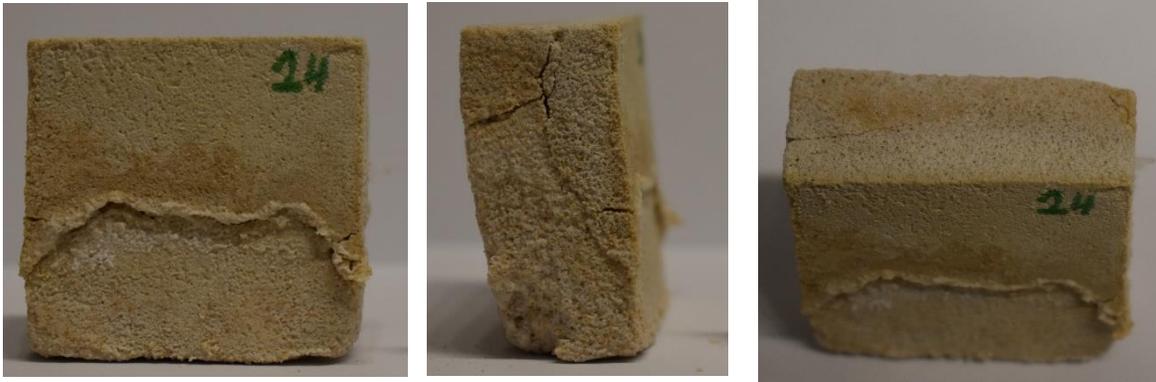
Figure 34: POS-5-HL-S after the 10th cycle

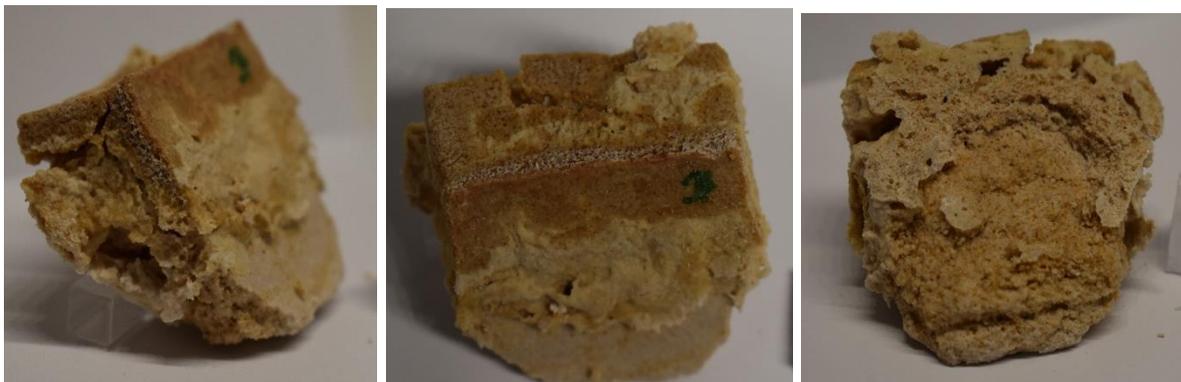
Figure 35: The last sample of POS-10-HL-S disintegrating after the 12th cycle

None of the nano silica-modified samples survived beyond the 11th cycle, for, POS5-HL-S survived until cracking after the 10th cycle (Figure 34) with 1.90% average relative mass difference, and completely disintegrating by the 11th cycle. POS10-HL-S followed a similar trajectory, with mass loss accelerating after the 7th cycle, and by the 12th cycle (Figure 35), it had

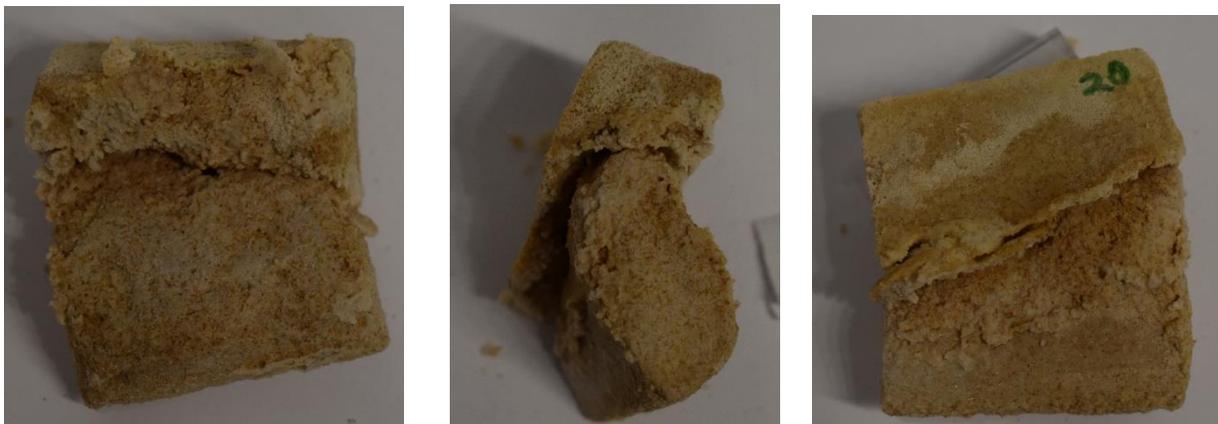
Figure 36: The last sample of POS-15-HL-S disintegrating after the 12th cycle

dropped to -18.75%, disintegrating shortly after. POS15-HL-S also saw early failure, disintegrating after the 12th cycle (Figure 36) with a mass loss of -13.37%.

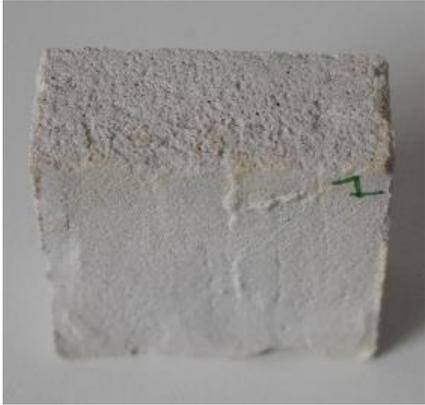
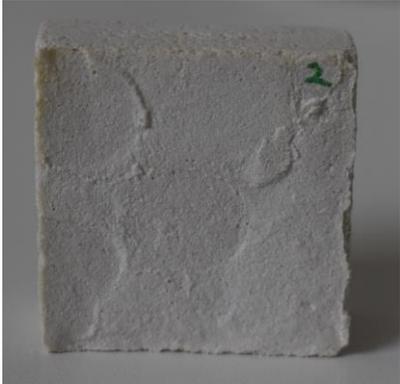
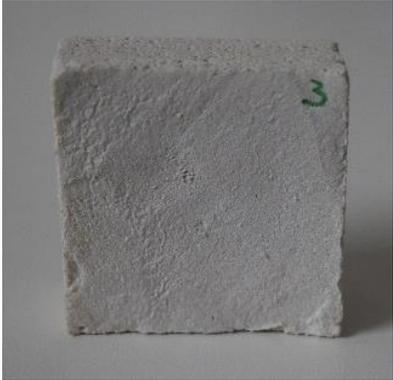
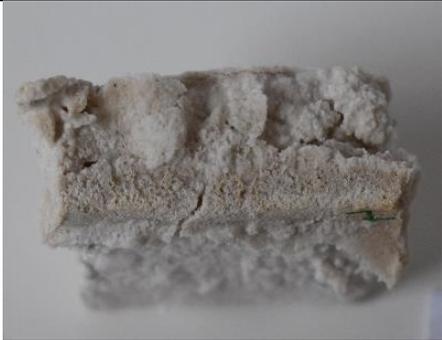
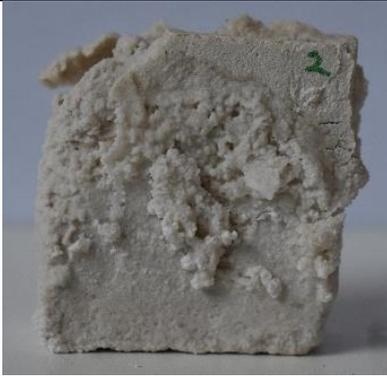
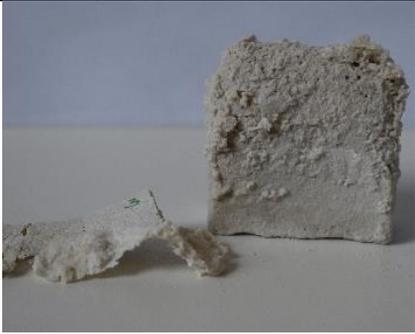
Specimen	TQ-HL		
Before accumulation

Specimen	Main categories of damage	Detailed damage and alteration type	Extent of damage or alteration	Remarks
TQ-HL	1. Surface change	a. Efflorescence b. Blistering	a. Extensive b. Extensive	The TQ samples showed early signs of surface change with tiny salt crystals on

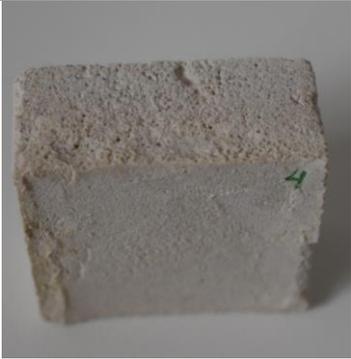
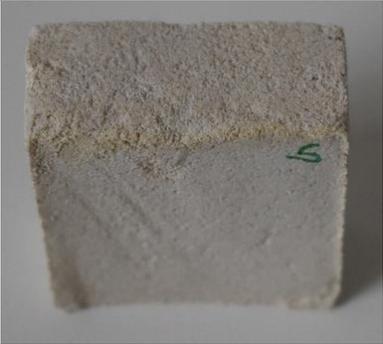
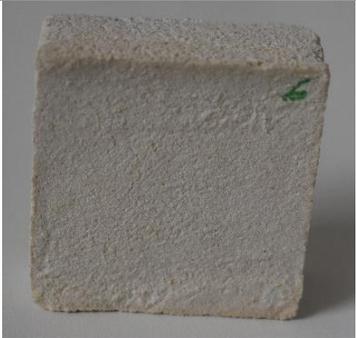
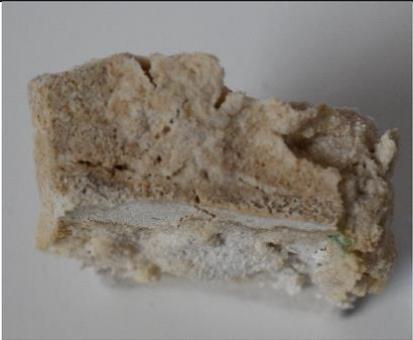
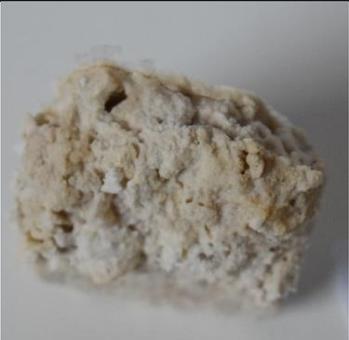
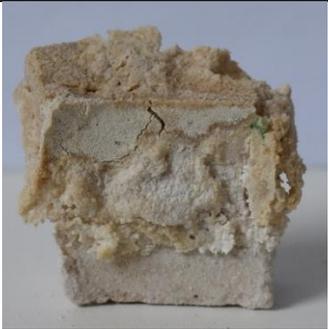
Specimen	POS-5-HL		
Before accumulation

Specimen	Main categories of damage	Detailed damage and alteration type	Extent of damage or alteration	Remarks
POS-5-HL	<ol style="list-style-type: none"> 1. Surface change 2. Loss of cohesion 3. Cracking 	<ol style="list-style-type: none"> a. Efflorescence b. Blistering c. Disintegration d. Splitting 	<ol style="list-style-type: none"> a. Not so extensive b. Extensive c. Extensive d. Limited 	These samples showed less salt crystallized on the surface in the early cycles. But one of it samples completely disintegrated before the end of the 15 th cycle

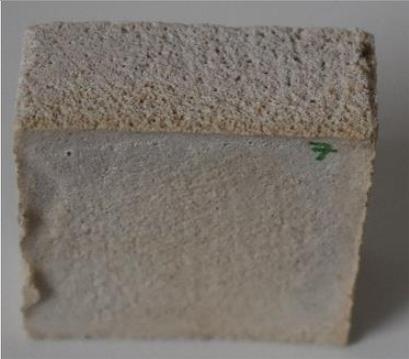
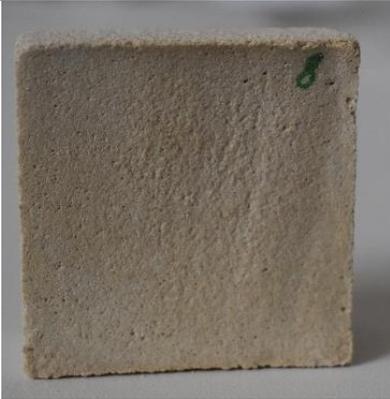
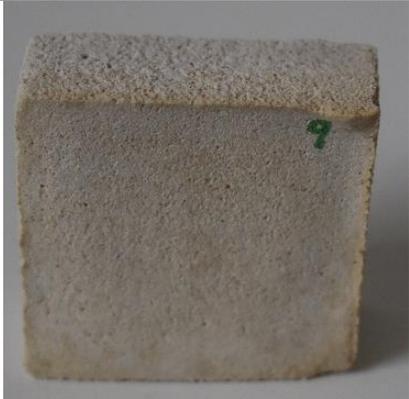
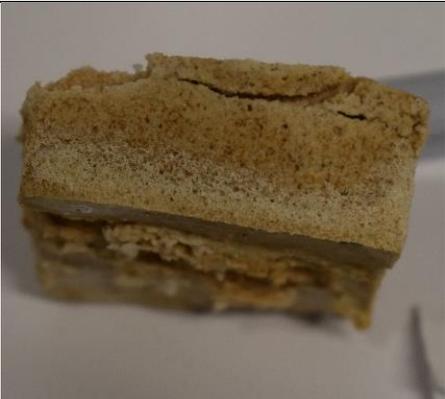
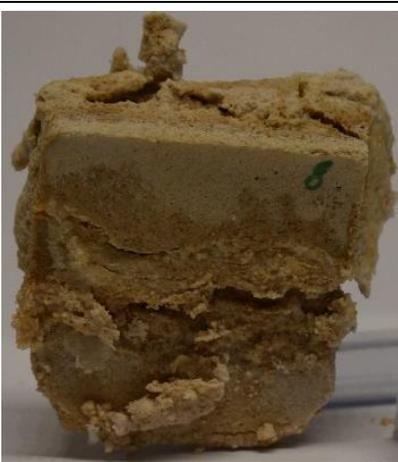
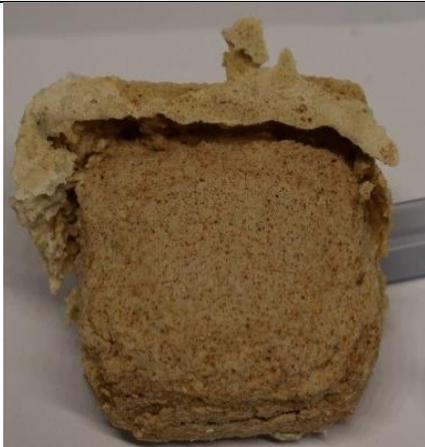
Specimen	POS-10-HL		
Before accumulation

Specimen	Main categories of damage	Detailed damage and alteration type	Extent of damage or alteration	Remarks
POS-10-HL	<ol style="list-style-type: none"> 1. Surface change 2. Loss of cohesion 3. Cracking 	<ol style="list-style-type: none"> a. Efflorescence b. Blistering c. Disintegration d. Splitting e. Fragmentation 	<ol style="list-style-type: none"> a. Extensive b. Limited c. Extensive e. Extensive f. Extensive 	<p>There were some salt deposition on the surface, after the second cycle.</p> <p>There were also some blistering after the 2nd cycle and eventually, disintegration and fragmentation of all its samples before the last cycle</p>

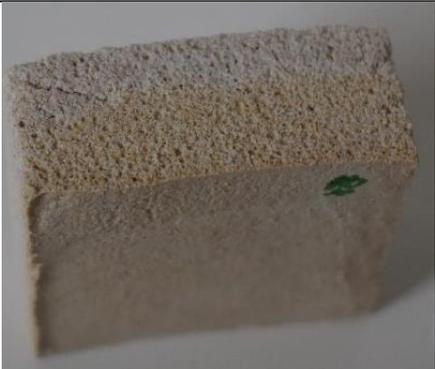
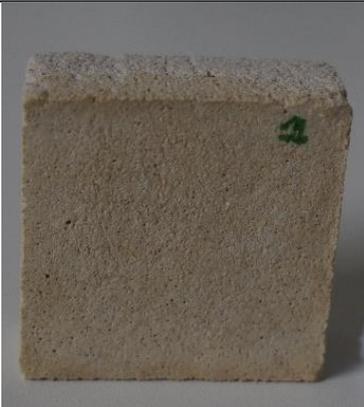
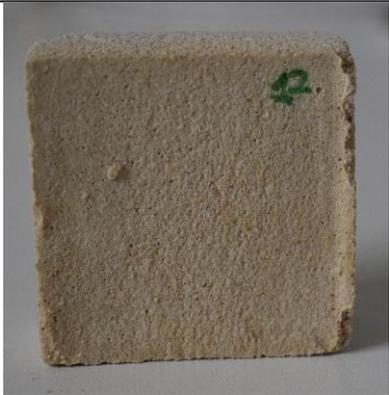
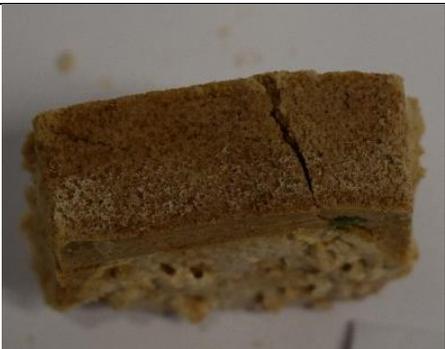
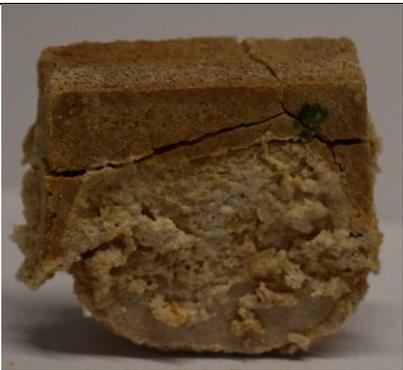
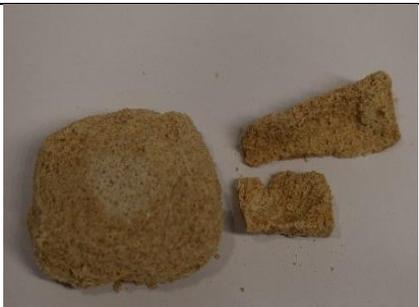
Specimen	POS-15-HL		
Before accumulation

Specimen	Main categories of damage	Detailed damage and alteration type	Extent of damage or alteration	Remarks
POS-15-HL	<ol style="list-style-type: none"> 1. Surface change 2. Loss of cohesion 3. Cracking 	<ol style="list-style-type: none"> a. Efflorescence b. Blistering c. Disintegration d. Splitting e. Fragmentation 	<ol style="list-style-type: none"> a. Limited b. Limited c. Extensive e. Extensive f. Extensive 	<p>There was some light salt deposition on the surface, after the second cycle.</p> <p>There were also some blistering after the 2nd cycle and eventually, cracks, disintegration and fragmentation of all its samples before the last cycle</p>

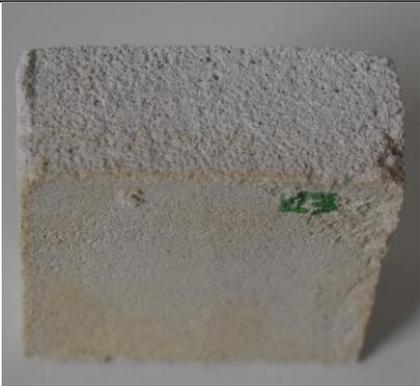
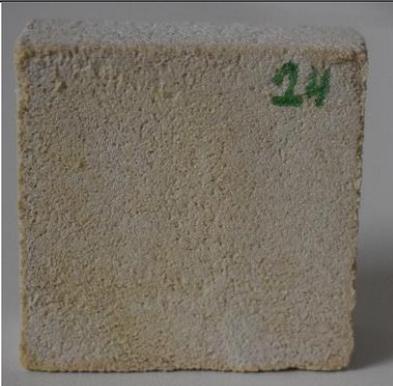
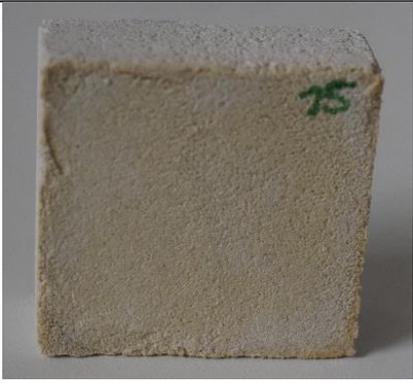
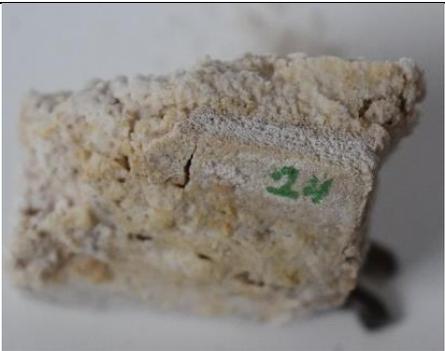
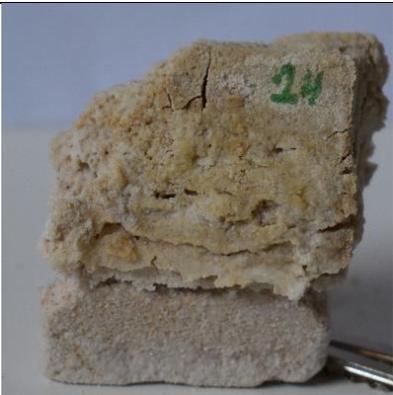
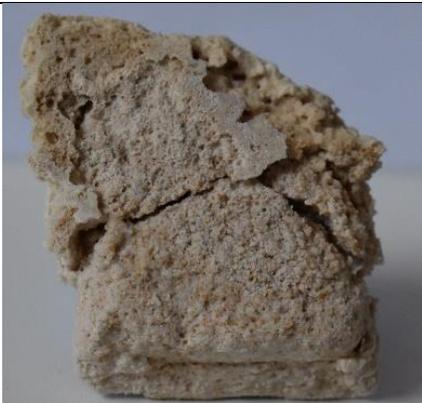
Specimen	POS-5-HL-S		
Before accumulation

Specimen	Main categories of damage	Detailed damage and alteration type	Extent of damage or alteration	Remarks
POS-5-HL-S	<ol style="list-style-type: none"> 1. Surface change 2. Loss of cohesion 3. Cracking 	<ol style="list-style-type: none"> a. Efflorescence b. Blistering c. Disintegration d. Splitting e. Fragmentation 	<ol style="list-style-type: none"> a. Extensive b. Limited c. Extensive e. Extensive f. Extensive 	<p>There was some salt deposition on the surface, after the second cycle.</p> <p>There were also some blistering after the 3rd cycle and eventually, disintegration of all its samples before the last cycle</p>

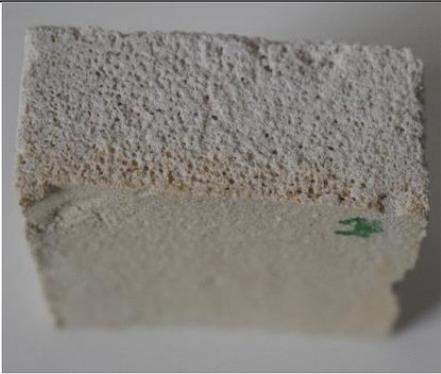
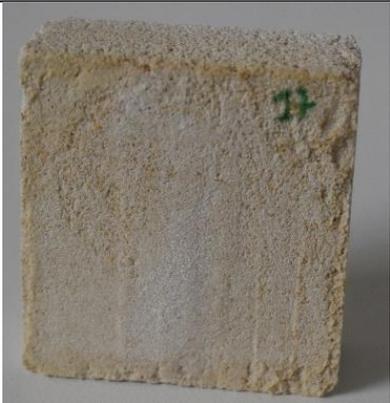
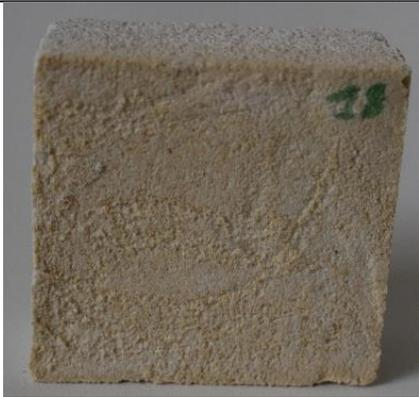
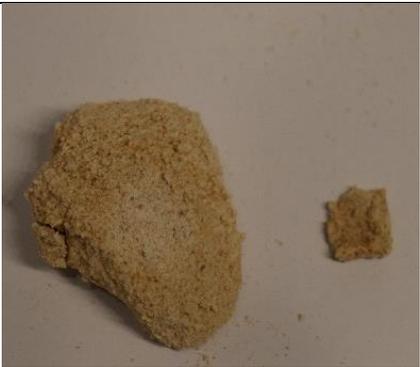
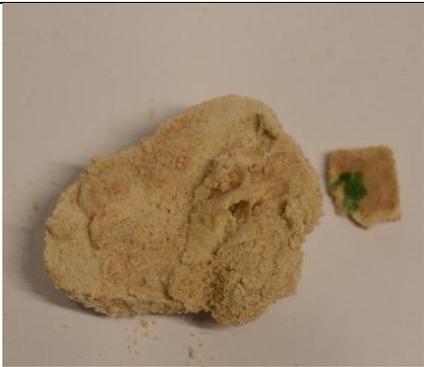
Specimen	POS-10-HL-S		
Before accumulation

Specimen	Main categories of damage	Detailed damage and alteration type	Extent of damage or alteration	Remarks
POS-15-HL-S	<ol style="list-style-type: none"> 1. Surface change 2. Loss of cohesion 3. Cracking 	<ol style="list-style-type: none"> a. Efflorescence b. Blistering c. Disintegration d. Splitting e. Fragmentation 	<ol style="list-style-type: none"> a. Extensive b. Limited c. Extensive e. Extensive f. Extensive 	<p>There was some salt deposition on the surface, after the second cycle.</p> <p>There were also some blistering after the 2nd cycle and eventually, disintegration of all its samples before the last cycle</p>

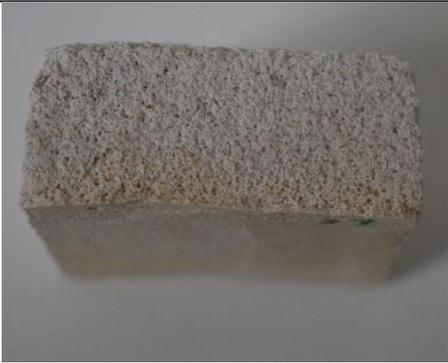
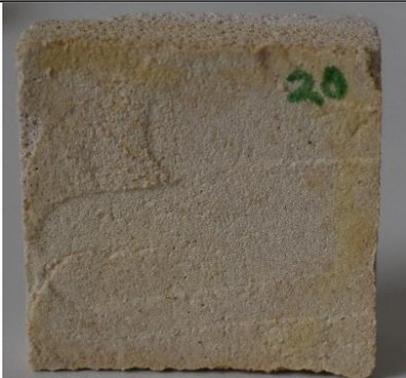
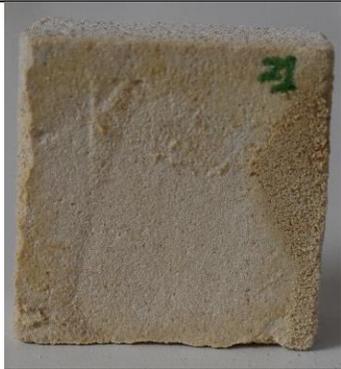
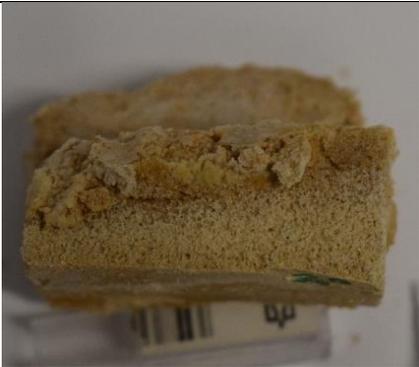
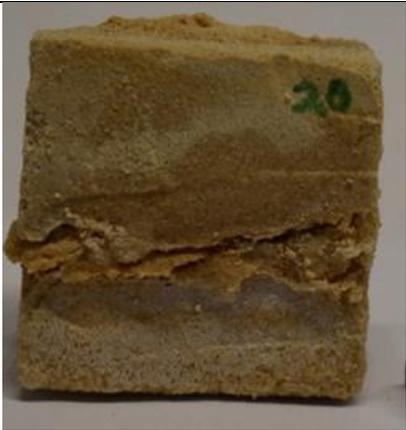
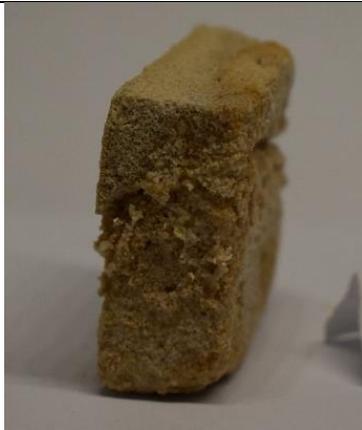
Specimen	POS-15-HL-S		
Before accumulation

Specimen	Main categories of damage	Detailed damage and alteration type	Extent of damage or alteration	Remarks
POS-15-HL-S	<ol style="list-style-type: none"> 1. Surface change 2. Loss of cohesion 3. Cracking 	<ol style="list-style-type: none"> a. Efflorescence b. Blistering c. Disintegration d. Splitting e. Fragmentation 	<ol style="list-style-type: none"> a. Extensive b. Limited c. Extensive e. Extensive f. Extensive 	<p>There was some salt deposition on the surface, after the second cycle.</p> <p>There were also some blistering after the 2nd cycle and eventually, disintegration of all its samples before the last cycle</p>
