Proceedings of the 5th Historic Mortars Conference

5th Historic Mortars Conference

19-21 June 2019
Pamplona, Spain

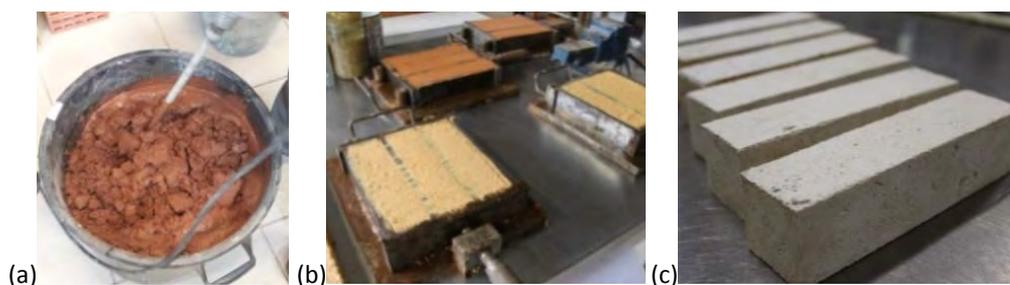
Figure 2. Production of the T_E mortar (a), prismatic specimens of T_AP and T+CL in the metallic moulds (b) and prismatic specimens of C mortar (c).

In order to reproduce, as much as possible, the method carried out on construction site, all mortars were produced using a mixer blade (Figure 2a). Dry materials were placed in a bucket and the water was slowly added. An initial mixture of 8 minutes was carried out; after this period, the mortar that adhered to the bucket edges was removed and added to the remaining mortar, followed by a further 3 minutes of mixing (Figure 2Figure 2a). This was considered time enough for the mortars to be homogeneous. The T+CL mortar was produced the day before of their specimens were moulded. The remaining mortars were produced the same day of moulding. For each plastering mortar different types of specimens were produced in metallic moulds: six prismatic specimens with 40 mm x 40 mm x 160 mm (Figure 2b and Figure 2c), moulded in two layers mechanically compacted with 20 strokes each and manually levelled; three planar specimens with 200 mm x 500 mm x 15 mm (Figure 3), manually compacted and levelled.

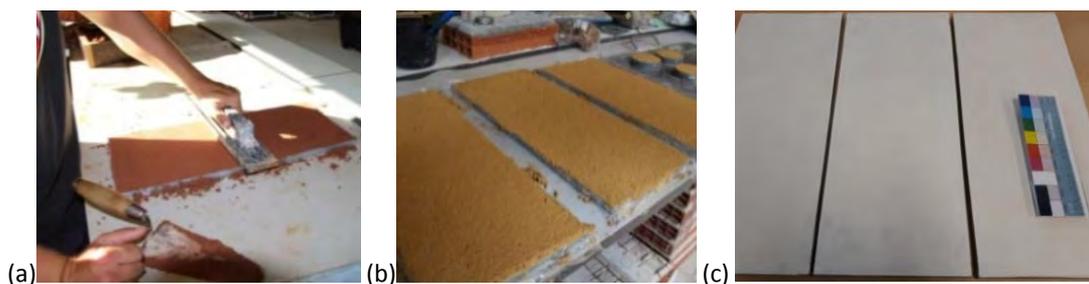
Figure 3. Finishing of planar specimen of T_AP plaster (a) and planar specimens of T+CL plaster (b) and planar specimens of G plaster (c).

The gypsum finishing coat was only applied, with 1 mm of thickness, to the G planar specimens. Only the prismatic specimens were demoulded when dried, after at least 7 days. All specimens were placed in laboratory conditions at 20 ± 2 °C and 65 ± 5 % prior to the characterization tests. The age of the specimens of each plastering mortar for each characterization test can be observed in Table 2. A longer aging of T+CL mortar was justified by the fact of being the only mortar with slow reaction due to carbonation. For this reason, the mechanical strength was only assessed after 4 months. Unstabilised earth mortars (T_E and T_AP) harden just by drying. Cement-based (C) and gypsum-based (G) mortars are known by their fast hardening reactions. Therefore these mortars were tested for strength after 2 months.

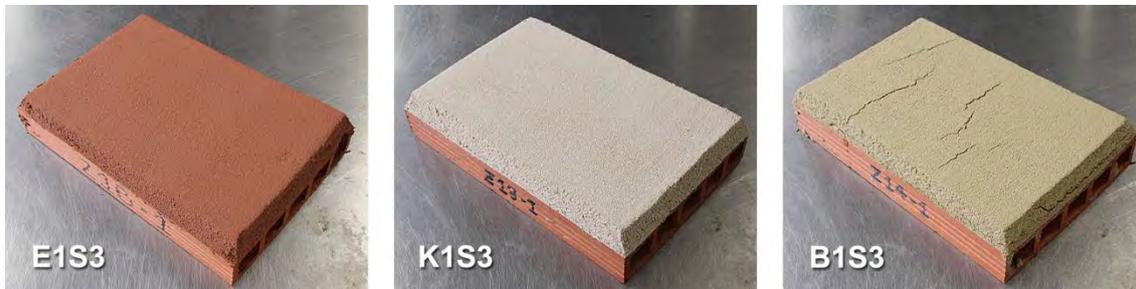
Figure 4 presents the samples of 20 mm plaster layer applied over hollow bricks. The occurrence of plaster cracking is significant on montmorillonitic mortar B1S3, rare on illitic mortar E1S3 and absent on kaolinitic mortar K1S3, which is in accordance with the results of the linear drying shrinkage test and also reflects each mortars clayish earth mineralogy.

Figure 4. Samples of 20 mm plaster layer applied over hollow bricks: E1S3 - Illitic mortar; K1S3 - Kaolinitic mortar; B1S3 - Montmorillonitic mortar.

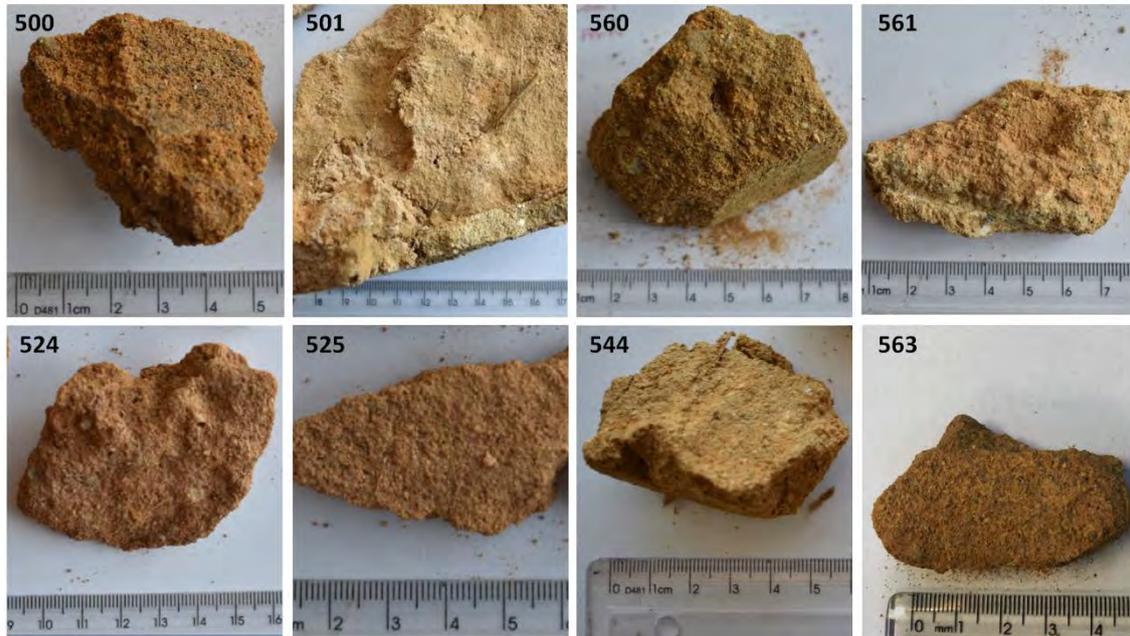
Figure 2. Fragments of the mortars studied in this work

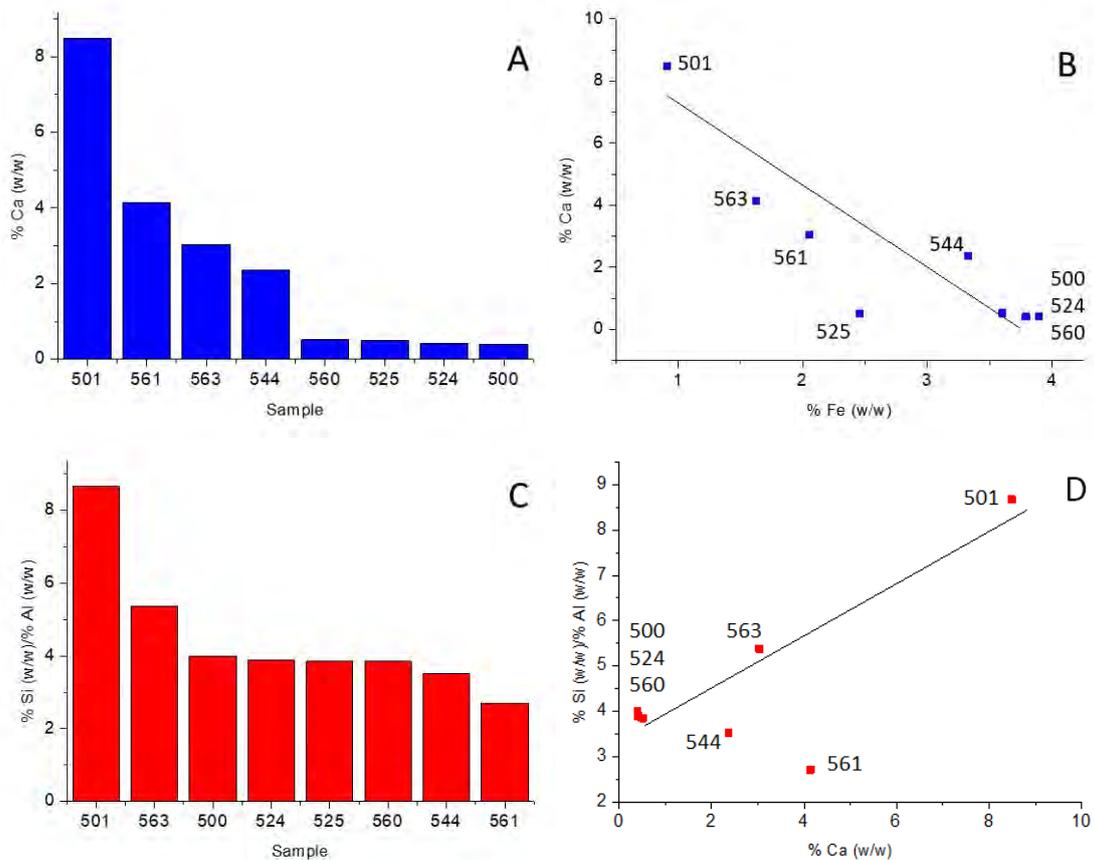
Figure 6. Comparison of mortar samples in terms of elemental composition. A: % content of Ca (w/w); B: correlation between the content of Ca and Fe; C: Si/Al ratios; D: correlation between Si/Al ratio and Ca content

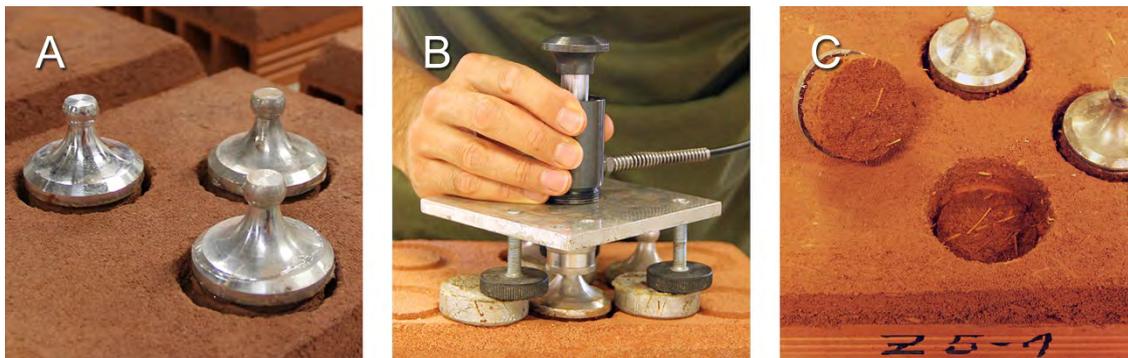
Figure 2. Pull-off test: A - Metallic devices glued to the plaster specimens; B – Pull-off equipment perpendicular to the specimen being tested; C – specimen after cohesive rupture

The DIN 18947 [9] defines the assessment of adhesive strength of earth plasters to a support based on the EN 1015-12 [8] test procedure. However, there are problems to assess the adhesion by EN 1015-12 standard [8] test procedure even for air lime-based plasters and renders [11]. In fact this test is generally performed on plaster samples that are cut on *in situ* plasters or, in laboratory, on a plaster specimen applied on a support. In the laboratory, that support can be a concrete small slab, a brick or a ceramic tile. The cut of the sample is generally performed when the plaster specimen is hardened; that is always the case *in situ*. The cut should penetrate few millimetres on the support itself. After the cut, a metallic device with circular area (Figure 2A) is glued to the sample ensuring complete contact. The pull-off can be applied through it. The pull-off can be applied by a pull-off test equipment (Figure 2B) or even by a tensile test equipment. The rupture can occur: in the thickness of the sample - cohesive rupture (Figure 2C) - meaning that the adhesive strength is higher than the registered value; by the contact surface between the mortar and the support - adhesive rupture - registering the adhesive strength; by the support, meaning that the adhesive strength is higher than the registered value [8]. In this last case it also means that the plaster is stronger than the support, what can be a problem for architectural heritage conservation, considering that the plaster should be there to protect the support and not imposing extra tensions. Both the type of rupture and the adhesive strength, that is obtained by the quotient of the maximum force and the contact area, are registered.

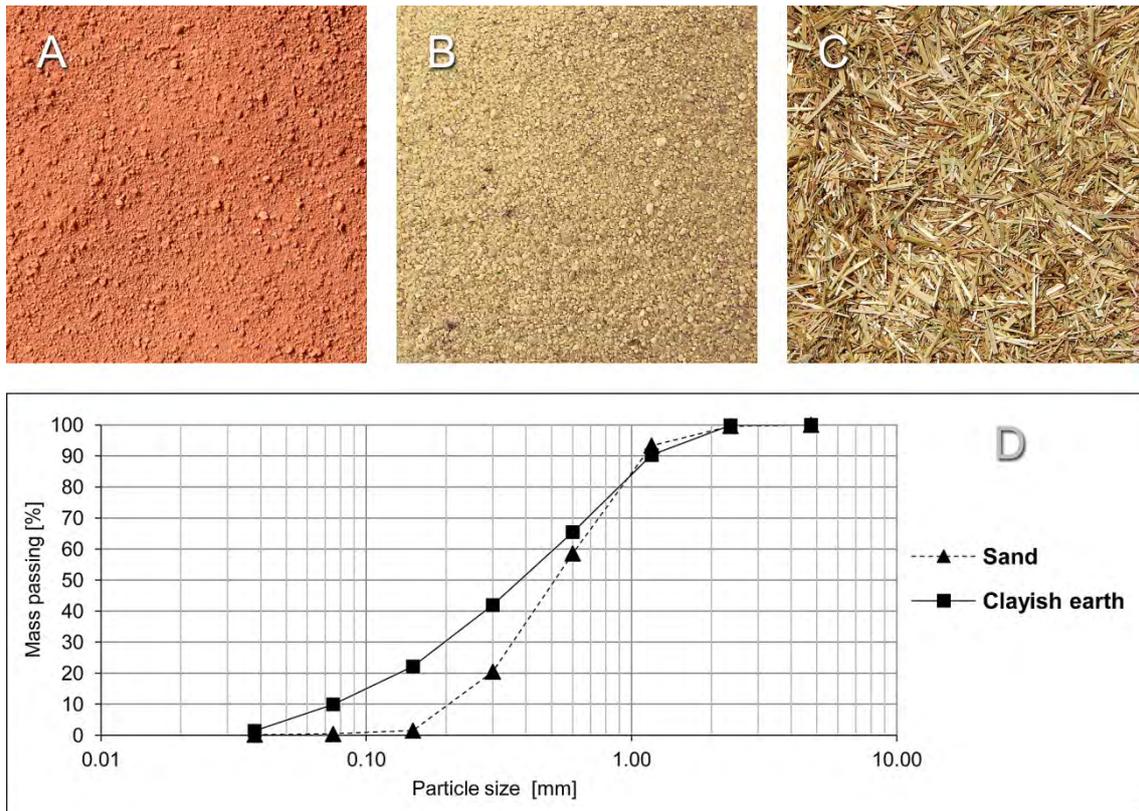
Figure 3. Clayish earth (A), sand (B), oat fibres (C) and dry particle size distribution of the sand and clayish earth (D) used in the mortar formulation.

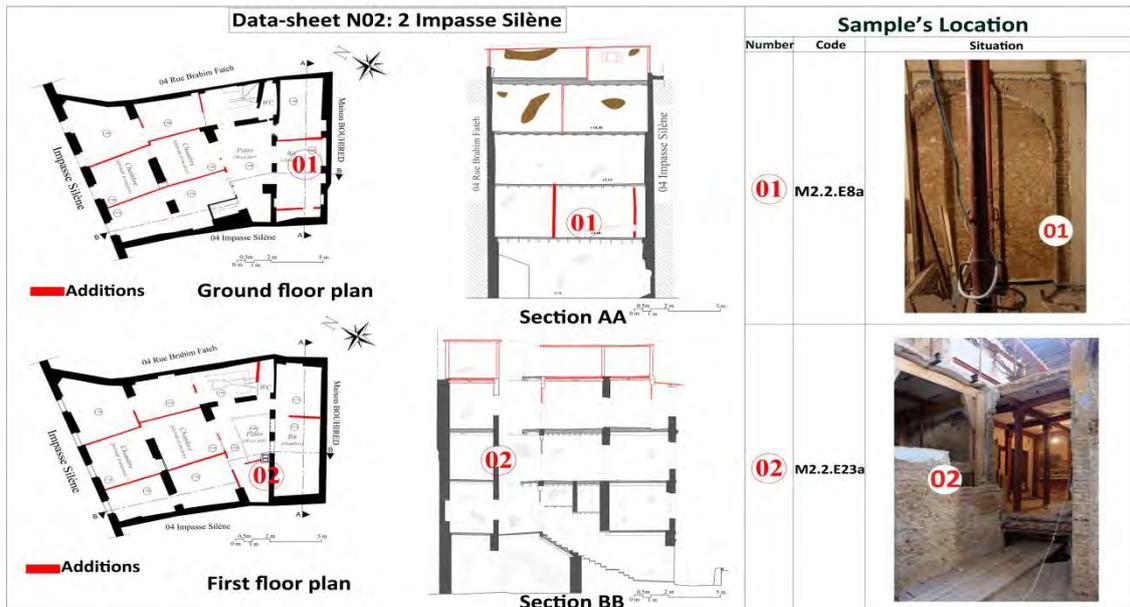
Figure 5. Data sheet of the house layout and the collected samples position

Four attached houses under current restoration works define our study area. They form an interlocked cluster located in the lower Casbah (Figure 1), on a commercial street resulting from a French enlargement of the medina's organic fabric, near an old synagogue converted into a mosque, a market hall and a historical fountain, their entrance is on a dead-end street. The corpus presents different states of conservation: a well-preserved martyr house (related to the Algerian revolution against the French occupation) and three partially collapse ones, due to the 2003 earthquake and a bombing incident during the colonization. Nine samples were collected composed of five bricks and four mortar fragments from various parts and levels of the houses. They were located on the data sheet below (Figure 5).

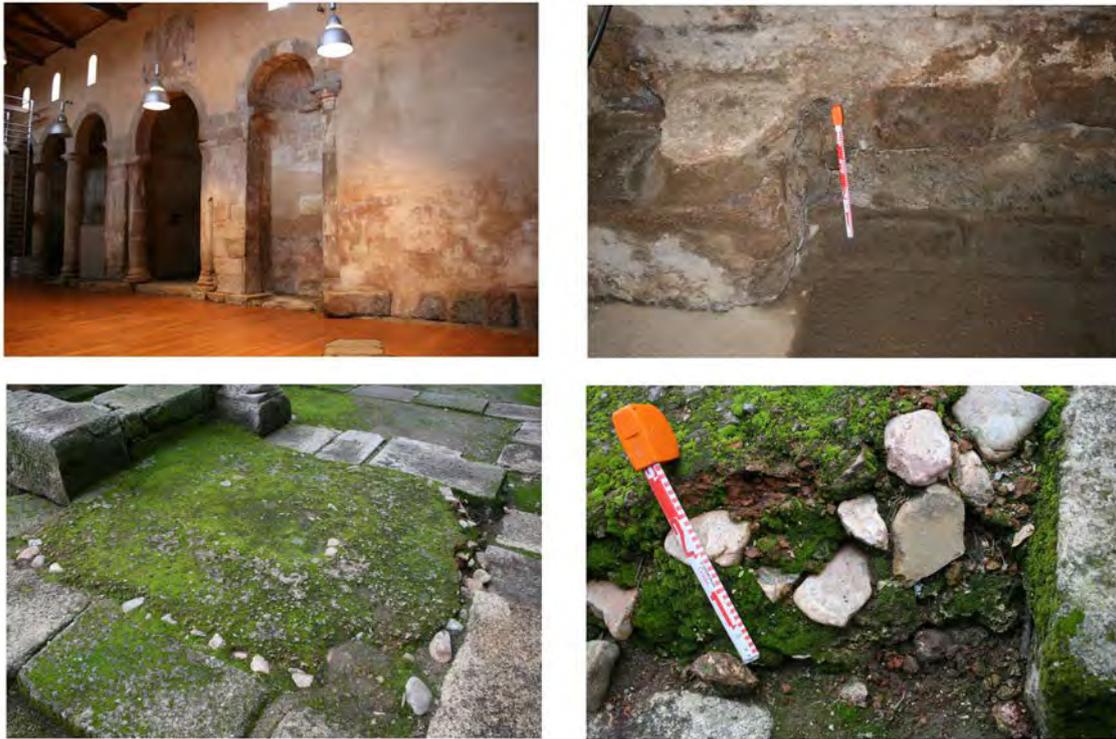
Figure 2. Detail of some sampling points, inside the exterior (north façade) of the building.

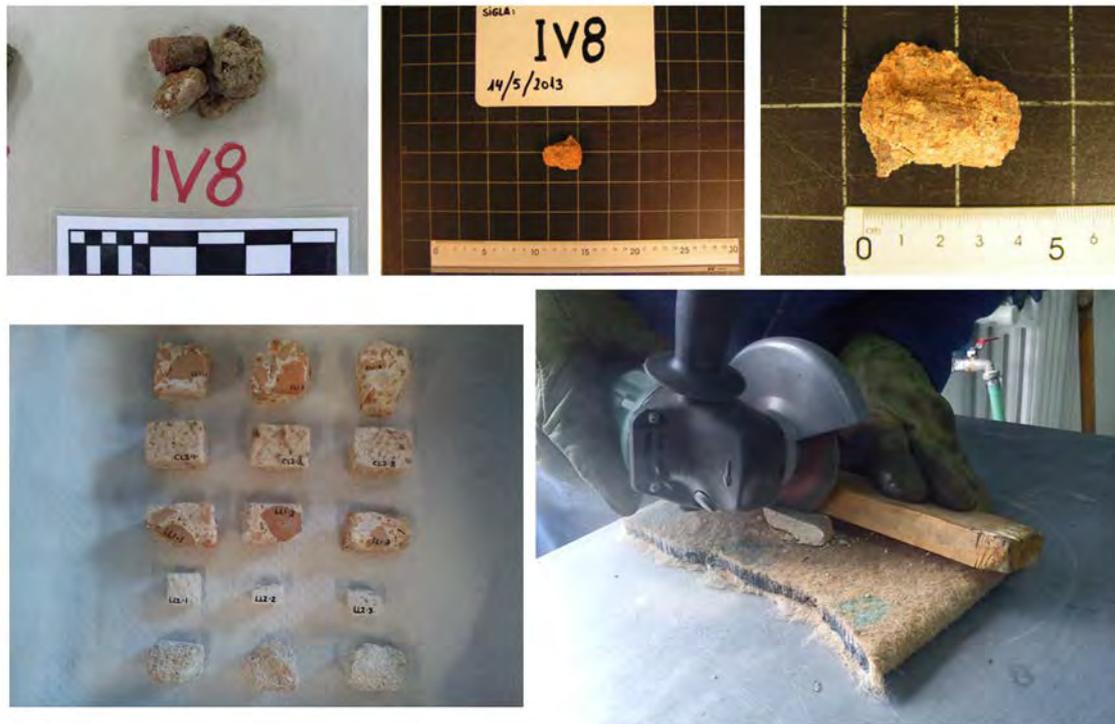
Figure 3. Sequence of preparing the IV8 sample.

The manufacture of the test-tube consists in cutting the samples through a diamond disk or cutting edge to achieve the shape of a cube with dimensions of between 1 and 2 cm each side. The cuts were carried out with a radial with hydraulic pump and dry mechanical cuts. Finally in the surfaces was developed a polishing treatment with blade disc between 600 and 1800 grain-fine. Thanks to this process a polished planes were generated, in which the lime matrix, the aggregates, the ceramic additions and other components were perceptible clearly. This procedure has also been carried out recently in the development of a mortars catalogue for a doctoral thesis [7].

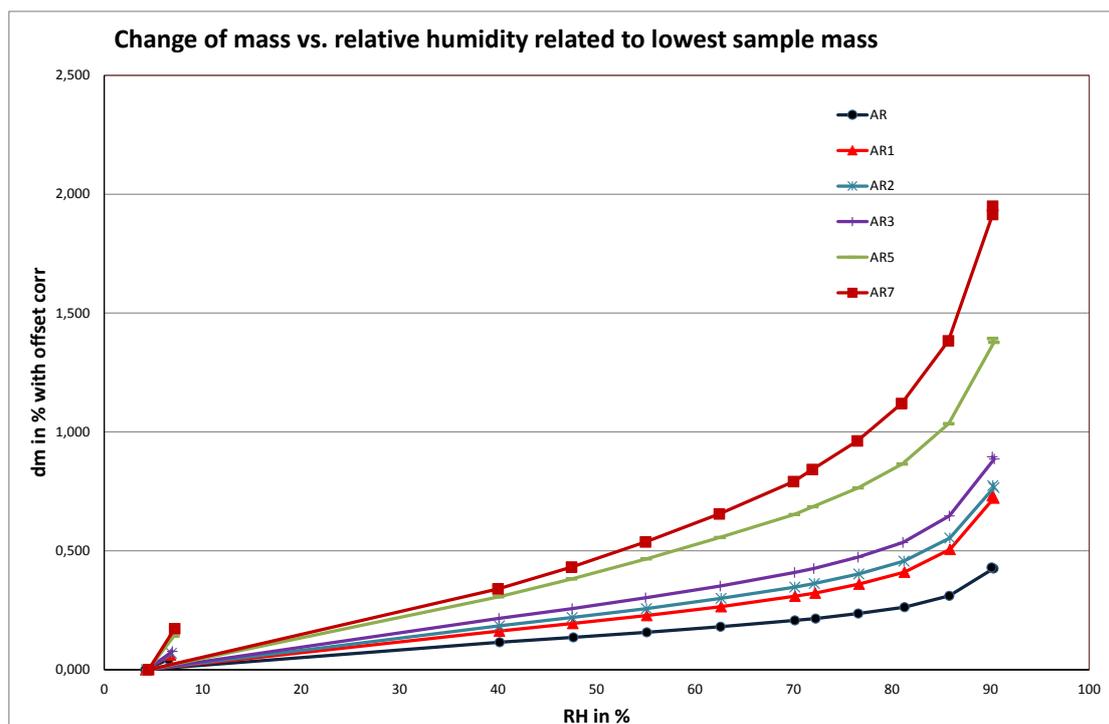
Figure 10. Water vapour absorption of samples as a function of relative humidity.

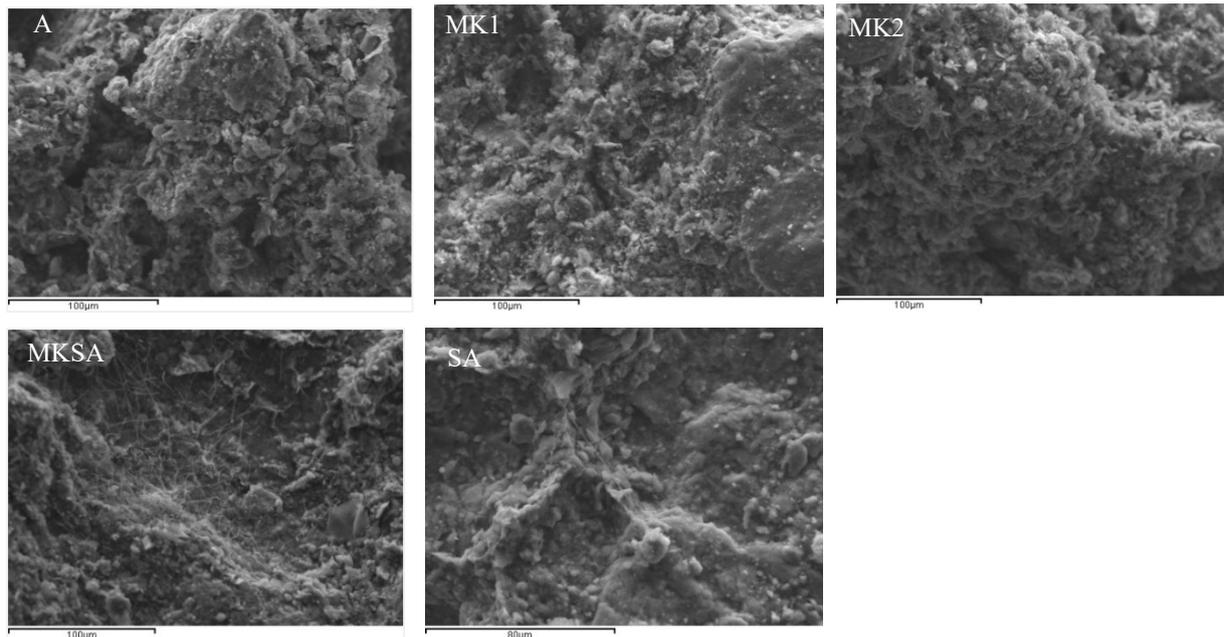
Figure 6. SEM images of the specimens (scale-100µm for A, MK10, MK20, MKSA and 80µm for SA).

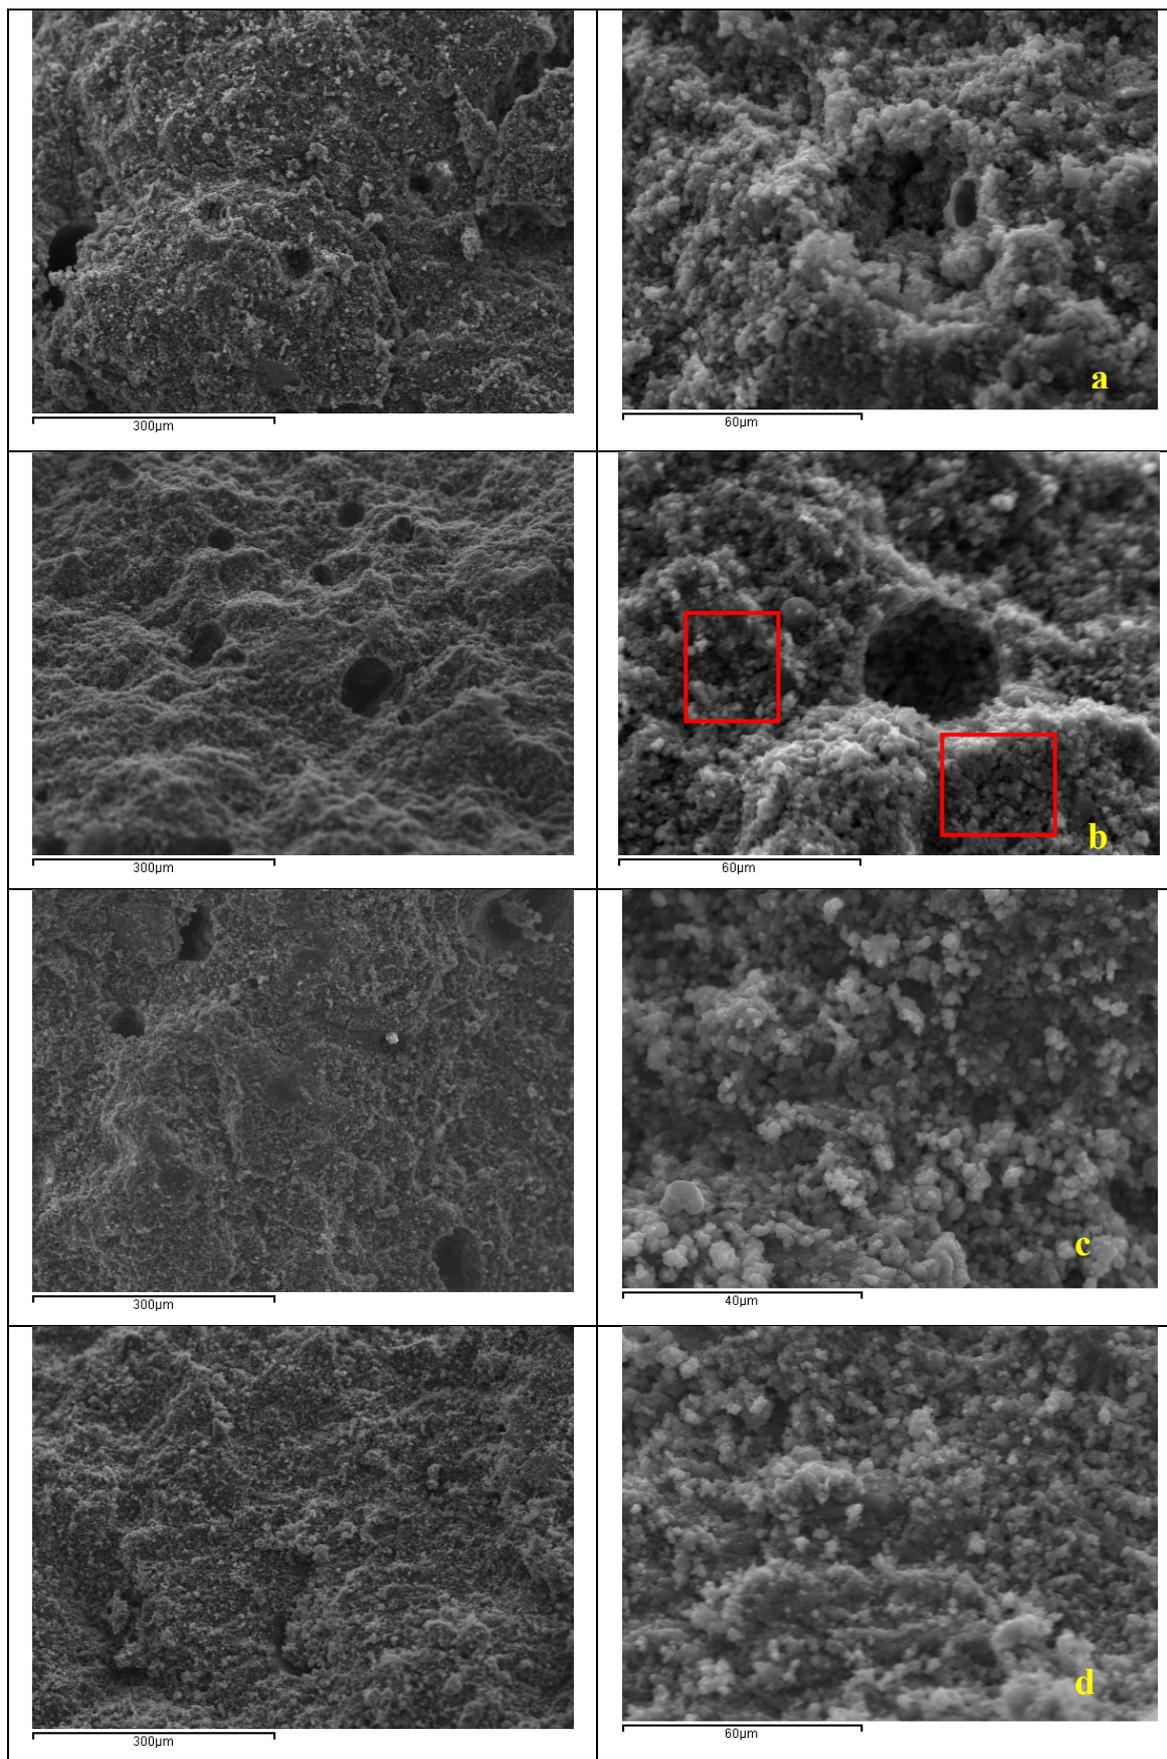
Figure 7. SEM micrographs of nano-modified lime pastes a) LNS3, b) LNA3, c) LNAC d) LNC at 90 days at different magnification

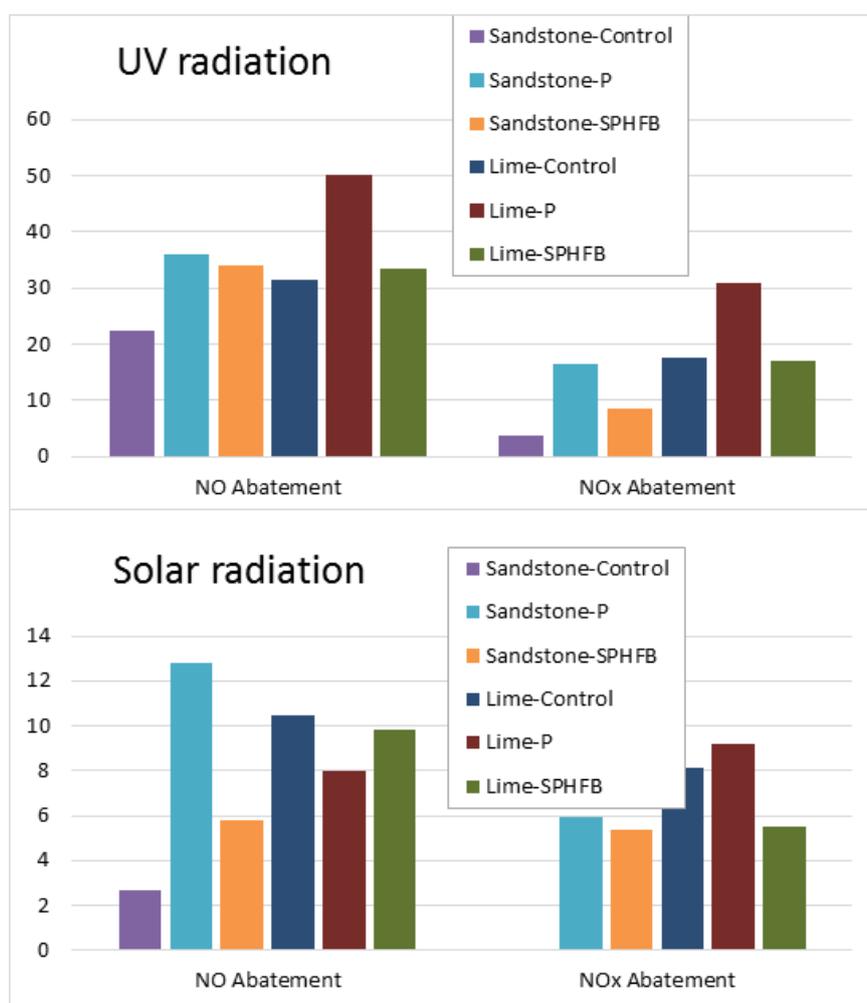
Figure 6. NO and NOx abatement of different samples treated with active coatings: non-treated sample (Control), only heterostructured photocatalyst TiO₂/ZnO 50:50 in a 1% (w/v) dispersion (P); and a dispersion containing both photocatalyst and superhydrophobic agent (SPHB).

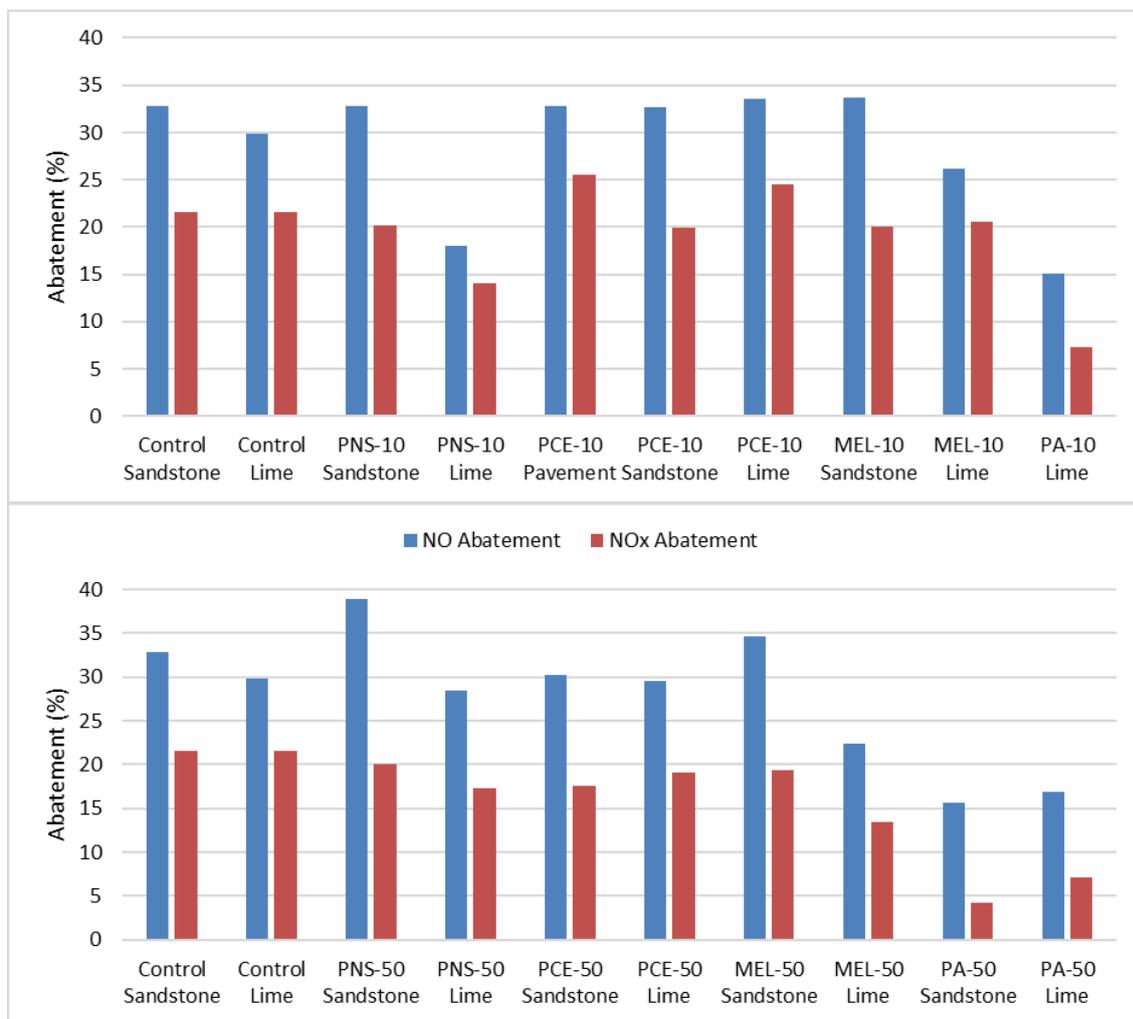
Figure 7. Effect of the different dispersing agents: NO and NO_x abatement of the coatings prepared with TiO₂/ZnO 10:90 (top) and 50:50 (bottom) photocatalysts.

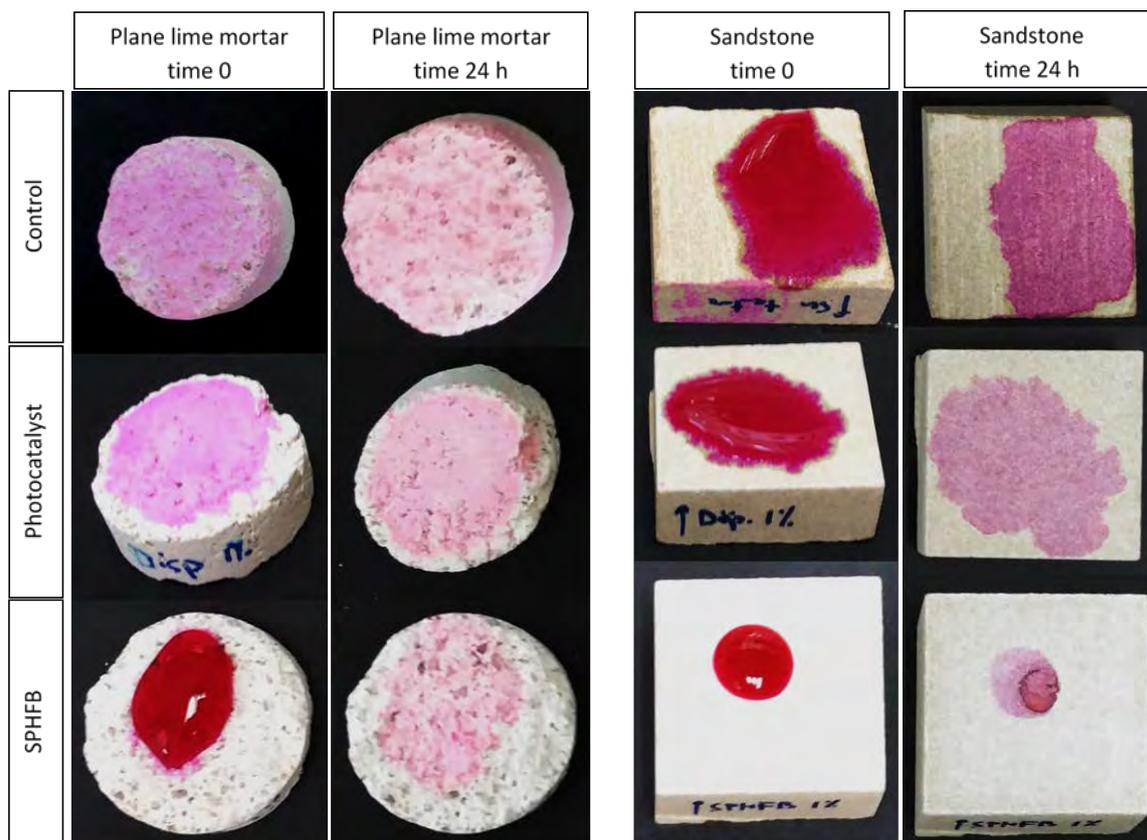
Figure 9. Results of the photocatalytic self-cleaning test at time 0 and 24h for lime mortar and siliceous stone samples. White coloring in Sandstone at time 0 is due to the light source.

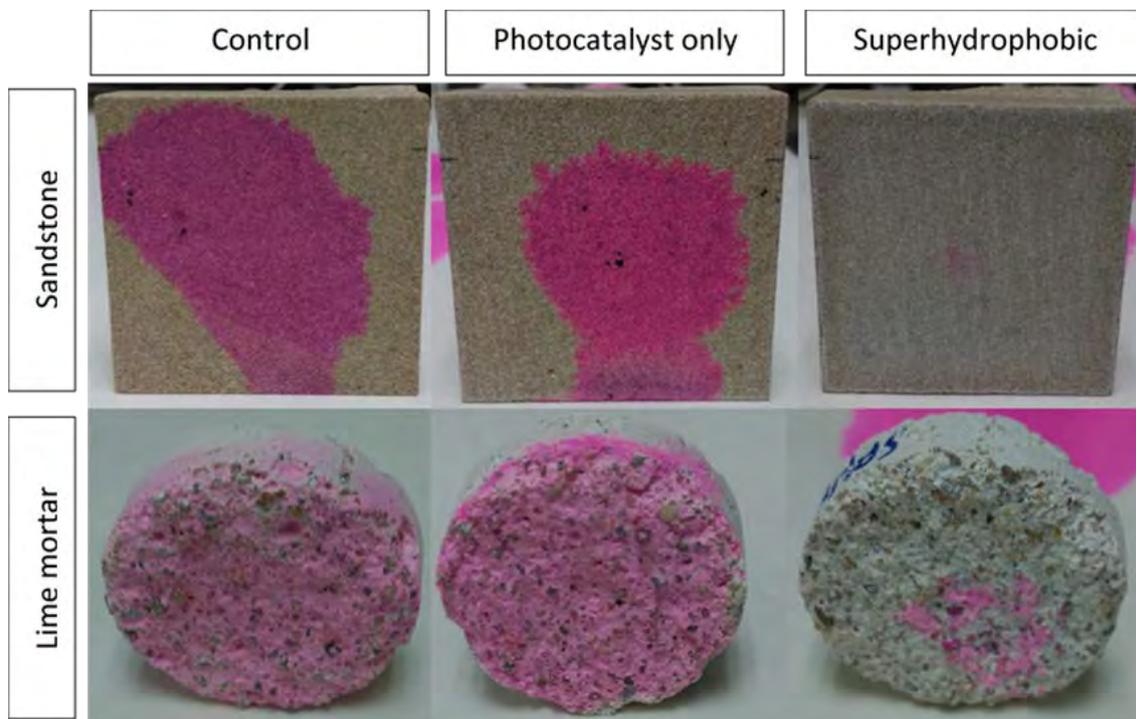
Figure 10. Results of the self-cleaning test for samples in vertical position: dye was deposited onto lime mortar and siliceous stone samples for one minute in horizontal position and then moved to vertical position.

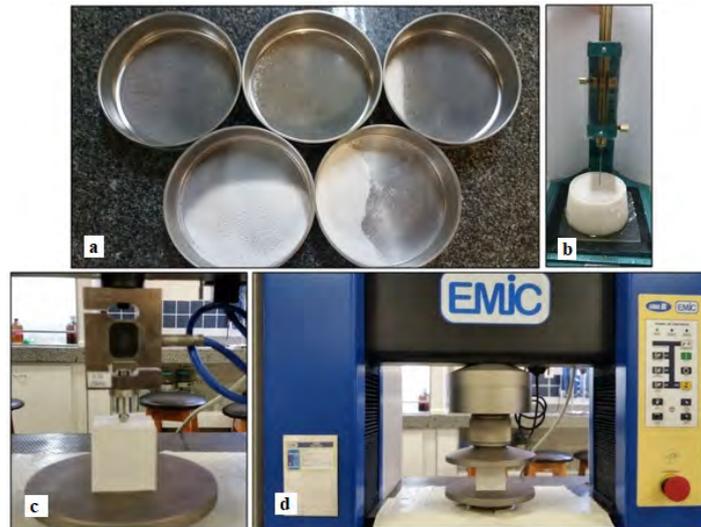
Figure 1. Gypsum plaster tests: a. Grain size tests: sequence of sieves and retained material; b. setting time using the Vicat apparatus; c. Hardness; d. compressive strength.

For determination of hardness, a universal EMIC test machine was used, applying indirect contact loading between the machine and the specimen through a metal sphere with a diameter of 9.5 mm. A load of 50 N was applied for 2 seconds. Then, this load was increased to 500 N during 15 s. This process was applied to the lower molding faces and to two other opposing lateral faces chosen from all the specimens, that is, 3 faces. The ball produces an impression on the surface of the specimen, which must have a measured depth. NBR 12129 [6] highlights that the value adopted for the series should be the average of the three results obtained, except when one of the individual values diverges more than 15% from the mean, being excluded from the depth calculation. If more than one diverges, the test must be remade. The hardness value (N/mm^2) is calculated by the division the load applied (N) by the product of π , diameter of the sphere (mm) and average of the depth (mm).

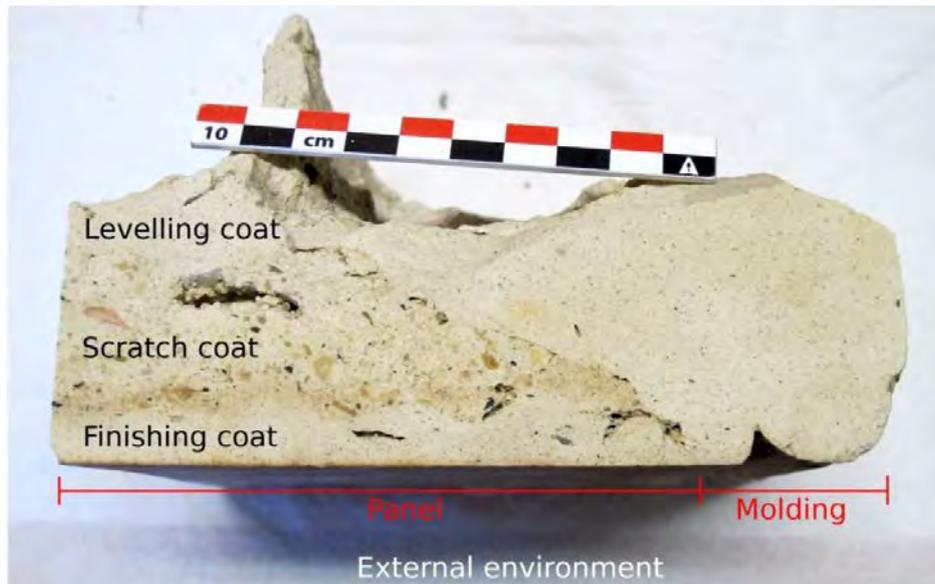
Figure 2: Cross section with different coat types. Render sampled from the building “Hôtel Amelot de Bisseuil”, Paris, France (1660).

The observation of the layers, their position in the render, their thickness and the grain size of their inclusions inside, allows a categorization of coats: 9% of the layers correspond to a leveling coat, i.e. a layer directly applied on an irregular support (rubble or brick masonry/timber-framed wall) in order to equalize the surface. 39% of the layers are scratch coats, which are quite thick (1-6 cm) and usually contain grains up to 10 mm large. 44% of the layers are finishing coats, i.e. the final and therefore superficial coats of the render. This kind of layer is generally much finer than the scratch coat; it contains small grains (diameter <5mm); the following Figures 2 and 3 illustrate a typical render stratigraphy and the coat types.

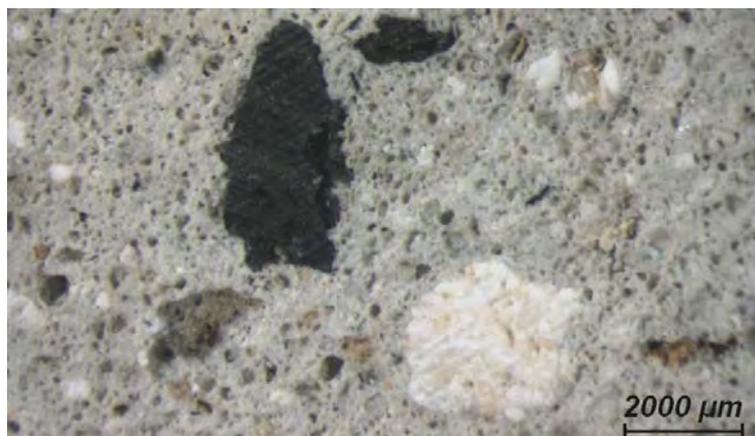
Figure 10: Microscope observation of a coal fragment (black grain on the left) and a gypsum rock fragment (white grain on the right) in the scratch coat of the "Séminaire Saint Rémy", Meaux, 1776

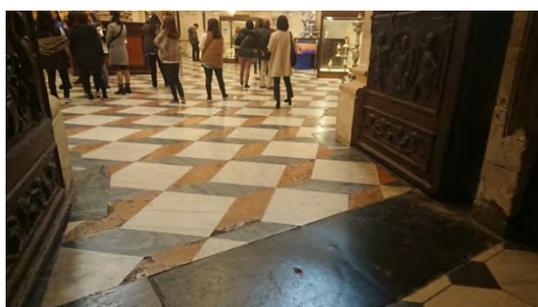
The pavement of the major sacristy of the Cathedral of Seville is composed of two types of paving stones: white and dark grey marble and red limestone (Figure 1). The different resistance to wear between marble and limestone is due to their distinct geological formation: the first is a metamorphic rock where calcite crystals form a compact microstructure, while the second is a sedimentary rock, composed of calcium carbonate with fossil fragments, more porous and sensitive to water or mechanical actions. In this case, the limestone slabs suffered from spalling, a pathology that lead to significant losses of material along time. The result is now inappropriate, both from the aesthetical and the security of the users' point of view. In fact, large holes with more than 1-2 cm depth already exist in some of the paving stones and were the main reason to carry out this intervention.

Figure 1. Major sacristy of the Cathedral of Seville: general view of the stone pavement

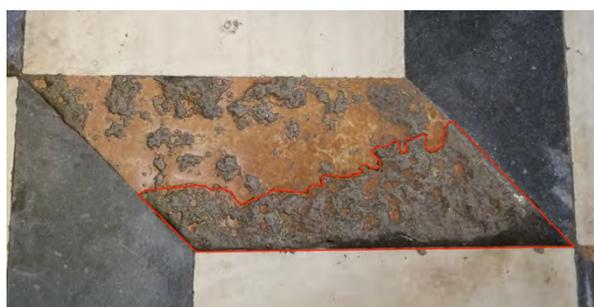
The first step was the analysis of the areas that needed to be restored. The quantity of damaged stones was very large in the total of the pavement, so, the criterion that helped deciding which had to be restored in first place was based on those that represented a real danger of stumbling to the users: they had large holes and loss of material corresponding to one, or more centimetres in depth, leading to levelling irregularities between the damaged slabs of limestone and the adjacent slabs of marble (Figure 2). A total of sixteen pieces, two of them with total loss of the surface, were selected.

Figure 2. Detail of one damaged paving stone: the red line shows the part to be restored with stucco marble

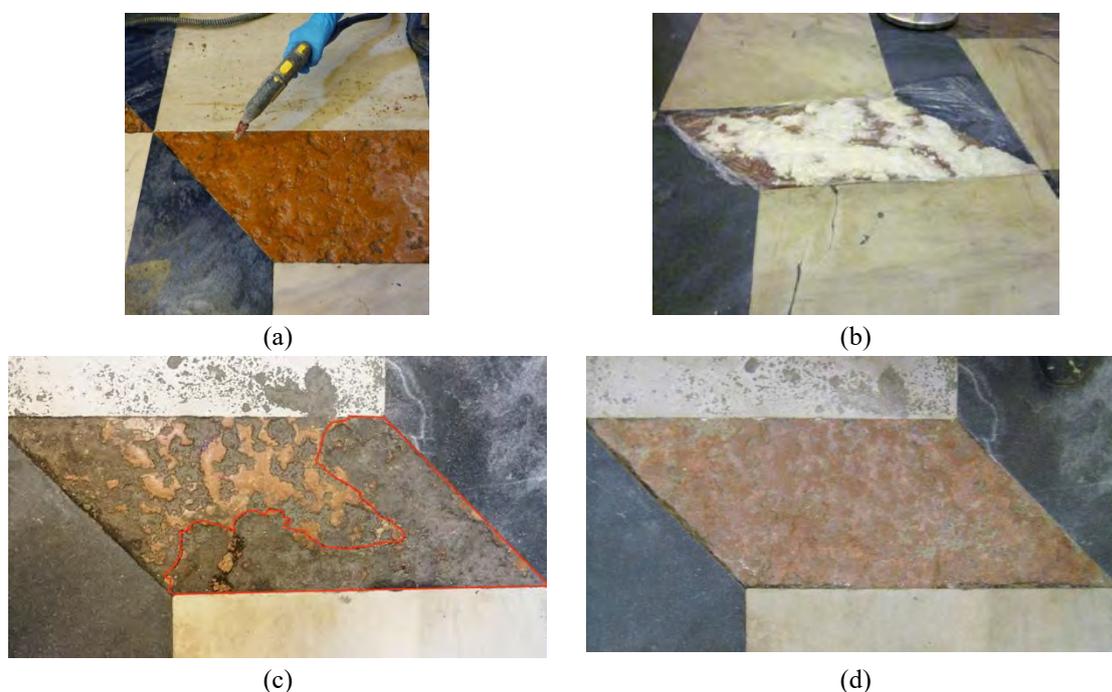
Figure 3. Cleaning of the paving stones: (a) using the steam cleaner; (b) application of paper pulp with ammonium bicarbonate; (c) stone slab before cleaning; (d) the same slab after cleaning

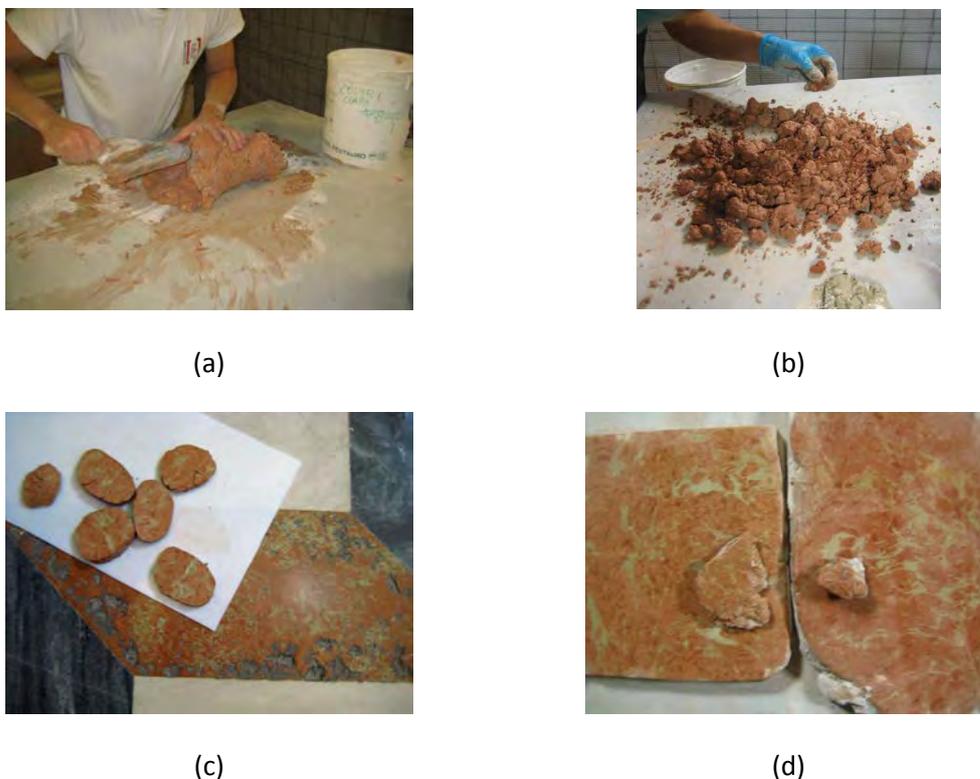
Figure 5. Preparation of stucco marble pastes: (a) mixing the gypsum plaster with the kneading water; (b) selecting different colours to obtain a similar esthetical effect; (c) final mixes before curing; (d) two pieces of limestone above the two recipes of stucco marble selected

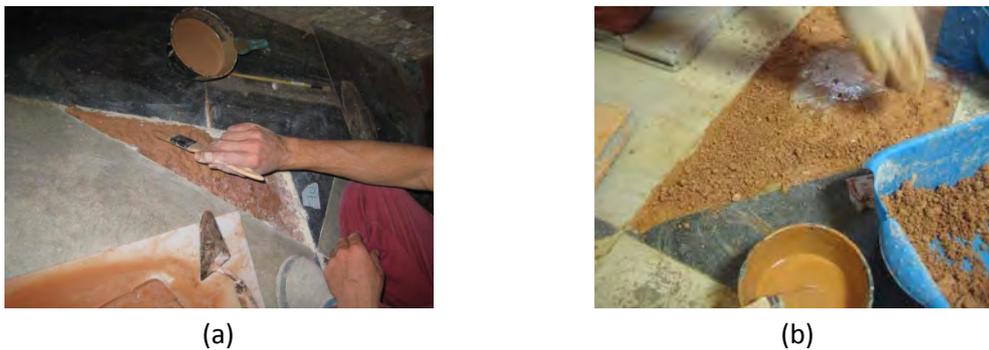
Once the stucco marble paste was prepared, the first step consisted in the application of a grout (Figure 6a) constituted by a fluid paste of the same stucco, to make a bonding interface, improving the adhesion to the limestone. Afterwards, a layer of the same stucco paste mixed with siliceous gravel was applied, which worked as compression filler (Figure 6b). This mix was carefully compacted by hand.

Figure 6. Application of the preparation layers: (a) stucco grout; (b) stucco mixed with gravel.

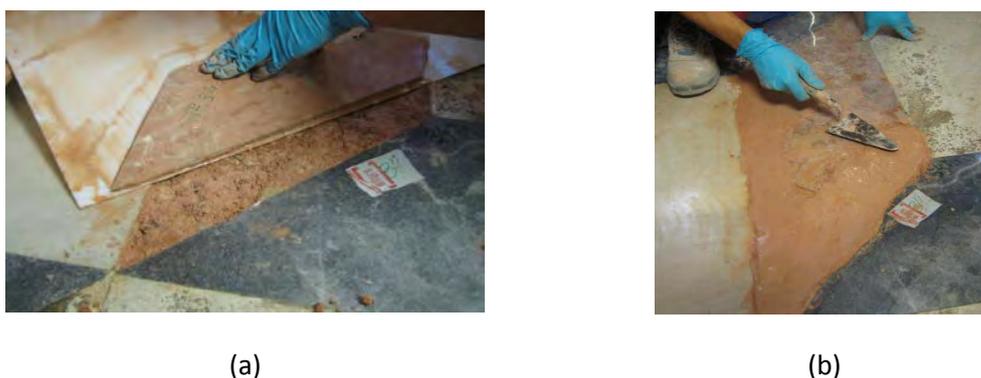
The layer of stucco marble with all the different colours and veins, previously moulded on a table to fit the shape of the corresponding stone slab, was finally applied (Figure 7a). This last layer was compacted following the traditional way of application of stucco marble, using a trowel to hit the surface in order to improve the bonding to the preparation layers (Figure 7b).

Figure 7. Application of the final layer: (a) fitting the previously moulded stucco marble paste; (b) compacting the surface with a trowel.

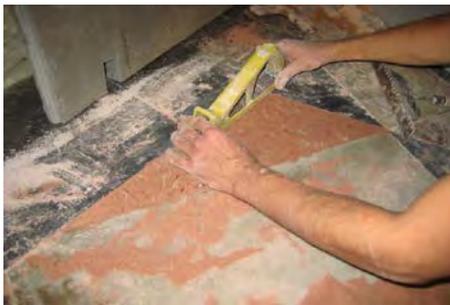
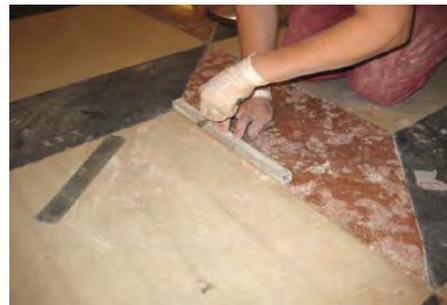
Once the paste was fixed to the damaged area of the slab, the excess of material was cut until levelling it with the adjacent slabs (Figure 8a) and the edges were redefined (Figure 8b). This step revealed the morphology of the veins and the tonalities of the interior of the paste.

Figure 8. (a) Cutting the excess of paste from the surface; (b) redefining the edges

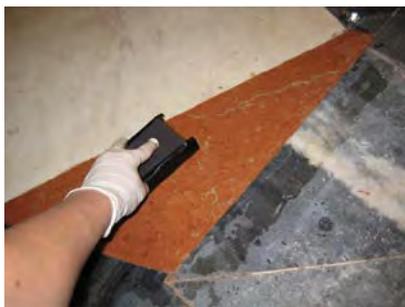
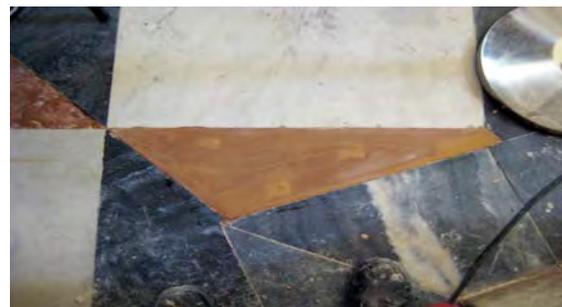
Finally, the gypsum was left for curing. Once it was completely hardened, the next process was the polishing of the surface using wet sandpapers. Between each reference of sandpaper, it was necessary to apply a layer of the same stucco in a very fluid consistency, for covering all the small holes caused by air bubbles in the paste. The aim is to achieve a homogeneous smooth surface without visible pores. They were used different grains of grit sandpapers (from 120 to 2000) (Figure 9). After the last sandpaper, it was cleaned and left to dry completely.

Figure 2. Finishing of the surface: (a) polishing using different wet sandpapers; (b) application of fluid pastes to fill the pores that still prevail

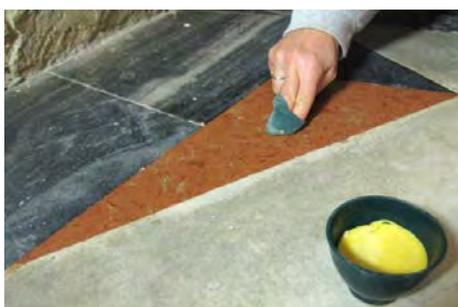
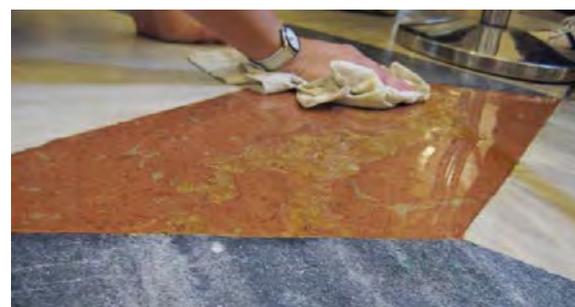
The last step of the stucco marble application process consists of another polishing operation and the protection of the external surface against moisture [8, 9]. In this case, first it was applied crude linseed oil which was left for one day in contact with the surface, until saturation of the porosity of the paste, followed by a mixture of bees wax with a little portion of carnauba wax (Figure 10).

Figure 10. Protection of the external surface: (a) application of a mixture of waxes; (b) final polishing of the surface
