Proceedings of the 5th Historic Mortars Conference

5th Historic Mortars Conference

19-21 June 2019
Pamplona, Spain

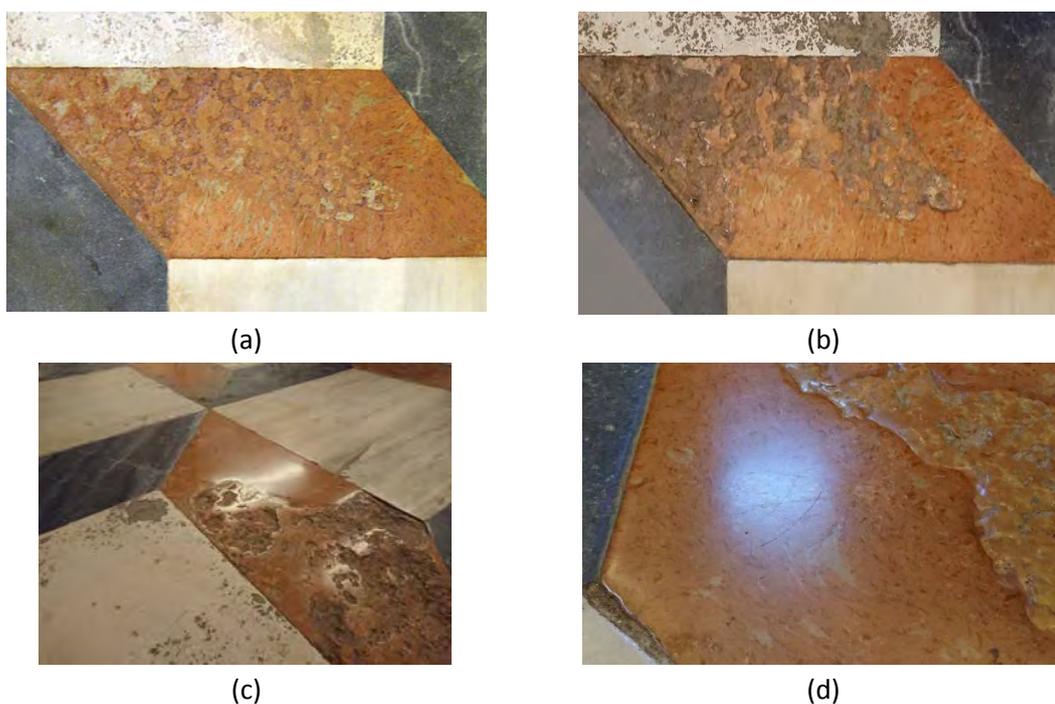
Figure 11. Evaluation of the intervention after one year: (a) stone slab just after restoration; (b) the same slab after a year of use; (c) stone partly restored, where the dirtiness on the unrestored holes is visible; (d) surfaces of the stone and of the reintegrated parts in stucco with some visible scratches

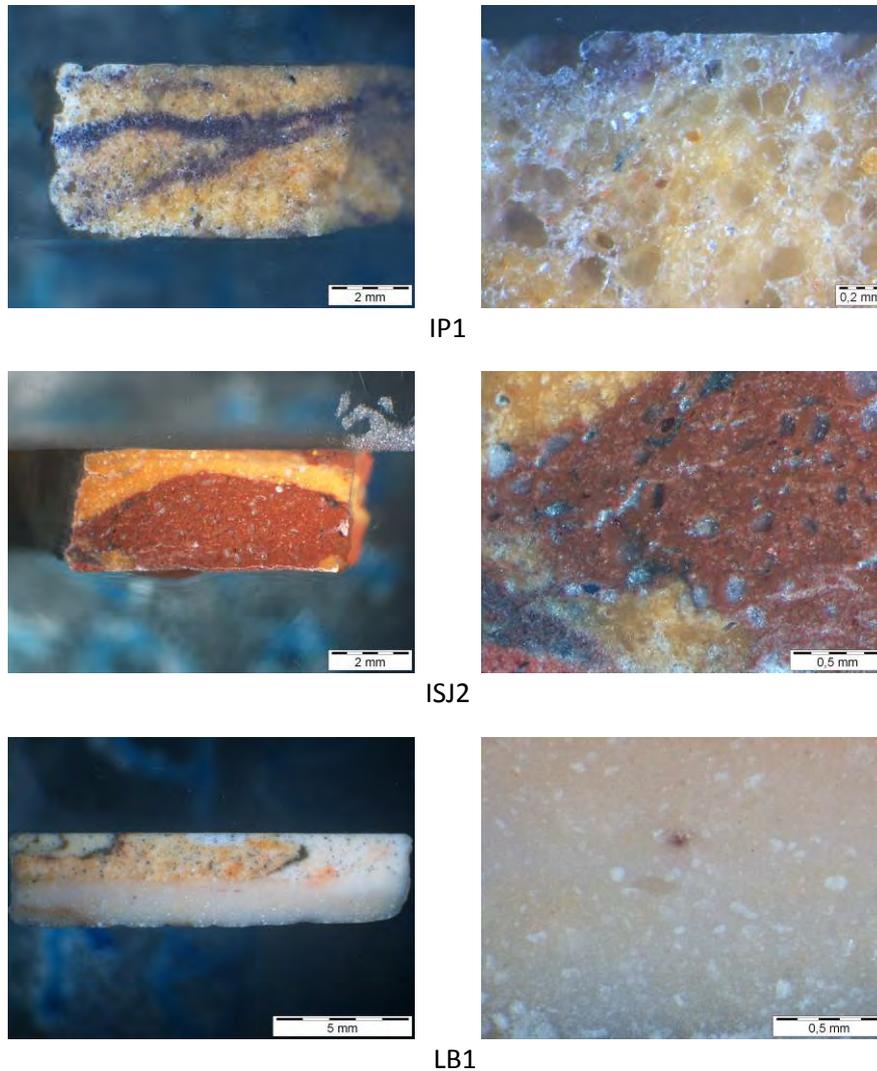
Figure 4. Cross-section polished surfaces of samples IP1, ISJ2 and LB1, showing the stratigraphy and the porosity of the matrixes

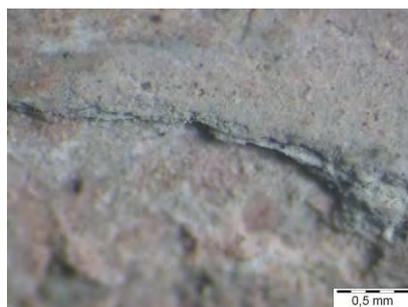
Another important detail that was possible to see in samples with fracture and detachment of the surface of the stucco marble is the difference between the compactness and orientation of the last micrometres of the plaster (forming a layered structure) and in depth (Figure 5). Similar observations have been made in samples of Baroque stucco marble of a Polish chapel using SEM [1], attesting the importance of the procedures of repeated grinding and polishing the surface, often referred in the literature [2-4]. During the execution of these procedures, the holes appearing at the surface are filled with a low consistency mixture of gypsum and glue. Turco [4] states that “in the imitation of marble what counts the most is the superficial appearance and gypsum plaster is the binder that allows obtaining the most perfect results”.

Figure 5. Sample IP3: image showing the difference between the texture of the plaster in the bulk and closer to/at the surface

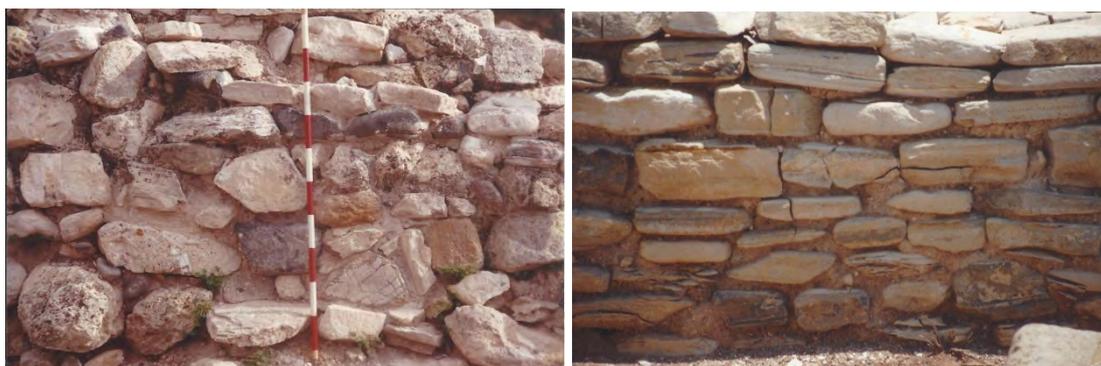
The bibliographic and in situ research showed that clay was diachronically the main material used as a binder between rubble stones (Figure 1) and ashlar (Figure 2), as well as between adobes (Figure 2). It was mixed with small stones to fill the space between the two external faces (shells) of rubble and ashlar stones (Figure 2), as well as between the successive layers of stones and adobes. The thickness of the mortar between the successive layers of adobes was about 1-3 cm. An interesting aesthetic result derives from the use of a different colour of clay as a binding material in adobe walls in Khirokitia, Marki-Alonia, Alambra-Mouttes, Maroni-Vournes (Figure 2) and Hala Sultan Tekke, when compared to the colour of the adobes themselves. This was probably not intentional, as these structures were then plastered.

Figure 1. Clay mortar between rubble walls in Khirokitia and Kalavassos-*Ayios Dhimitrios*

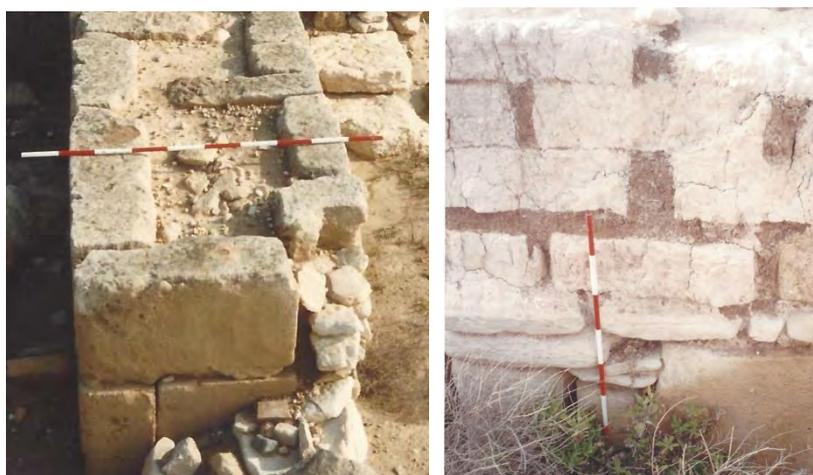
Figure 2. Clay mortar used between ashlar blocks in the Late Bronze Age Settlement of Hala Soultan Tekke and between adobes in the Late Bronze Age settlement of Maroni-*Vournes*

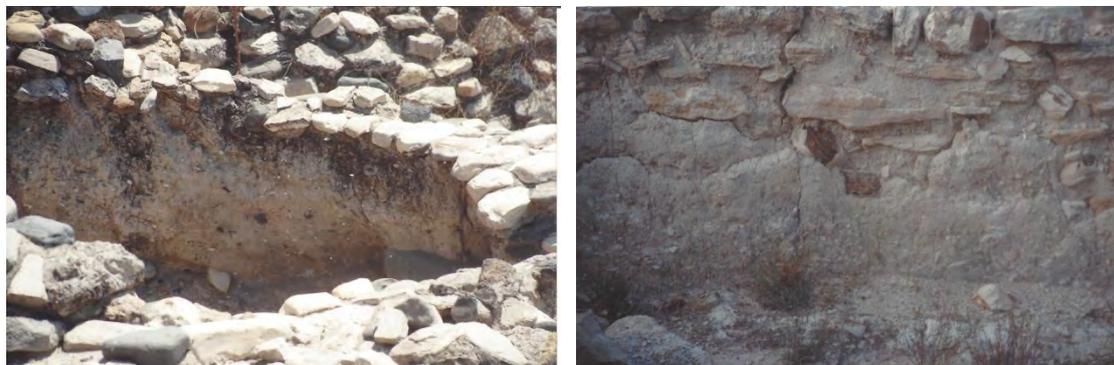
Clay was also used as a plaster on rubble and adobe walls from the Neolithic period (Figure 3) onwards for structural and aesthetic reasons [3]. There are also some rare bibliographic references for the existence of plaster over ashlar in Enkomi [4] and Kition [5], but the plaster found on these ashlar surfaces may be related to later phases of Late Bronze Age buildings being reused. Plasters were often laid in a considerable thickness [3] of up to 7 cm (Enkomi) [4] or even 10 cm (Lemba) [6], in two or more thin successive coats for structural reasons in order to avoid them collapsing under their own weight. The final thin coating of finer ingredients was often applied over a coarser base layer. The coarser layer contributed to the better adhesion of the coating to the structure of the wall, especially in the case of adobes. The plastering was most probably carried out by hand and the smoothing of the finished surface was achieved with the help of a stone tool. The final smoothing results in a better aesthetic outcome and also serves to fill any voids in the plaster. A variety of colours can be observed in the clay used as plaster, dependent on the provenance of the raw material used, such as red (Enkomi), white (*Alambra-Mouttes*) or yellowish (*Morphou-Toumba tou Skourou*).

Figure 3. Clay plasters from the Neolithic settlement of Khirokitia and the Middle Bronze Age settlement of *Alambra-Mouttes*

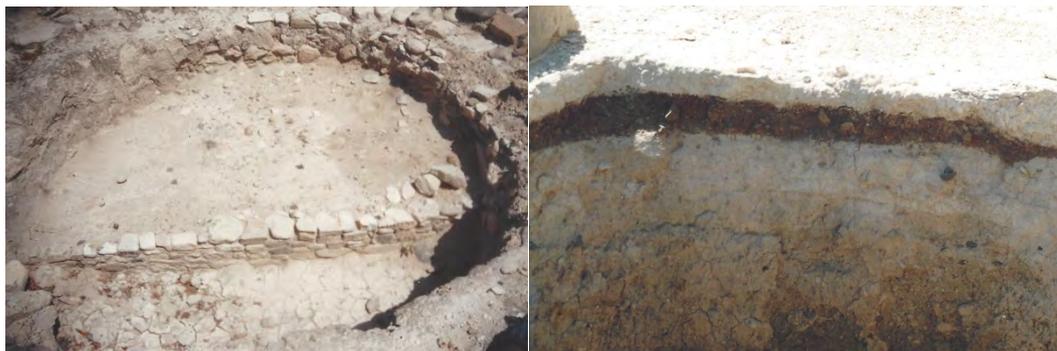
In the lower part of the vertical walls, where they met the horizontal floors, a series of small rounded stones (pebbles) were sometimes laid to ease the curvature of the wall plaster [8] (Khirokitia), which continued as floor coating. The floor coating often constituted of two or three successive layers of a considerable thickness of up to 25 cm (*Kalavassos-Tenta*) [9] according to the duration or lifespan of the structures. A fine-grained coating was often laid over one or two coarser substrates, often placed above a base layer of flat stones (Figure 4). Floors were sometimes compressed in order to achieve a compact final surface. There are also cases where the floor coating was laid on the physical rocks without any previous substructure of stones. In the floor plasters, a variety of additives were recognised by the excavators such as pebbles, ash, straw, grass, fossils and charcoal (*Enkomi*, *Cap-Andreas-Kastros*, *Lemba-Lakkous*).

Figure 4. Plaster floors from the Neolithic settlement of Khirokitia and the Late Bronze Age settlement of Kalavassos- *Ayios Dhimitrios*

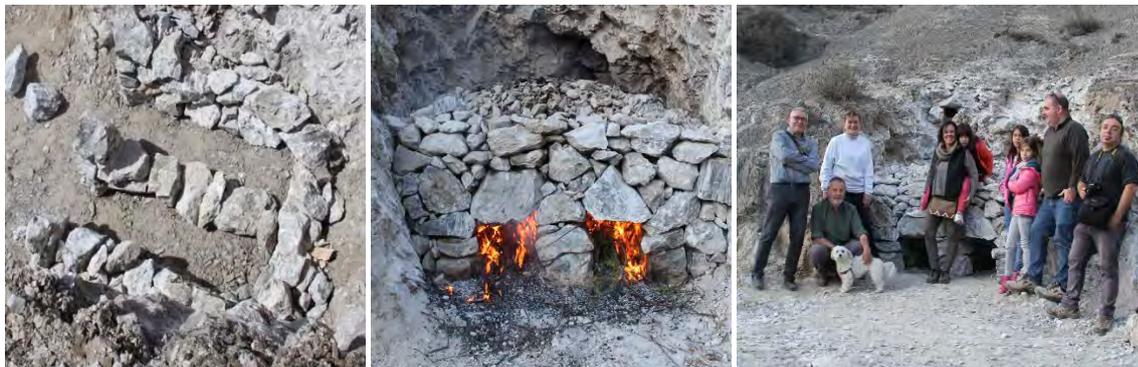
The kiln was assembled in the same place where the extraction was made, taking advantage of the hole left by the cut with the backhoe. For the creation of this traditional kiln, two side walls were built and one in the center, above them, the gypsum stone was placed in the form of a vault, leaving two holes in the lower part for the placement of the fuel. A plant called "boj" was used as fuel, in addition to wood, material, which was extracted from the same mountain where the gypsum stone was.

Figure 1. Pictures of the elaboration of the traditional oven in Pallars by the CEG brigade

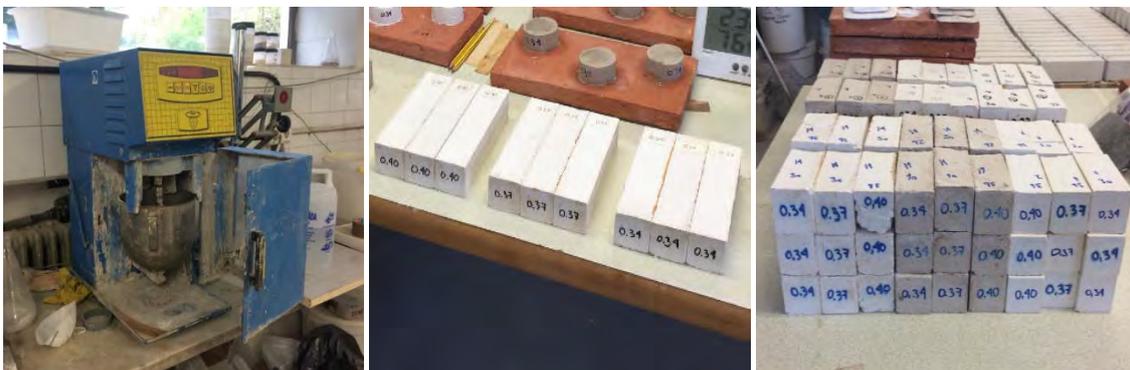
There were made rectangular prism- shaped specimens, both with traditional gypsums (Pallars and Albarracín) for the tests. All of them were design following the Spanish standard UNE-EN 13279-2 [7] using metal molds with measurements of 4x4x16cm and following the dosages of water and plaster previously provided. Additionally, it was taken into account, two different mixing times: one and three minutes.

A total of 18 test pieces were made, three pieces for each W/G ratio, as well as for each mixing time. (Figure 3).

Figure 3. Preparation of test pieces for the mechanical tests according to the Standard Norm UNE-EN 13279-2.

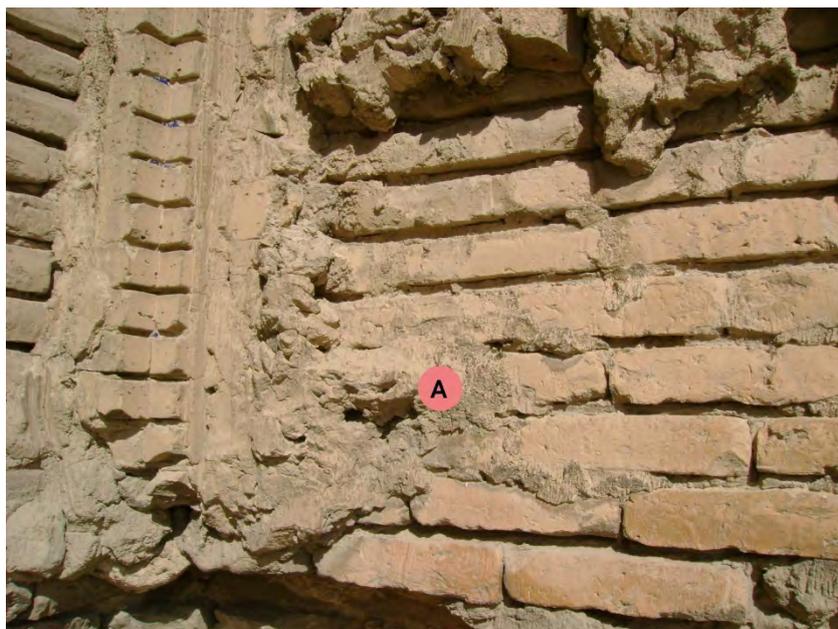
Plaster A is used as a multi-layered coat between two brick layers to compensate for irregularities in the masonry and is located in the northern entrance area to room 6 in 2 m height (Figure 2 and 3).

Figure 3: Plaster A, sample location, entrance area to room 6

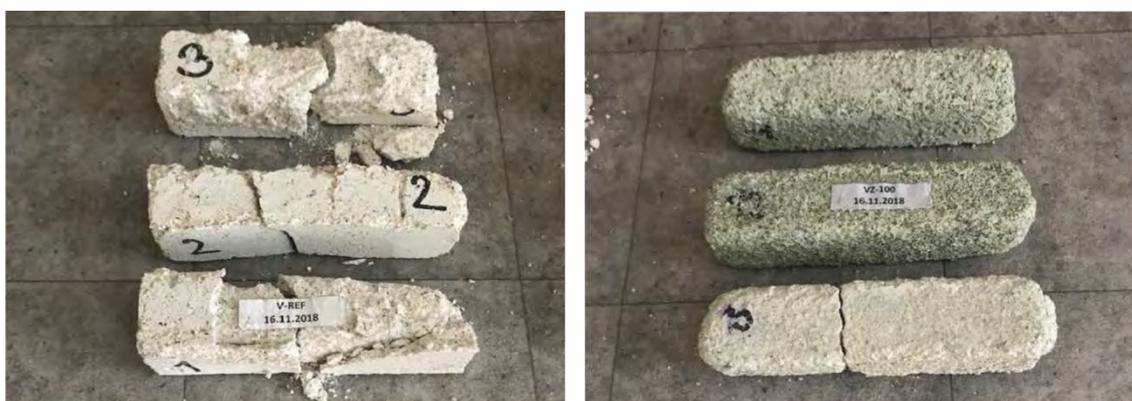
The table shows that the renders with NZ are not resistant to crystallization of sodium chloride. All render samples were also broken down after several crystallization cycles of sodium sulfate, where gypsum with high molar volume is likely to occur. The NHL renders break down in the sodium sulphate solution earlier due to the presence of the aluminate phase and the formation of bulkily ettringite breaking the structure of the render. The use of NZ as aggregate slightly improves the resistance of renders to crystallization of sodium sulphate. A detailed study of the NZ impact on the render's resistance to salts crystallization, including XRD, XRF, and SEM EDX analyses, is beyond the scope of this paper and will be part of the separate forthcoming publication.

L-Q after 6 cycles of Na₂SO₄ crystallization

L-NZ after 9 cycles of Na₂SO₄ crystallization

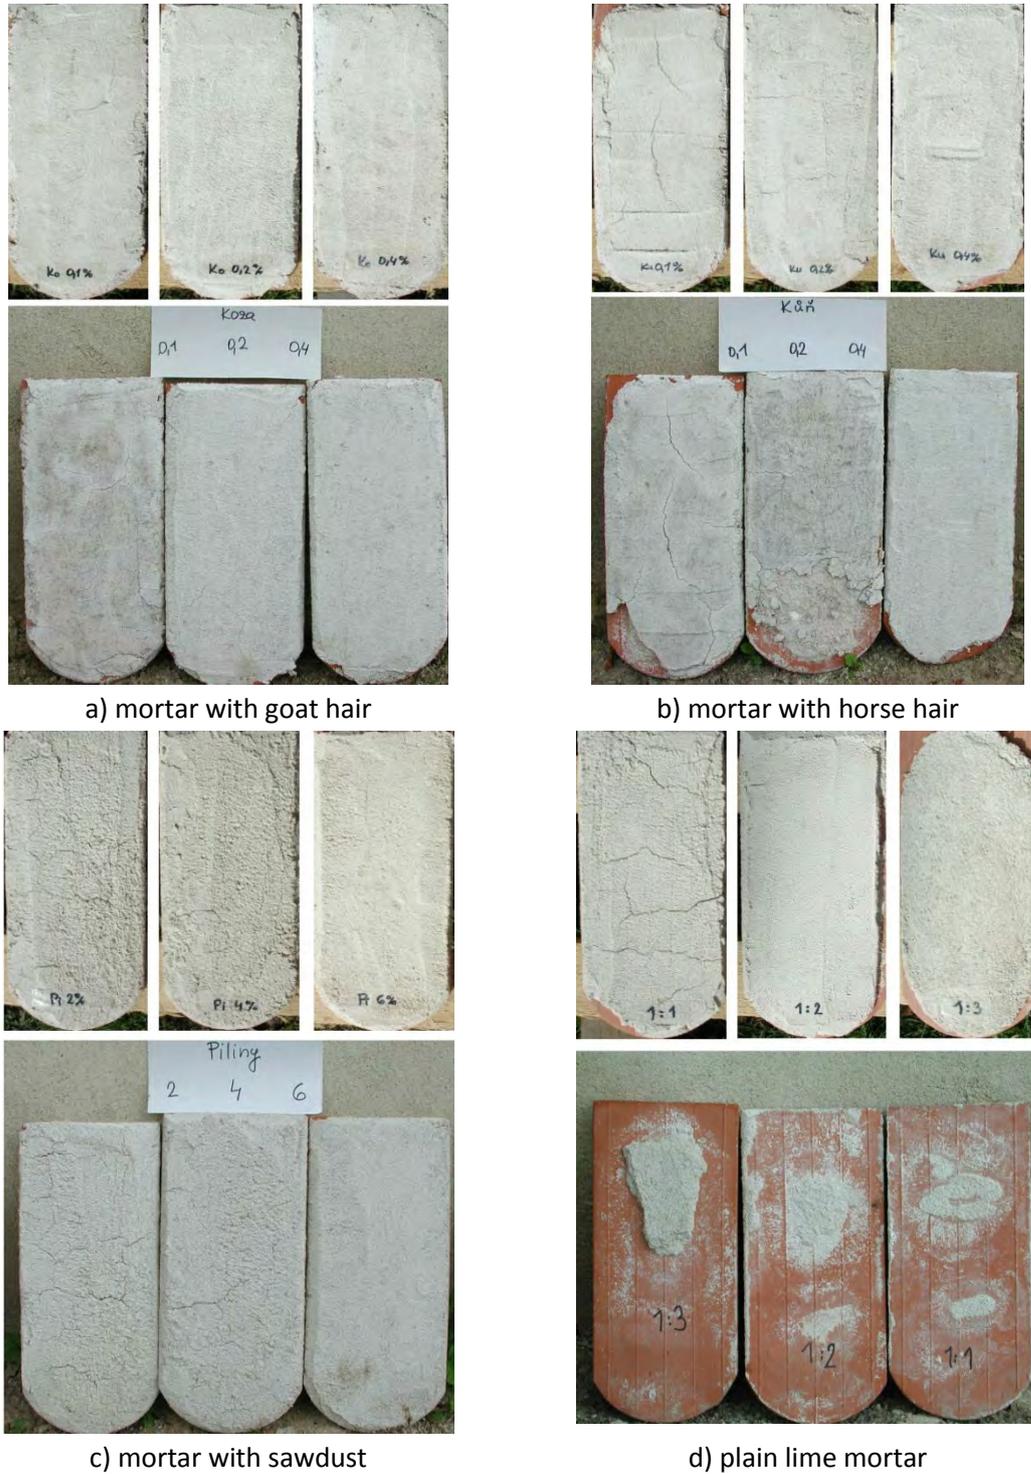
Figure 1. Damage patterns on mortars before and after one year of weather exposure.

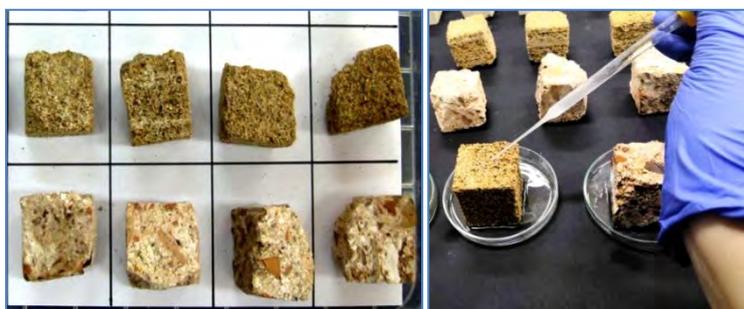
Two types of substrates were selected a) a porous sandstone, consisted of quartz, calcite and K-feldspar and b) a historic lime mortar. Cubic specimens ($3 \times 3 \times 3 \text{ cm}^3$) were cut off from larger blocks and dried at $60 \pm 5 \text{ }^\circ\text{C}$ to constant mass. Aiming to primarily investigate the effect of the alteration of the dispersion medium on the morphological and rheological characteristics of the dispersions, all four newly formed nanolime dispersions were applied drop to drop on the top face of the cubic specimens, by the use of a pipette and a brushstroke, allowing the nanolime dispersions to be fully absorbed between two consecutive applications (Figure 1). The nanolime dispersions were being placed under ultrasonic agitation throughout the application procedure. The application of the nanolime dispersion was completed after 10 consecutive applications. Upon consolidation completion, the samples were stored in a sheltered box for 28 days, under laboratory atmospheric conditions ($T = 20 \text{ }^\circ\text{C}$, $RH = 60\text{-}80 \%$).

Figure 1. Application procedure

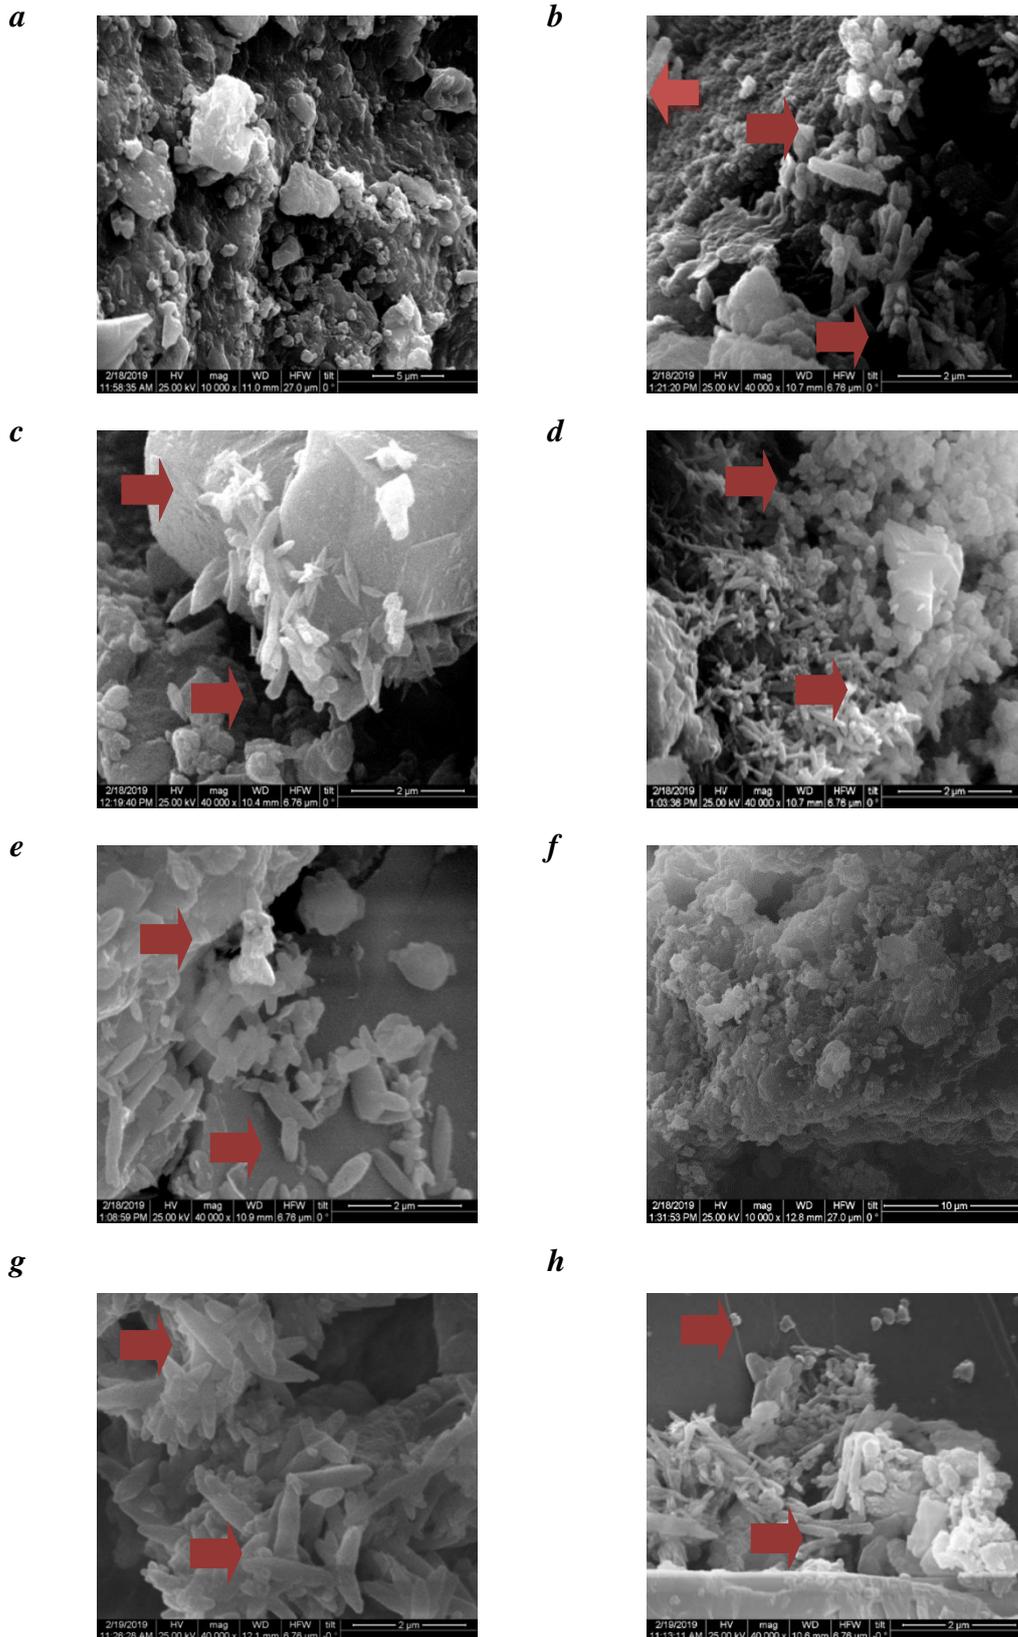
Figure 7. SEM observations of *sandstone* a) untreated and treated specimens with sandstone of b) Exp01, c) Exp02, d) Exp03 and e) Exp04 and of *mortar* f) untreated g) Exp02 and h) Exp03

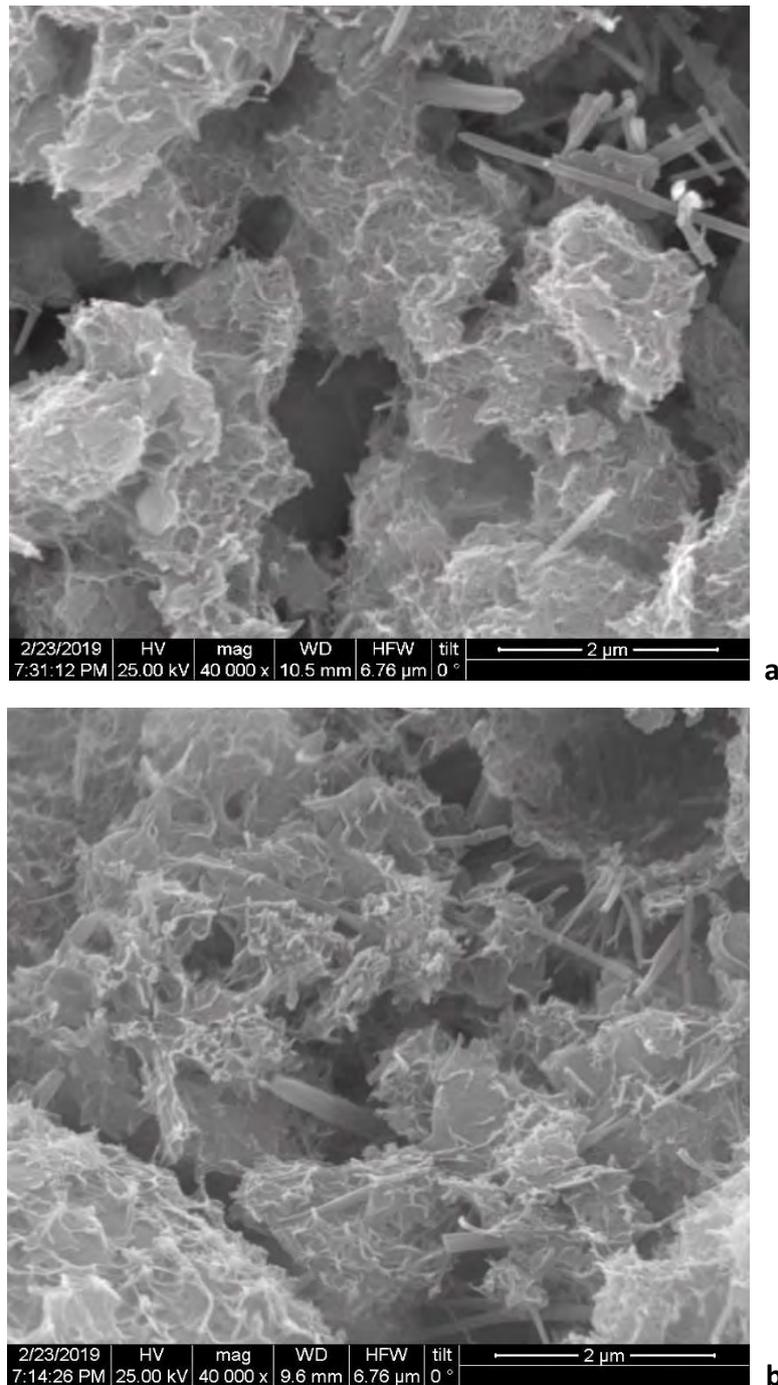
Figure 3. SEM photomicrographs of the binder matrix formed during setting in the reference mixture (a) and the LMC2 mixture, containing 0.2 wt% CNTs (b). The curved fibrous formations in the lower picture – having very similar morphology to the C-S-H hydration products – are attributed to CNTs. These are absent in the upper picture that depicts the hydrated matrix at the same magnification.

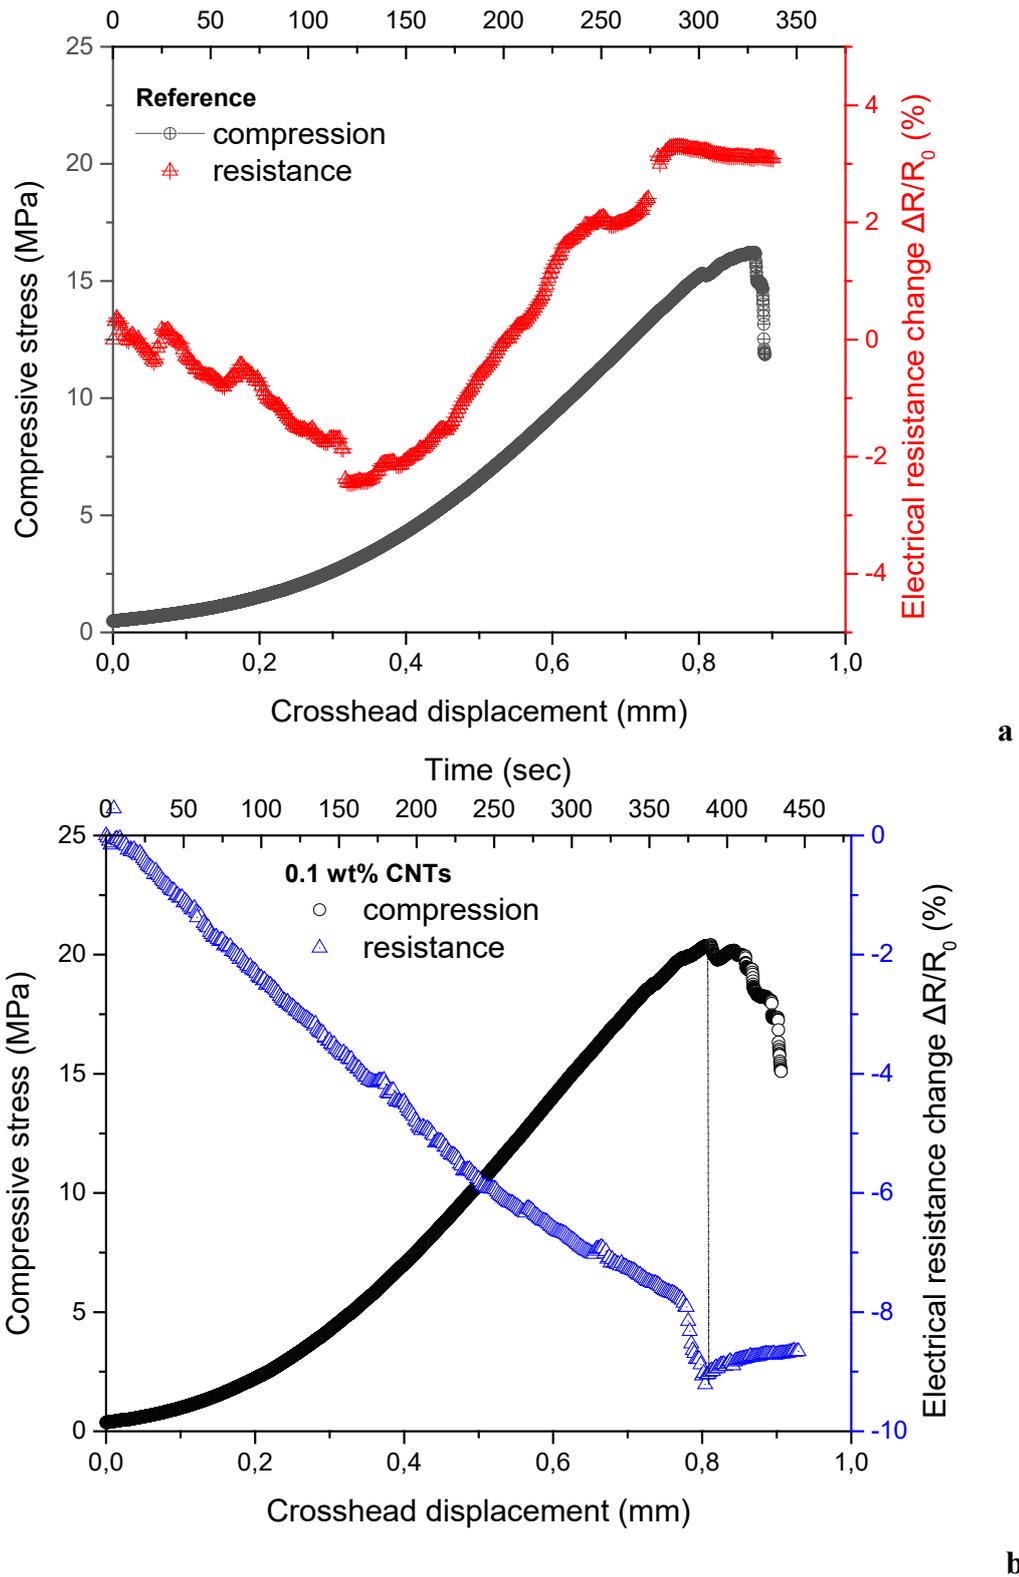
Figure 6. Representative graphs of the piezoresistive response of two ternary mixtures, i.e. LMC2 (a) and LMC2 (b) during monotonic compression, after 28 days setting/hydration time.

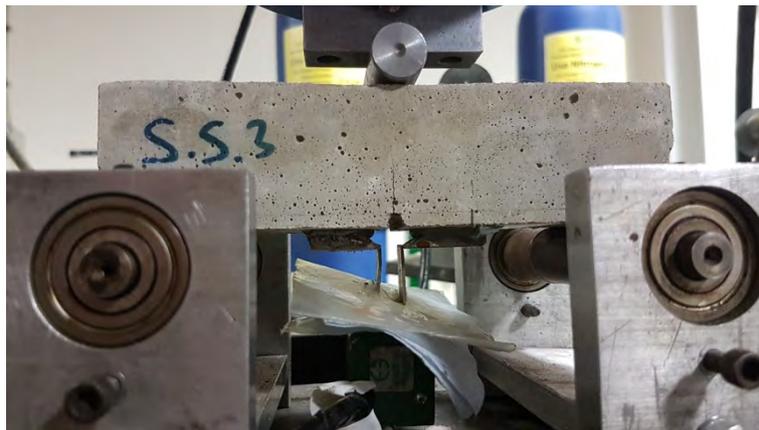
After 14 days all specimens were subjected to three-point bend testing (Figure 3) in order to damage the specimens and activate the healing mechanism. Specimens were then re-tested in flexure until failure after three days of further curing. Three-point bend tests were carried out in displacement control with a rate equal to 0.0001 mm/s. In order to induce the crack, samples were pre-notched with a notch depth of 5 mm. Tests were carried out for each notched mortar specimen, by using a servo-hydraulic universal machine with a load cell capacity of 100 kN. The Crack Mouth Opening Displacement (CMOD) mode was used through a clip-on extensometer.

Figure 3. Testing arrangement on notched beams

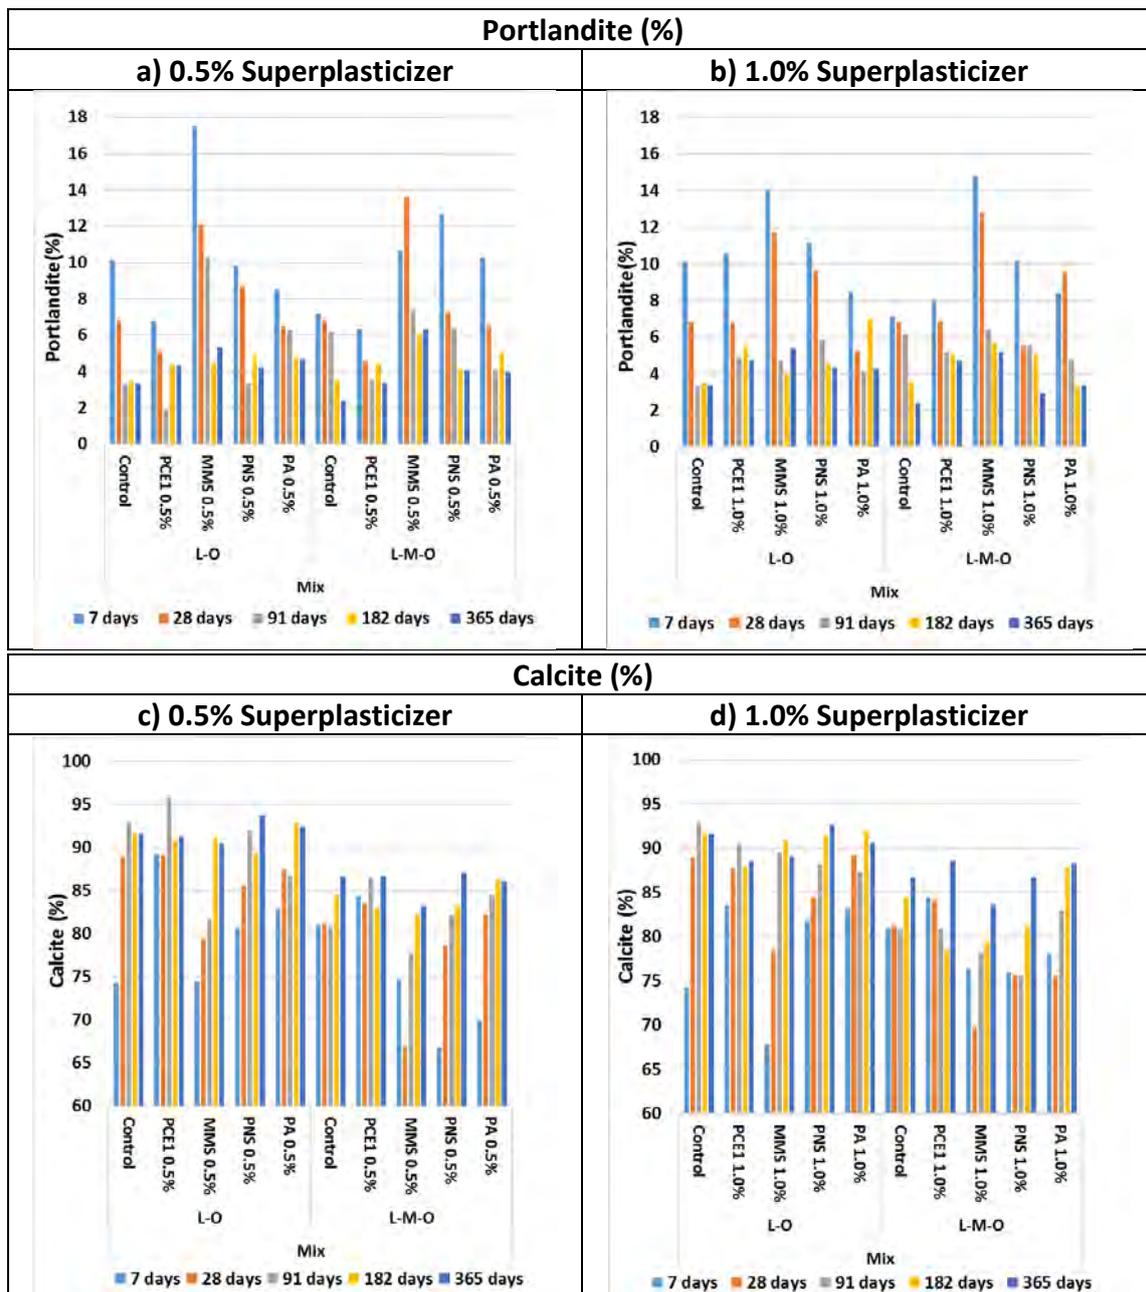
Figure 7. Percentages of Portlandite ($\text{Ca}(\text{OH})_2$) and Calcite (CaCO_3) of grouts at different curing times.

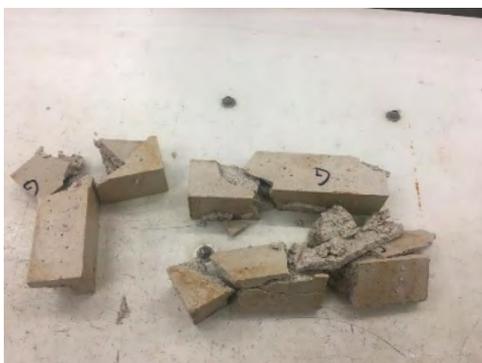
The plain grouts subjected to frost resistance test (freezing-thawing (F–T) cycles) underwent serious decay leading to the total destruction of the sample after just one cycle (Fig. 9).

Figure 9. Pure air lime grouts subjected to one freezing-thawing cycle

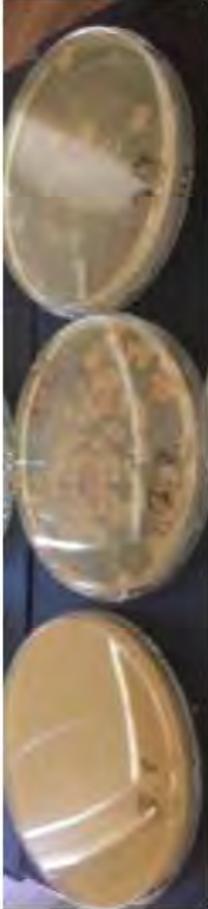
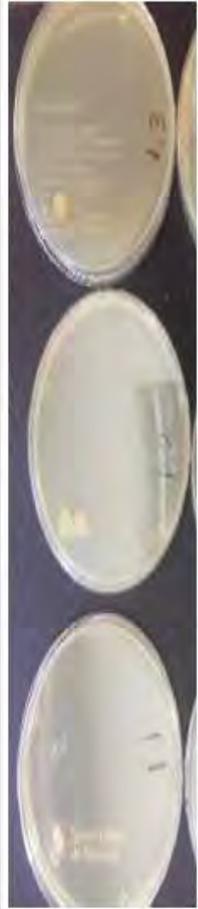
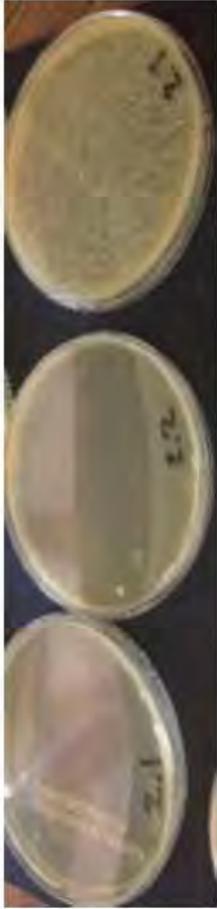
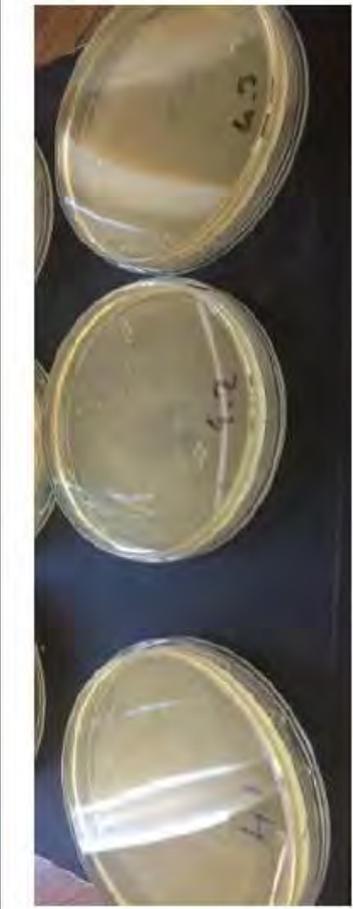
Table 2. Results of biocidal study

The behavior was the same in every TiO ₂ -bearing sample: the growing of <i>Pseudomonas Fluorescens</i> was fully inhibited

As can be seen in Table 2, the growing of *Pseudomonas Fluorescens* was noticeable in control lime-based rendering mortar and decreased (less CFU) for renders composed of nanosilica and oleate. Maybe the hydrophobicity of the surface hampered the microbiological colonization. No appearance of bacterial colonies was observed in all the samples that contain titanium dioxide in the mortar's formulation.

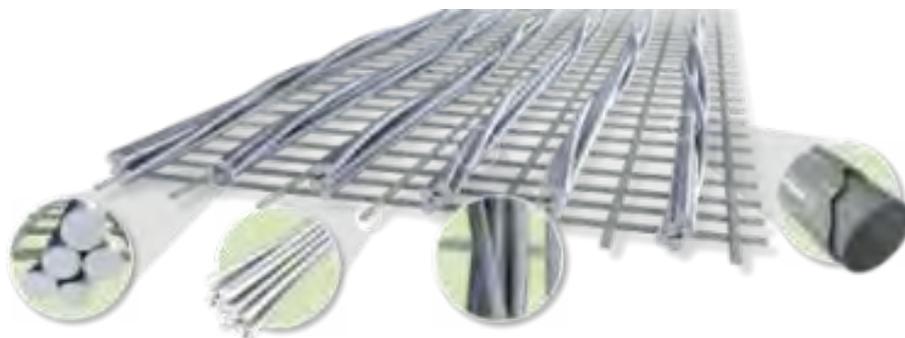
SRGs are made of fine ultra-high tensile galvanized steel filaments, twisted to form cords and tailored similarly to unidirectional fiber sheets (carbon, aramid or glass), see Figure 1, in order to be easily installed on site with the manual lay-up technique.

Figure 1. Galvanized Steel fiber sheet

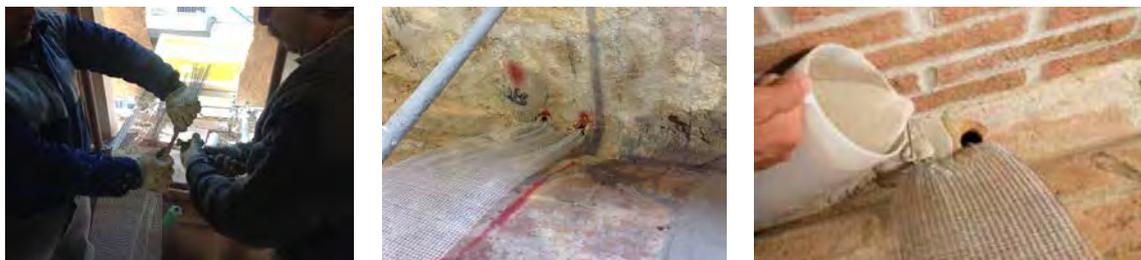
SRG presents several advantages respect to traditional FRP composites systems: being made of high strength steel cords, makes them have a considerable shear strength when cords are subjected to stresses perpendicular to their development, not present in other types of fiber. This property makes them particularly attractive for column wrapping and also for easily realizing mechanical anchors/spikes, prohibitive with typical FRP strengthening solutions. Simply cutting the mesh on which cords are glued, allows to directly anchor the end of an SRG strip, see Figure 5, or realize single and double side spikes for containing masonry wall expansion when subjected to combined axial and bending actions.

Figure 5. Double side spikes for anchoring

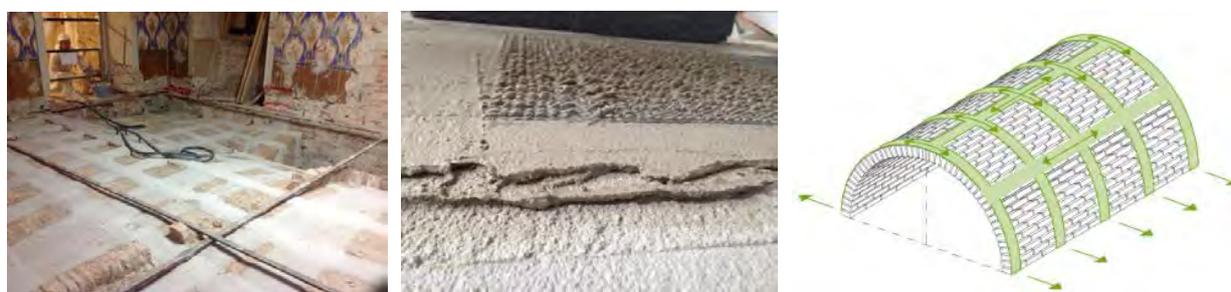
Ministry of Cultural Heritage. The design of interventions started from the damage survey and from the identification of the activated collapse mechanisms. To improve the integrity of the structures, the connection wall-to-wall and wall-to-floor was obtained installing typical steel ties. The survey of the horizontal elements allowed recognizing four different types of vaults: stone vaults, brick vaults with 2 different thickness 5 cm and 12 cm and no structural vaults realized with wooden frame. Structural vaults (stone and brick with hydraulic lime) were retrofitted using ultra-high tensile galvanized steel filaments installed with hydraulic lime based matrix (NHL 3.5) at the extrados. This solution guarantees the restoration of compromised structural continuity and the improvement of the bearing capacity of the vaults thanks to the presence of an element able to absorb tensile stresses, without increasing dead loads. The choice of the inorganic matrix has been adopted to ensure compatibility with the existing substrate in terms of breathability, porosity and hygroscopicity required from the Cultural Heritage Authority in case of frescoes at the intrados (Figure 7).

Figure 7. SRG extrados strengthening

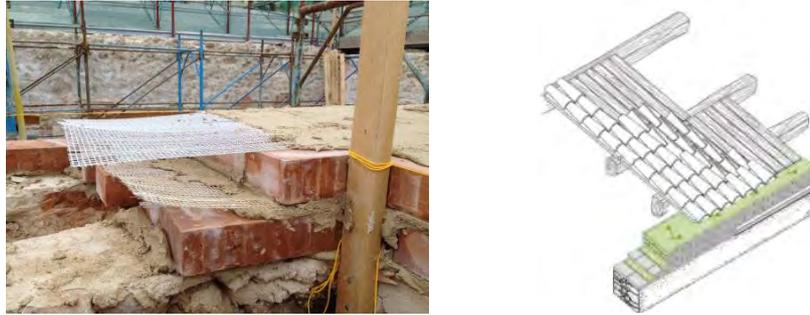
- strengthening of building portions by means of bond beams reinforced with interposition in joints of galvanized steel fiber sheet strips and pure natural hydraulic NHL 3,5 lime mortar. The reinforced-masonry beams were included at different heights of the masonry walls;
- the masonry vaults were repaired and reinforced with unidirectional galvanized steel fiber sheet. The anchorage at the ends of the strip was performed by rolling the ends of the steel fibers and insert them into the holes on the masonry walls and injected with fluid hydraulic lime based mortar to anchor the sheets (Figure 8).

Figure 8. Ring beams reinforced with interposition in bed-joints of galvanized steel fiber strips

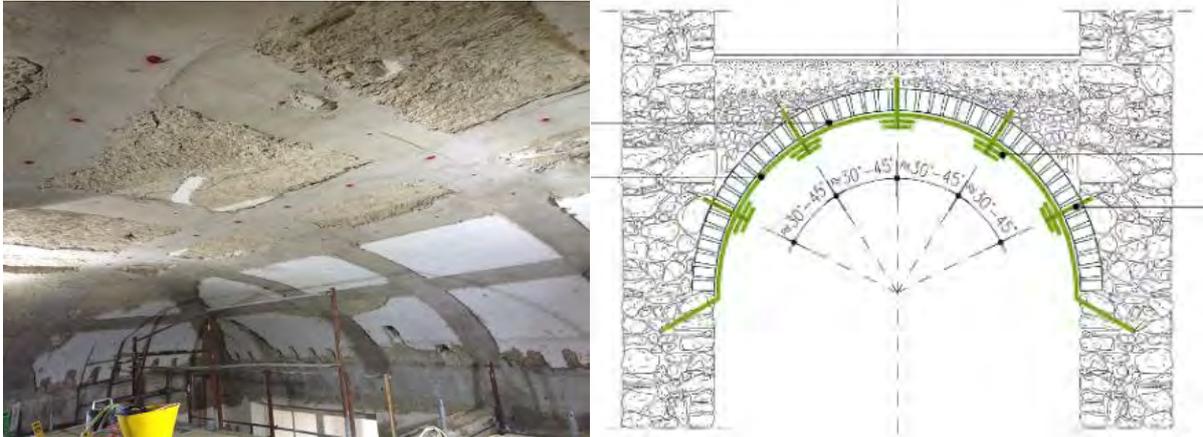
- remove plaster only in the strips where SRG was applied;
- drill holes in the position of spikes;

- apply SRG system with ultra-high tensile galvanized steel filaments and hydraulic lime based matrix;
- insert spikes realized with the same fibres;
- inject fluid hydraulic lime mortar from the center of the spikes.

Figure 9. Intrados strengthening of vaults

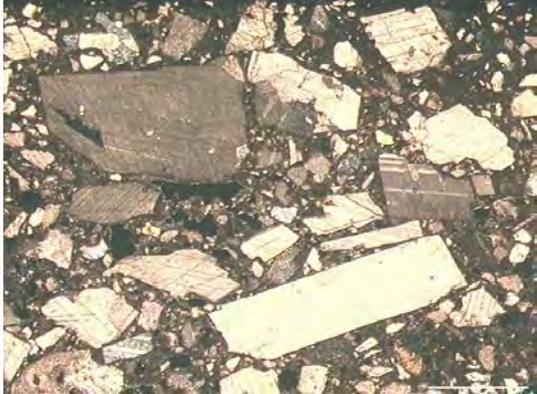
- i) poly-crystalline (size 0.5 - 3.5 mm), sub-rounded boundaries; each clast contains only few calcite crystals ranging from 0.1 to 2.0 mm and often showing polysynthetic twinning;
- ii) single crystal (size up to 5 mm), euhedral, clear, unit extinction, angular boundaries according to the calcite rhombohedral cleavage; twinning lamellae are lacking (Figure 1).

Figure 1 (left) - Single calcite crystals (finish coat of plaster Cividate C., *domus*)
Optical microscopy on transverse thin section – XPL

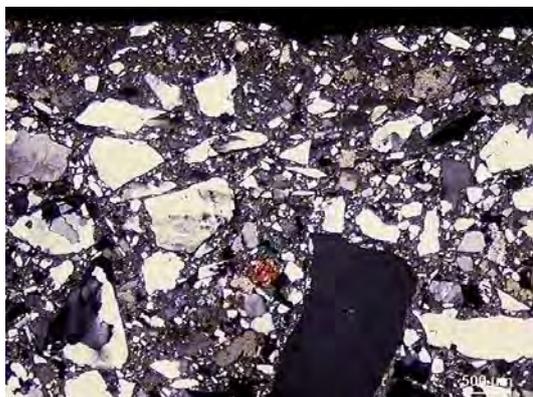
Figure 3 (left) - Single quartz crystals (finish coat of plaster - Milan, p.zza Fontana) -Optical microscopy on transverse thin section - XPL

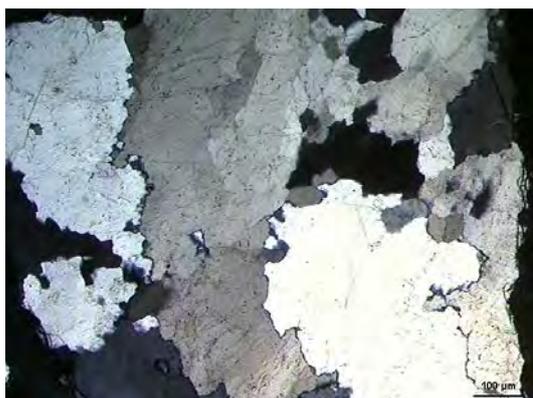
Quartz crystals (ii) coming from crushed pebbles (Figure 5) are clear, unit-extinguishing, irregular shaped (Figure 6) and match the single crystals of quartz used in the aggregates.

Figure 5 (left) - Quartz crystals in a quartz pebble (river Muggia)
Optical microscopy on thin section - XPL

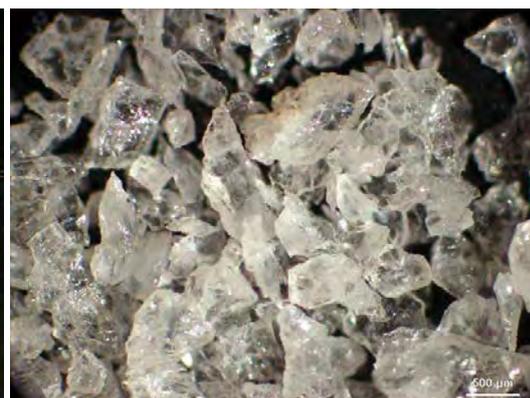
Figure 6 (right) - Quartz clasts obtained through the crushing of a quartz pebble

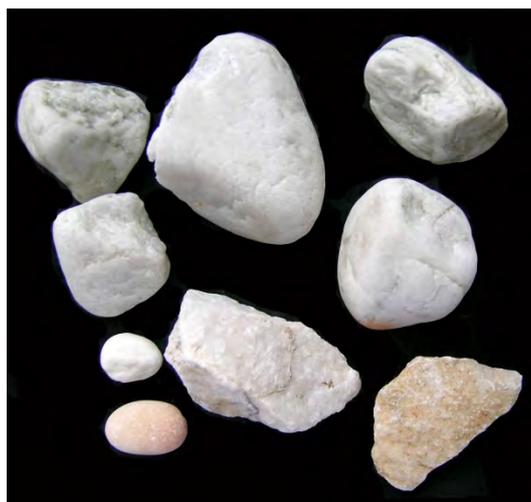
This material is totally lacking in quotations of Latin texts, but also a mere distinction between quartz and calcite was impossible without a mineralogical skill, especially if quartz and calcite are in the form of smooth pieces (Figure 7).

Figure 7 - Pebbles (maximum size 4 cm) of quartz (above) and of calcite (below)

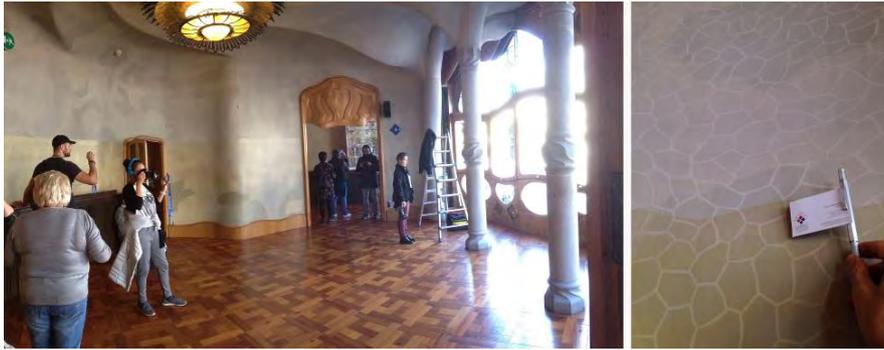
Figure 4. Main living room and detail of the finishing of the coatings.

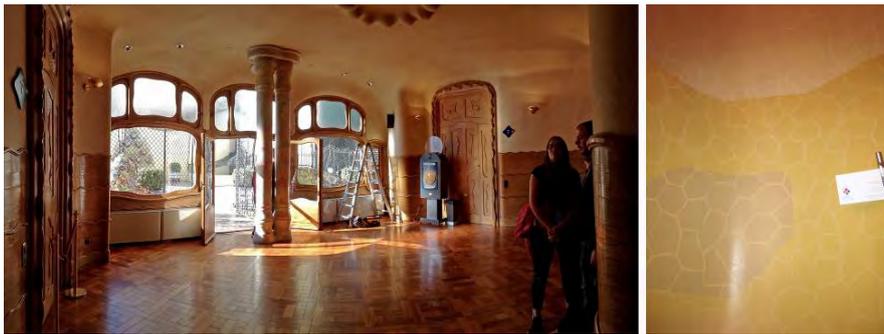
Figure 5. Dining room and detail of the finishing of the coatings.

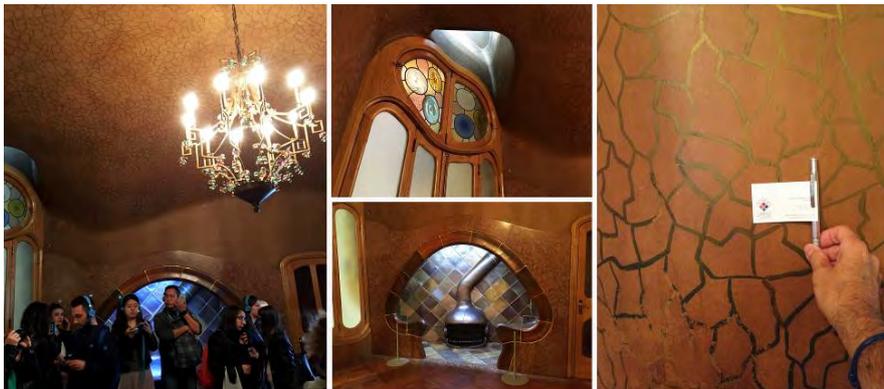
Figure 6. Fireplace room and detail of the finishing of the coatings.
