Proceedings of the 5th Historic Mortars Conference

5th Historic Mortars Conference

19-21 June 2019
Pamplona, Spain

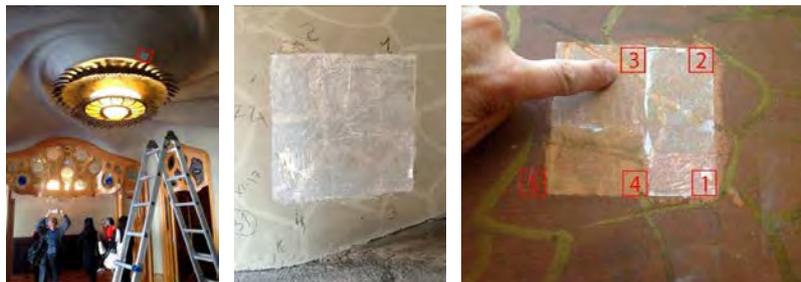
We have analysed samples of this type from careful stripping of the paints superimposed in small pieces of walls and ceilings in previously selected points according to their potential information, in order to establish the nature of the underlying [7]. Up to 35 tests have been retained in strategic points. We performed the stripping in local areas selected because the historic finishing was probably preserved, or in points where some repairs should be made, in order to compare repaints and mortars. They were carried out mechanically using paint-stripping gels, by carefully removing the superimposed paints up to reach the original lime stucco finish. The size of those samplings rises from 10x10 cm up to 15x20 cm (Figure 7a).

The stripping allowed inferring that some of the noble living rooms keep the original lime stuccoes that presumably cover the stays (Figure 7b). This procedure has helped to settle the finishing technique and has provided one of the first surprises. The stuccoes were hot-ironed and besides, they preserve the incision of the punch that profiles the famous Gaudi “trencadís” along all the walls and ceilings, a finishing that fragments the flat surfaces by means of an outline that modulates small pieces that form a mosaic (like broken tiles). The observation of these stripping samples reveals that the “trencadís” is placed at the same level as the whole stucco (Figure 7c).

Figures 7a, 7b and 7c. Selective samples showing the different layers along the interventions.

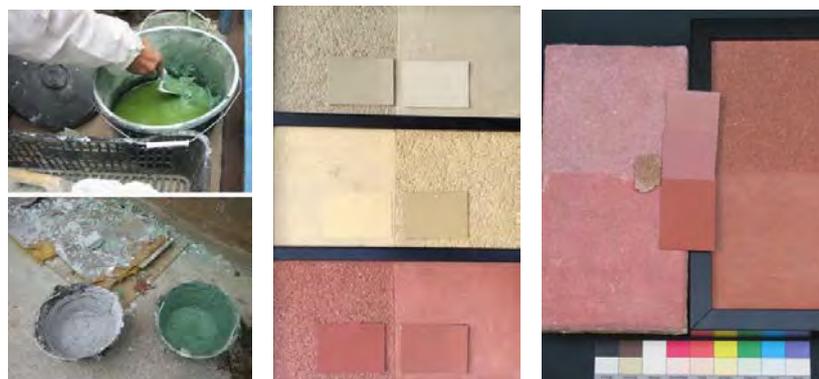
Figures 8a, 8b and 8c. Making up of coloured stucco palettes with chromatic controtype.

We have built up some test samples of traditional lime mortar trowel and hot-ironed finished [5, 7] (Figs. 8a to 8c), to be used as a reference pattern to controtype the original finishing detected in Casa Batlló. In this way, we could perform some tests of surface stripping and basically, to check the presence of organic products which are usually applied to pressed and ironed finishing like the studied ones [7, 8].

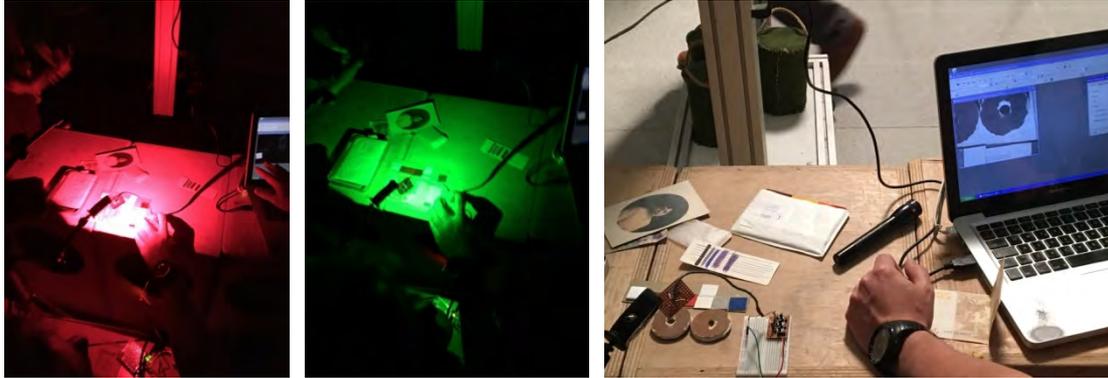
Figures 9a, 9b and 9c. Examination of samples with infrared camera and different color filters.

As a non-destructive technique, infrared reflectography was also used to study the underlying layers of the pictorial layers without the need to extract samples. The coatings were examined with a monochrome camera with both Ultraviolet (UV) and Infrared (IR) filters. After different attempts at different wavelengths and placing different tone filters, it was concluded that overlay acrylic paint did not allow to see the lower layers. (Figure 9a to 9c).

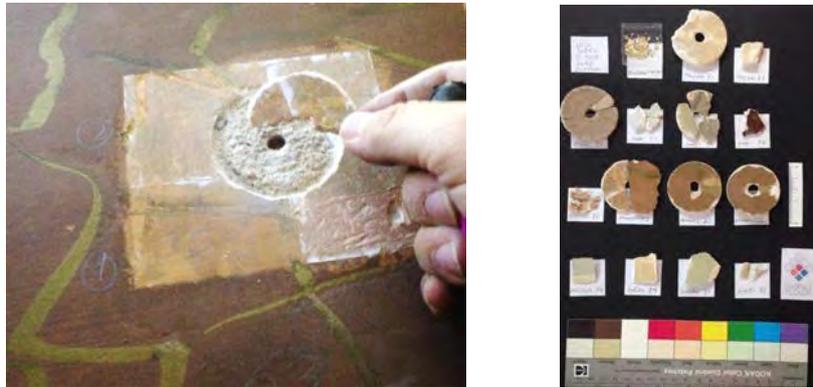
Figure 10. Detail of a sample extracted off the walls' coating in the main room of the Casa Batlló.

Figure 11. Collection of the samples extracted in different points of the main floor.

Following the in-situ stripping, and once assessed the potential of the original mortars preserved, we proceed to extract small, unaltered and representative samples. All the coating thickness is kept, to allow implementation of different analytical techniques. Up to 16 samples have been extracted from coloured lime mortars (Figure 10 and 11).

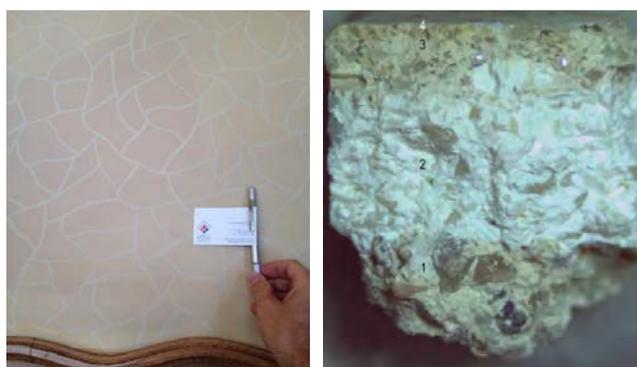
Figures 13a and 13b. Wall presently painted, and coloured lime stucco section.

The vertical walls and ceilings show continued finishing corresponding to a high-quality lime-mortar stucco, with pure white lime (in this case magnesium lime) and marble sand and marble powder as a well selected arid (of 0.5 mm) on top of a clay-rich rendering, to provide hydraulicity (Figs. 13a and 13b). All this lime stucco was coloured wholesale with different mineral pigments depending on the lounge and the wished chromatism in each room. The dining room, westward oriented, displays a stucco dyed with ocher iron oxide (Figs. 14a and 14b), whereas the main living room, eastward oriented and opened to the Passeig de Gràcia was pigmented with ultramarine blue and barium white (Figs. 15a and 15b). The Fireplace room holds a lime stucco dyed with natural iron oxides, like hematite. All of them are very good shape stuccoes, with well cohesive strata and showing an execution technique typical of a stucco master. It should be emphasized how meritorious is that this coating remains continued along walls and ceilings, despite the continual presence of sinuous shapes.

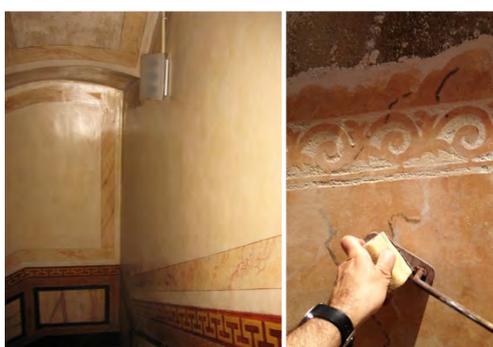
Figure 19. Hot-ironed stucco’s technique, applying a hot iron tool over the surface of the lime mortar, that ends up by giving a shiny and smooth result, as shown in the pictures.

The original finishing that mimics the “trencaadís” technique and shapes its irregular quartering consists of a trowel finish stucco over which traditional soapy inks are applied, basically to carry out hot-ironed stuccoes [5]. Following the traditional recipe, the procedure consists of a mixture of soap flakes dissolved in water that is taken to boiling and is further mixed with some lime putty and water. In this procedure, the soapy inks coloured with pigments are applied on the stucco which is hot-ironed over its surface. Hence, the stucco achieves a very soft finishing, similar to marble (Figure 19). In the Casa Batlló the analyses detected traces related to soap and wax in the extract with solvents got from the coloured layers (Figs. 21a and 21b) thus confirming our hypothesis. These inks were dyed with natural pigments, and presumably they had no uniform colour, but were multitone with alveolar shapes.

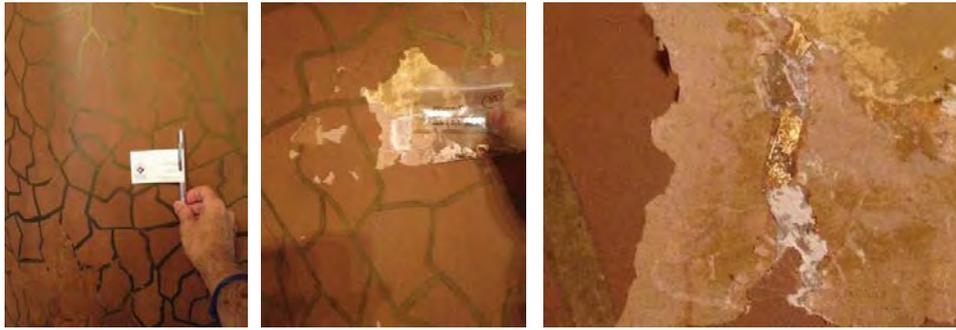
Figure 22a. Current paint. Figure 22b. Extraction of micro-samples. Figure 22c. Detail of the golden leaf appeared in the selective stripping.

If the stucco application technique described before is already a high difficulty work, in the Hall of the Fireplace the “trencadís” is even more surprising. Whereas in the outside rooms a “trencadís” of bright colours and with a white joint was mimic, in this room darker tones of ceramic colours were retained, including the excellence of gold in the joints (Figure 22a). In this room, in parts behind the heating appeared some gypsum mortars repaint with purpurin, probably coming from repairs between 1960 and 1990, which we used as a comparative pattern with the original finishing (Figure 22b).

In this case, the soapy coloured inks previously reported were applied, hot-ironed with a dominant clay tone. Firstly, the “trencadís” joints were sgraffito with the lime mortar still tender and were filled out with white stucco inlayed in the groove left by the sgraffito tool. Remarkably, in this case these white joints (Figure 23a) were goldened with fine gold leaf (Figs. 22c and 23b). To end up, a general polish was made.

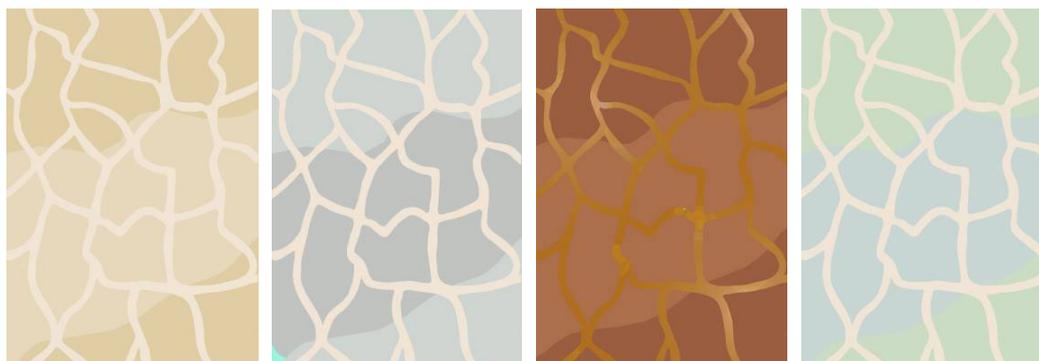
Figure 27a. Chromatic pattern of the Dining Room. Figure 27b. Living Room's chromatic pattern. Figure 27c. Fireplace Room's chromatic pattern. Figure 27d. Chromatic pattern of the Sacristy.

We have been able to establish the chromatic patterns in the main rooms of the noble floor of the Casa Batlló (Figure 27 a-d), from the chromatic deduction by binocular observations of the coloured stuccoes, combined with the analytic detection of the different pigments used to colour them and together with the colour references inferred in the selective stripping performed, considering also the dominant multitone chromatism in the backdrop and in the “trencadís” joint.

Chamber	Colour 1*	Colour 2*	Colour 3*	Fig.
Dining Room	F2.15.75	F2.10.80	F2.06.84	27a
Living Room	S7.05.75	QN.02.78	F2.06.84	27b
Fireplace Room	D2.30.50	D6.25.65	Gold leaf	27c
Sacristy	K2.09.79	L0.04.78	F2.06.84	27d

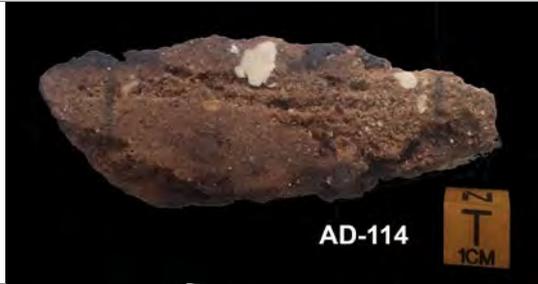
Sample	Room Type	Layers (L) Thickness (cm)	Colour	Photographs
AD114	A Floor	L1 (1.5)	Brownish

However, the AD114 floor substrate displays one layer. This mortar corresponds to a brownish coloured external layer of 1 – 2.5cm thick composed by clay-sandy aggregates mixed with lime binder with lumps (1 - 3mm) and occasionally larger lumps are observed (7 mm).

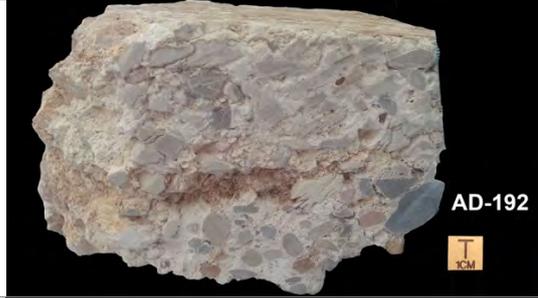
AD192	B Floor	L0 (0.1) L1 (5.5) L2 (4-6) L3 ?	Whitish rose Greyish Whitish

The macroscopic structure of the AD-192 mortar displays a complete structure of opus signinum type floors. The outermost very thin layer (<1 mm) is whitish-cream and corresponds to a lime nature layer. Immediately below, there is a greyish-whitish layer of 5.5 cm thick with oriented crushed limestone fragments in the upper part of the layer. Mortar is based on lime and aggregates in a proportion from 1:2. Limestone aggregates of angular shape and homogeneous size (1-2 cm) compose this layer. The innermost layer of 4 to 6 cm thick corresponds to a whitish mortar composed by rounded aggregates from riverine sands (1-3 cm). This inner layer exhibits binder-aggregate ratio of 2:1. Between these layers chips of wood have observed, probably used to increase the stability of layers but also could be remains of wooden rammers that used for compaction [19]. Below, a preparatory layer composed by large round pebbles up to 12 cm is observed.

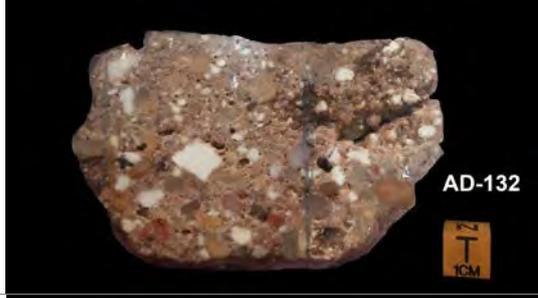
AD132	A Wall	L0 L1 (1.5) L2 (2)	Whitish Whitish yellow Whitish orange

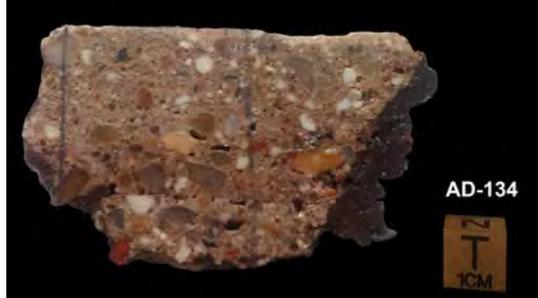
AD134	A Collapsed wall	L0 (0,2) L1 (2) L2 (2)	Whitish Whitish Whitish

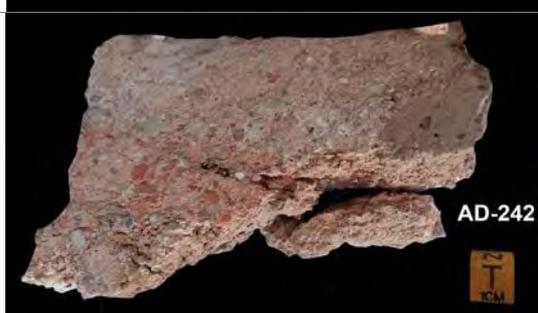
AD242	C Wall	L1 (4) L2 (2) L3 (2,5) L4 (2)	Whitish rose Reddish Whitish rose Brownish

Multilayer construction technology is observed in samples AD-242 and AD-124 see Table 1. Sample AD124 displays six layers including the mural painting layer. The outermost layer L0 corresponds to a thin layer of < 1mm of whitish colour of lime well held to the next. The L1 layer correspond to a whitish in colour mortar of 2 cm thick composed by 2 - 5mm siliceous sandy aggregates with scarce fragments of tiles and lumps of lime. The L2 layer is a reddish layer of 2 – 2.5cm thick with large amount of tile fragments ranging from 1 to 5 mm in grain size providing the distinctive red colour. Occasionally siliceous aggregates of fine grain size are present. The L3 layer of whitish-creamy colour exhibits abundant and heterogeneous grain-size aggregates of siliceous nature. The thickness of the layer varies between 1 to 2cm thick. The L4 layer correspond to a whitish mortar of 2 cm thick exhibiting a larger binder/aggregates ratio than previous layers. The aggregate grain size is preferentially lower than <4 mm and lime lumps are frequent. The innermost L5 layer corresponds to a brownish clay mortar. The sample AD242 exhibit similar structures and features but the innermost layer couldn't be recovered. This sample shows a clayed brownish mortar joined laterally to the main layers.

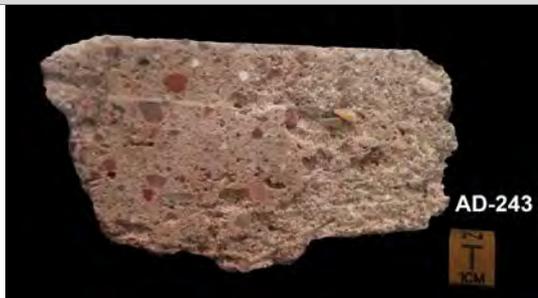
Sample	Room Type	Layers (L) Thickness (cm)	Colour	Photographs
AD243	C Collapsed wall	L0 (0.2) L1 (2) L2 (2.5)	Whitish orange Whitish orange Whitish orange

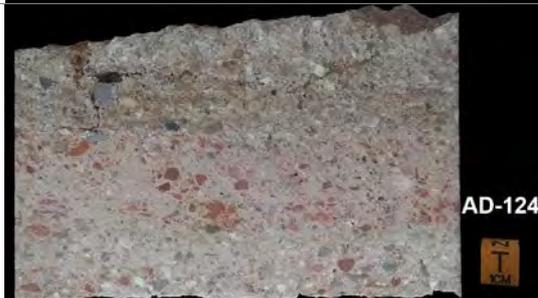
AD124	E Wall	L0 (0.1) L1 (2) L2 (2-2.5) L3 (1-2) L4 (1-1.5) L5 (1) L6 (1)	Whitish Greyish Reddish Creamy Creamywhitish Whitish Brown

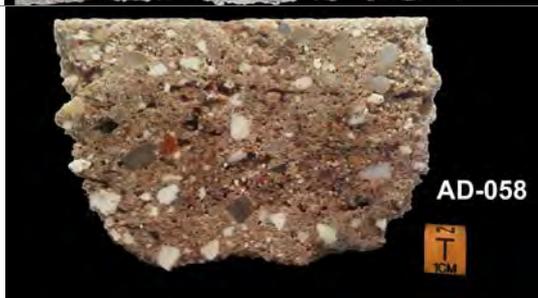
AD058	H Wall	L0 (0.1) L1 (1.5) L2 (2.5)	Whitish Creamy greyish White reddish

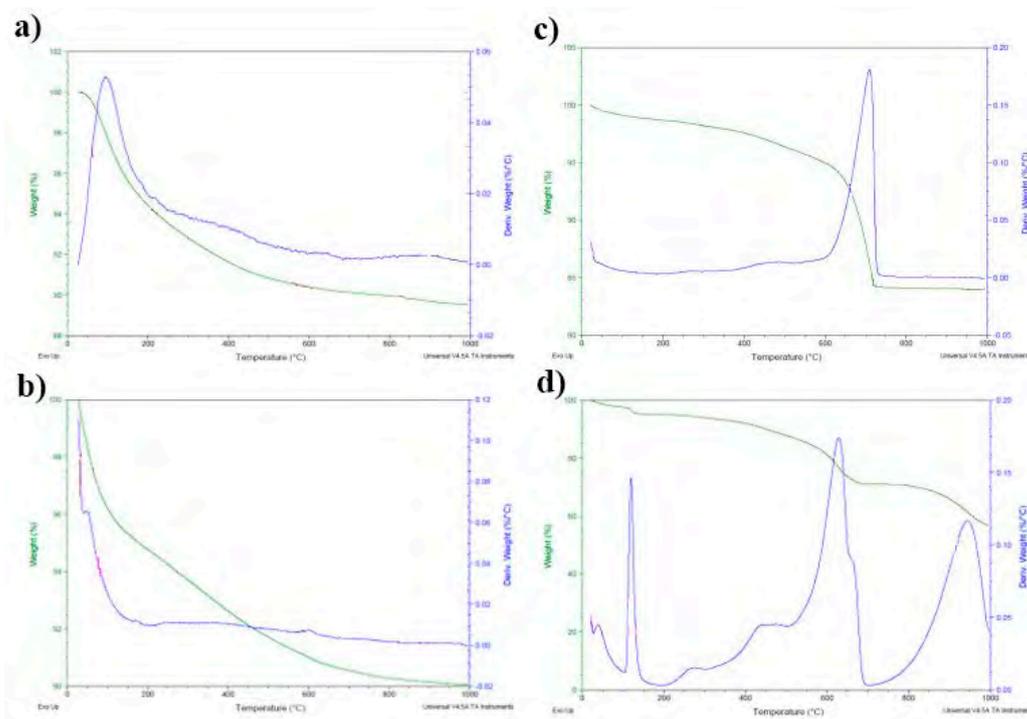
Figure 4. Thermographs of a) Labraunda mortar from the *Natatio*, b) repair mortar from the building Andron A c) Augusta Emerita mortar from the Snow Well d) Kom El-Dikka mortar from the Sahareg

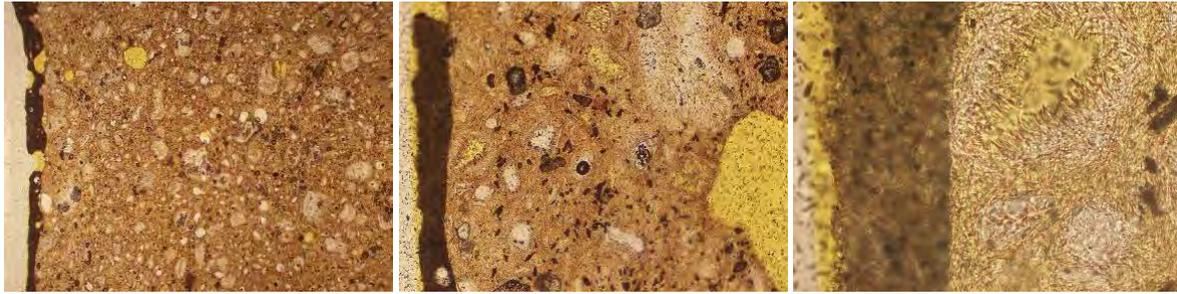
Figure 8. Gypsum plaster from 18th century Drottningholm Theatre, seen in three different scales. The width is equivalent to 4.5, 0.9 and 0.225 mm in the pictures above. The sample is a gypsum plaster with very fine ballast in size 0-0.5 mm with a large amount of stone flour. The render is very rich in binder and has a mixing ratio of about 1: 0.25-1: 0.5 between gypsum and stone flour. The surface of the render is covered by a lime paint layer with a layer thickness of 0.05-0.1 mm, which means that it is made with a thicker lime paint about 1: 2 in volume ratio between lime paste and water. When the lime paint and gypsum plaster meet, the difference between the lime's fine-grained structure and the needle-shaped plaster is clearly visible. Illustration: Kristin Balksten.

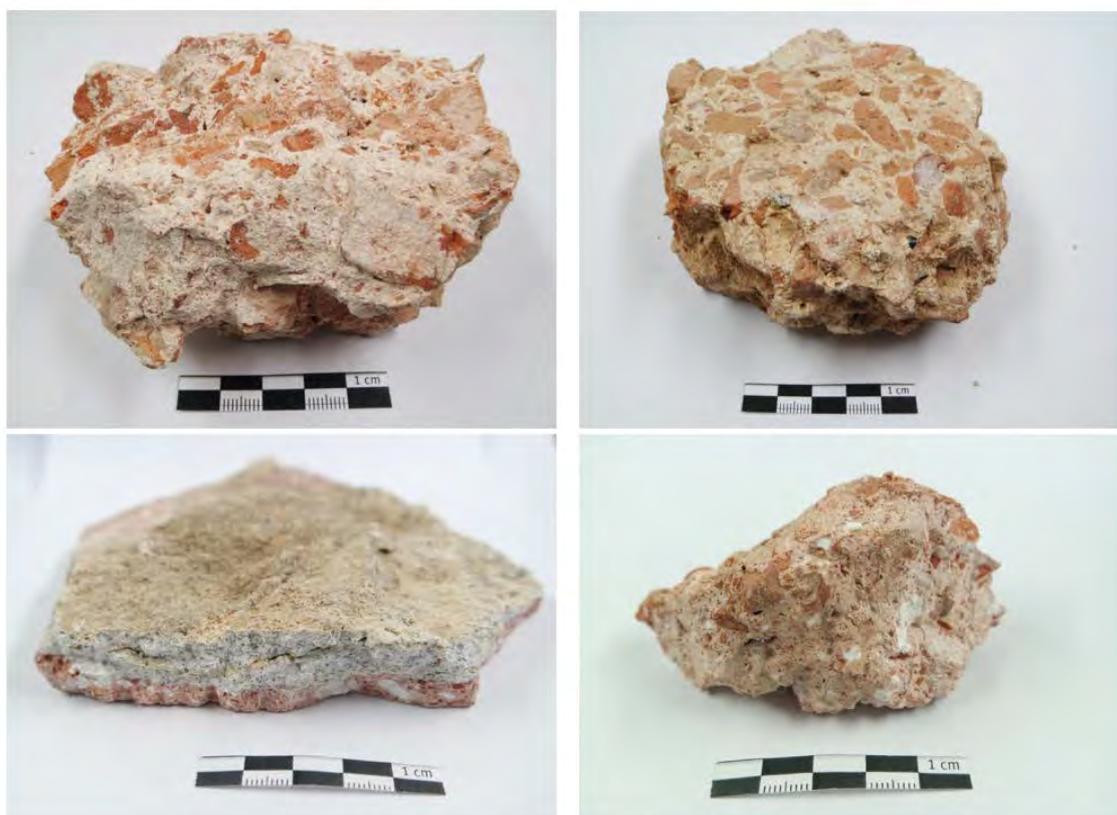
Figure 1. Exemplary mortar samples from Colonia Ulpia Traiana (top left), the Roman museum Schwarzenacker (top right), Bruneck Castle (bottom left) and Sabiona Monastery (bottom right).

In total, 21 mortar samples from six Roman and five medieval objects in West Germany, East Tyrol and Northern Italy were analyzed. An overview is given in Table 1. Exemplary images of the samples are given in Figure 1. The Roman ones can be dated back to the early 2nd until late 4th century AD and were taken from residential buildings or thermal bath buildings [9]. The medieval samples can be dated back to the 13th until 16th century and origin from water cisterns [10].

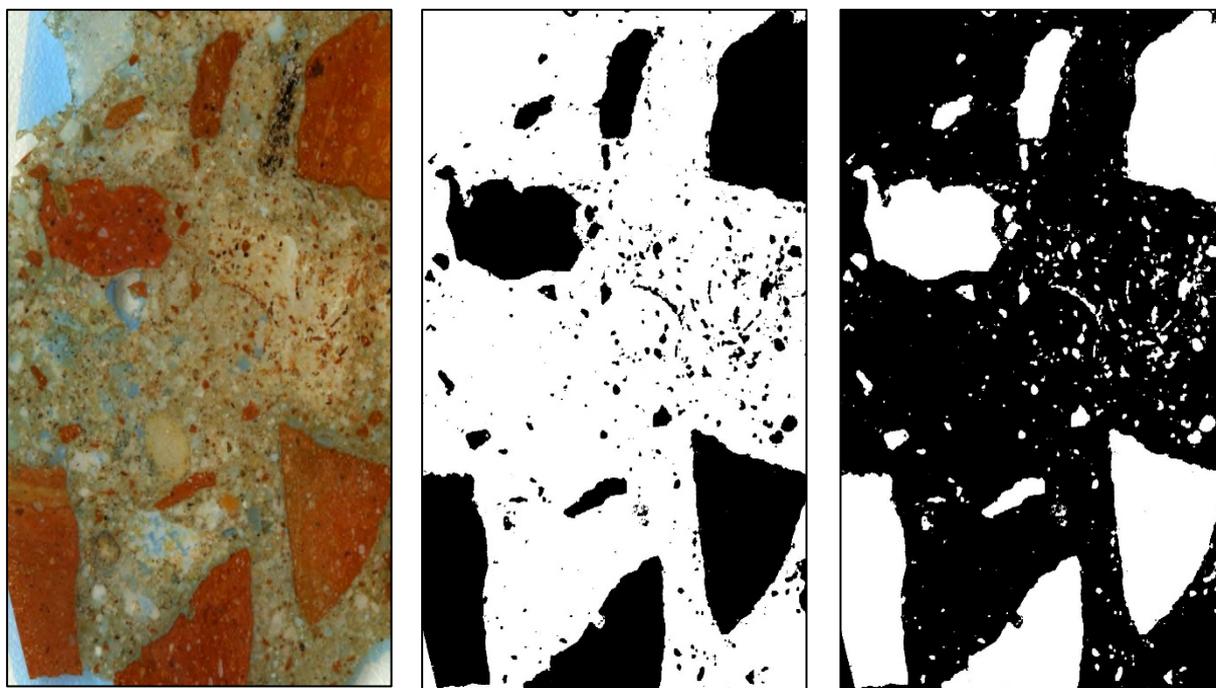
Figure 4. Section of the thin section of sample CA2 (left), brick fragments marked in black (center), binder marked in black (right). Image width approx. 17 mm.

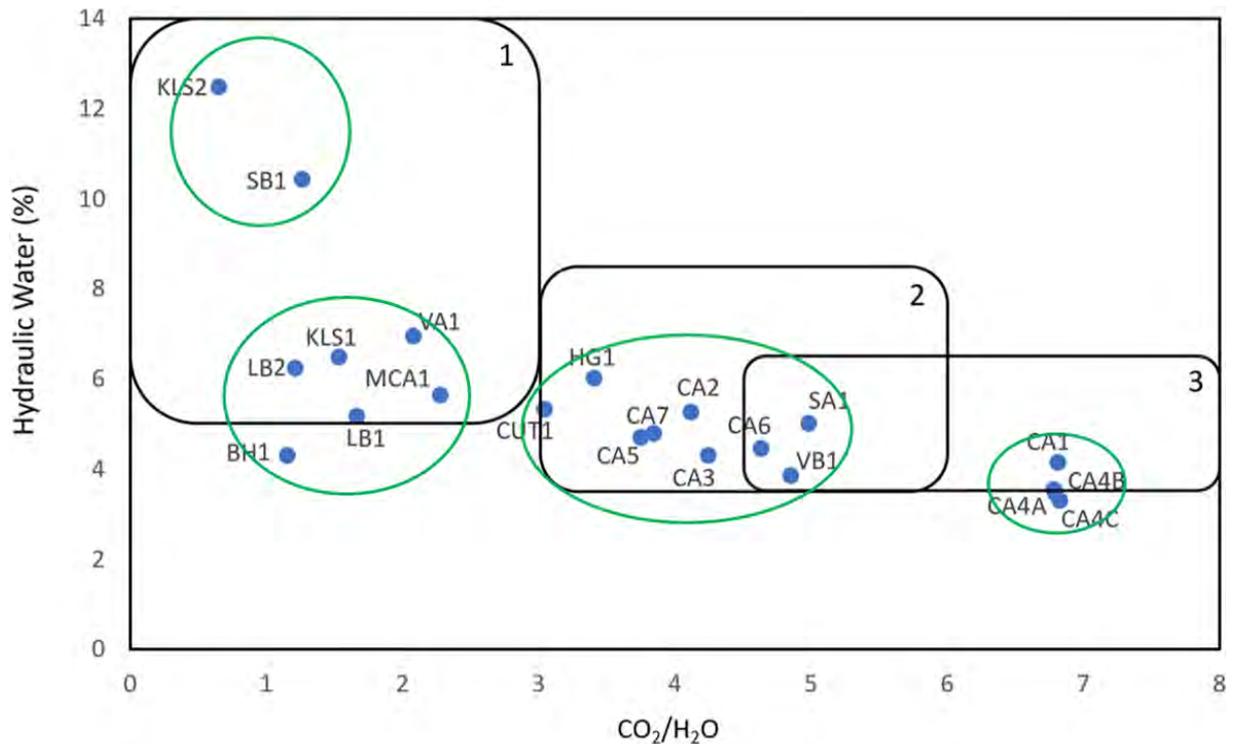
Figure 6. Hydraulic Water (%) against $\text{CO}_2/\text{H}_2\text{O}$ ratio. Different categories (1-3) as suggested by Moropoulou et al. (2005) [18]. 1: mortars with natural pozzolana. 2: mortars with artificial pozzolana. 3: hydraulic lime mortars. Framed in green are the four categories into which the examined mortars were classified according to chemical parameters.

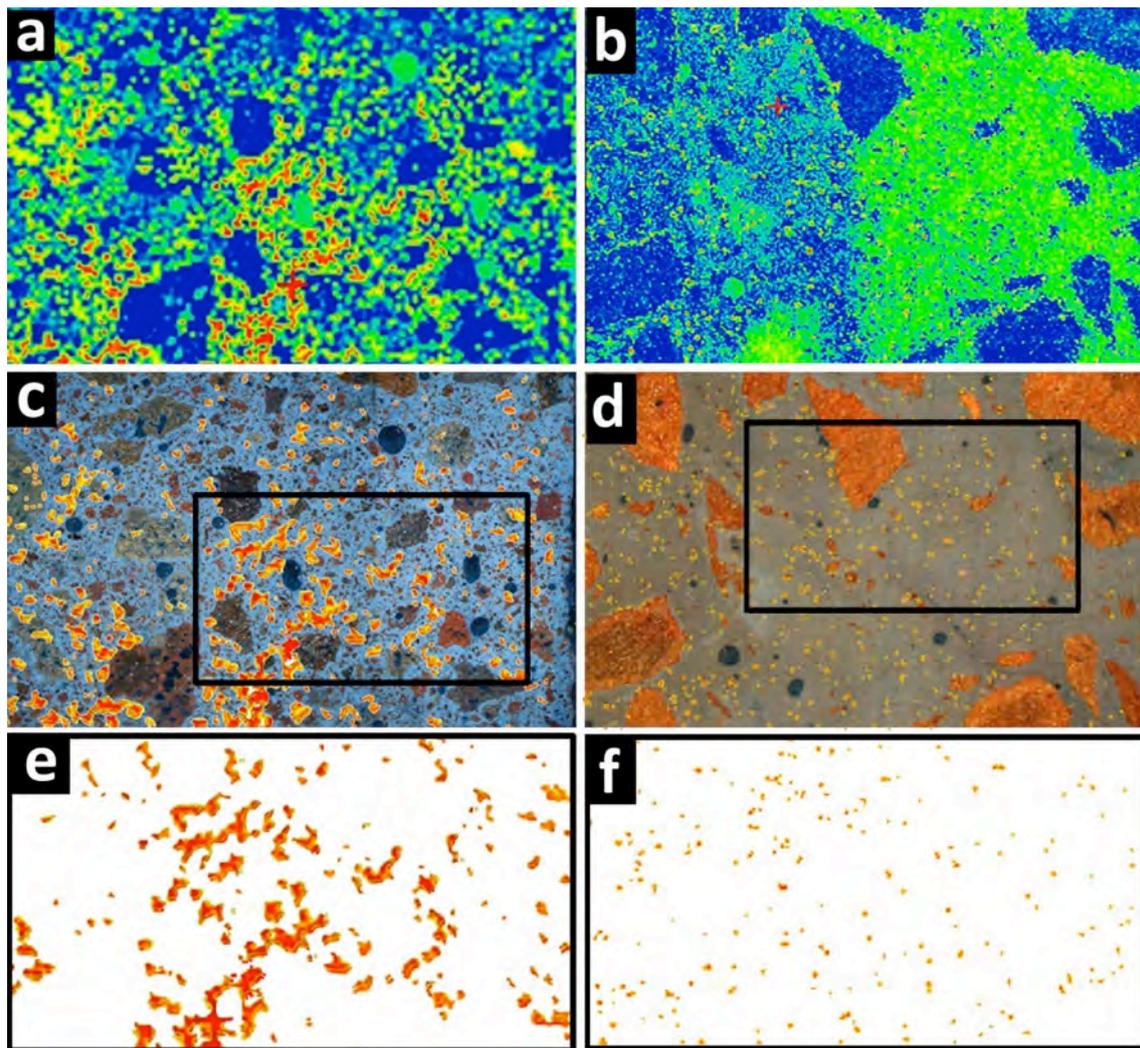
Figure 4: A comparison of two types of experimental mortar, with quantitative volumetric analysis provided by pixel-counting equivalent areas of the highest density of bound water of a FTIR maps overlaying scaled OM images. Scale (both): Red to Blue: 2.5-0.0. Area of black rectangle is 0.5 mm^2 . The pixel density of the left, lime-pozzolana mortar is 3.5 x that of the right, ceramic-lime mortar.

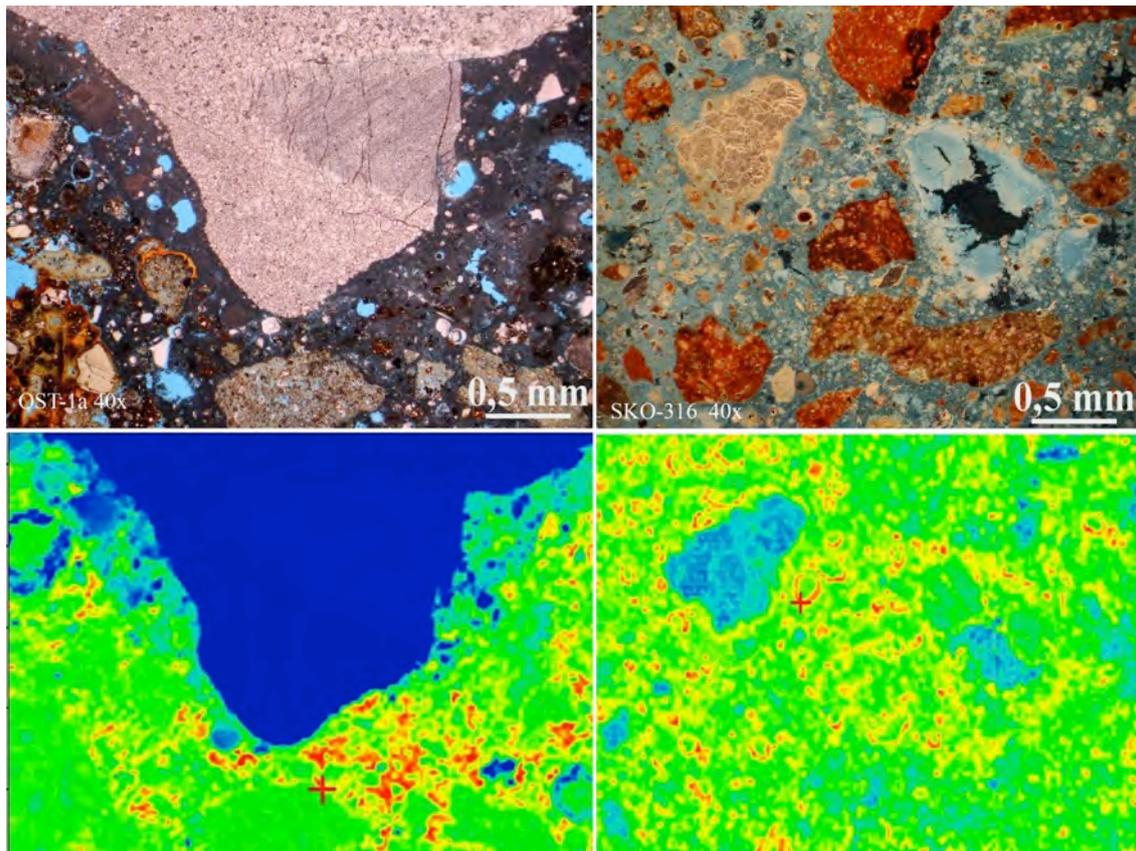
Figure 6: OM image (upper) and FTIR image (lower) of a lime-pozzolana mortar, 2nd century, Ostia Antica (Italy) (Left) and a lime-ceramic mortar, late Antique, Školarice, Slovenia (Right). Note differing locations and density of reaction products (red/orange in the FTIR maps) and clearly identifiable reaction rings in the right sample. Bands as described in text.

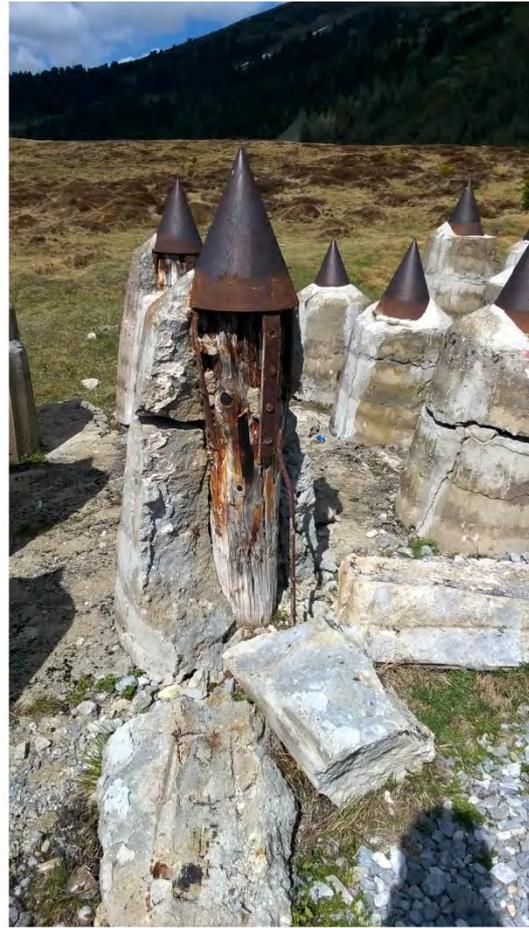
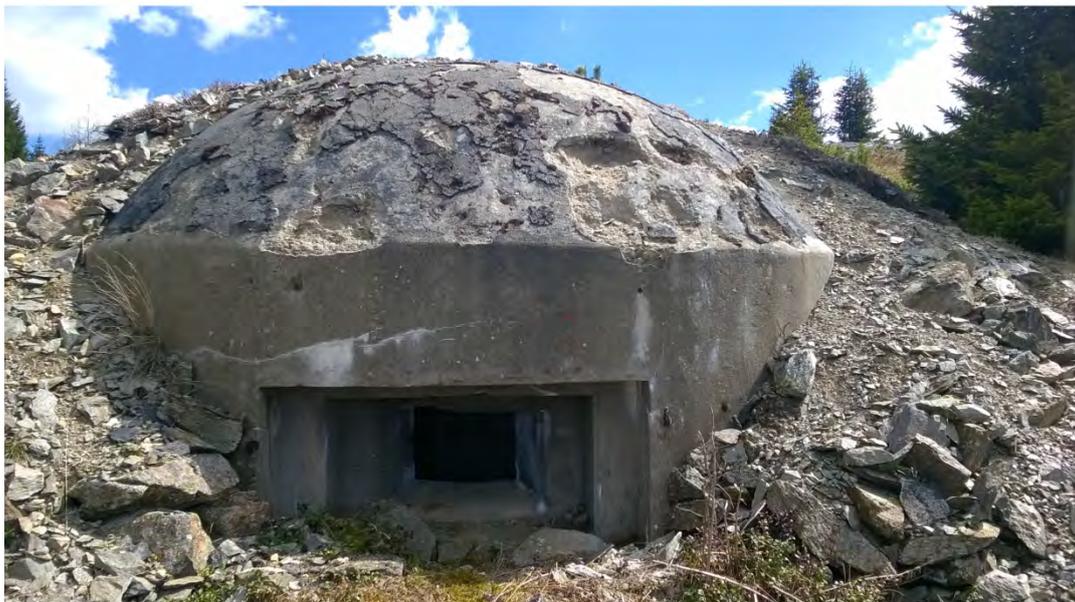
Figure 2: Photographs of the two investigated concrete structures: (a) anti-tank barriers located in the high moor of plateau Plamort, (b) deteriorated anti-tank barrier exposing tree trunk as well as iron cone fastening and (c) investigated bunker covered with residuals of bituminous surface protection.

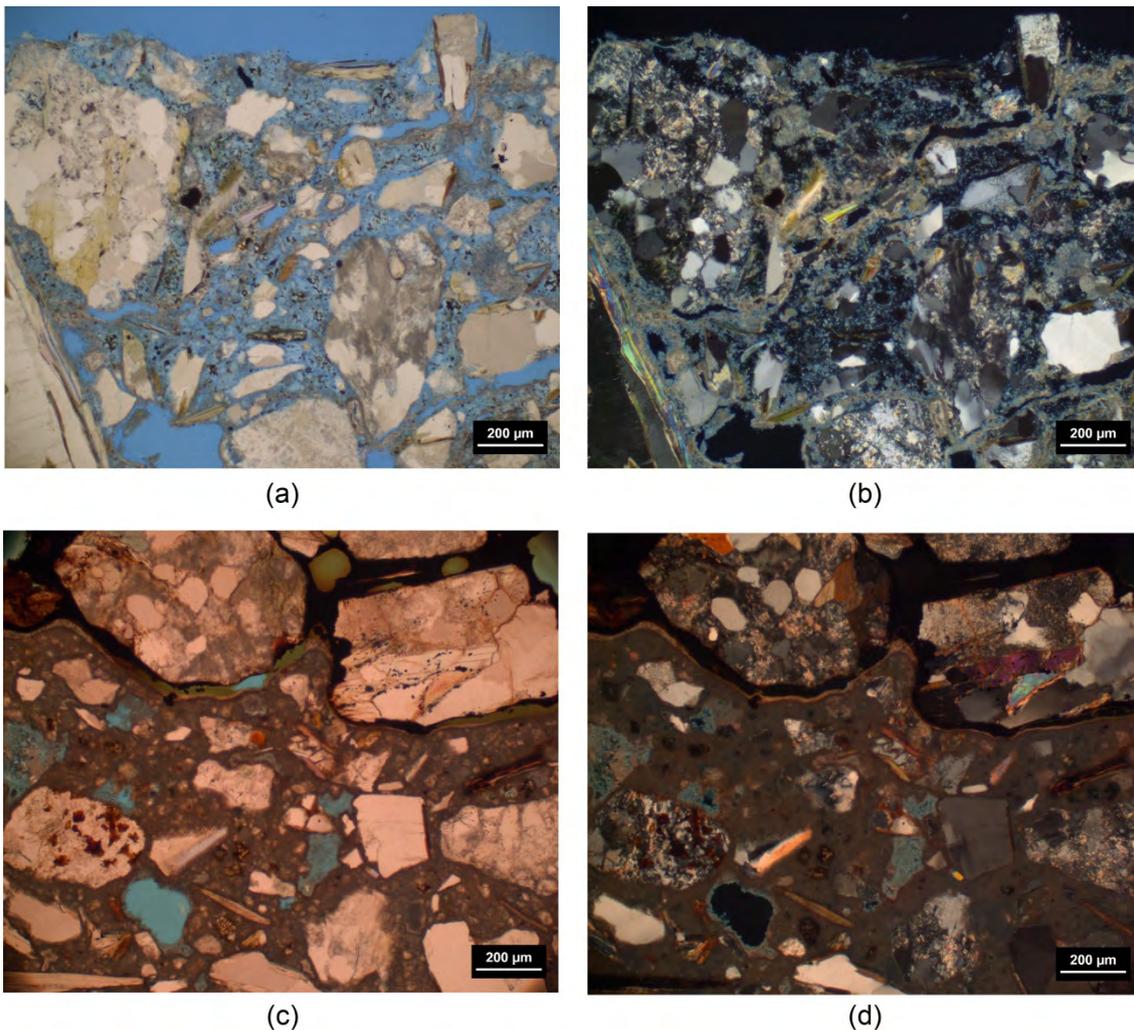
Figure 3: Exemplary micrographs of thin sections: (a) near-surface part of ATB showing a dark-brownish matrix with high content of aggregates as well as irregular formed voids (PPL), (b) same spot of sample ATB in XPL highlighting PCD, (c) near-surface part of B showing a dense dark-brownish matrix in contact with the above located bituminous mortar (PPL) and (d) same spot in XPL highlighting pore lining (calcite).

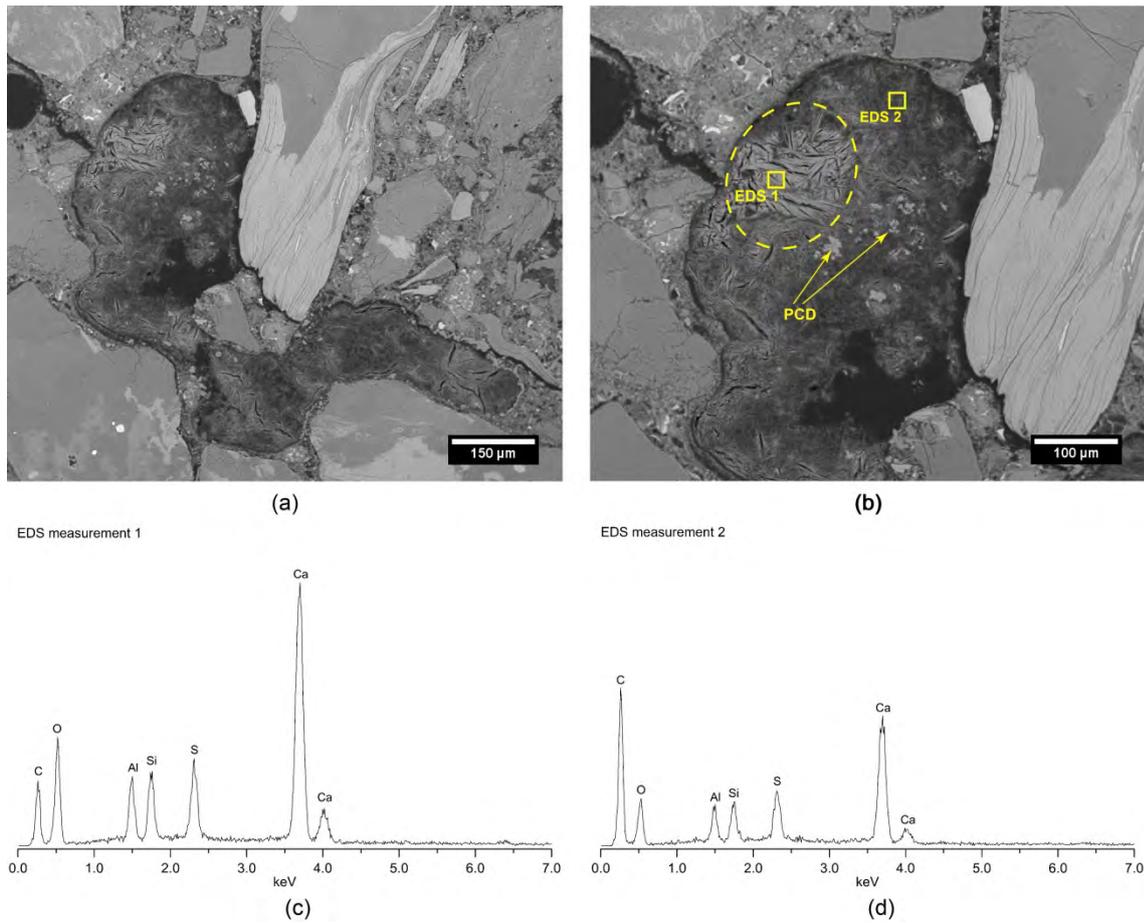
Figure 4: SEM-EDS analysis of specimen ATB: (a) void that is almost completely filled with a mass of needle-like crystals, (b) closer view of the same spot revealing crystals that are either randomly oriented or well-oriented (the latter is marked by oval). Additionally, clusters of granular calcium carbonate crystals (mostlikely PCD, marked by arrows) within the mass of needle-like crystals were observed. (c) EDS spectra of measurement 1 within well-ordered crystals and (d) EDS spectra of measurement 2 within randomly oriented crystals.

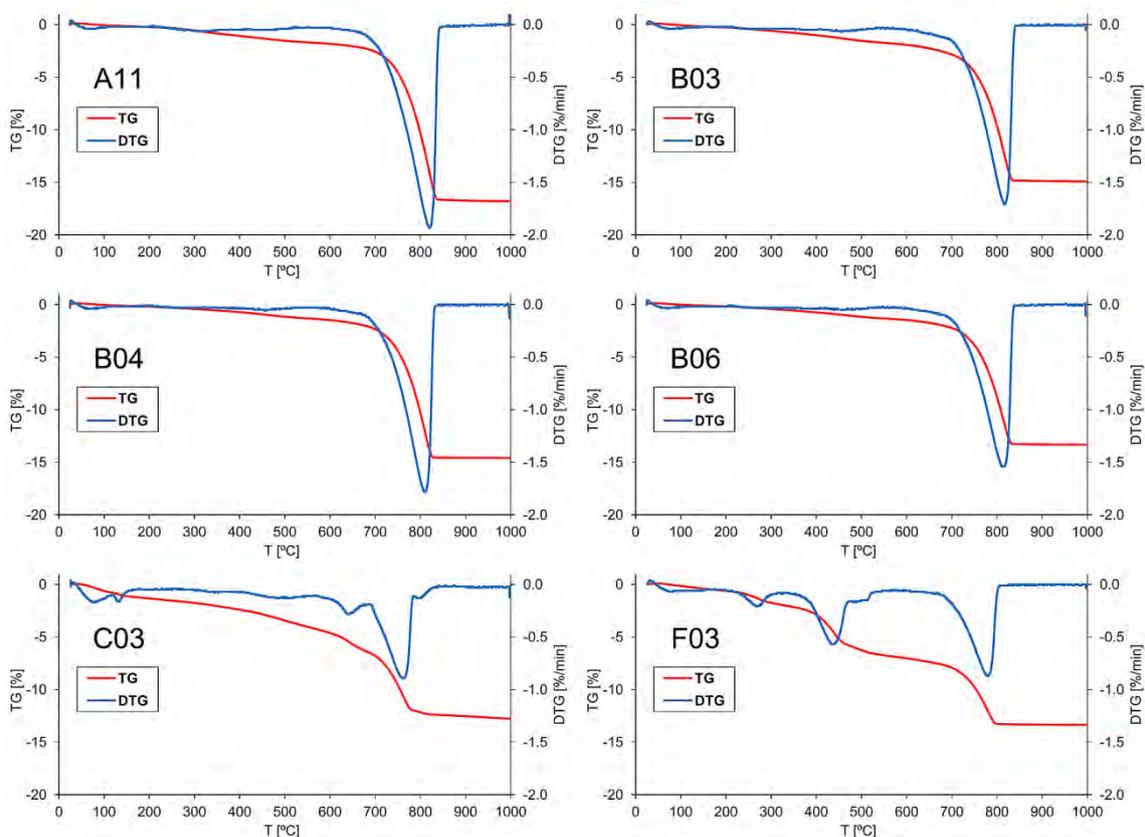
Figure 4. TG-DTG curves of samples A11, B03, B04, B06, C03 and F03

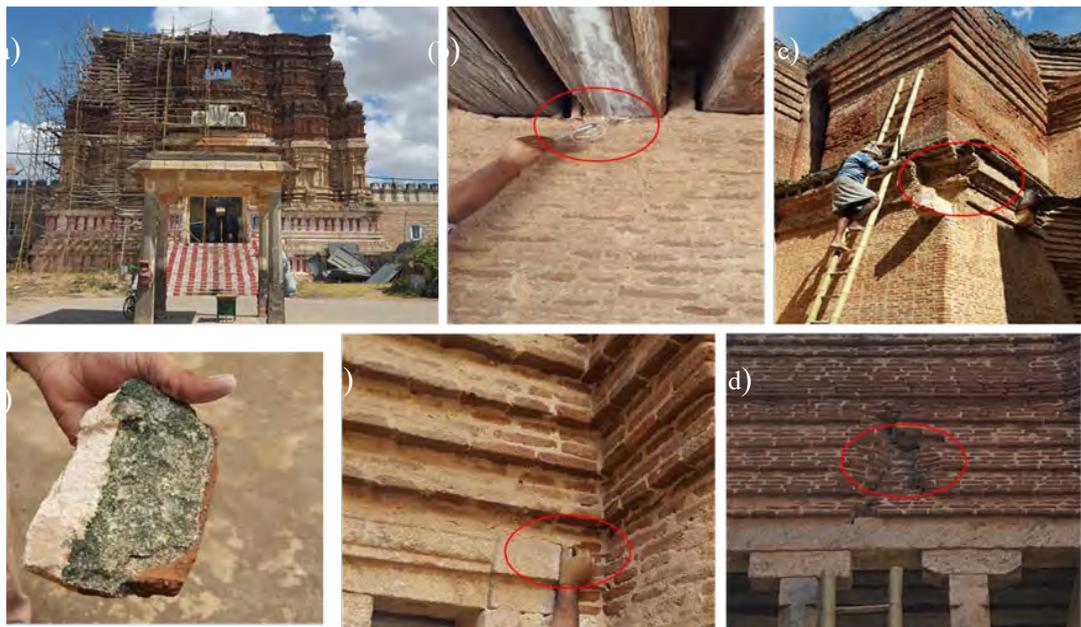
Figure 1: (a) - Front view of the entrance tower, (b) to (e) - sampling locations inside the tower, (f) – a detached sample from the top of the tower

A total of five representative samples were collected from different parts of the tower with a mortar chisel and labelled as TR1, TR2, TR3, TR4 and TR5. By visual examination, it could be indentified that the texture of the mortar was identical throughout the structure. A few non-structural cracks and missing units could be located in the structure. Five different locations were identified for sampling as shown in Figure 1. One sample was collected from the top tier which was already detached from the structure.

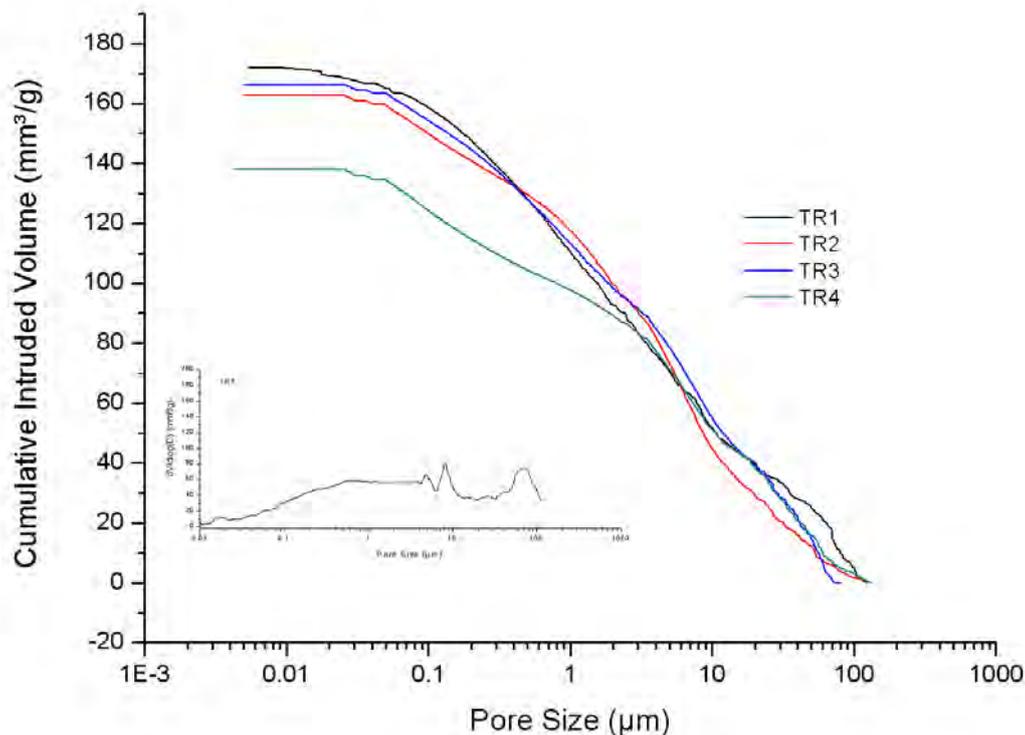
Figure 6. Cumulative and differential intrusion curve obtained from MIP analysis

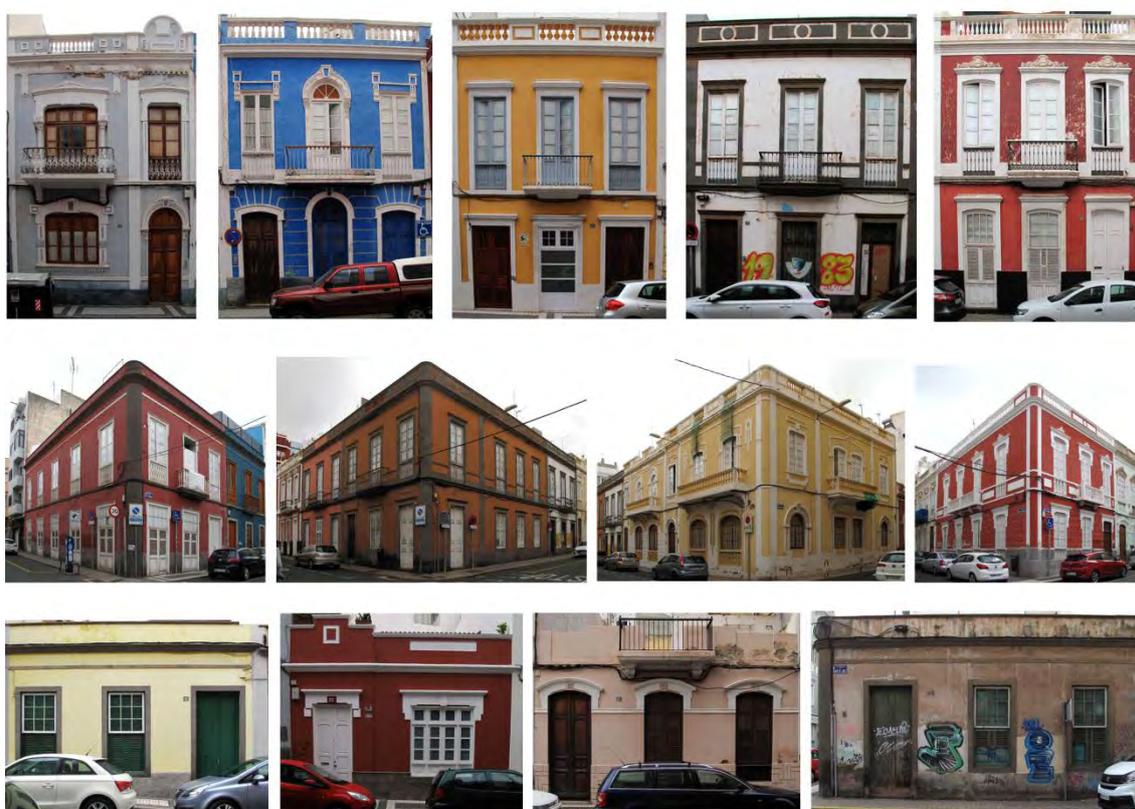
Domestic buildings of the period are mainly two-story with architectural features characterized by straight and high rectangular door and window frames on stonework; facades topped by balustrades or stone cornices [9], as well as high-quality design on iron-work balconies (Figure 3).

Figure 3. Neoclassical examples of urban architecture in Arenales neighbourhood

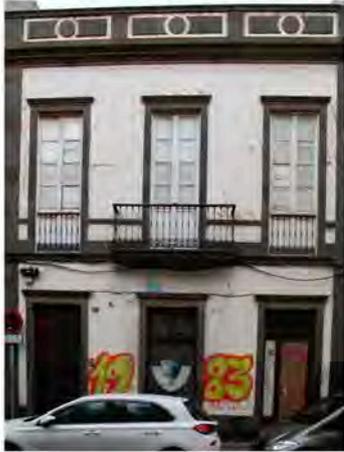
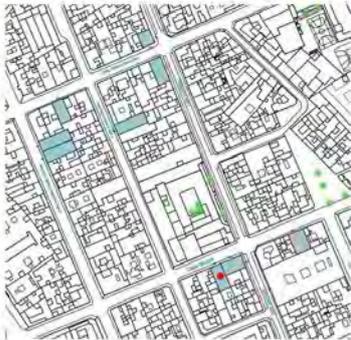
Figure 4: General data sheet

General data sheet is composed of four sections. Firstly it offers general building information as the address, author, year of construction and the number given to the building in the local catalogues.

Figure 4 includes general information collected during the building selection and invitation to participate phases. Figure 5 shows the sheet to be completed during sampling procedure. Lastly, data sheet required during the sample visual analysis is shown in Figure 6. This contains information about the render, colour, structural aspect and apparent condition of the samples.

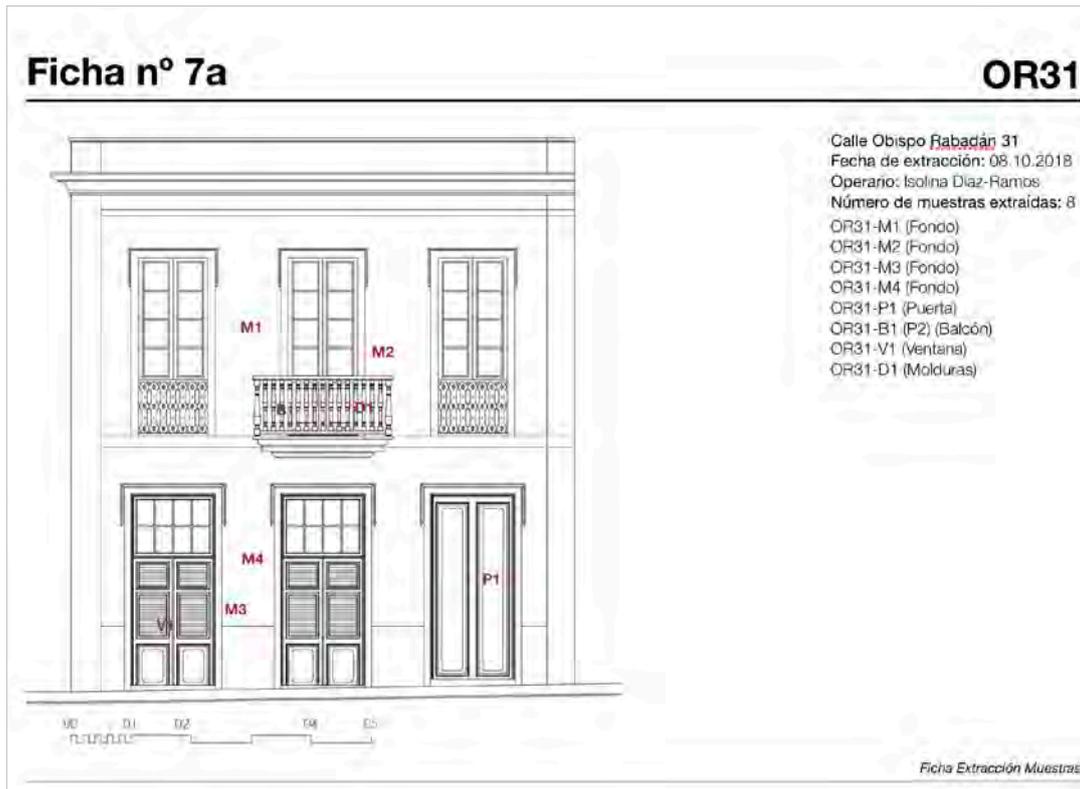
As shown in the Figure 5, sheet contains information about the samples' location and name. It is also appointed the removal date and the name of the technician who extracted the material. Dwellings on the corner were recorded in two data sheets, following the building elevation of every street, named 'a' or 'b' as in the example.

Figure 5: Data sheet of sampling extraction

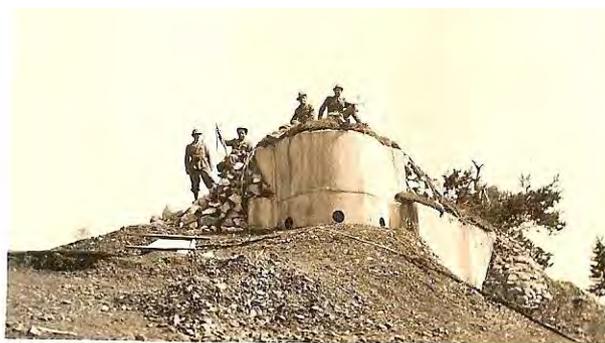
In its final form, the border stretched for 289 kilometres from the borders between the Kingdom of Italy, Austria and the Kingdom of Yugoslavia in the north to the gulf of Rijeka in the south. The fortification efforts to protect the newly formed border soon led to a systematic building approach from both countries. The Italians erected the Vallo Alpino, as the last stretch of their defence system protecting the northern borders all the way from Genova. The Yugoslavs established the Rupnik line defence system. Both nations used the basic logic of the doctrine adopted in the construction of the Maginot line. The new doctrine replaced the concepts of national defence in a specific zone using the system of fortified positions of the permanent fortification type [4]. To put it simply, both nations established sets of primary defence fortified positions in the valleys facing the Rapallo border and a main fortified defence positions, the secondary line, on hilltops above these valleys. Both systems were interdependent and connected in a complex unified defence line of enormous scales. In the case of the Rupnik line, smaller fortified structures or machine-gun nests formed the primary defences. Stronger infrastructure hosting large calibre artillery was positioned mostly as the secondary defence on the hilltops (Figure 1).

Figure 1: Hilltop bunker after construction.
