Proceedings of the 5th Historic Mortars Conference

5th Historic Mortars Conference

19-21 June 2019
Pamplona, Spain

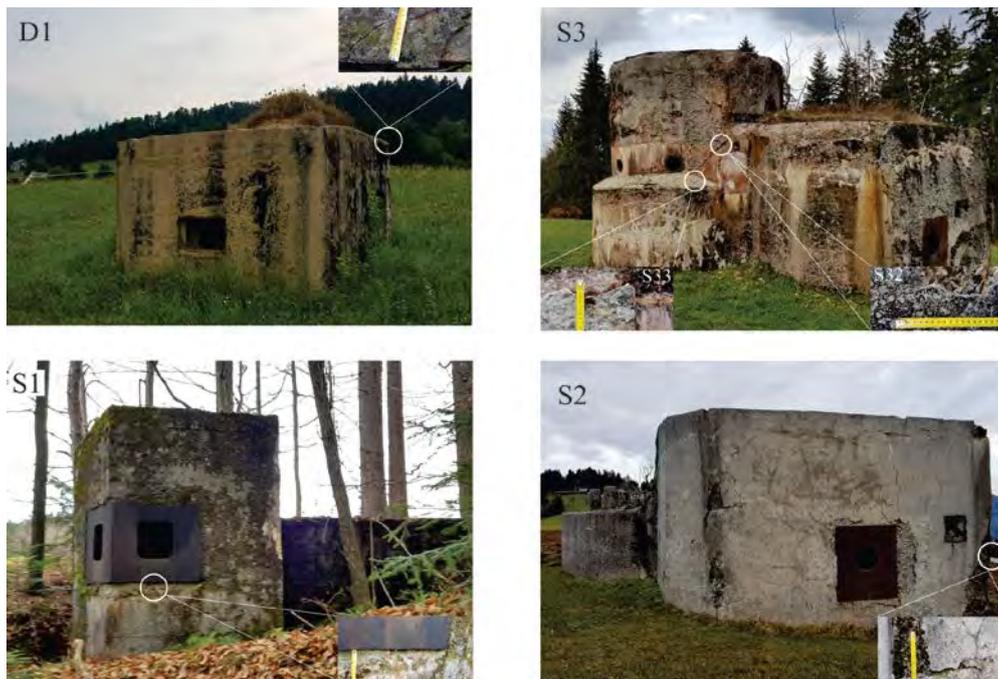
Figure 4: Bunkers that are subject of the study.

Sample S1 (Figure 4) is homogenous, with aggregate : binder : pore ratio equal to 64:35:1. The aggregate grains are angular with size ranging from a few micrometres to a few millimetres (Figure 6). The analyses by SEM and EDS confirmed that the source of the aggregate is limestone rock. Observed SiO₂ fragments, which are rare, could be part of ground granulated blast furnace slag added to the cement binder. This conclusion is also supported by the sample's colour, which is of greenish appearance, typical for the cement-based composites with the ground granulated blast furnace slag as supplementary binder. We also observed a few empty cracks in the sample.

The composition of sample S2 (Figure 4) is different from that of sample S1. The aggregate: binder : pore ratio is equal to 47:50:3, which indicates higher content of the cement binder in mortar S2. The source of the aggregate grains is dolomitic rock. The aggregate particles are angular, with the grain size distribution up to a few millimetres. Cracks were detected also in mortar S2, but the majority of them were filled with new phase. The detailed investigation confirmed the presence of amorphous phase rich in aluminium and sulphur ions (Figure 7). The source of sulphur ions could be gypsum from cement. Moreover, the process of dedolomitization was detected inside of some aggregate grains of sample S2, in

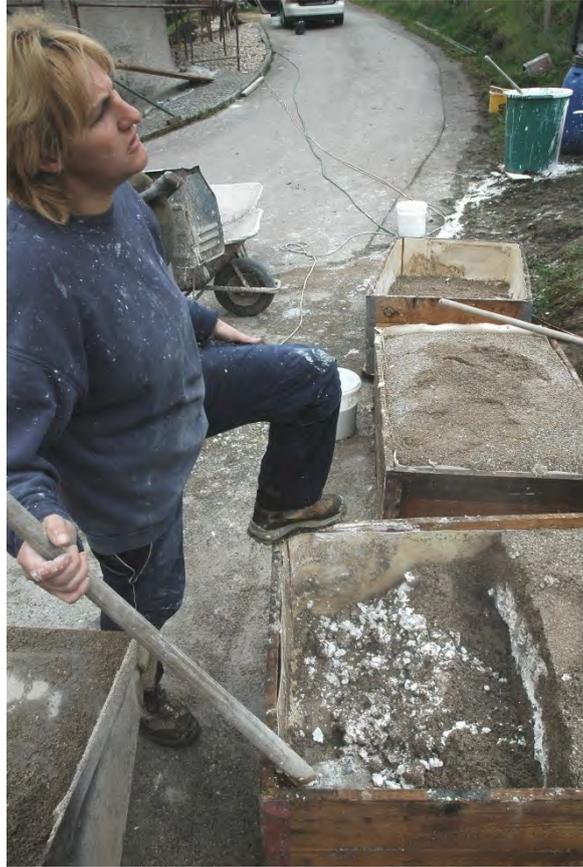
Figure 1: Dry slaking of WAM in boxes (2009)

Quicklime granulates, used for agricultural purposes with an average grain size of 0.5 to 1 cm, were filled together with local fluvial sand of carbonate origin in layers in large wooden boxes and sprinkled with water. As soon as the reaction reached its apex, the ingredients were mixed up and the façade was immediately rendered. The boxes were then filled up for the next charge (Figure 1). When the mortar was applied on the wall it was still warm with an estimated temperature of around 35 to 40°C. The mortar consisted of three volume parts of natural river sand and one volume part of granulated quicklime. The render was applied in 15 mm thickness in one layer by throwing it by trowels.

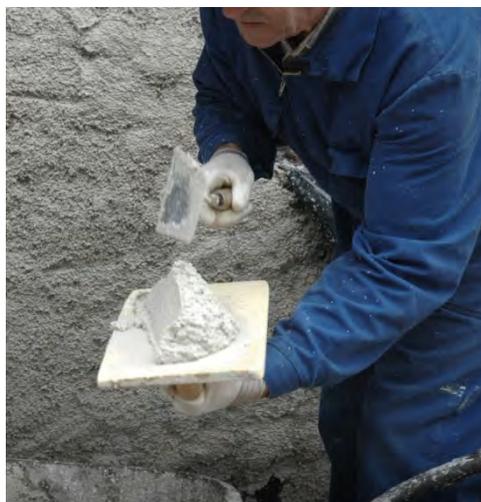
During the application the masons reported about a very good consistency and workability (Figure 2). The mortar was soft and “cosy” getting easily thrown off the trowel. It didn’t set faster as usual, although the renderers used sprinkling water to keep it formable. The method of continuous dry slaking, mixing and refilling the wooden boxes produced enough mortar to get the work done in a day. Next morning the crew came back to evaluate the surface and apply a final lime wash on it. The render set over night and although minute shrinkage cracks and a few expanding lime lumps were recognisable all over the surface, there was no significant damage to observe (Figure 3). Furthermore, the observation carried out seven years after the application showed only minor spallings on the surface, predominantly near to the footing zone of the chapel (Figure 4).

Figure 2: Rendering with warm mortar (2009)

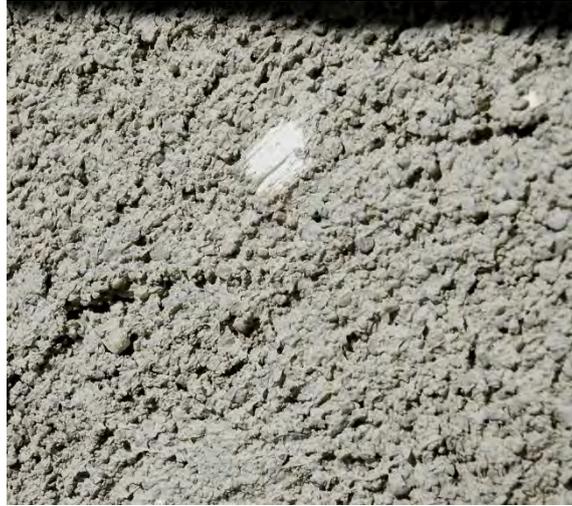
Figure 3: Fresh WAM render with lime lump (2009)

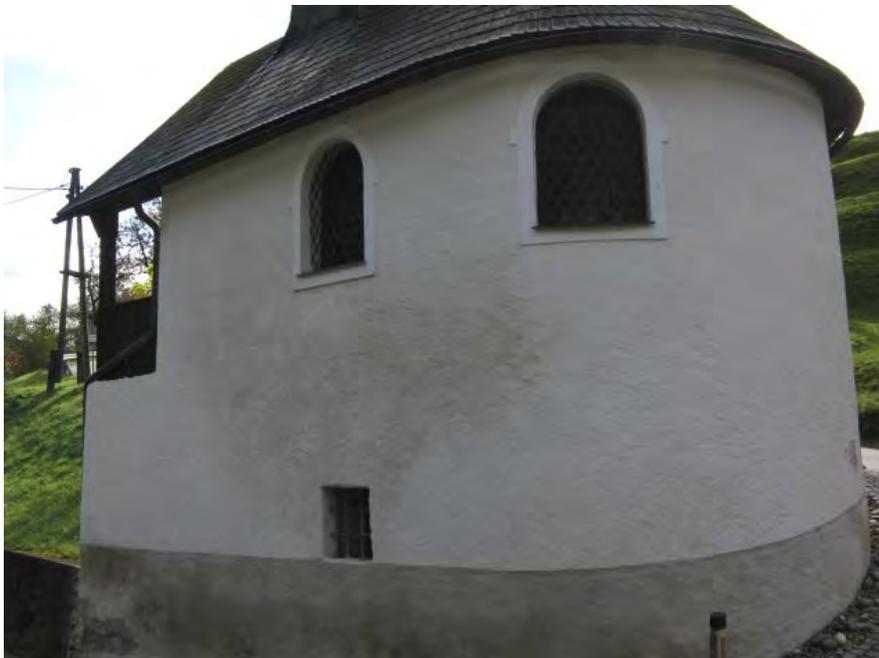
Figure 4: The chapel in 2016, seven years after the application. Only minor damages are visible

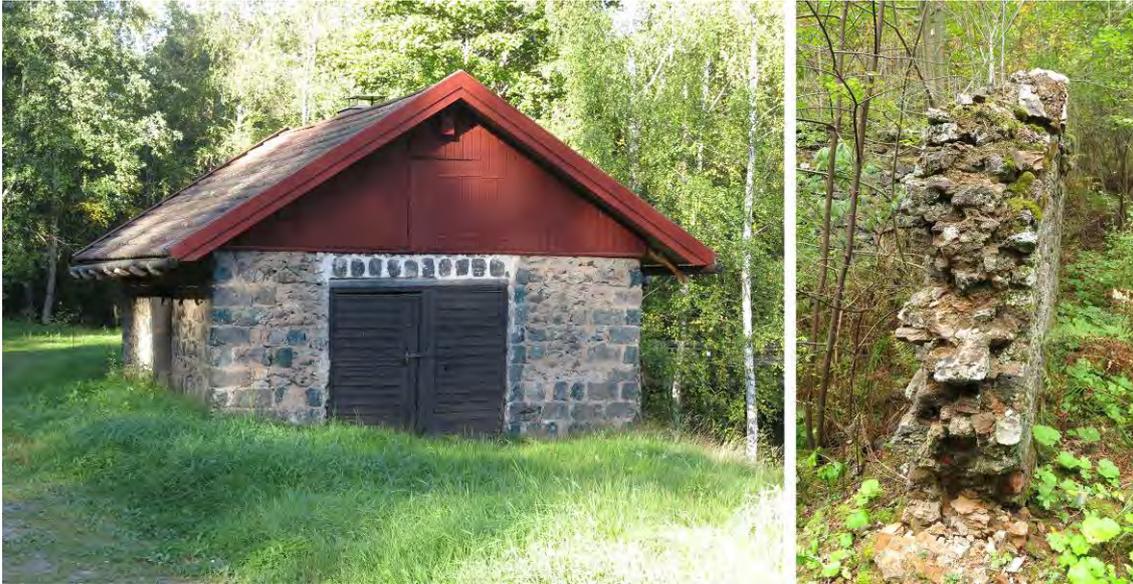
In Bergslagen, the building tradition is clearly characterized by the iron industry. This is most clearly visible by the occurrence of the building blocks made of the slag in different formats. Both cast blocks and slag chips were used, which were used as building blocks. Both mansions and barns were built of slag blocks and chips. It is recognized as a glassy stone that varies in colour from black, green and blue (Figure 1).

Figure 1 left. BF slag mortars and masonry blocks of cast slag in forge shop at Flatenbergs hyttan. The repair above the door is made with pure lime mortar. Other parts of the building still have the original mortar. Figure 1 right. Example from Schisshyttan the ruin of a steel workshop constructed in 1763.

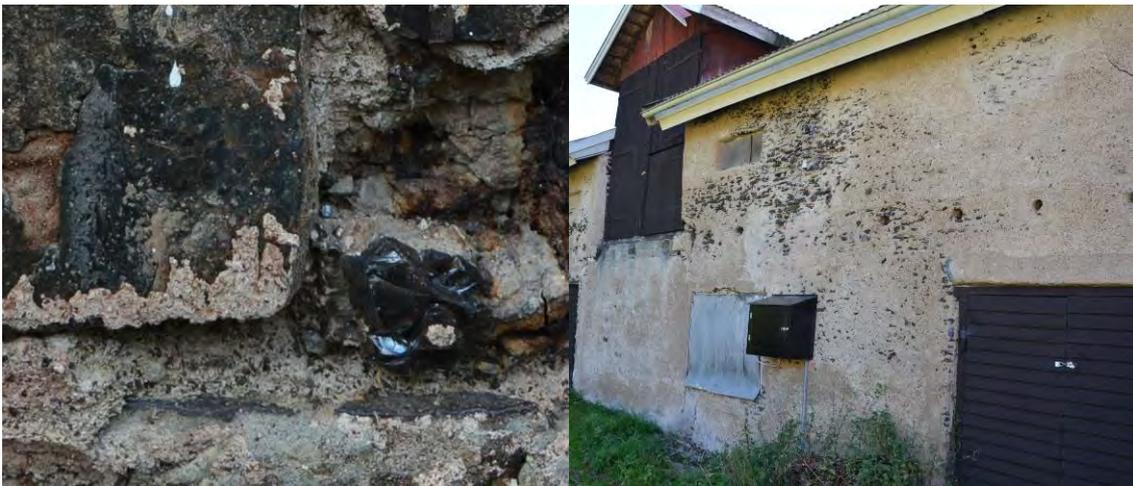
Figure 2 left. Slag stone with a glassy structure. Figure 2 right. A barn made of slag chips.

Coarse crushed slag chips, cm to dm size, was often used in masonry in the Bergslagen area (Figure 2). There are some examples of houses where the walls are cast of a lime mix with or without slag. Masonry blocks cast of slag were commonly used in the area from the late 18th to early 20th century [17] (Figure 3, 4).

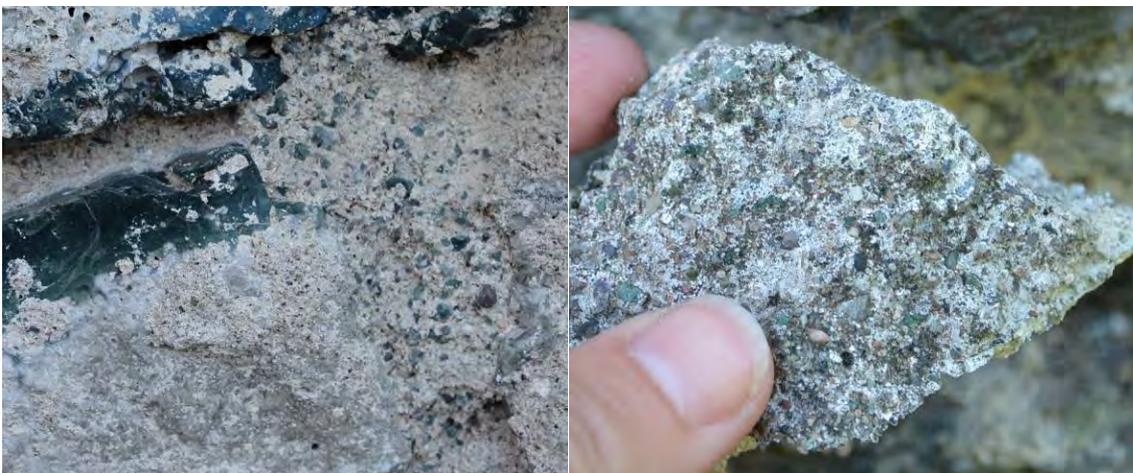
Figure 3 left. Cast slag blocks and slag mortar where the slag particles are rather big. Figure 3 right. A slag mortar with both sand and slag granulates.

The use of BF slag in mortars was very common in this area during the studied time interval. Masonry and renders of the houses that are still in use are generally in good condition. The types of construction are given in table 1. The BF slag mortars are dark greyish to yellow brown and the slag can often be seen as green-grey glassy particles, see Figure 3.

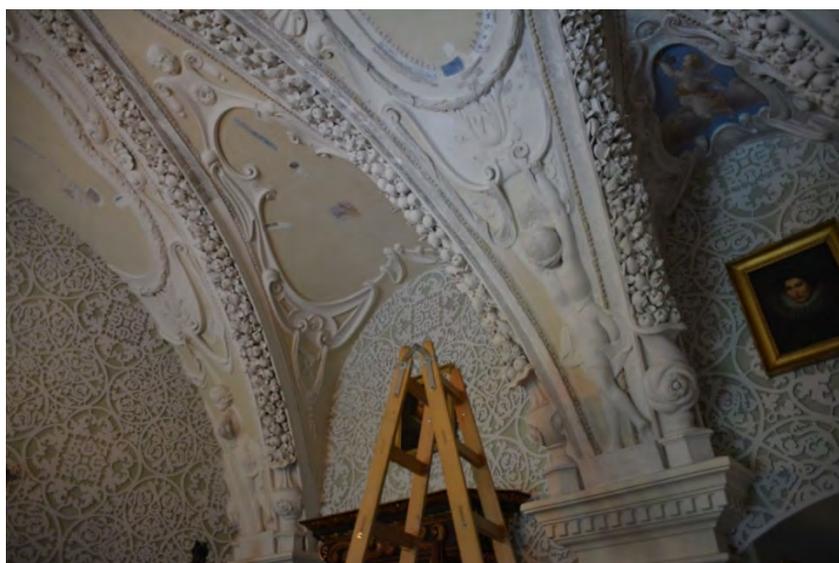
Figure 1. Stucco decorated vaulted ceiling of the Great Chamber at Červená Lhota castle at the stage of detailed surveying – a preparatory phase for uncovering the frescos and cleaning the coatings.

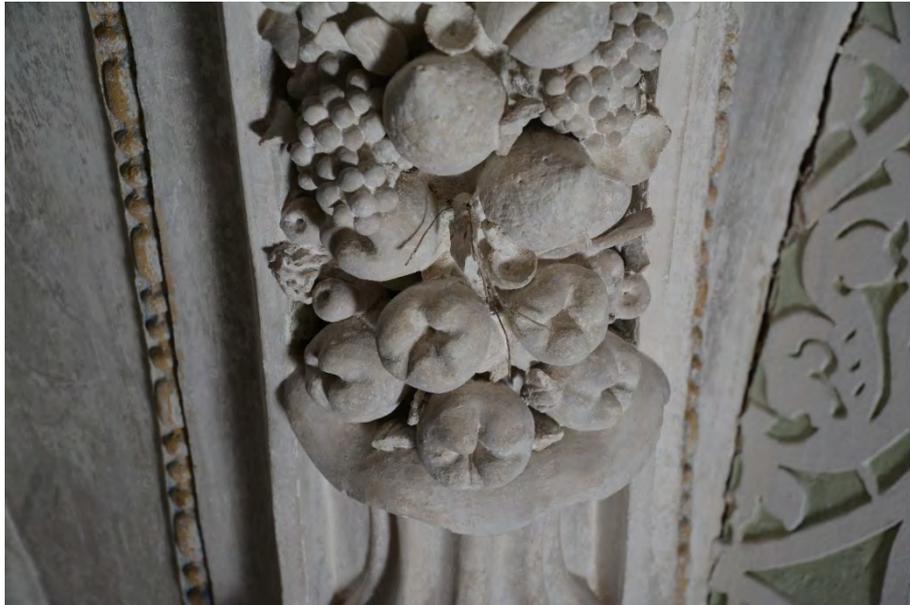
Decorated mortar ribs were made at the cross-sections of the barrel vault with the side lunettes. One rib was composed of two parallel L-shaped mortar profiles that had a running bead mould next to them from their outer sides and a rich fruit decoration in between them, Figure 2.

Figure 2. Bottom part of a rib formed by two L shape mortar profiles enclosing the vase with the fruit. Transfers from the rib to the plain vaulted surfaces are decorated by a bead moulding.

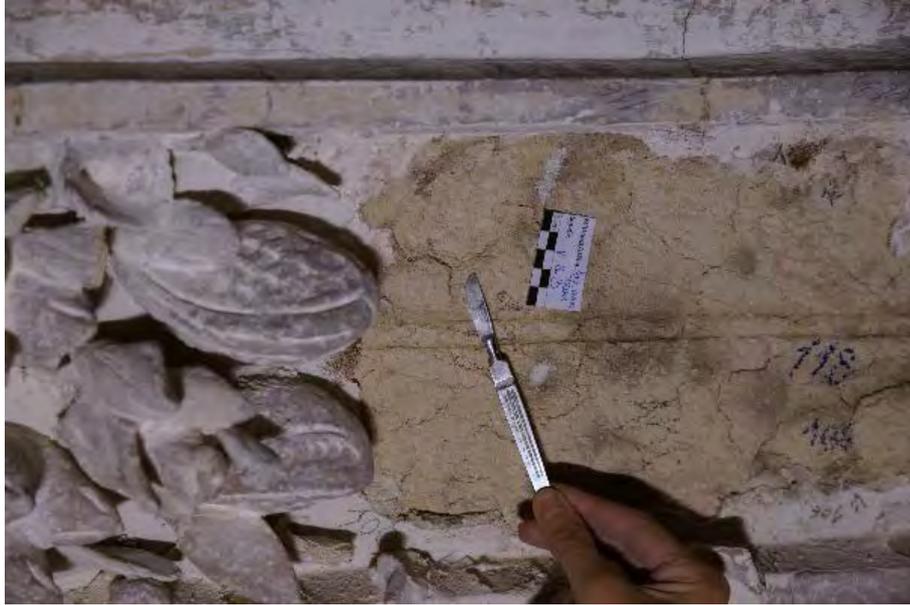
Figure 3. Top part of a rib with some fruit pieces fallen out showing the first coat and the remains of the adhesive mortar II layer on sides and between the fruits. The scalpel points at the position of sample MCL1.

Fruit pieces were composed of an inner modelling mortar and an outer stucco layer. It seems the fruit pieces (more than 20 different types) were mostly prepared on a working desk and then attached to the substrate formed by the hardened (stiffened) first coat. The pieces were glued to the substrate by app. ~5 mm thick layer of a relatively fast setting adhesive mortar II, Figure 3. Rarely, an iron nail was found placed in the centre of a fruit piece that helped to anchor the heavier pieces and/or those which were at the top of the vault (at this position the whole weight is to be borne by the tensile capacity of the adhesive mortar). An alternative approach, the use of a mould for modelling the same fruit shapes seems less probable so far. Small decorations were also prepared separately on a desk and then glued to the already well-set fruits by using the adhesive mortar I, Figure 4. It is possible that some smaller pieces and fruits were also modelled directly on the spot but probably only in the cases where it was convenient in terms of appearance and composition, and/or easiness of application. All stucco decorations had several historic layers of lime wash coating. The last two were applied by spraying covering entirely the original final finish.

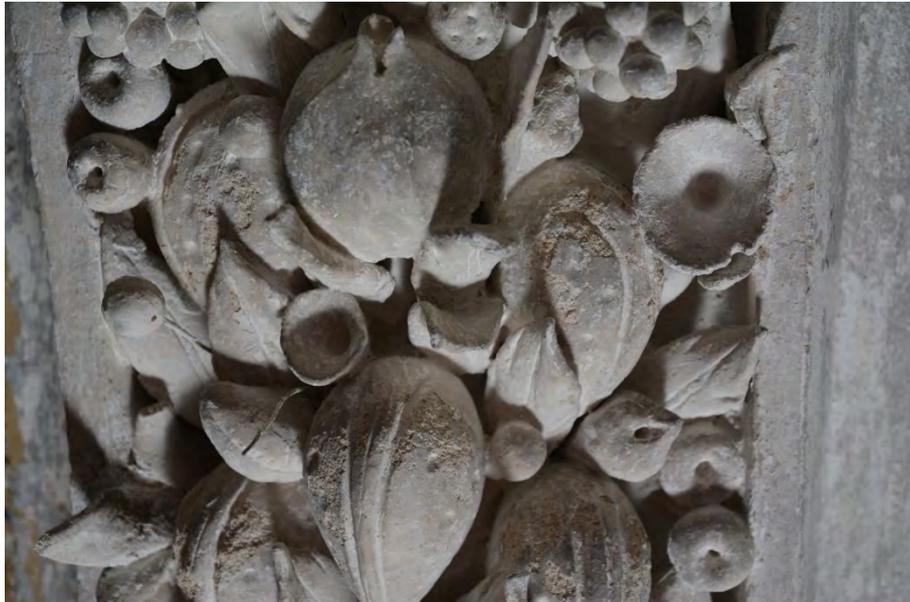
Figure 4. Detail of the fruit pieces (almonds, pomegranate, grapes and cherries) with small decorations (leaves, cups and other shapes) added for an enrichment.

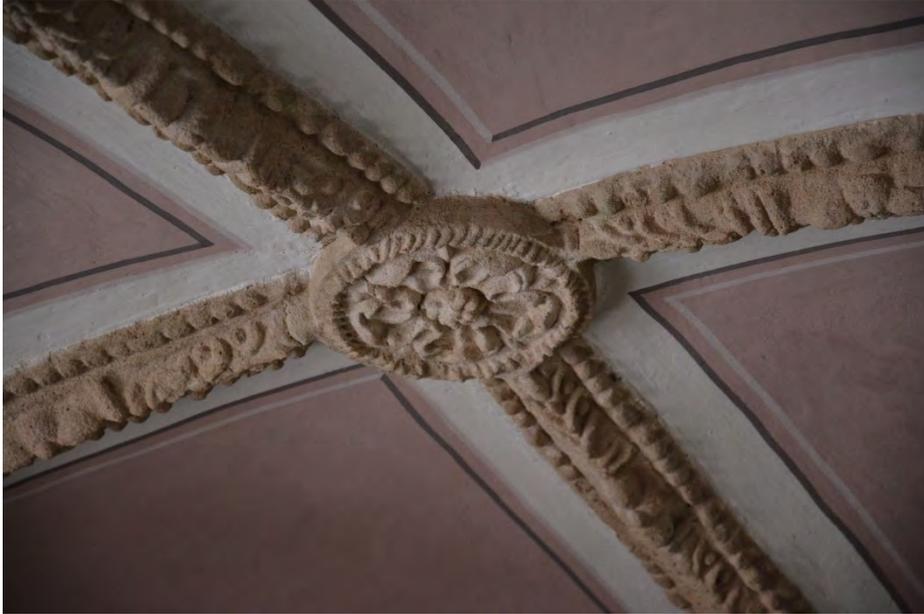
Based on the symbols depicted on the stucco it can be dated after 1641 when the castle changed its ownership [7], Figure 5.

Figure 5. Stucco decoration made at an earlier refurbishment phase of the castle.

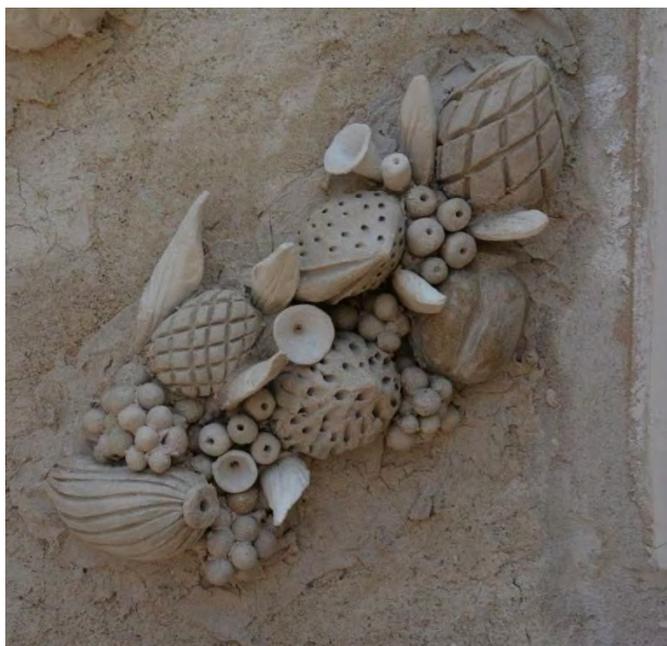
Figure 9. Trial replicas of the fruit decoration made according to the analytical results. Lime binder was made from marble sampled at the original outcrop, burnt in a wood-fired kiln and processed by wet slaking following the historic procedures.

These open issues require a further analytical research. They can be also at least partially answered by building experiments, when adequate raw materials (matching the original ones) are acquired and processed by the contemporary historic production techniques. The resulting mortars are then assessed by the same analytical techniques as are used for the characterisation. This is actually the current stage of ongoing research where material experts work with practical conservators who have practical experience with the preparation and application of mortar, Figure 9.

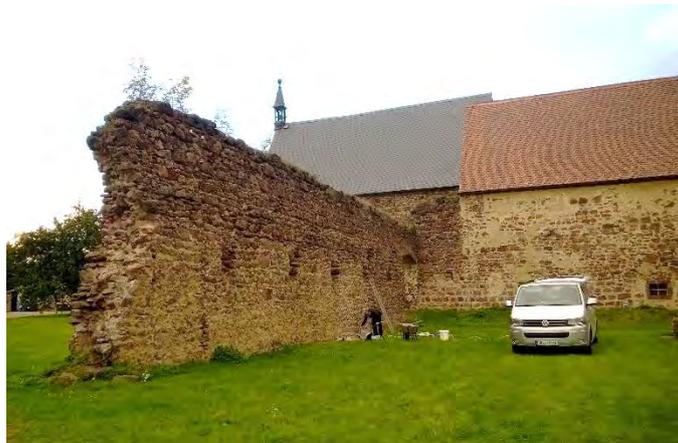
Figure 1. Test wall in Buch, middle of Saxony/Germany

The paper presents the results of a case study with different HAM mixtures in comparison to mortars which are hot mixed but applied after they cooled down, on salt contaminated historic stonework (see Figure 1) as well as accompanying laboratory tests.

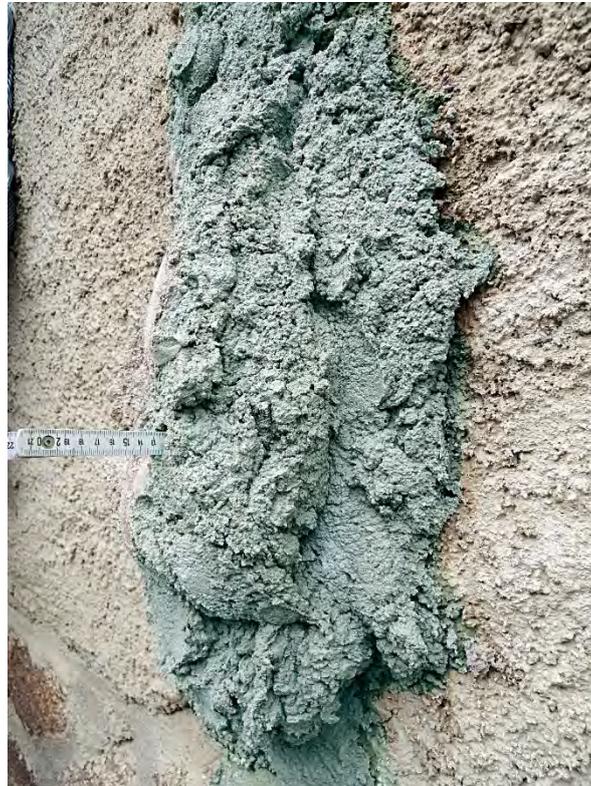
In Figure 3 a trial with a H3 mixture on a wall can be seen. The folding meter documents that the layer, which was applied at once, is 13 cm thick. It sticks to the wall and sets in less than a minute.

Figure 3. Hot applied mortar (HAM) in mixture H3, with pumice, allows a thick package of mortar applied in one step because of very fast setting

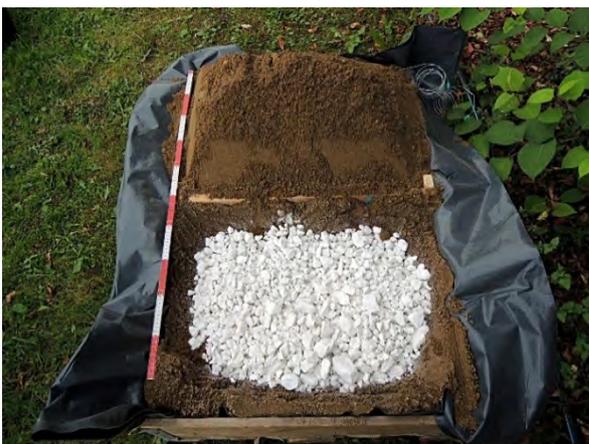
Figure 4. Wooden box covered with a thick plastic foil to prepare a hot mixed mortar in a sand-quicklime sandwich technique

For HAM preparation – on site and the same for laboratory tests - first 2.5 volume parts of sand are measured in a heavy duty basket (normal baskets do not withstand the high temperature). Then quicklime is added and covered either with another 2.5 volume part of sand or (for additional laboratory tests) by brick sand or pumice. With a single paddle mixer the mass is quickly homogenised. In this state the first slaking reaction starts because of the earth-moist condition of the aggregates. After a first quick mix the water is added at once and mixing continues. The water content in this stage is very high so a liquid slurry is the result and mixing works without agglutination of aggregate and binder. Moreover, the maximum temperature of the system is reached in this stage: measured temperature was up to 80°C, what means a boiling slurry. Due to slaking and water uptake the mortar stiffens very quickly. Workability is reached within seconds, and after some minutes and in some cases even quicker the mass is consolidated and not workable anymore. The processing time is ruled by the mixture, water content, the temperature of ingredients and the stirring time. For this reason, especially when working with HAM on site with unknown sand and quicklime brands, foregoing tests to adjust water addition in a fixed stirring time, are essential. Time of workability in the given mixtures differs from 100 seconds to 30 hours, depending on the water content. For that a standardised mixture is essential to compare results [9].

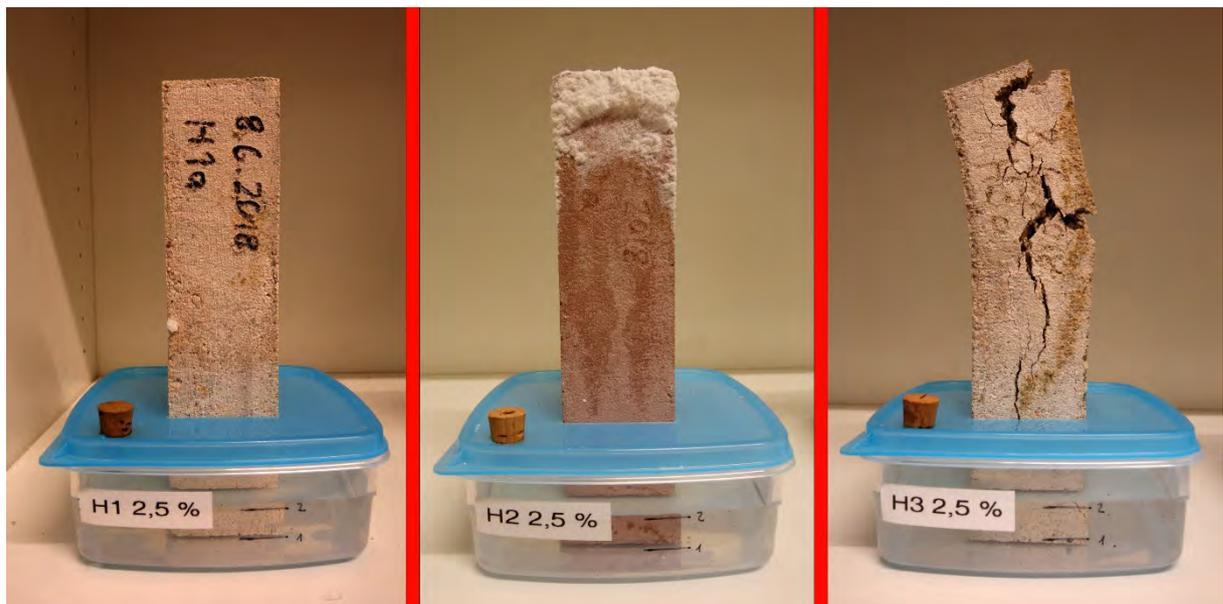
Figure 9. Mortar prisms of hot applied mortars with different mixtures in a 2.5% magnesium salt solution after 60 days

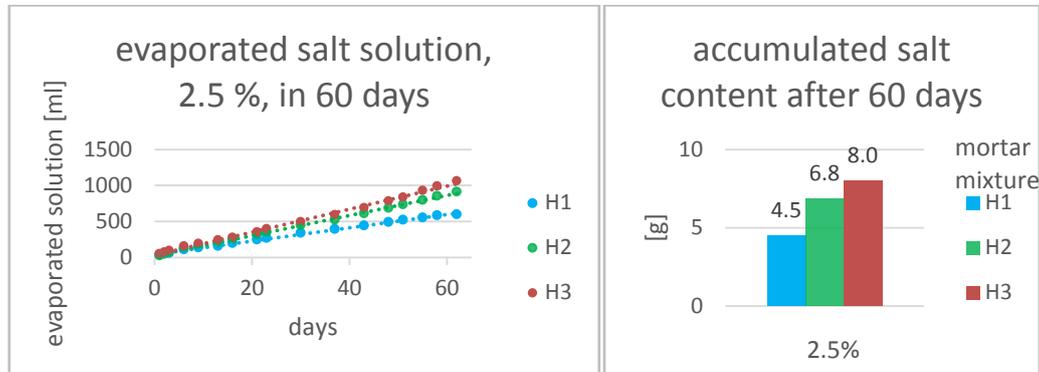
Figure 10a+b: diagram with evaporated salt solution after 60 days and table with the accumulated salt content

In diagram 10a a linear progression of water uptake during the 60 days is visible. The small aberration from the regression line can be explained by imperfections during filling with salt solution. There is neither a fast uptake at the beginning nor a decelerated uptake towards the end of the experiment because of blocking the pores with salt efflorescence. Uptake of salt solution is lower in mixture H1 compared to mixture H3 with resulting different salt accumulation (Figure 10b). In the mortar mixture H3 8.0g of magnesium salt is accumulated, which means an average salt load of 2.1 wt-% in the mortar. The conclusion for practice of the salt experiment is, that the hot applied mortar can be adjusted to the needs of the craftsman. If a long lasting, durable mortar with a moderate water uptake is wanted, mixture H1 is to favour. If salts should be transported to the surface to be removed i.e. by brushing, mixture H2 is to recommend. If the mortar is used as a sacrificial render with highest performance in water uptake and best in salt accumulation, in a short period, mixture H3, also the “lightweight” under the compared mortars, is to prefer.

absent. Mortar H2 has a big crust on the top of the prism but also no damage. On the contrary, mortar H3 shows no efflorescence, which is comparable to H1, but has the highest grade of decay. These phenomena can be compared with the water uptake and the evaporation rate and parallel with the salt enrichment. In figure 10 the water uptake and the sum of accumulated salt after 60 days are presented for every mixture.

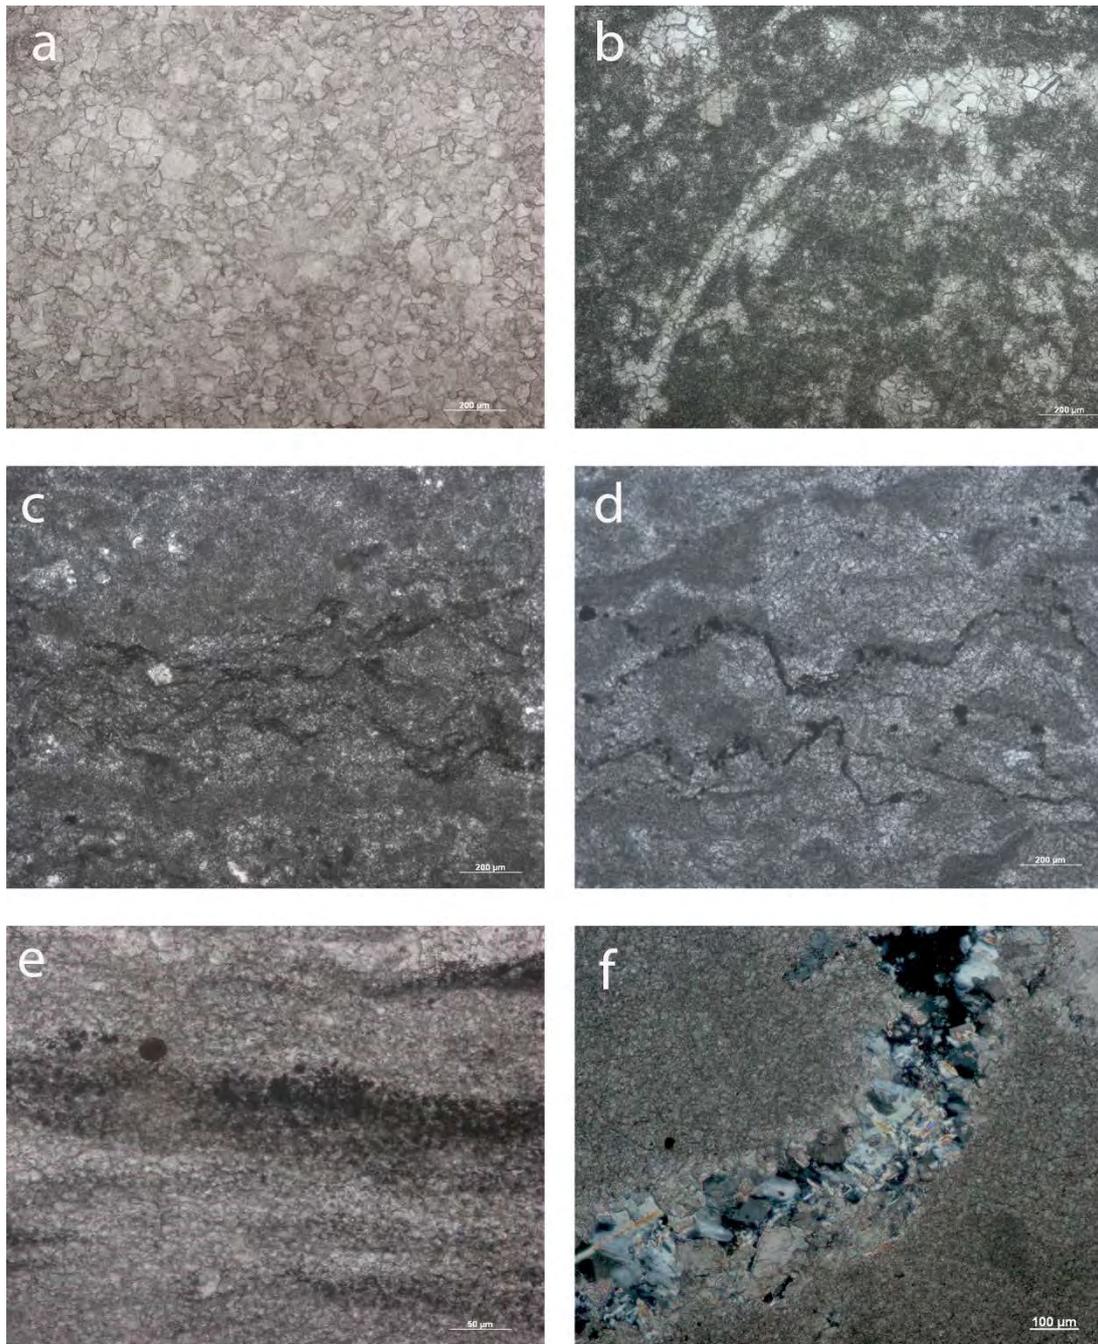
Figure 2. Micrographs of dolomitic rock samples. (a) sample C1; (b) sample C-02; (c) sample D-01; (d) sample E-dol; (e) sample G-01; (f) sample I-01 (all images are under XPOL, except 2a, PPL).

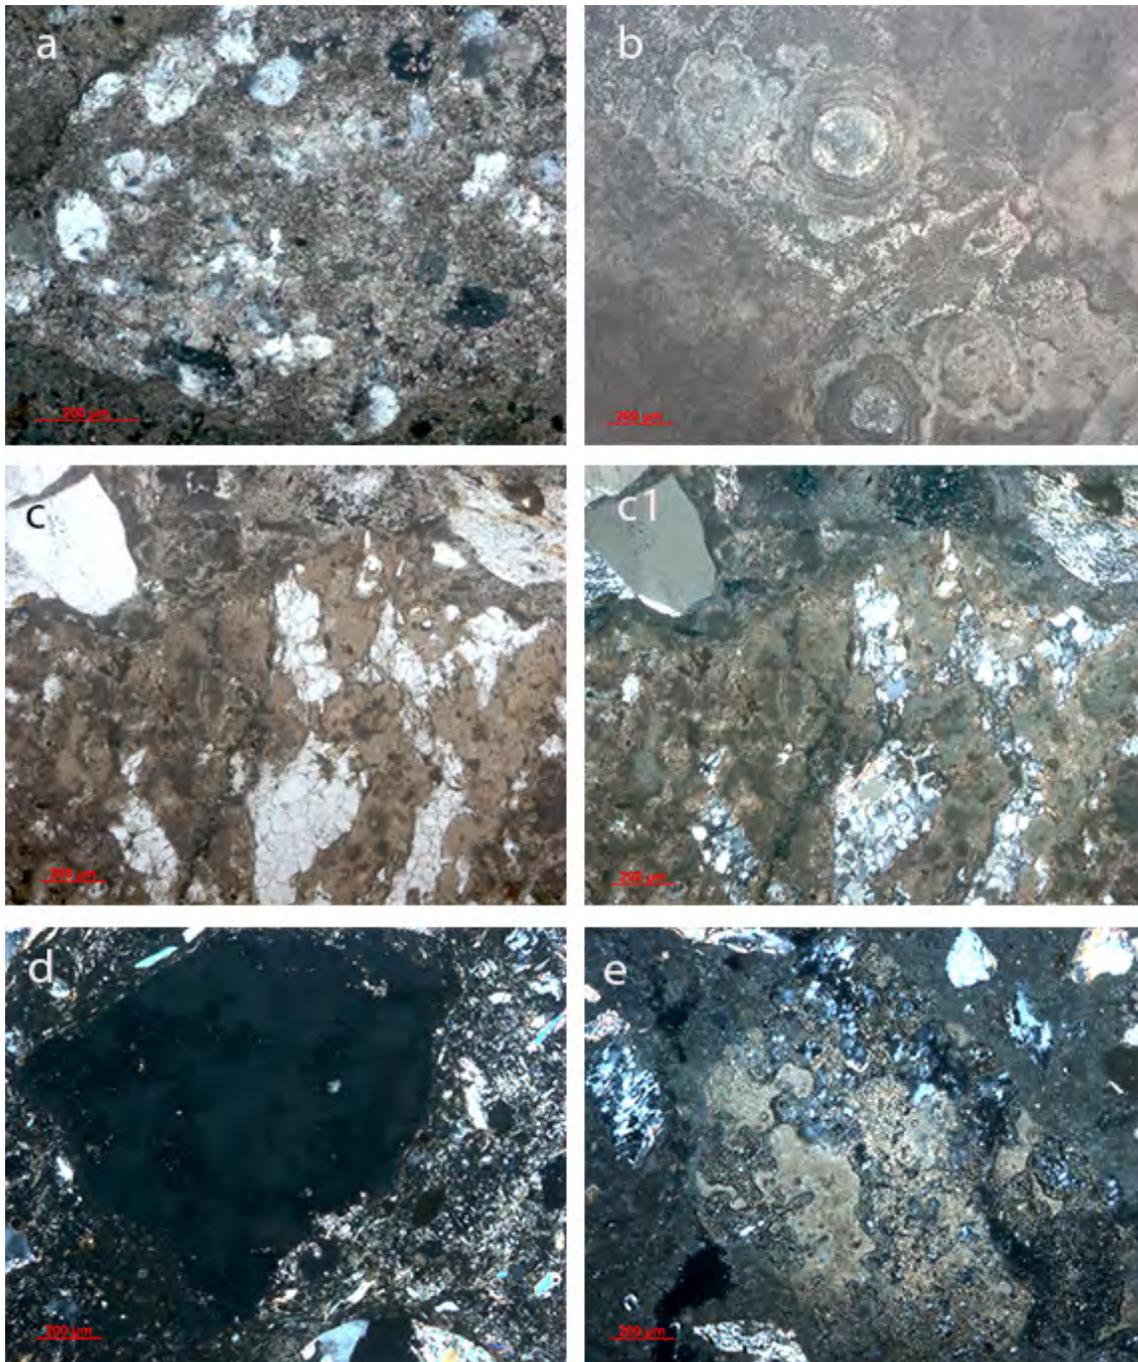
Figure 3. Micrographs of the binder of archaeological samples. a) underburnt rock fragment (XPOL); b) textural features related with the presence of hydromagnesite (XPOL); c-c1) lime lump with unreacted quartz (PPL and XPOL respectively); d) overburnt vitrified (amorphous) BRP, formed in the hottest areas of the kiln where the temperatures reached were sufficient to start melting the carbonate phases. Some quartz grains are clearly visible inside the lump matrix. –(XPOL); e) lime lump with partially melted siliceous phases.

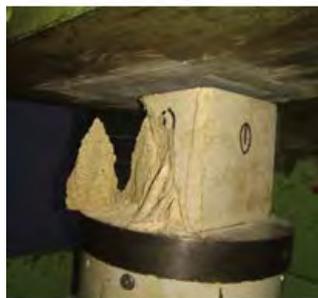
Figure 1. Failure of the coral stone cube under compression

Compressive strength of the stone specimens was found to vary from 35 to 70 MPa with a standard deviation of 17.5 MPa and average strength of 58 MPa. The results revealed that there was no significant strength difference between the specimens that appeared intact and the ones that possessed light weathering. Figure 1 shows a typical failure of coral stone cube under compression. From the water sorptivity tests, the capillary porosity for the samples was found to be between 8.5% and 13.5%, with a coefficient of variation of 13.4%.

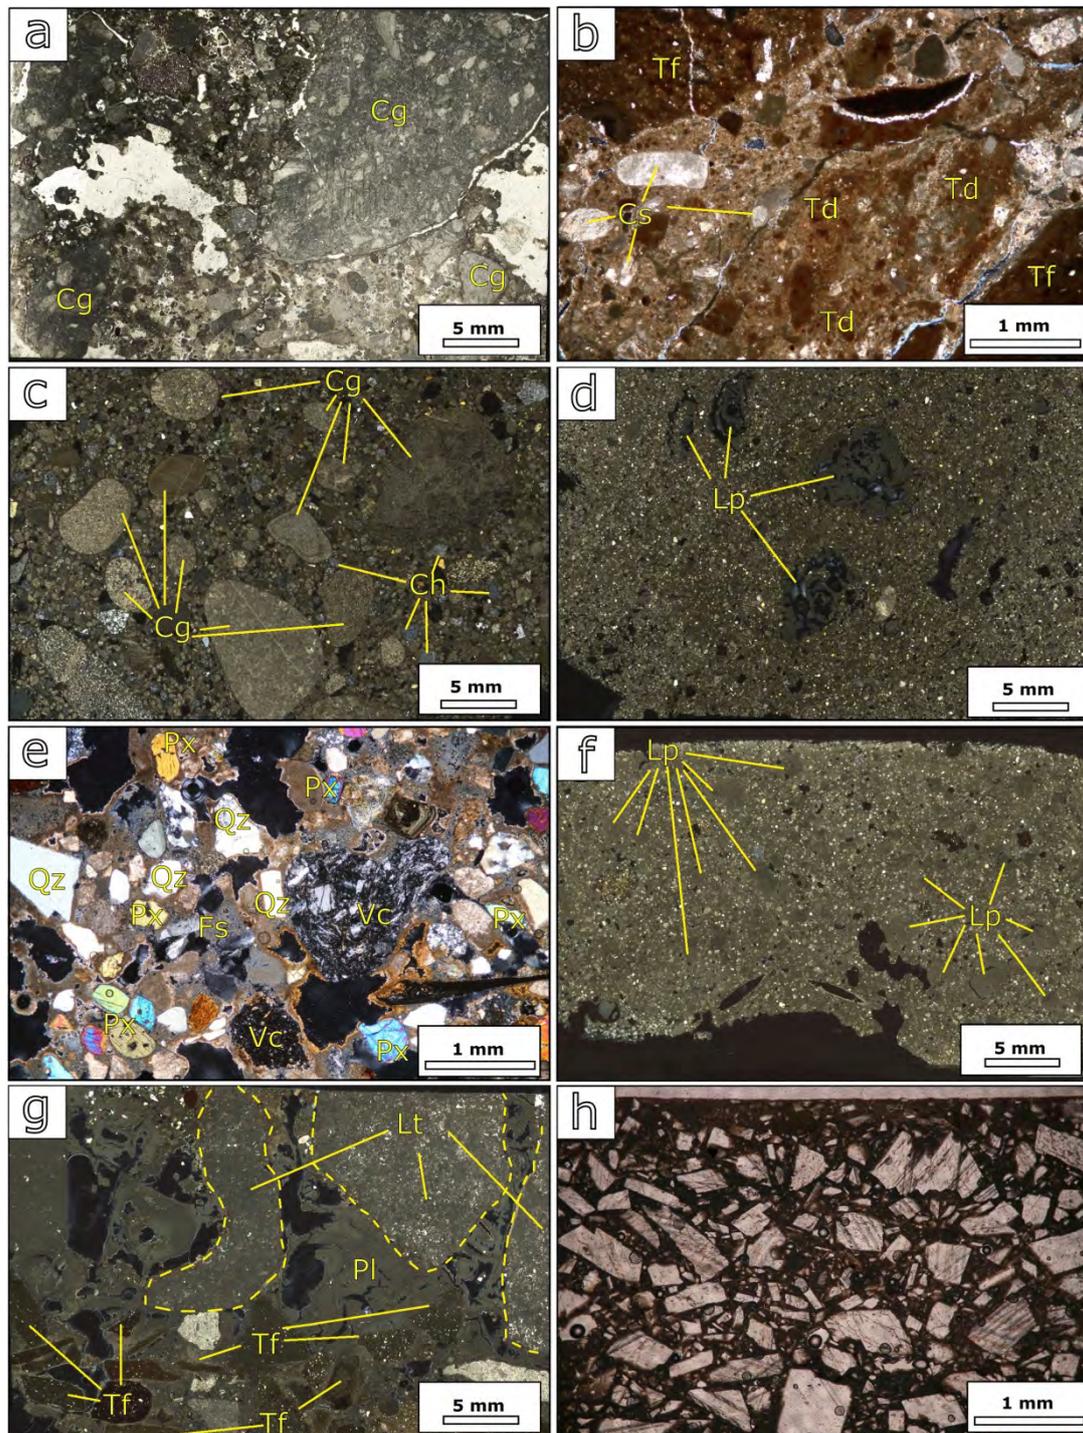
Figure 3. Petrographic analysis on thin section of mortar-based compounds. a) OM-TL-Pn, theatre mortar from platform foundational *opus caementicium* (Cg: carbonate gravel); b) OM-TL-Xn, *terracotta* dust (Td) and *terracotta* fragments (Tf) with secondary aliquots of carbonate sand (Cs) from the bottom *cocciopesto* layer of theatre platform foundation; c) OM-TL-Xn, square rubble masonry wall joint mortar (Cg: carbonate gravel; Ch: chert); d) OM-TL-Xn, brick wall joint mortar (Lp: lime lump); e) OM-TL-Xn, pyroxenes (Px) and volcanic (Vc) aggregates in a wall joint mortar, with subordinated feldspars (Fs) and quartz (Qz); f) OM-TL-Xn, Late Antique wall joint mortar with diffuse presence of lime lumps (Lp); g) cross section of I cen. AD mosaic bedding screed (Lt: limestone *tesserae*; Pl: lime-putty setting bed; Tf: *terracotta* fragments of the nucleus); h) OM-TL-Pn, Ist style wall painting, *intonachino* layer with diffuse euhedral spathic calcite. (OM: optical microscopy; TL: transmitted light; Xn: crossed nicols; Pn: parallel nicols)

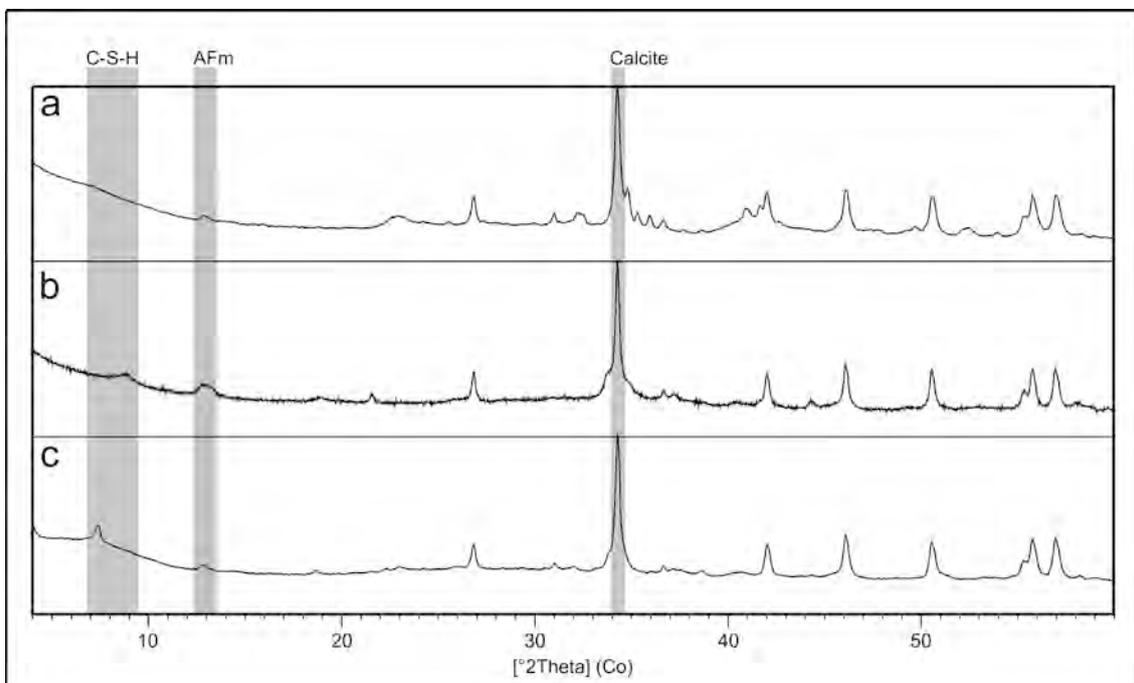
Figure 5. XRPD patterns of the binder fractions of selected hydraulic mortars, with highlighted the main diffraction peaks of the anthropogenic binding phases: a) theatre, *cocciopesto* mortar at the base of the foundation platform; b) *Thermae Felices Constantinianae*, coating mortar of a pool; c) Republican city walls, foundational concrete.

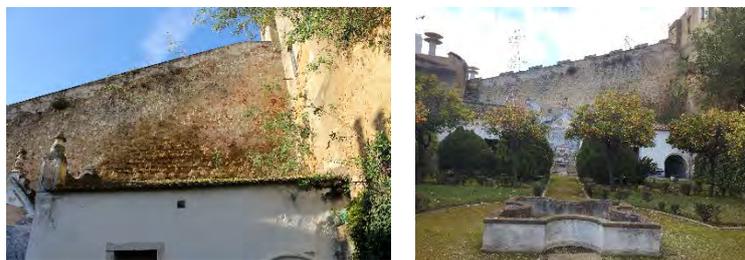
Figure 4 – Wall section at the north of Independence Palace garden: (a) general view and (b) detail of the wall

This Palace is classified as a national Portuguese monument and is located at São Domingos Square (Figure 1 (3)) very close to the popular Rossio Square. Presently, it is the headquarters of Historical Society of the Independence of Portugal. In the back part of the palace there is a garden and a section of the Fernandina Wall with around 20 meters long (Figure 4). This wall section has been subjected to intensive weathering exposure and to several interventions, such as a staircase on its top and the repair with different mortars - Figure 4. Although it was not possible to extract any core sample from this section, the façade that is visible seems to be a rubble limestone masonry.

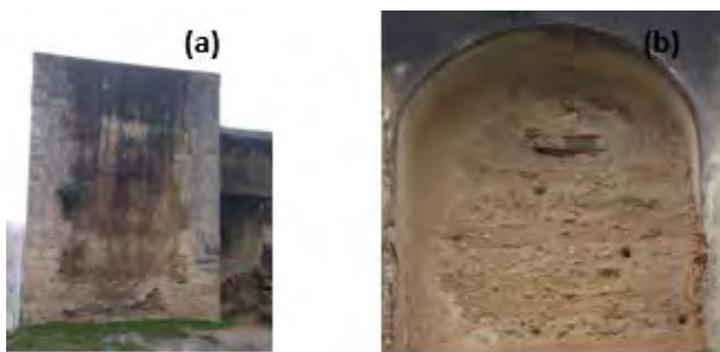
Figure 5 – Gil Vicente’s School: (a) small tower with stone masonry corners and rammed earth and (b) rammed earth section of the Wall

The walls of the garden of Gil Vicente's School presents one of the most protected and preserved sections of the Fernandina Wall, with a well preserved section of about 50 m, with small towers and large walls. Sited on the eastern section of the Fernandina Wall (Figure 1 (4)), it was the only surveyed site visited in the East section. The building techniques used includes stone masonry, mainly in the small towers base and corners, as well as rammed earth in other areas of the small towers (Figure 5 (a)) and on a Wall section that could be observed (Figure 5 (b)). It was possible to induce that the rammed earth was air lime stabilized because white friable nodules could be easily observed on the rammed earth surface, dispersed within the earthen matrix. The stabilization of rammed earth with air lime was a common technique on Portuguese defensive structures like castles and fortresses [5]. The rammed earth section presented a very eroded render with lack of cohesion that was falling, exposing the rammed earth technique (Figure 5 (b)).

Two samples were extracted, one from the wall and another from the small tower. The observation of these samples confirms that they are built with rammed earth technique. Also, an intervention held in 2016 [6] in the construction of a car parking in the opposite side of this Wall section confirms this technique.

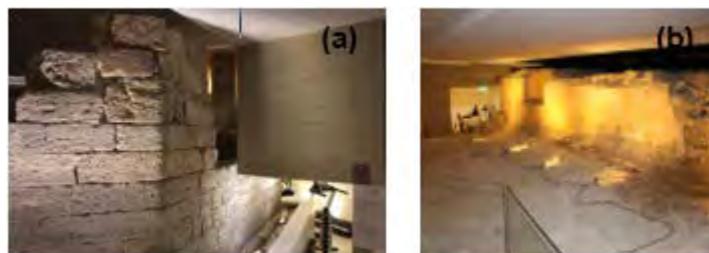
Figure 8 – Corpo Santo Hotel: (a) João Bretão Tower and (b) nucleus of the tower

According to Vieira da Silva [2], this part of the city is lacking in studies about the Fernandina Wall. Nevertheless, when Corpo Santo Hotel start being built, an archaeological and restoration campaign was performed and important data was collected [8-9], having the Hotel won an international prize for this preservation. This part of the Wall was built to protect attacks from pirate ships entering the Tagus river (Figure 1 (7)). Nowadays, the hotel offers a large room where remains of the João Bretão Tower and a section of the adjacent Wall are visible (Figure 8). Two core samples were extracted from the top of João Bretão Tower. These samples allowed to observe the top layers of the rubble stone masonry walls of the tower.

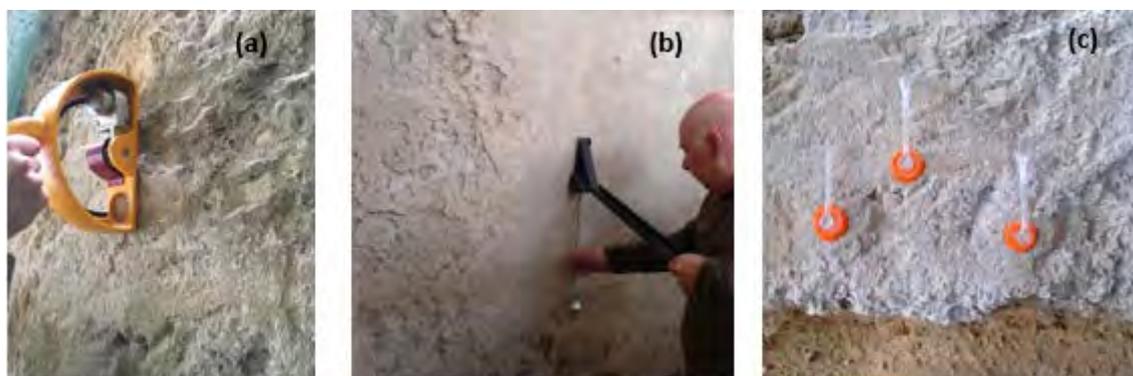
Figure 9 – *In situ* tests: (a) Pendular sclerometer in Bragança Terraces Residence wall section facing south; (b) Sphere impact test at a wall facing East inside Jogo da Pela Tower and (c) Karsten tubes test at a wall section facing East at Bragança Terraces Residence

The water absorption test under low pressure was performed based on EN 16302 standard [14] specific for cultural property materials, with Karsten graduated tubes with a scale of 0 to 4 ml of water capacity [11] (Figure 9 (c)).

A defined area of water contacts with the test surface by the application of a waterproof plasticine. The water volume absorbed during short intervals of time is registered; in the present case, up to 30 min or when all the 4 ml were absorbed due to the type of porous materials in presence. Results are expressed by absorption curves [14].

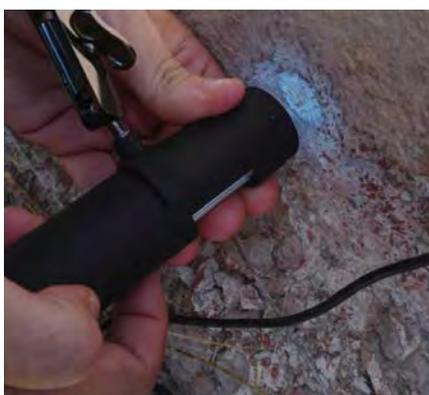
Figure 5. Sampling-shoots microphotographs with a portable hardware.

This monitoring of the samples has already been applied in other locations such as *Medina Albalat* (Romangordo, Cáceres), *La-Sé-Cathedral* of Idanha-a-Velha (Portugal) or in the Roman site of *La Magdalena* (Alcalá de Henares, Madrid) [13]. In all of them, high-resolution microphotographs were taken with minimal impact on the original walls, and then the images were processed. Previously, the sampling points should be chosen according to the objectives and the targets, the conservation of mortars and their morphological characteristics [14]. Finally, we proceeded to remove the outside layers of vegetation and organic remains that could modify the results, and the photographic sequence was developed with shots of between 10 and 25 megawatts each all. Neither in the checking nor in the sampling were damaged during the work.
