Proceedings of the 5th Historic Mortars Conference

5th Historic Mortars Conference

19-21 June 2019
Pamplona, Spain

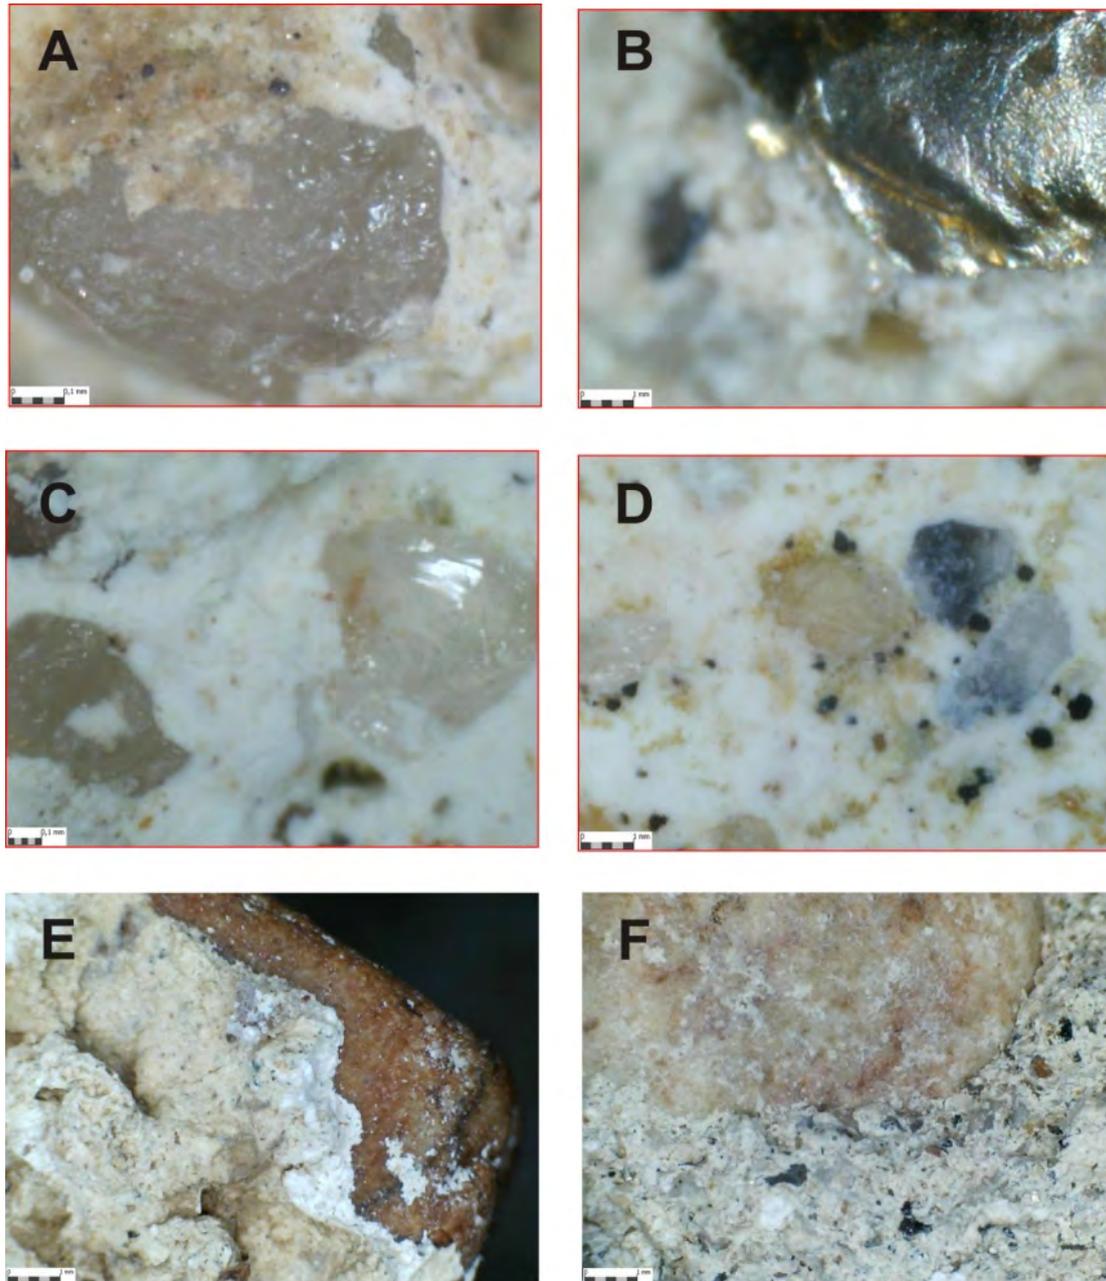
Figure 8. Different aggregates identified in the mortars of *Los Hitos*: A) Quartz in sample HIT3; B) Mica in sample HIT5; C) White and rose quartzes in sample HIT11; D) Small sizes aggregates with feldspar in sample HIT12; E) Piece of quartzite in sample HIT19; F) Sand and graves in concrete of simple HIT37.

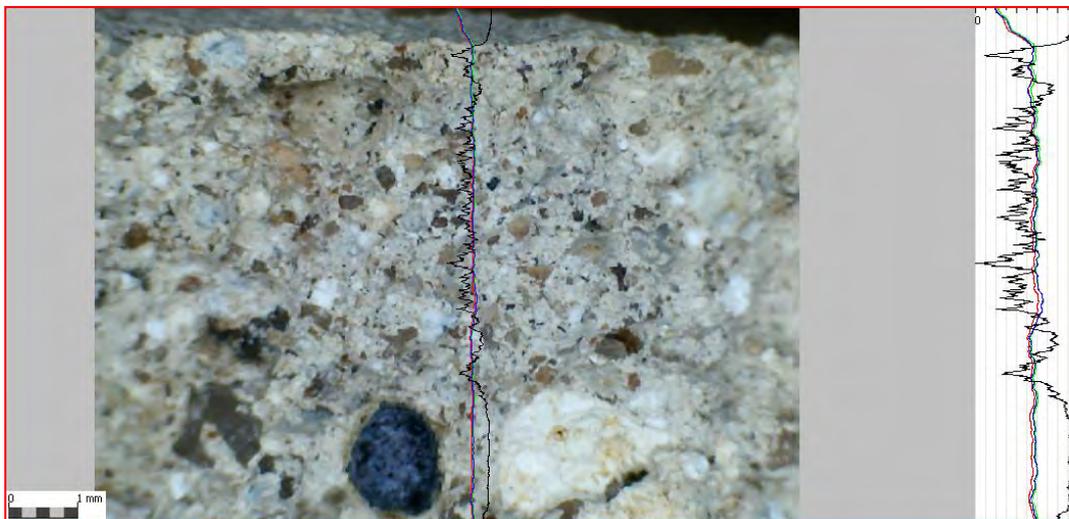
HIT4. The vectors indicate a homogeneous chromatic variation, for the aggregates do not present chromatic variations that change the tones and the saturations ranges. As the graph on the right shows, the peaks respond to small crystals of quartz and mica, unlike the extremes, represented by the mortar interface and a large lime nodule.

Figure 10. Colorimetry graphic of sample HIT4 shows saturation and hue, while lime-nodules and quartzes change the results of graphic (high-low peaks).

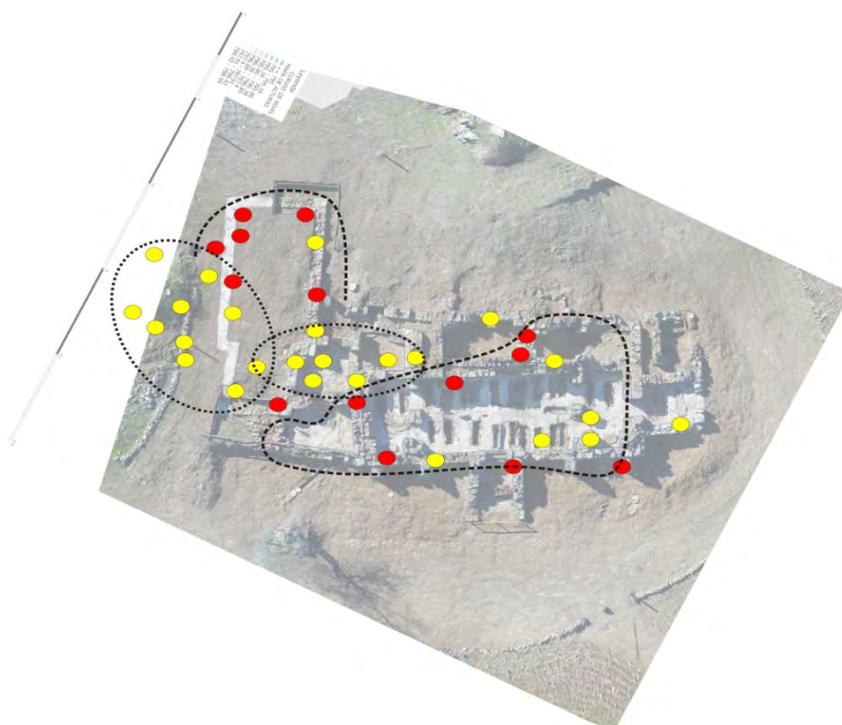
Figure 16. Distribution of the mortars documented in colours (mortars in red; concretes in yellow), and the relation between the situation and the complex.

As figure 16 shows, where the central area corresponds with the palace and the left sides correspond with later expansion, mortars were documented in the palace and the church and coating, while concretes (with aggregates higher size average) were documented outside, pillars corridors and isolated rooms.

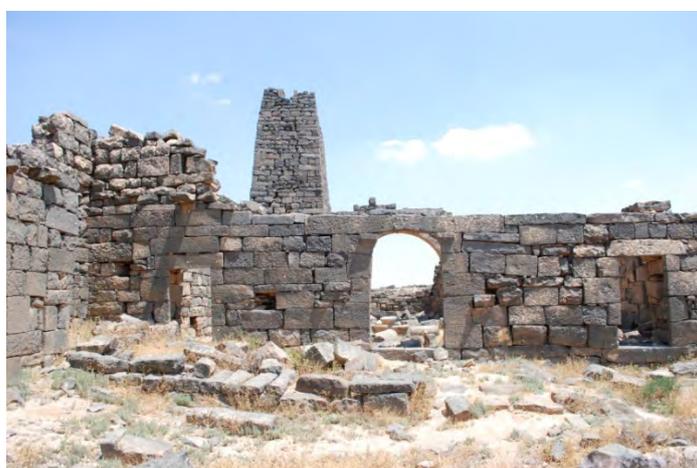
Figure 3. The façade of the church of SS. Sergius and Bacchus (photo by Piero Gilento, 2017).

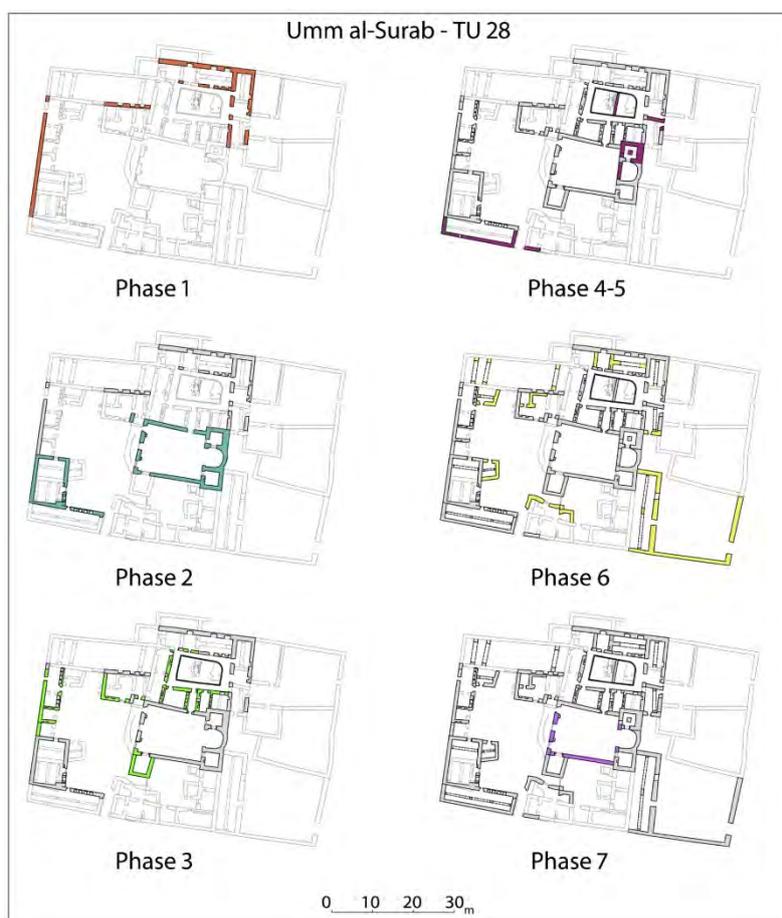
Figure 4. The seven building phases of TU28 (Anastasio, Gilento, Parenti 2016 [3])

The stratigraphic analyses of the standing remains, carried out between 2009 and 2012, led to the identification of at least 7 construction phases as highlighted in Figure 4 and described in Table 1 [3, 8].

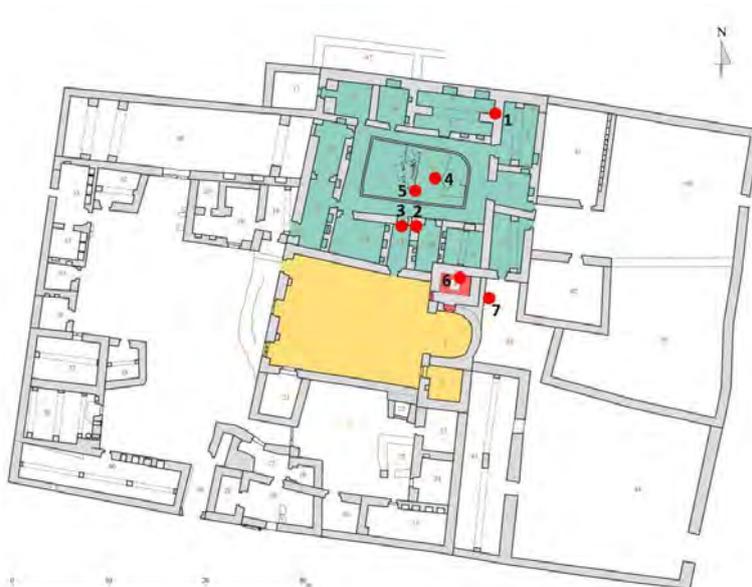
Figure 5. Plan of Topographical Unit 28 in yellow the church and in green the monastery and the localisation in red spots of the seven mortar samples (modified by Piero Gilento and Sara Peñalver Martín, 2018).

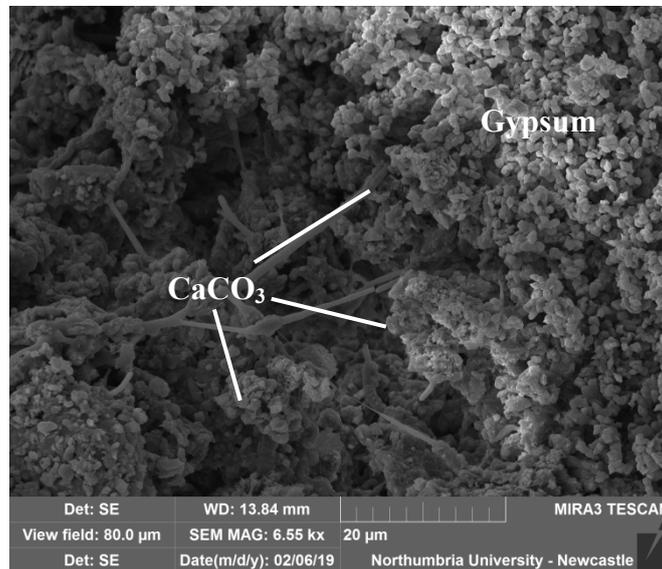
Figure 9. SEM image of the binder in sample SM-28-2.

In samples SM-28-2 and SM-28-7 pseudo-prismatic gypsum crystals (1-10 μm sized) were found within the carbonate-based binder (Figure 9). Gypsum crystals were bigger than CaCO_3 crystals, most likely as a consequence of their higher susceptibility to dissolution and recrystallisation processes during long-term weathering, due to their higher solubility with respect to CaCO_3 [19].

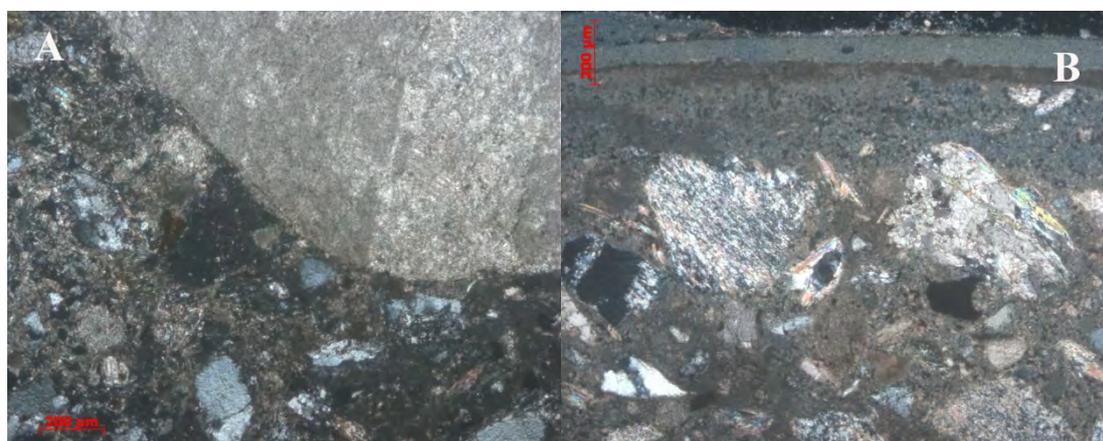
Figure 3: thin section images 5x, XPOL. A) Sample 12781, bedding mortar from the convent. An unsorted sand with carbonate phases is visible. B) Sample 315, the plaster consists of a single layer of *arriccio* covered by a whitewash layer.

Convent. The bedding mortars collected from the convent were much poorer in binder (B/A 1:1). They also differ from the mortars from the church in the aggregate because here the finer grain size is also present together with medium and coarse sands (up to 1 cm). The aggregate also contains carbonate rock fragments (Figure 3A). The plasters are characterized by a high amount of binder when compared with the bedding mortars from the same areas. The plasters consist of a single layer of *arriccio* made of unsorted sand with a grain size from fine to coarse. The aggregate is mainly composed of fragments from metamorphic rocks (gneiss, schist), quartz in single crystals, dolomite, limestone and micas (Figure 3B).

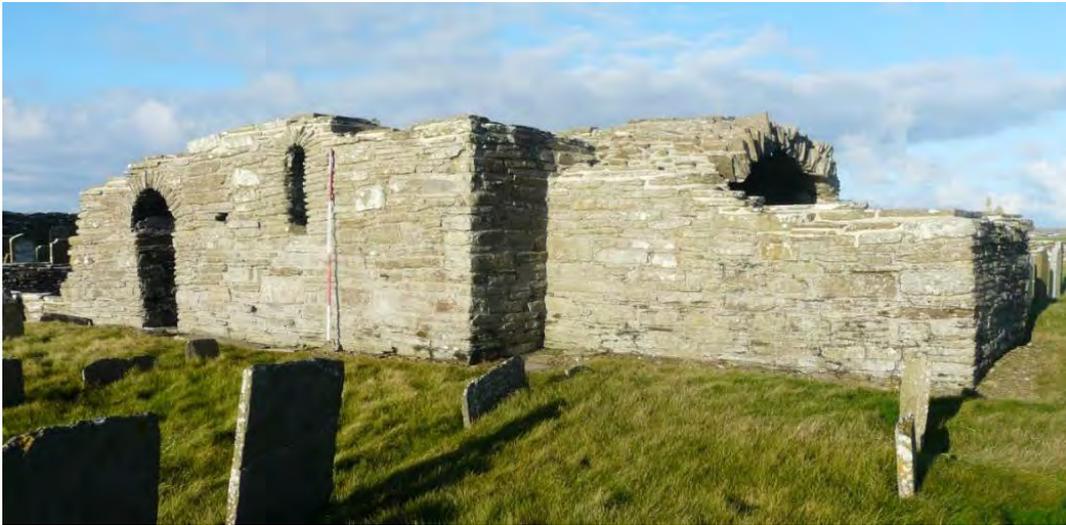
Figure 1a (above) – Crosskirk Tuquoy from the south-east. Note the putlog socket between nave doorway and window. Scale 500mm; photograph Mark Thacker.

The ruinous remains of Cross Kirk present a bicameral architectural form, wherein a smaller narrower chancel (in this case barrel-vaulted) is situated at the east end of a wider but coeval nave (see Figure 1a). This planform is widely distributed at Late Norse sites throughout Scandinavia, Scotland and Ireland, and most of these buildings have been ascribed to the 11th-13th-century on planform alone [1-3]. The multiphase form of the church at Tuquoy, however, has had increased significance for North Atlantic scholars since

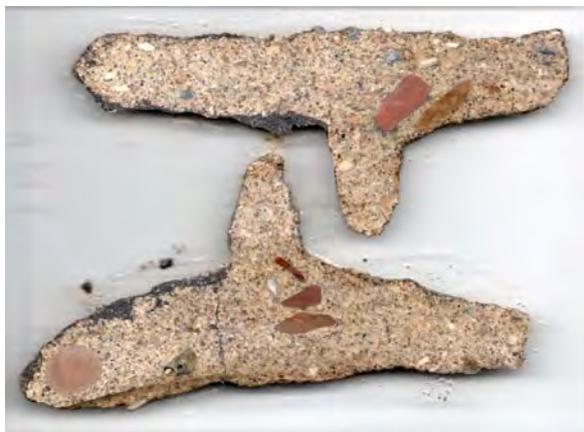
Figure 2a. Thick section mortar Type A x 2. Note: thin mortar ‘tails’ (with coherent rounded ends which may have abutted underlying constructional clay mortar in the masonry joint) and the more planar face of the former mortar surface. Field of view approx. 120mm; Photograph M. Thacker

- **Type A** – A fine, hard and buff-coloured lime mortar included with a high concentration of coralline algae fragments (hereafter *maerl*) which displayed a spectrum of altered colours and textures. These samples generally presented a planar face, with surviving mortar 'tails' on the reverse which had been moulded to the jointing in the face of the underlying rubble wall (see Figure 2a).
- **Type B** – A very lime-rich, fine, soft and white-coloured lime mortar containing a low concentration of discoloured *C. edule* shell fragments with distinctively ribbed morphologies. Also presenting a planar face, with surviving mortar 'tails' on the reverse which had been moulded to the jointing in the face of the underlying rubble wall (see Figure 2b).

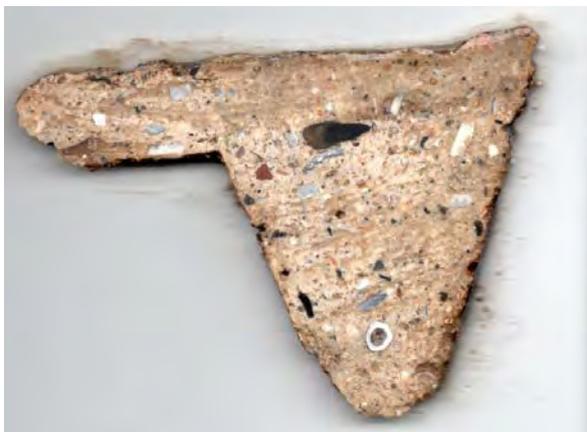
Figure 2b. Thick section mortar Type B. Note very wide mortar tail suggesting much coarser underlying rubble wall; planar face of previous coating surface; high concentration of discoloured bioclasts including probable *maerl* and shell in this particular section. Field of view approx. 100mm; Photograph M. Thacker

The planar surface displayed by many of the mortar fragments within the curated assemblage suggested the collection was dominated by ‘coating’ fragments, which had been deposited in a plastic state upon and/or within the surface of a masonry wall. Moreover, the smooth texture of the moulded tails and other surfaces suggested that these mortar fragments had been in direct contact with bare rubble stone and were not underlain by earlier mortars in these particular wall face contexts. Most of the mortar samples collected during the 1982-3 excavations were found in stratified deposits and labelled by context, and when mortar was found adhering to a wall this was recorded in the sample labelling (O. Owen pers. com.). Indeed, some of the labels associated with the Type A samples characterised above clearly referred to the ‘hall’ building from which they had been removed, and some labels gave a valuable hint of phasing. Type A sample TWO.04, for instance, was described as “plaster from 1 after removing 2”, with Wall 1 referring to the external face of the hall and Wall 2 part of a substantial workshop immediately adjacent. Although also displaying a mortar tail indicating initial deposition within the surface of a masonry wall, the building from which Type B sample TWO.08 had derived was not immediately clear from its label description of ‘shaped plaster’; the lack of reference to a particular building in this instance probably therefore indicating retrieval from a secondary depositional context. Both Type C sample labels clearly indicated they had been removed from the neighbouring Cross Kirk, however, and the lack of mortar tails in these coating fragments was therefore of some interest.

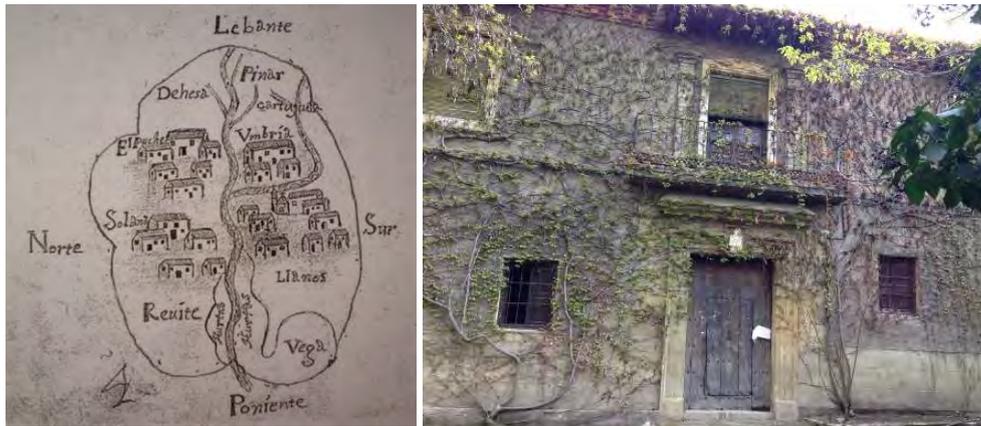
Figure 1. Iconographic representation of the real estate, Catastro de la Ensenada (1752).

Aragoneses is represented. It is a manor house located on an isolated plot surrounded by gardens (Figure 1).

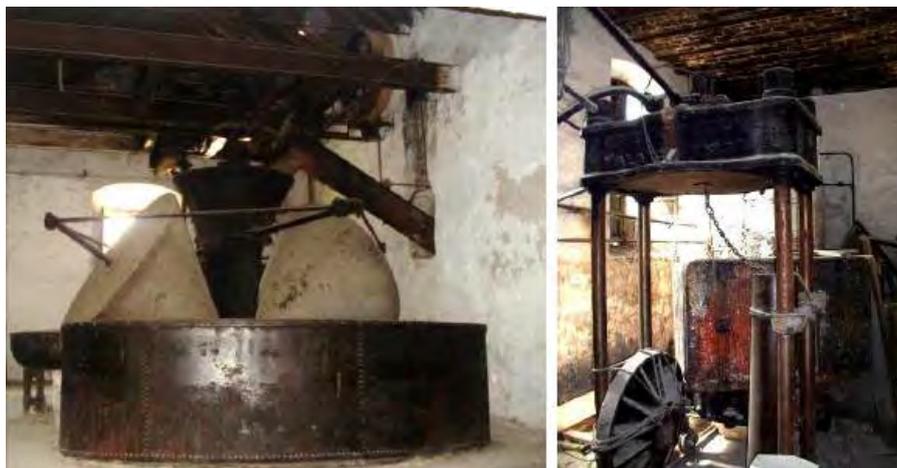
Figure 3. Water mill and presses with steam engine, all of them from 19th century

At the end of the 19th century, the water mill was modernized with an attached double-height room housing new hydraulic presses and a steam engine. They will replace the 18th century ones with “counterbalance tower” and “press beam” function.

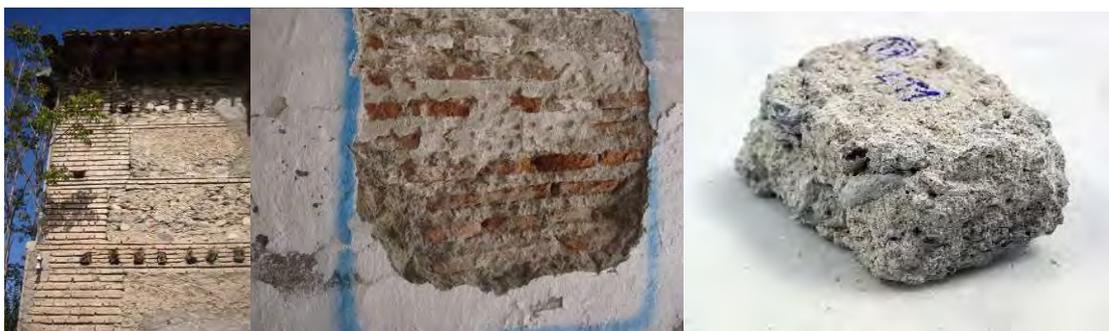
Figure 4. Mixed masonry walls

As it has been described, the building complex is a result of transformations and/ or aggregations over the centuries. This makes it difficult to verify the chronological dating of all the elements. The walls of the building are all mixed brick masonry with lime and pebble square inserts, regardless of the time of construction (Figure 4).

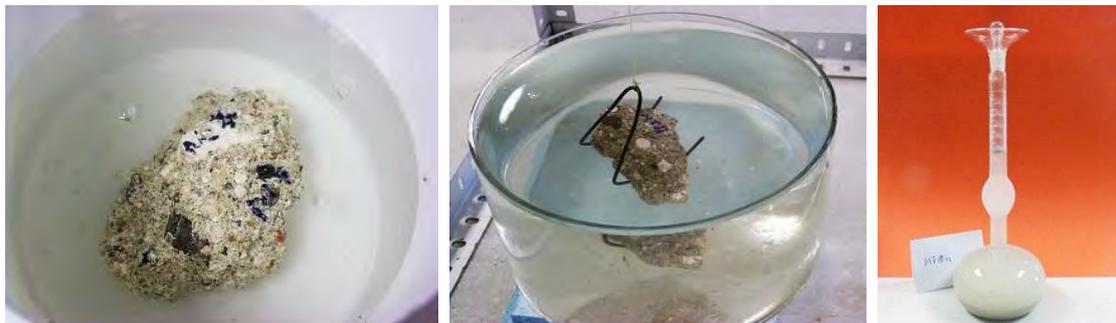
Figure 6. Hydraulic tests on mortars

Hydraulic tests have been carried out to determine the physical properties of mortars (Figure 6).

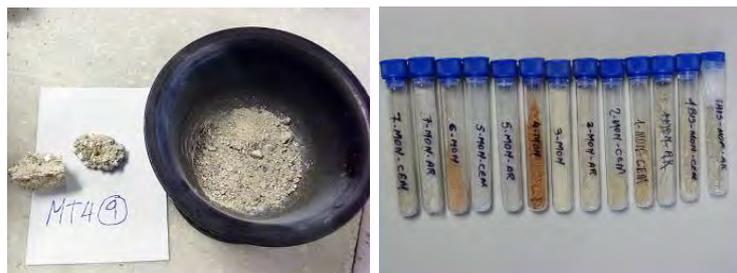
Figure 7. Finely grinded mortar samples for analysis by XRD.

In order to know the crystal structure, an X-ray diffraction (XRD) analysis was carried out with a Bruker D8 Advance powder diffractometer equipped with a high-stability copper-anode X-ray source and a SOL-X energy dispersion detector and large active area for X-ray diffraction (Figure 7).

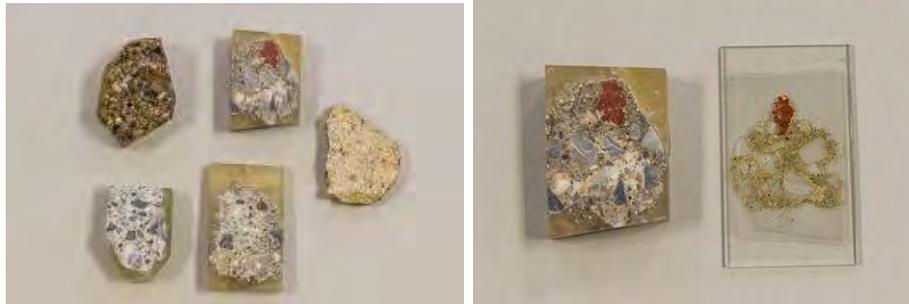
In order to obtain information on the studied samples mineralogy, thin sheets have been prepared for observation by Optical Polarization Microscopy (OPM) with a Kyowa polarized and transmitted light petrographic microscope, mod. BIO-POL (Figure 8).

Figure 8. Polished binder samples up to thin section.

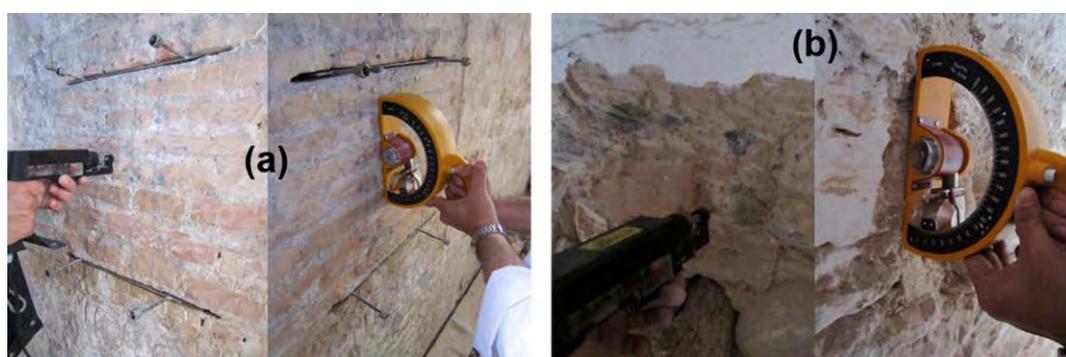
The tests were carried out in areas signed by figure10. In each test multiple repetitions were performed to, as far as possible, reduce the uncertainty of the average value obtained.

Figure 10 Localization of tests on mortars. (a) 19th-20th century construction; (b) 15th century construction remodelled in the 18th century.

As for the mechanical characterization NDTs on the mortar of the masonries under study (penetrometric and sclerometric), the dispersion of the results in the two test zones should be highlighted. Generally, it was found that the 19th-20th century mortar was of better quality than that the 15th-18th century one. In this respect, the correspondence with the

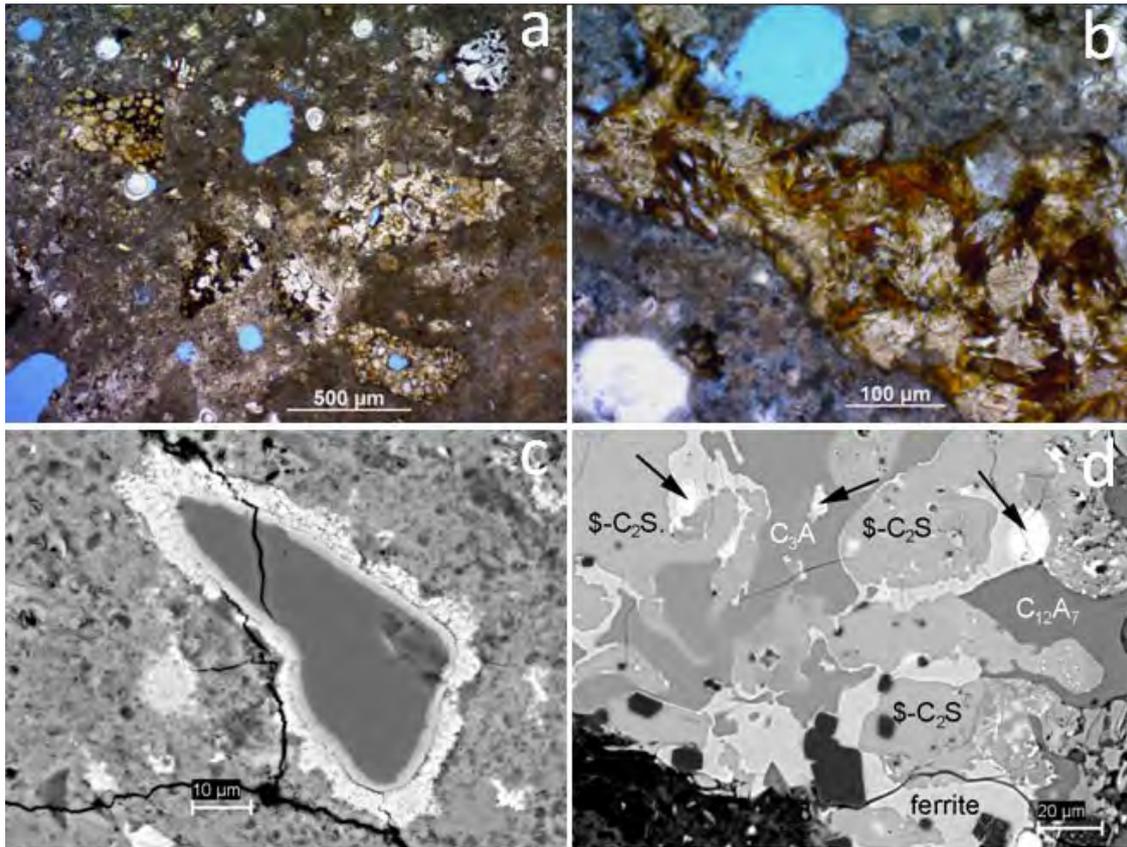
Figure 2 Typical residues in the samples from the 1860s; a: large unhydrated cement grains in a completely carbonated binder (G-1860s, PPL), b: large residue containing C_2S with finger-like extensions into brown ferrite (G-1860s, PPL), c: silica residue with traces of calcium diffusion (outer rim of C_2S ; A-1869, SEM-BSD), d: heterogeneous residue containing different type of sulfur-bearing cement phases (CaS is indicated by arrows). Coarse crystal sizes indicate slow cooling rates (A-1869, SEM-BSD).

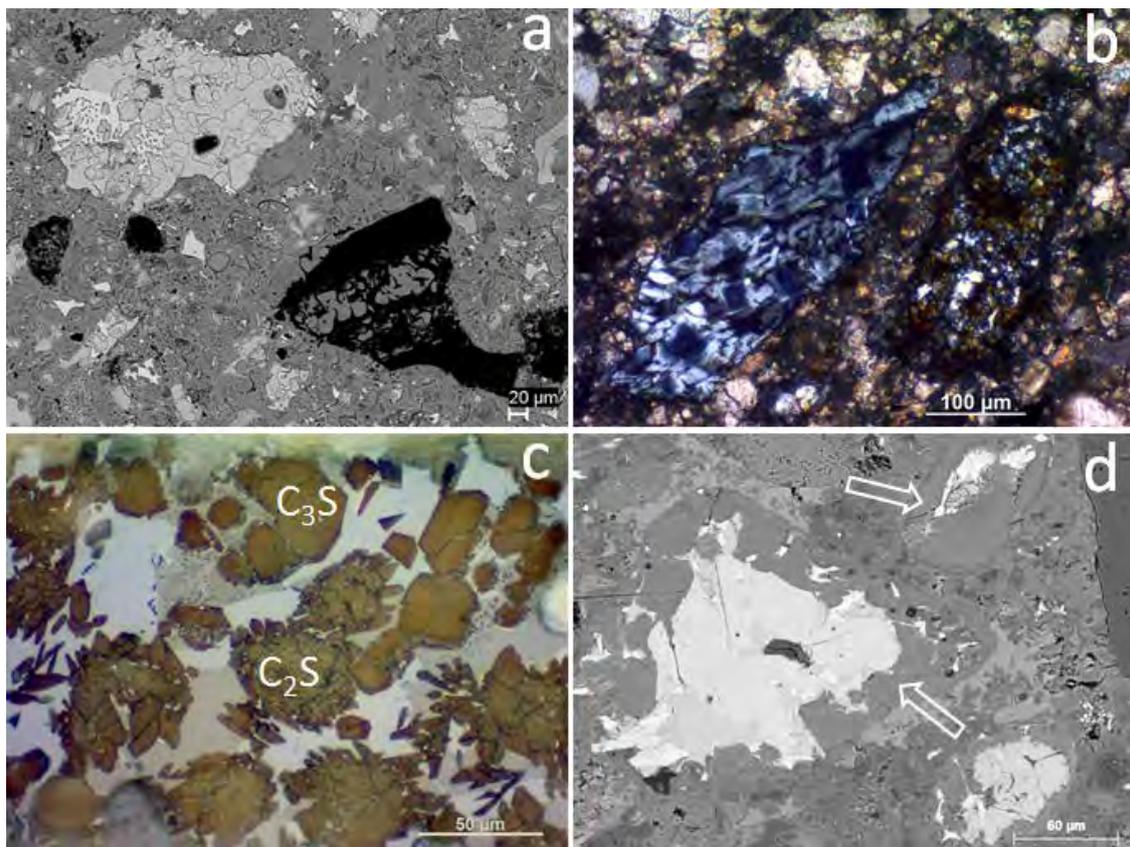
Figure 3 Typical residues in the samples between 1879 and 1900; a: unhydrated cement grains (top left) and brow coal residue from the fuel (black, G-1879, SEM-BSD), b: large residue containing tabular C_2S in a glassy matrix (left) and anhydrous cement (right; A-1893, XPL), c: cement residue with coarse aluminite (grey) and ferrite (white), C_3S (brown angular grains) and dismembered C_2S indicating slow cooling (A-1899, RL, Nital etch), d: cement grains exhibiting thick hydration rims (arrows, CH-1900, SEM-BSD).

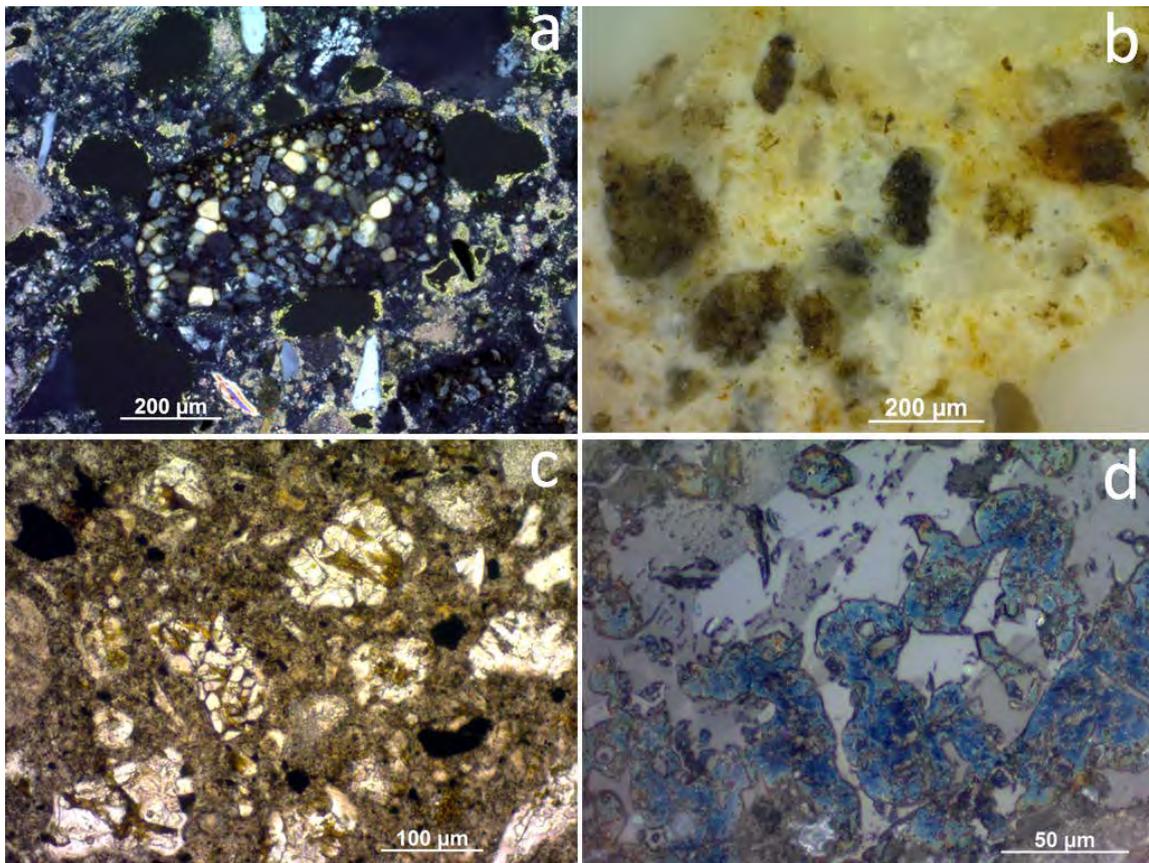
Figure 4 Typical residues in the samples between 1900 and 1908; a: large unhydrated cement grain consisting predominantly of C_2S with few C_3S crystals (A-1903, XPL), b: unhydrated cement grains in sample A-1907 matrix (IL/DF), c: cement residues in a terrazzo sample (H-1908, PPL), d: cement residue with coarse aluminates (grey), prismatic ferrite (white) and partially hydrated C_3S and C_2S (blue; H-1908, RL, Nital etch).

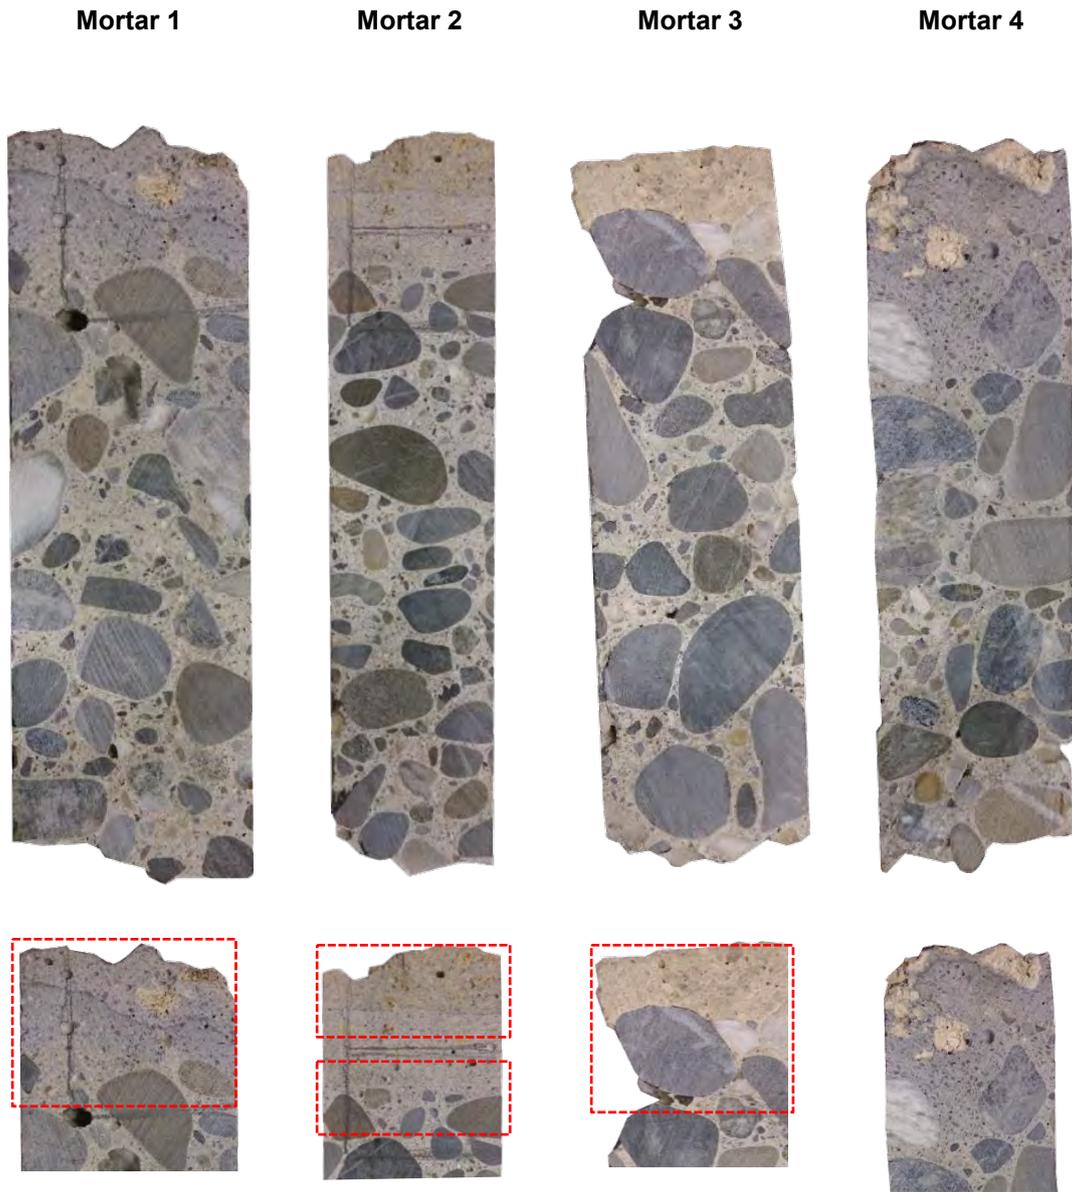
Figure 3. Cross section of samples M1 to M4

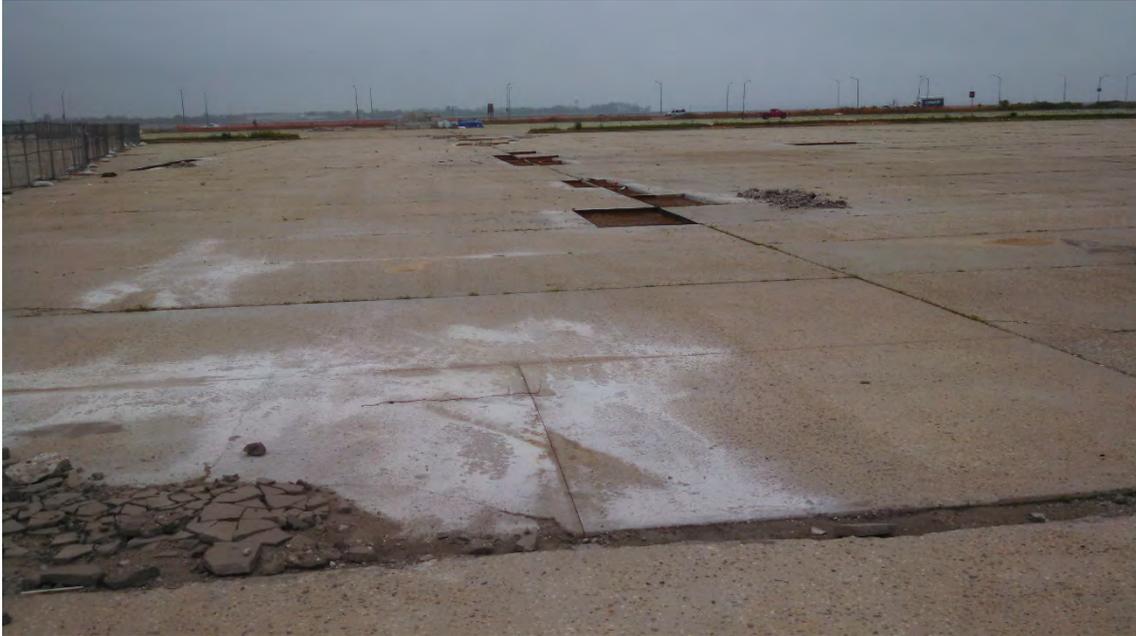
Figure 3. Typical damaged pavement areas, resulting from placement and removal of Hurricane Sandy debris.
Photo by the author, 2014.

In the wake of Hurricane Sandy in October, 2012, debris from the devastated adjacent community of Breezy Point, New York was deposited on Jacob Riis Park's concrete parking field by the US Federal Emergency Management Agency (FEMA). Damage to the pavement resulted from both the debris-handling operations and the direct impact of the storm itself. Repairs to the historic concrete specified by the US Army of Corps of Engineers (USACE) were to utilize concrete based on natural cement which conformed to the requirements of ASTM C10 to match the original pavement. At the same time, USACE performance requirements specified a minimum compressive strength of 31 MPa at 28 days, well beyond the typical properties of natural cement.

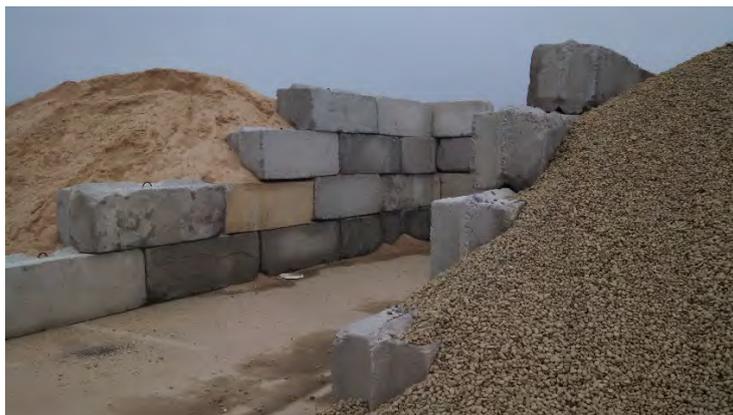
All concrete mixing was performed on site using a Zim mobile volumetric mixer. Aggregates were delivered to the site in bulk and were stored in separate piles (Figure 4). The blend of cements and pigments was delivered in supersacks with polyethylene pallet covers (Figure 5) and were stored on site under an impermeable tarp.

Figure 4. Onsite storage of fine and coarse aggregates. Photo by the author.

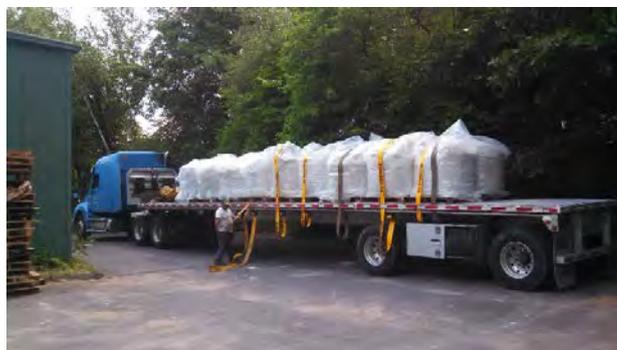
Figure 5. A truckload of pigmented Natural/Roman/Portland cement supersacks departs the Edison Coatings factory for delivery to Riis Park. Photo by the author.

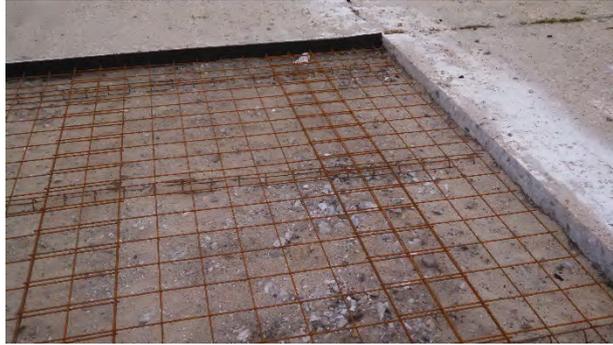
Figure 6. Typical prepared repair area, with welded wire mesh placed for reinforcement. Photo by the author.

Repair areas were sawcut and welded wire mesh was placed for reinforcement (Figure 6). Following placement, repairs were moist-cured for several days. Typical completed repairs are shown in Figure 7.

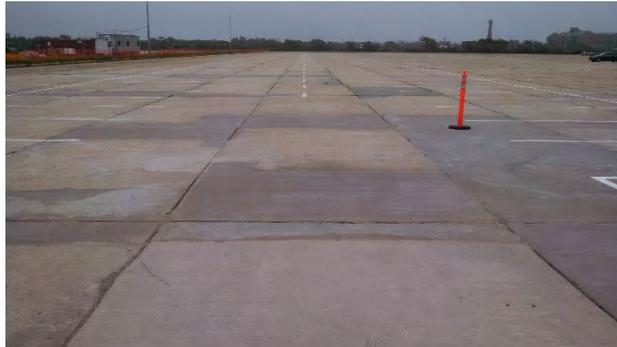
Figure 7. Typical completed Repairs. Photo by the author.

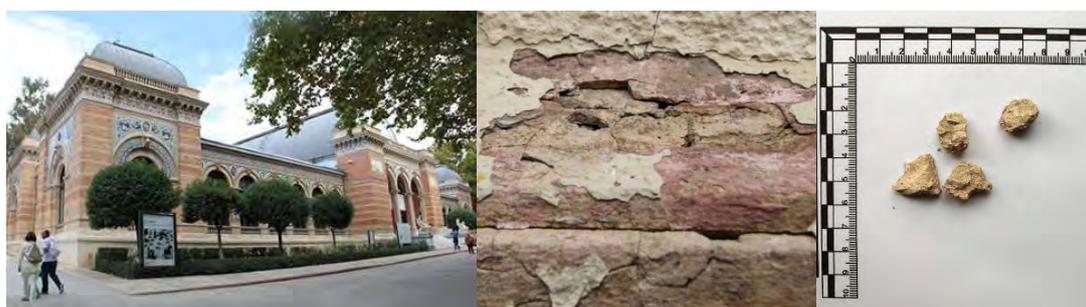
Figure 5. Main facade of the Velazquez Palace. Detail of the run profile decoration where the sample was taken.

In this case it is confirmed the use of natural cement on the facade decorations. With the use of petrographic microscope we can observe the characteristic lumps of over fired, well fired and under fired marls, typical of this kind of cement. This and the lack of alite crystals in the incompletely hydrated grains of cement confirm the use of natural cement in this building.

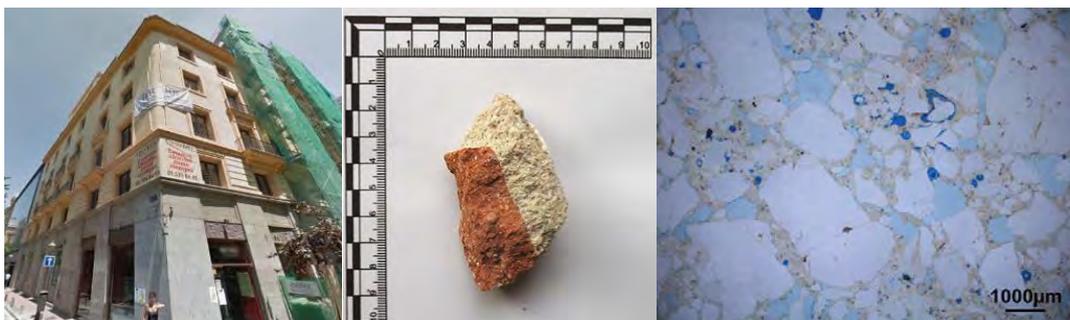
Figure 8. Facade of the building. Thin section photomicrograph. Incident light. Absence of lumps of calcined marls.

A sample was taken from the render of an interior patio. In this case Portland cement was used for the mortar. It can be seen clearly with a petrographic microscope the presence of non-hydrated belite and alite crystals (Figure 8 and 9) and the absence of lumps of calcined marls (Figure 7).

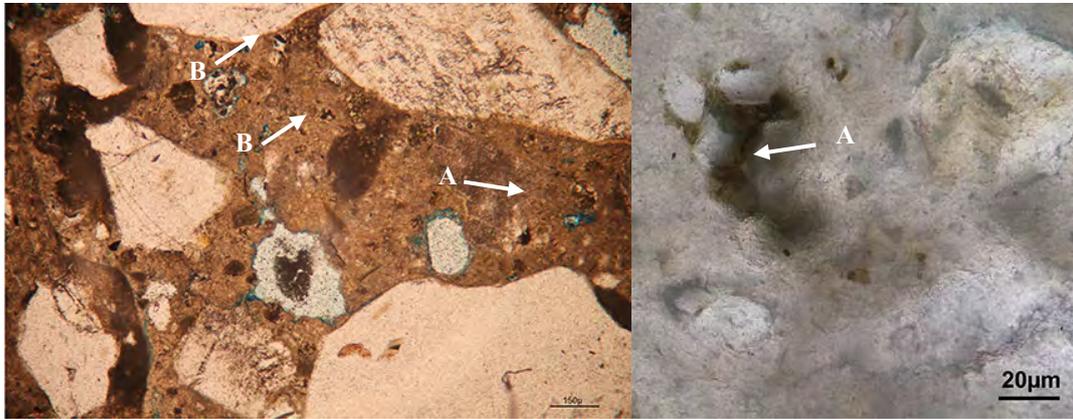
Figure 9. Thin section photomicrograph. Trasmited light. Detail of unhidrated belite (B) and alite (A) crystals.

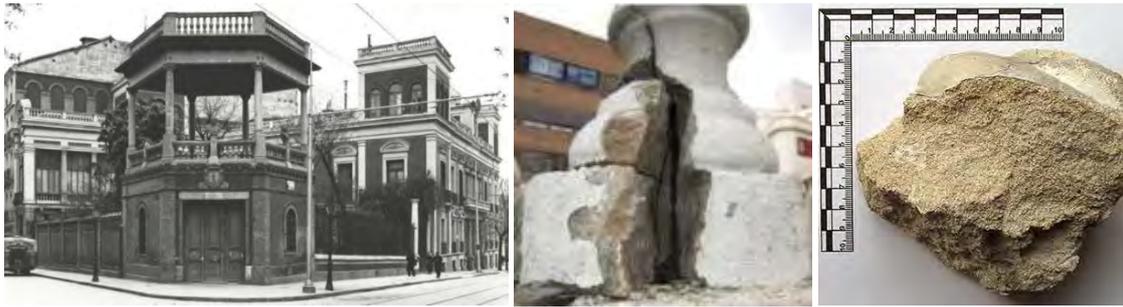
Figure 14.: Exterior view of the Cerralbo Palace. Garden pavilion. Detail of the damage of the balustrades of artificial stone.

The sample was taken from one of the balustrades of the garden pavilion. The sample have a light brownish "natural cement" typical color.

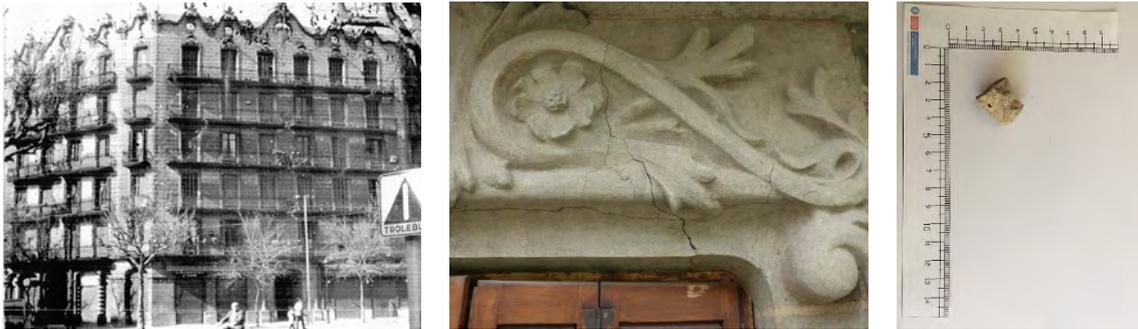
Figure 16. Facade photography of the building in 1959. Detail of the ornamental elements of the Villarroel street facade. Sample detail.

A sample is taken of one of these ornamental elements. The mortar presents a light brownish natural cement typical color. We can also see lumps of calcined marls with unhydrated belite crystals inside in the petrographic microscope. This and the absence of alite crystals or lime nodes in the mortar indicate that is a natural cement.

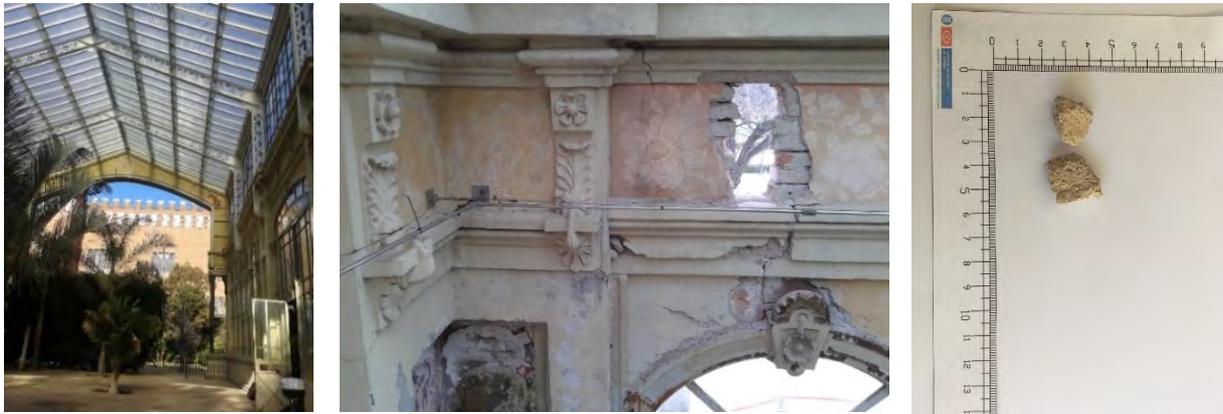
Figure 19. Indoor photographs of the greenhouse. Detail of the artificial stone decorations. Sample detail

A sample is taken in one of these decorative cash elements. In the optical microscope we can see the light brownish color of the sample and the presence of lumps of calcined marls with unhydrated belite crystals inside that indicate that is a natural cement.

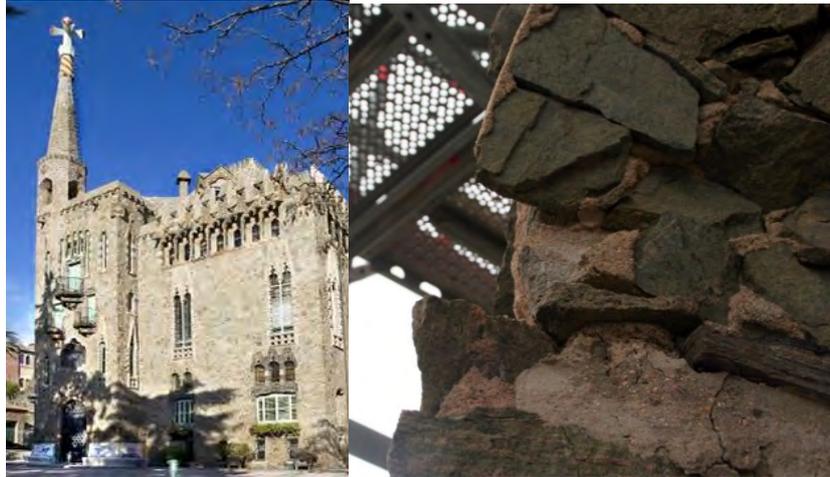
Figure 22. Fasade of Bellesguard tower and a detail of the masonry of the tower needle.

A sample is taken of the masonry mortar of the tower needle. The mortar has the characteristic brownish natural cement color. But if we analyze it closer in the petrographic microscope, we can see a completely different structure than in a natural cement sample. This characteristic color is due to the presence of ceramic fragments in the arid of the mortar that give it the hydraulic properties. This, and the presence of calcite nodules, which are currently carbonated, confirm that is a lime mortar.

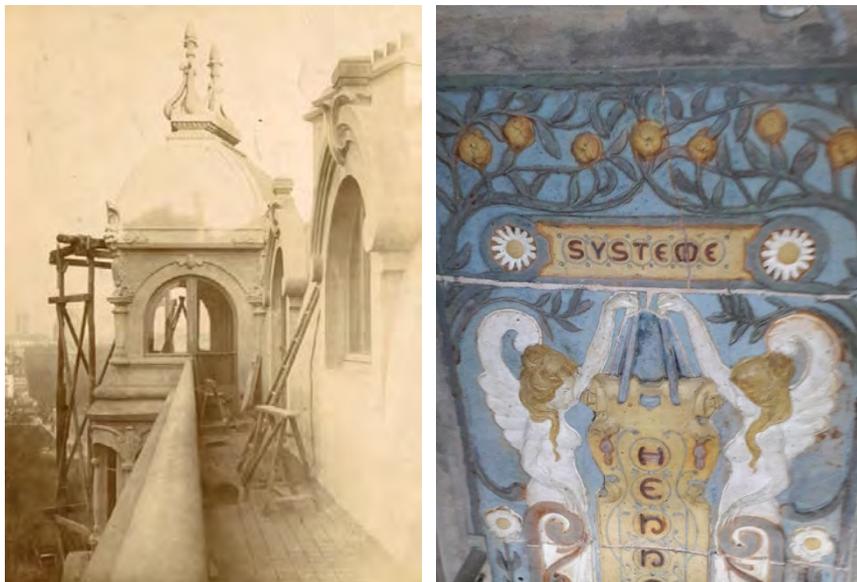
Figure 2. Art Nouveau style façade ornaments. a) Cast cement elements [7][8], b) Flamed stoneware from Alexandre Bigot.

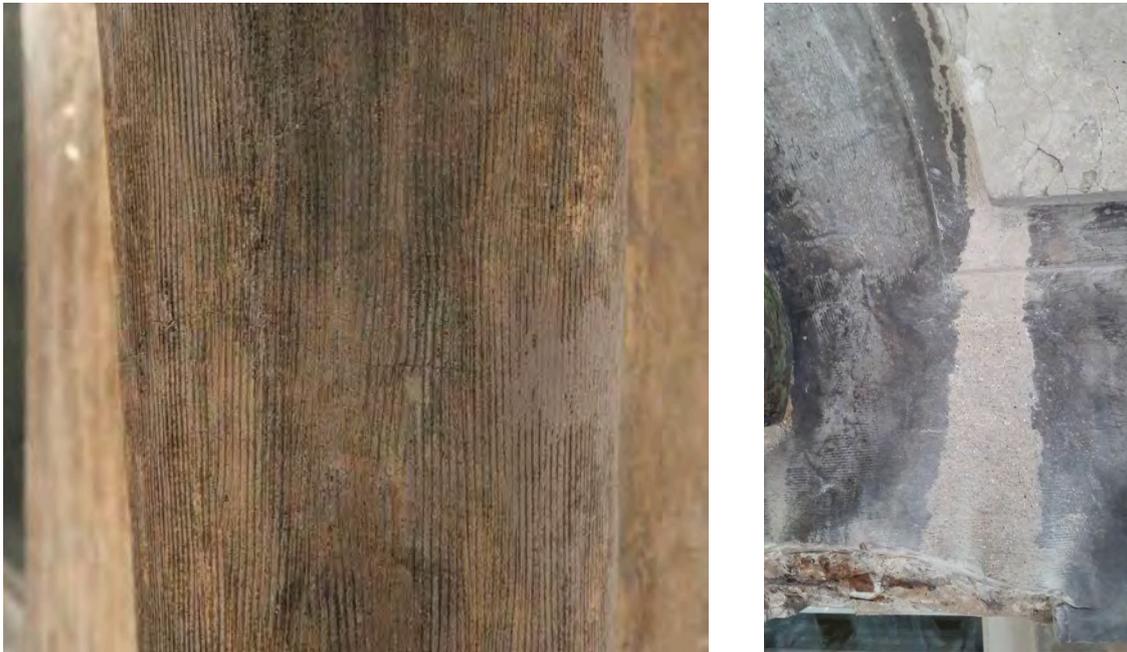
Figure 4. Detailed view of the façades. a) Chiselled finishing, b) Black crust under the paint.
