Proceedings of the 5th Historic Mortars Conference

5th Historic Mortars Conference

19-21 June 2019
Pamplona, Spain

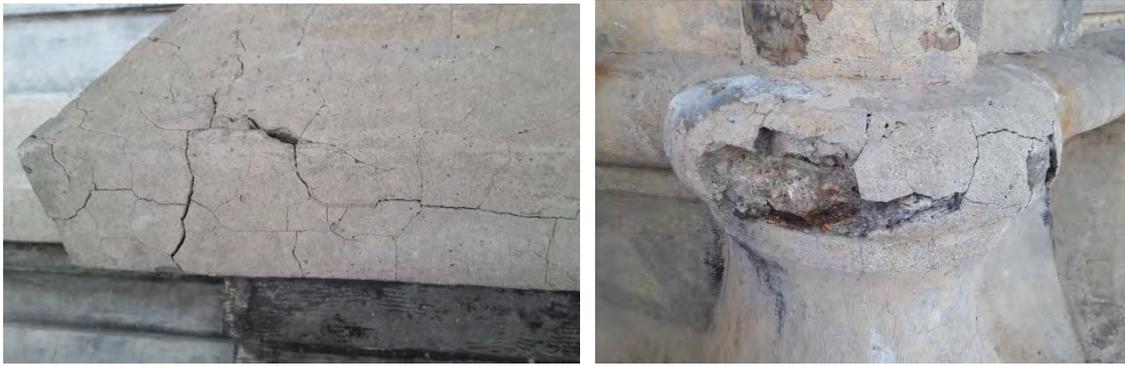
When the paint removal operation was finished, incredibly detailed finishing of the concrete emerged with light tool marks (Figure 4a) and a mixture of ochre and grey concretes. Locally serious cracking (Figure 5a and 6a), but also thick black crusts (Figure 4b), and spalls (Figure 5b and 6b) more massive than expected could be observed. It was also noticed that the structural elements were made of greyish concrete, while the finishing renders and the ornaments were made of ochre mortars.

Figure 5. Detailed view of the façades. a) Shrinkage cracks of the natural cement mortars, b) Spall revealing a highly corroded rebar.

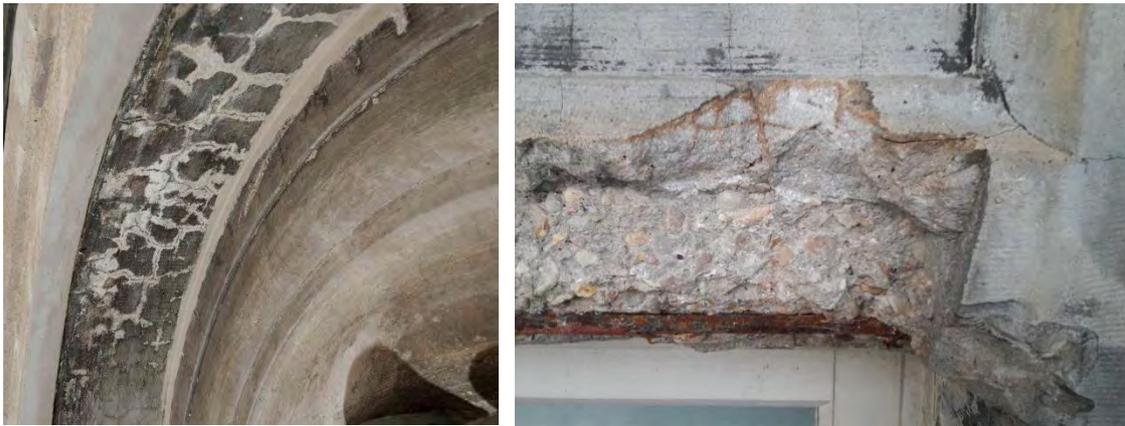
Figure 6. Detailed view of the façades. a) Shrinkage cracks of the natural cement mortars, b) Spall revealing a highly corroded rebar.

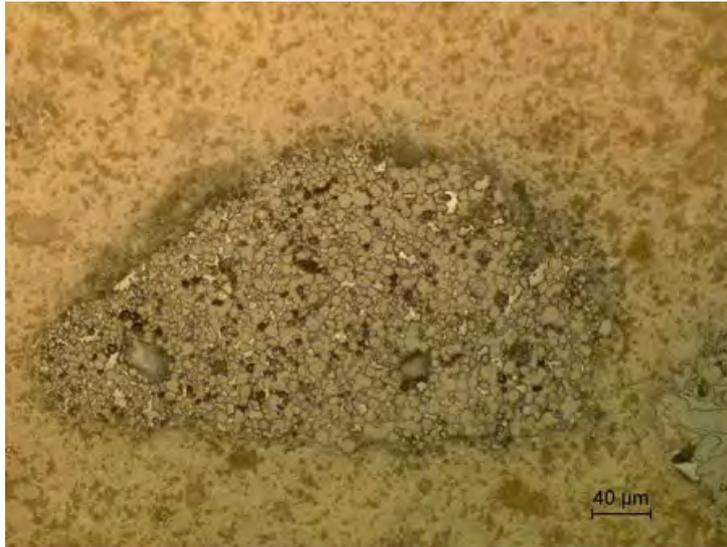
Figure 11. Large well crystallized clinker grain filled with small round beige C2S. Optical microscope view (G=X20) of the ochre render.

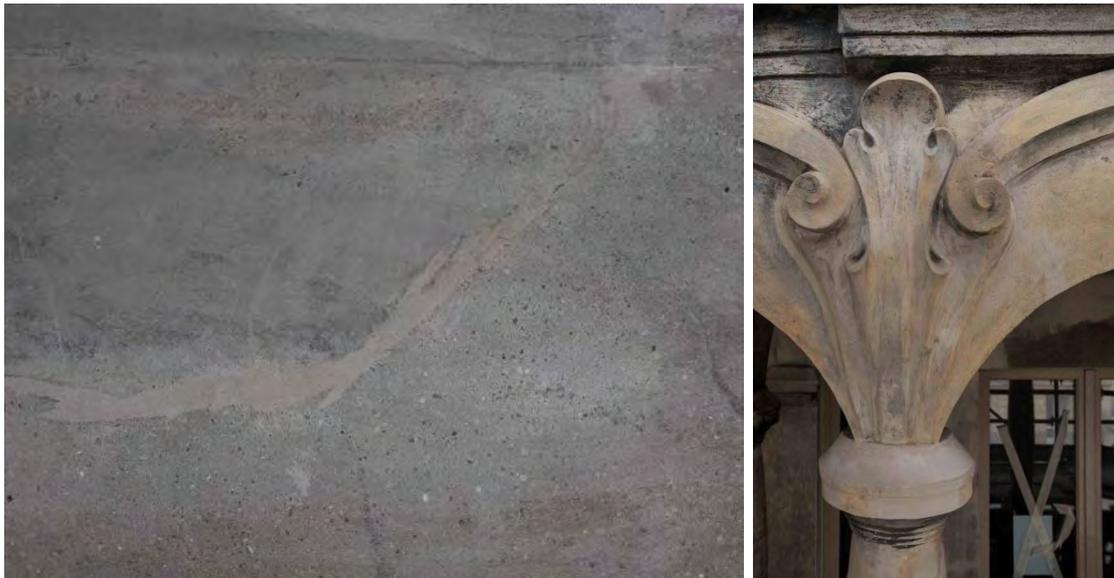
Figure 15. Cracks and spalls were repaired using slurries and natural cement-based mortars. Picture by Dominique Bouchardon

But there was still a need for waterproofing of the façades. As a consequence, the final restoration protocol did include the repair of the cracks and spalls with natural cement-based slurries and mortars (Fig. 15), and the application of a 3 layered water-based polyurethane coating, specifically designed to be sulphate-resistant and able to bridge the active cracks.

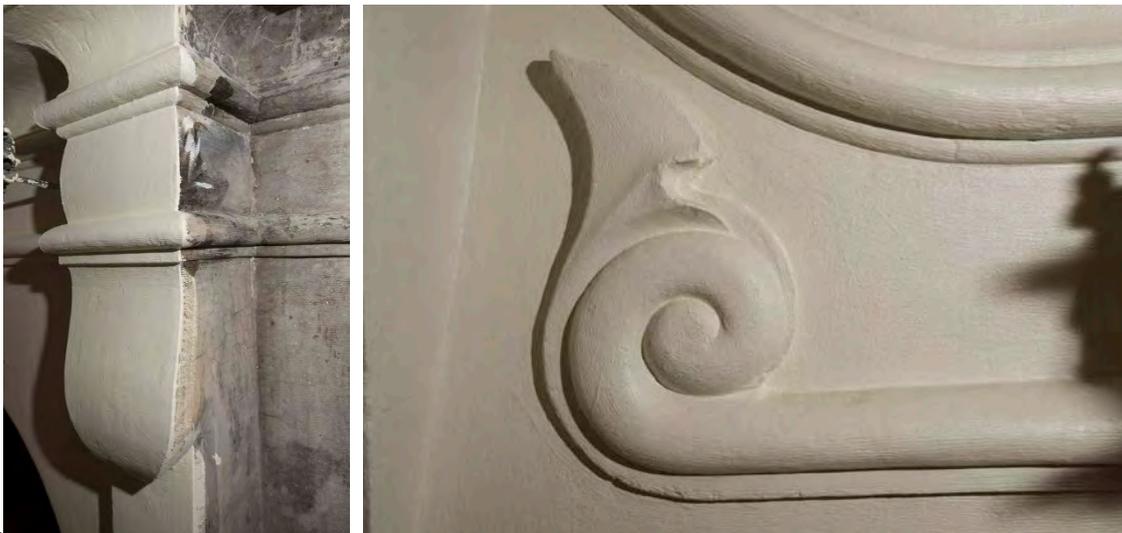
Figure 16. The water-based polyurethane coating dedicated to preserving the concrete unfortunately did mask the incredibly detailed surface of the façade. Picture by Dominique Bouchardon.

Unfortunately, the splendid grey and ochre shades of the façades, and the incredibly detailed handmade tool marks disappeared under the coating (Fig. 16). But without such a treatment, they might also have disappeared due to spalling and cracking. So, as the paint is removable, it is to be hoped that new treatments will allow conservation of both the material and the aspect in the future.

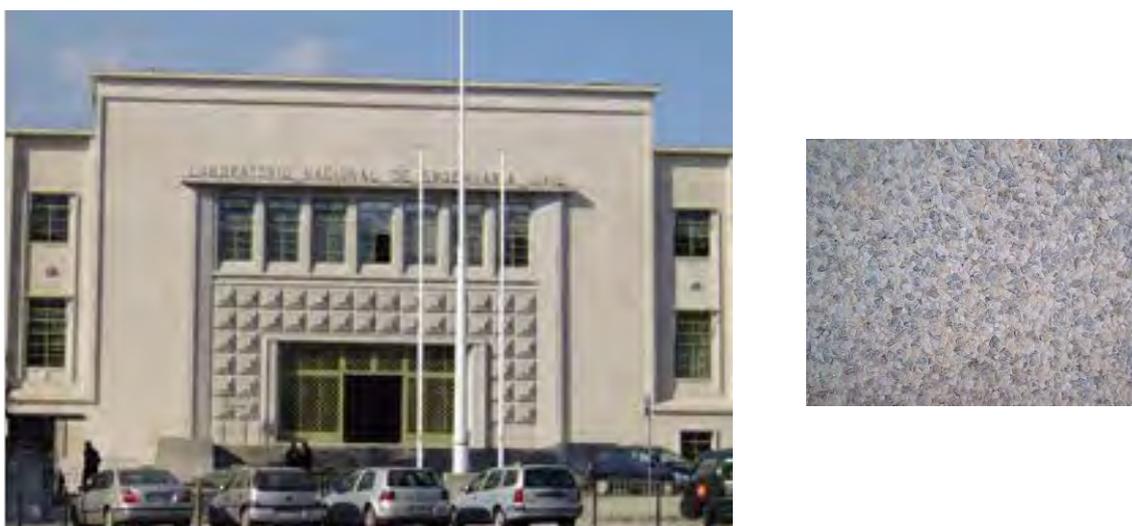
Figure 1 – Façade of LNEC main building covered with *marmorite* render: a) General view; b) Detail of *marmorite*

These *marmorite* renders were used both in public buildings of some importance, such as Lisbon University (1961) and National Laboratory for Civil Engineering – LNEC (1952) (Figure 1), and in housing urban buildings of the same period for medium and medium-high classes (Figures 2 and 3). They have also been used to retrofit older housing urban buildings, some for rent.

In Institutional buildings, neutral colours were used (combinations of grey and cream colours) (Figure 1), while in housing buildings several colours, such as red-pink, green and yellow, were adopted by adding inorganic pigments to the binder and choosing marble and limestone aggregates of matching colorations (Figures 2-3).

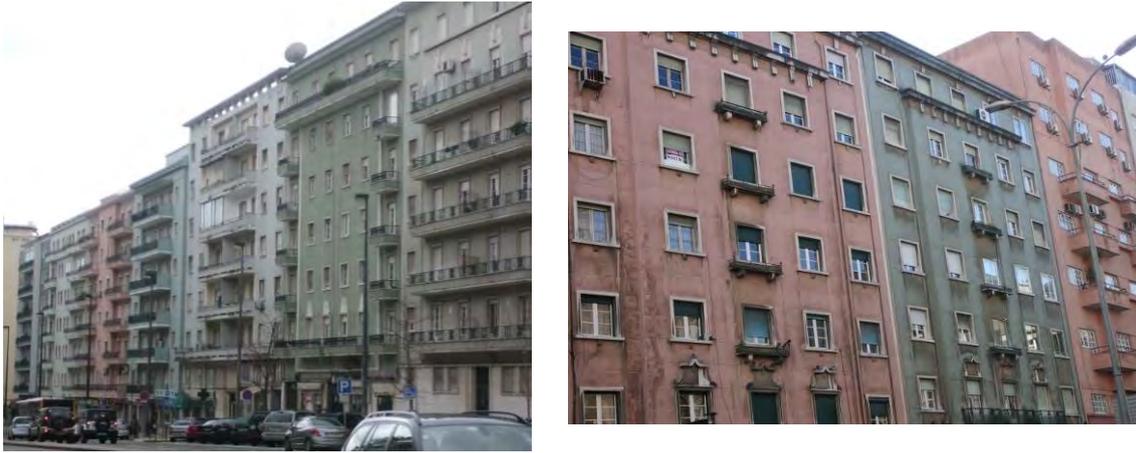
Figure 2 – Façades covered with colourful *marmorite* renders of Av. De Roma, Lisbon

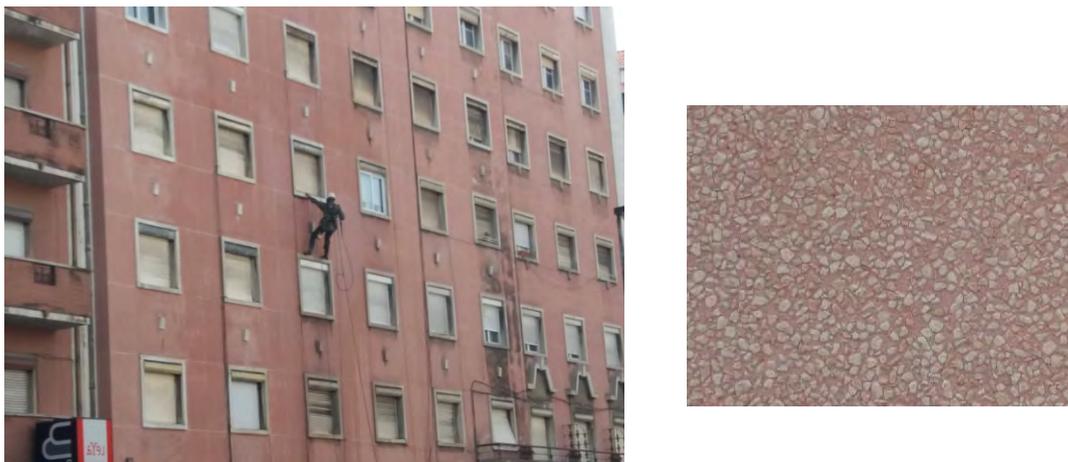
Figure 3 – Pink-red traditional *marmorite* render in Lisbon: a) General view during cleaning; b) Detail of red/pink *marmorite*

Being a very durable kind of render, after more than 5 decades, they show few anomalies, such as some cracks, stains and fungi and punctual erosion and lacunae (Figure 3).

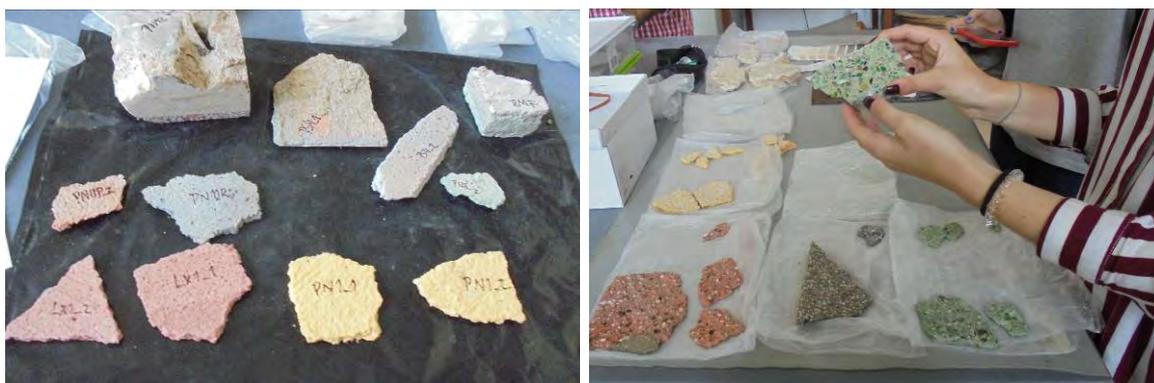
Figure 5. Samples of differently coloured *marmorites* collected

Samples of *marmorite* renders were collected in the districts of Lisbon, Santarém and Setúbal (within the region marked by the red circle in the map of Portugal mainland - Figure 4), in LNEC's main building, located in a heavy car and plane traffic, and in housing buildings mainly of the decades 1950-1960, with different colours. It should be noticed that the collection of samples was generally only allowed by the owners in the case of renders with anomalies and in limited quantity and dimensions. Such low quantities permitted chemical, mineralogical and microstructural tests, but in many cases were not enough for physical and mechanical testing (Figure 5).

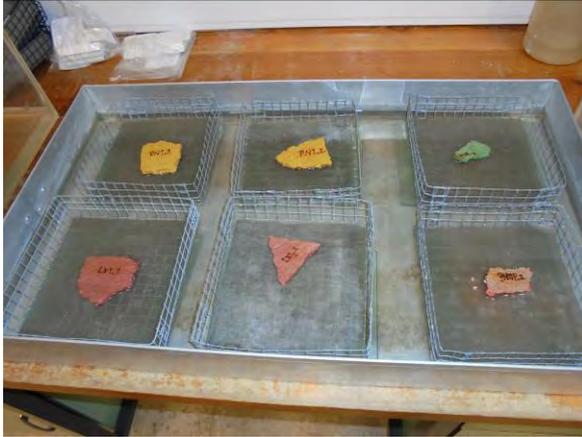
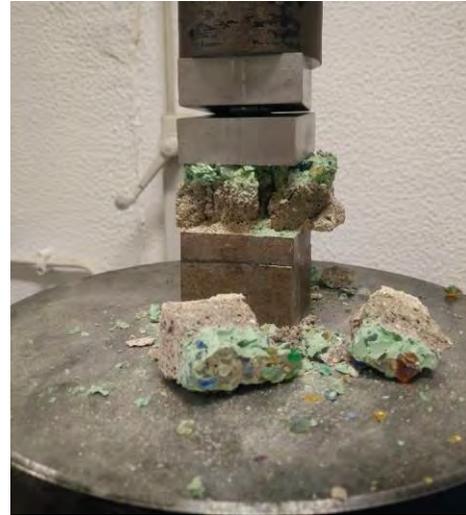
Figure 6. Physical and mechanical testing: a) Water absorption by capillarity; b) Compressive strength

- Open porosity by the method of hydrostatic weighing based on EN 1936 [9];
- Mercury intrusion porosimetry (only one case);
- Water absorption by capillarity by a method based on EN 15801 [10] and adapted for irregular samples [11] (Figure 6 a);

- Compressive strength using a method based on EN 1015-11 [12] and adapted for irregular samples [11] (Figure 6 b), using a Hoytom S.L., model HM-S equipment, with load cells of 200 kN and 2 kN.

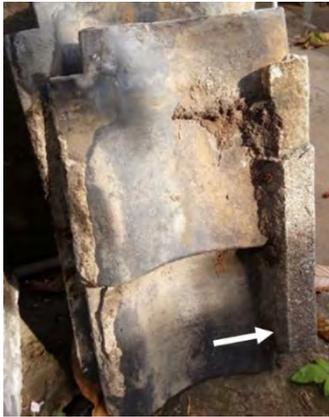
Figure 1a. The old Japanese roof-tiles with cement

Unfortunately, due to the lack of research and knowledge of craftsmanship specialization, it was discovered in recent cases of Taiwan that cement was used to repair the Japanese-roof-tile to achieve wind protection [8]. As a result, Japanese roof-tiles are damaged and must be discarded without being repurposed. (Figure 1a) Cement-based mortars contain high stiffness and mechanical strength, while low in water vapor permeability and production of soluble salts. Due to these reasons, mortars have been disapproved for application in the conservation of cultural heritage [9]. Numerous studies on the adequacy to be used in historical building have established that lime mortars are more suitable for conservation of old building compared to cement. These studies include the analysis of mechanical strength and physical and mechanical characteristics of different types of lime mortar and other additives that are used in historical buildings [10]. Most of these studies discuss the compressive strength and tensile strength of lime mortars, while a few discuss the adhesion strength of lime mortar and the background materials in restoration for historic monument, mainly for wall [11-12] or stone adhesion [13]. However, the adhesion strength of the lime mortar to roof-tiles has not been explored to ensure its wind resistance. It has also yet been discussed whether the application of lime mortar to roof-tile requires the ability to be removed from substrate without damage, in order for roof-tiles to be repurposed.

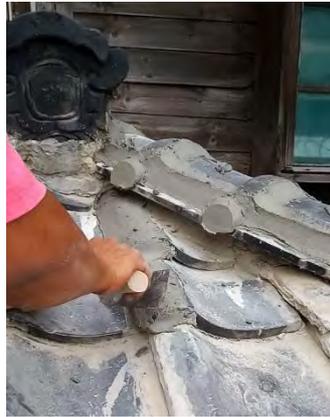
Figure 1b. Plastering the lime mortar on old Japanese roof-tiles

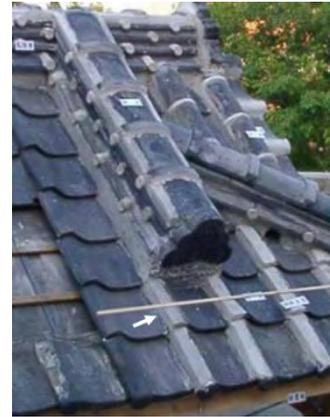
Figure 1c. The old Japanese roof-tiles with lime mortar [22]

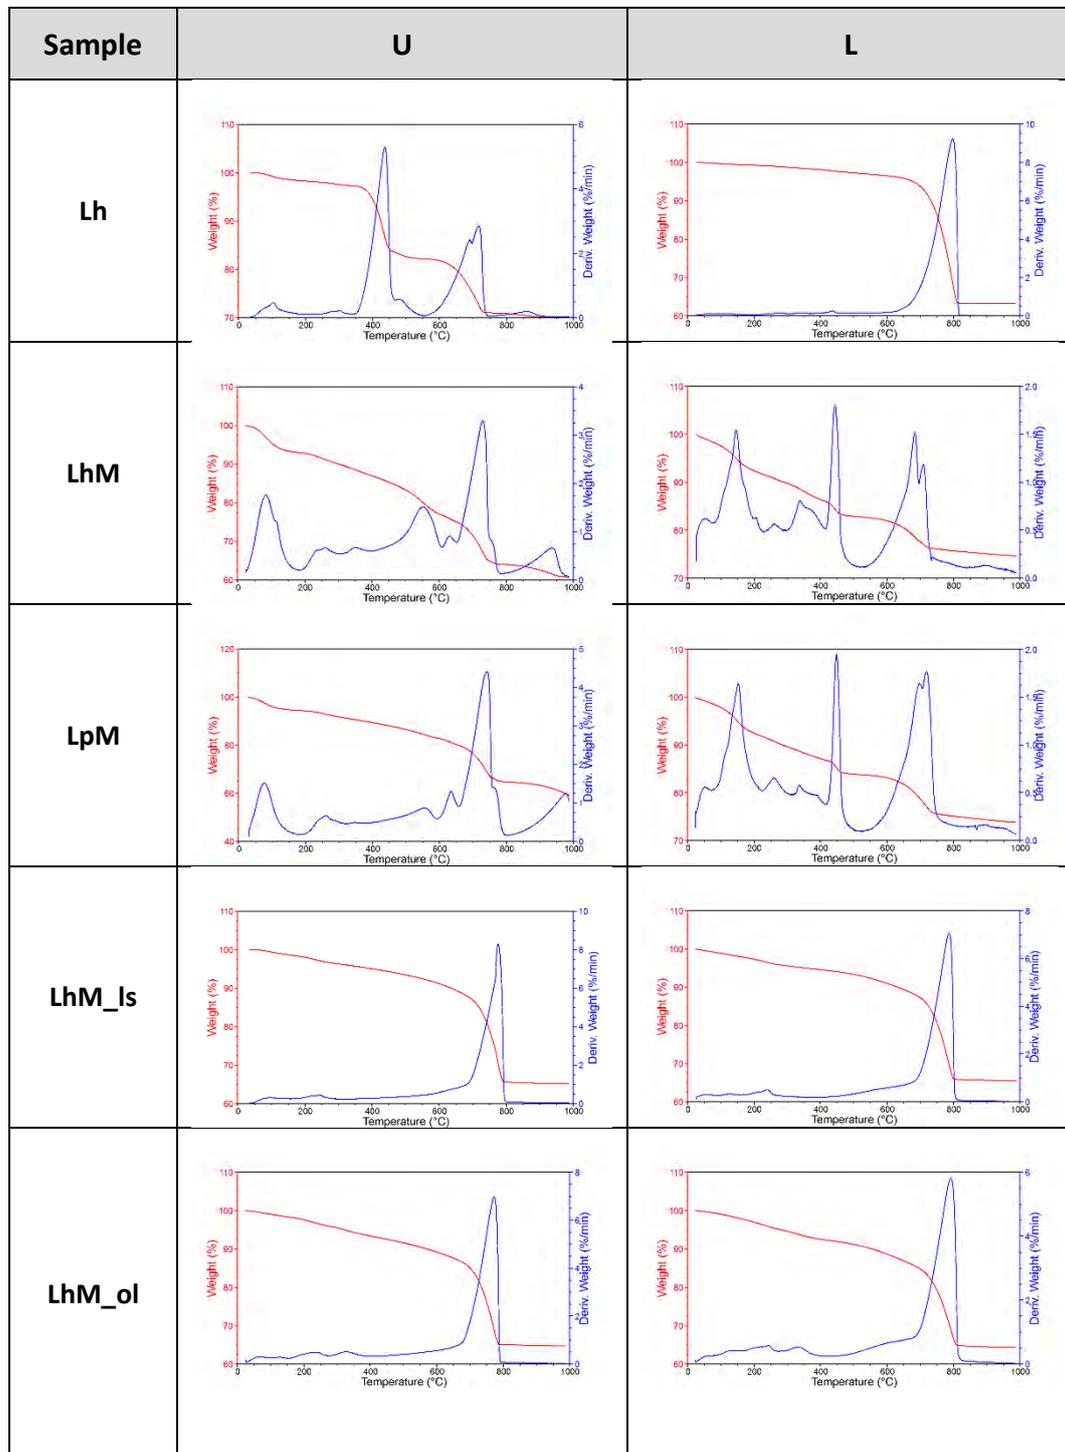
Figure 5. TGA/DTG (red/blue) curves of the binder fraction of samples extracted from upper (U-left) and lower (L-right) parts of the experimental wall.

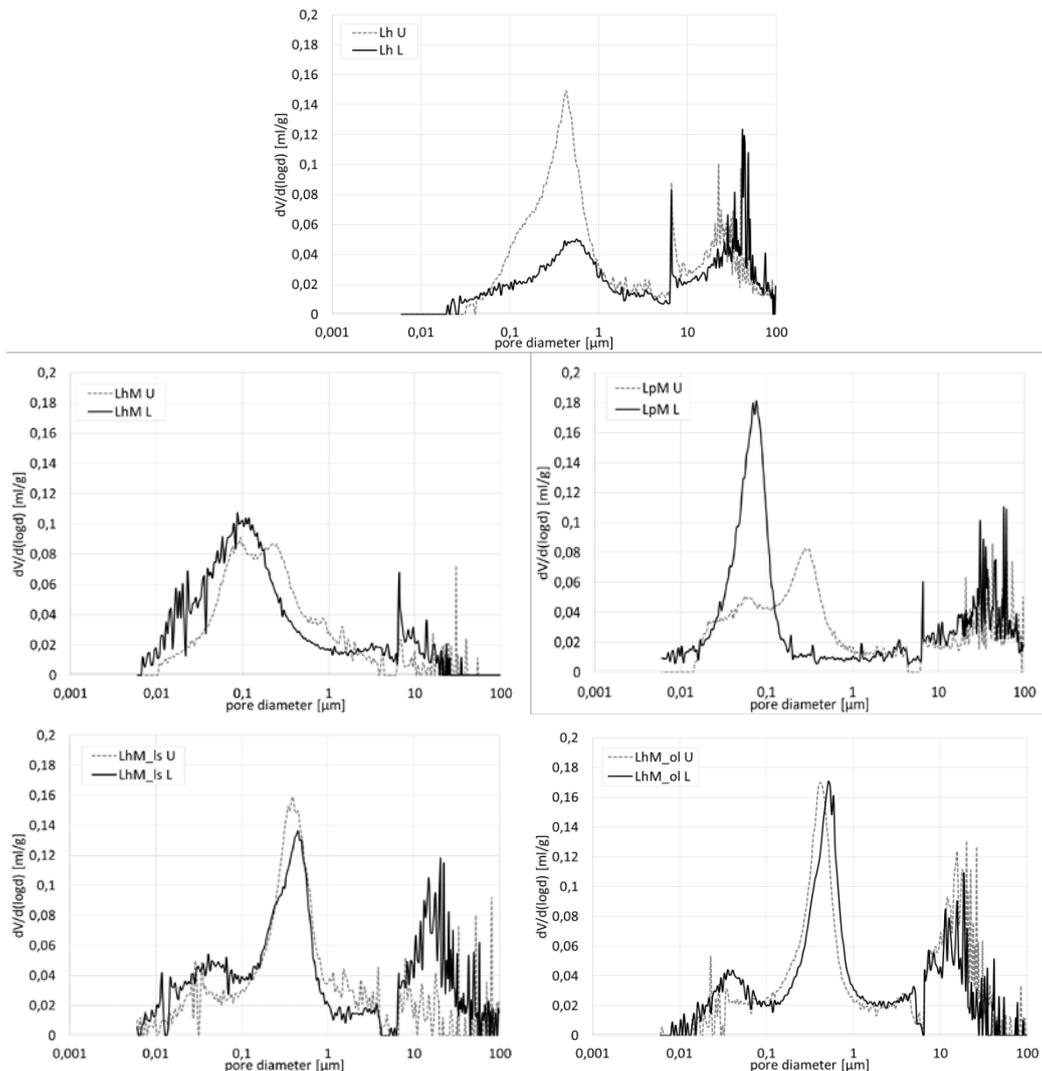
Figure 6. Pore size distribution curves for mortars taken from the upper and lower parts of the wall.

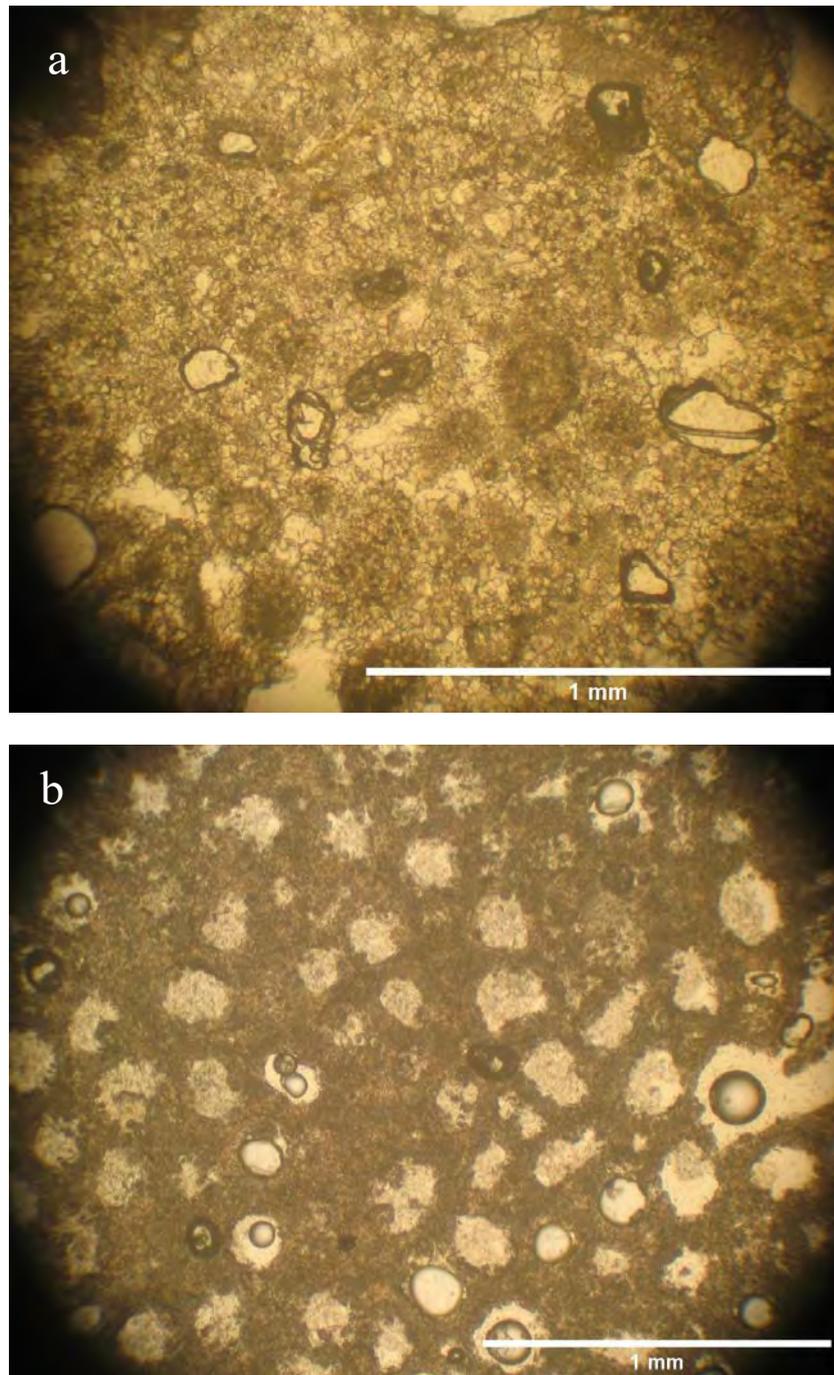
Figure 1. Optical microscope images of (a) crystalline oolitic dolostone and (b) part-burned dolostone showing oomoldic porosity.

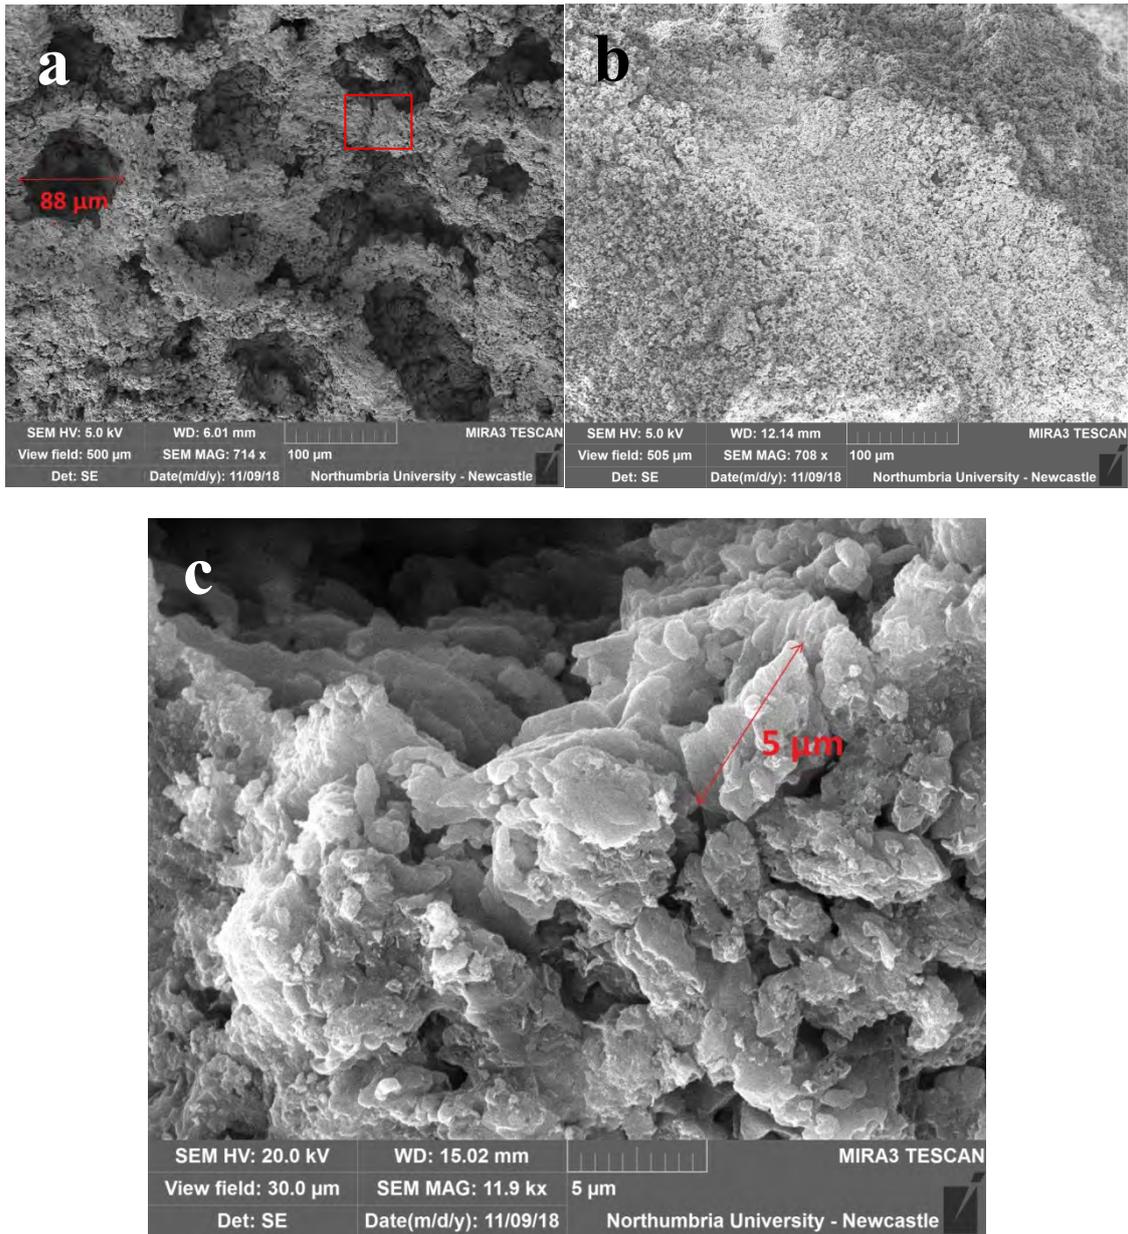
Figure 2. SEM photomicrograph of broken surface of a hard lump contained in the mortar.

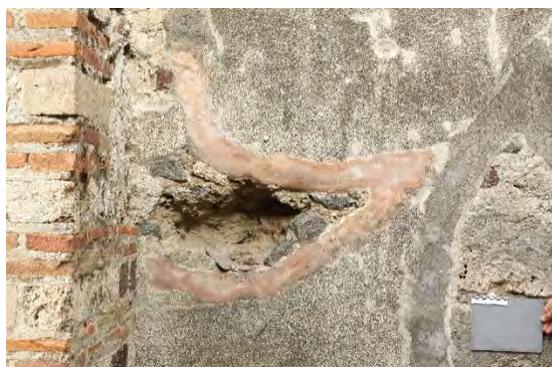
Figure 1. Reddish repair mortar No. 2002 in the Casa del Labirinto. (Fraunhofer IBP, 2017)

The history of repair mortars usually receives little attention. As a result, traces of previous restorations are often removed without documentation or justification. But this lies in the nature of things, because any intervention is aimed at maintaining or optimising the existing condition. Thus each generation of “conservators” tries to meet this challenge in its own way, leaving behind its own ideas and notions. In order to assess how successful historical measures to preserve cultural heritage have been, we need to look at these traces. The prerequisite for tracing a good overall picture is to find places that have always been open to international discussion and have a long history of conservation. The ancient city of Pompeii meets these requirements and, if we consider the archaeological site as an exposure laboratory for earlier conservation materials, its significance for this study becomes apparent. Since its first excavation in the 17th century, the preservation of Pompeii represents a special challenge [2], not least because of its extension. This, along with its “completeness”, makes ancient Pompeii special. Since restoration measures were carried out in different areas of the site at different times, a history of repair mortars has become legible. These historic tracks can be followed. To find answers to the question of how successful and durable the conservation materials actually are, a chronological classification is required. We solved this problem through extensive archive research and by comparing excavation reports, historical photographs and paintings with the on-site situation. However, this also restricts the applicability of the method, because it can only be used on “visible” mortars. Grouting material, for example, can only be dated indirectly. Be that as it may, this approach allows to identify correlations between used materials and durability as well as to classify the restoration measures over time. Moreover, the advantage of this classification method is that it is non-destructive. In the second step, the investigation focuses primarily on edge repairs, because these had noticeably changed their materiality over time, as well as their form, shape and surface structure. This type of mortar secures the edges of wall paintings and plasters so that no large quantity of water can penetrate into the structure, which can lead to deformations thus causing loss of substance (Figure 1).

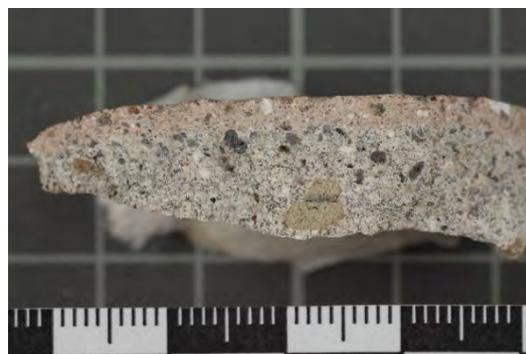
Figure 2. Cross-section of No. 2002, composed of a preparatory and a top layer. (Fraunhofer IBP, 2017)

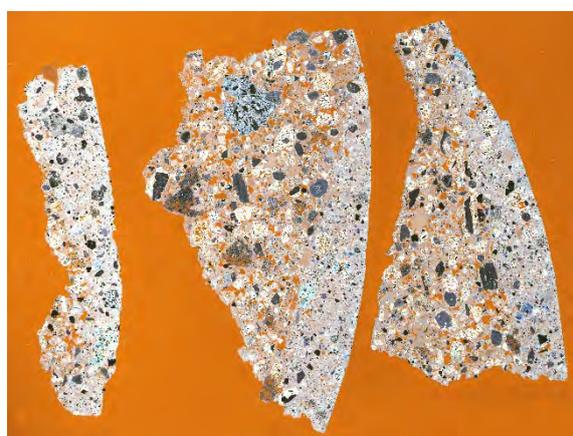
Figure 7. Thin sections inverted 2002_1/2/3. (Fraunhofer IBP, 2018)

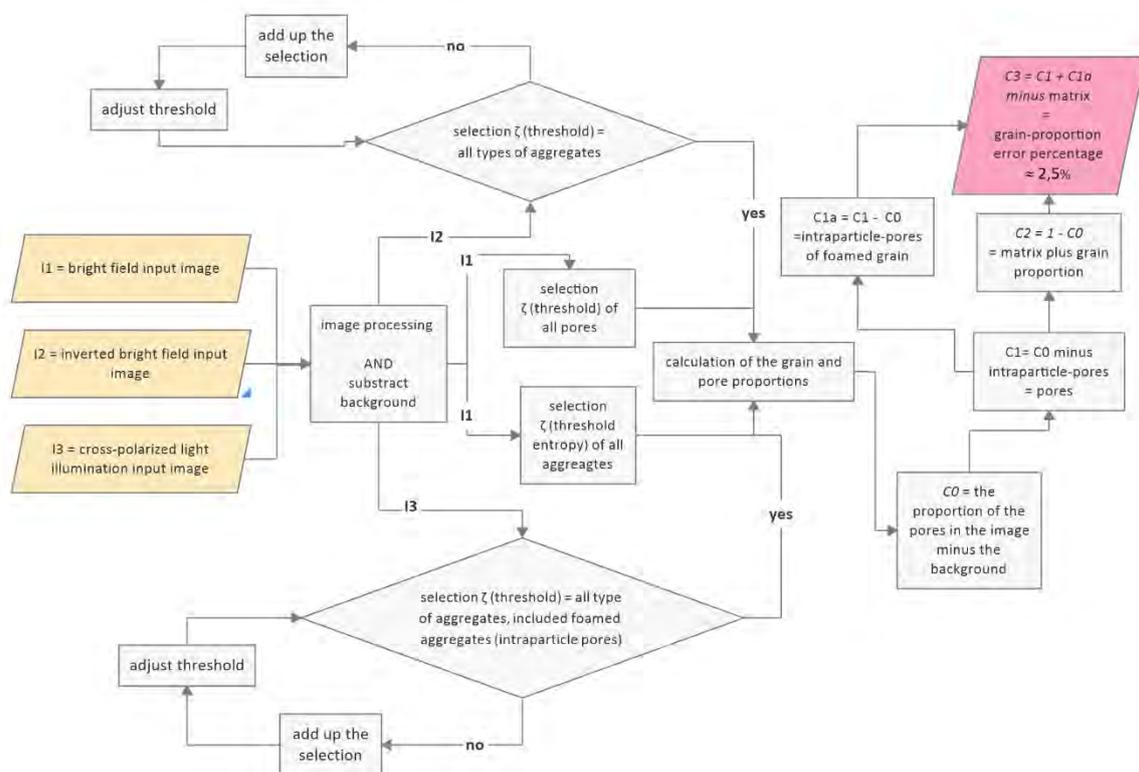
Figure 10. Procedure of the DIA. (Fraunhofer IBP, 2019)

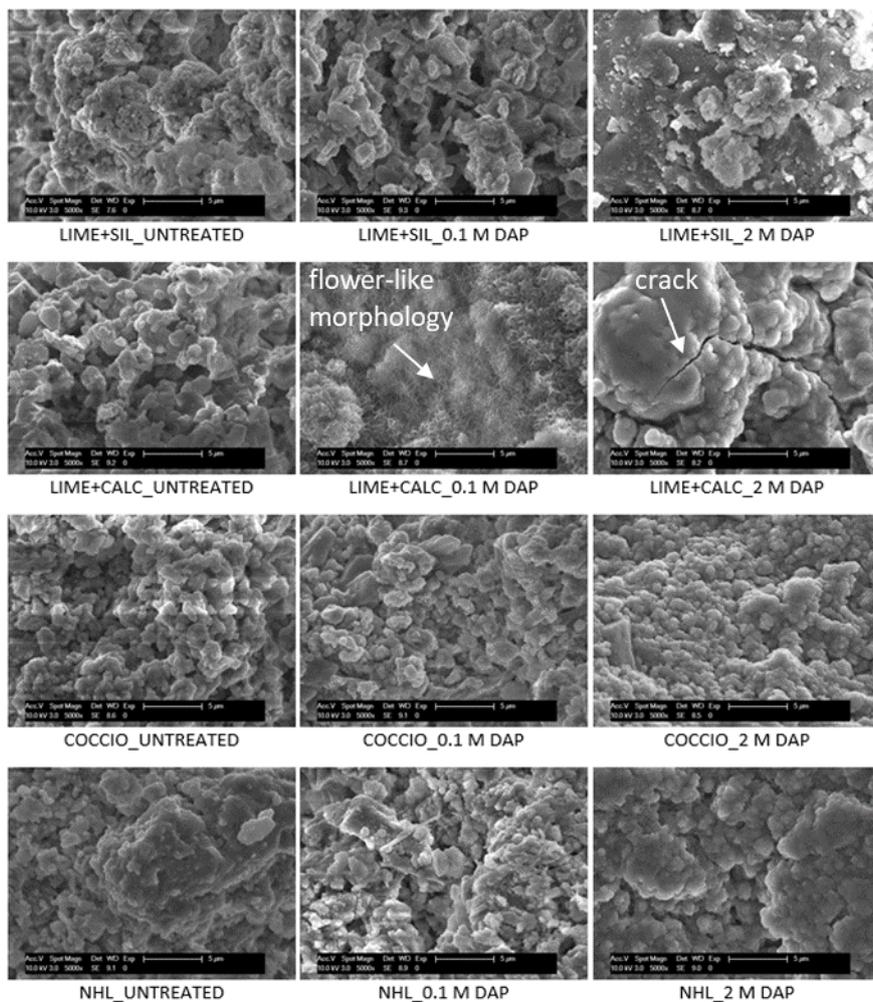
Figure 1. SEM images of untreated and treated samples (scale bar = 5 µm).

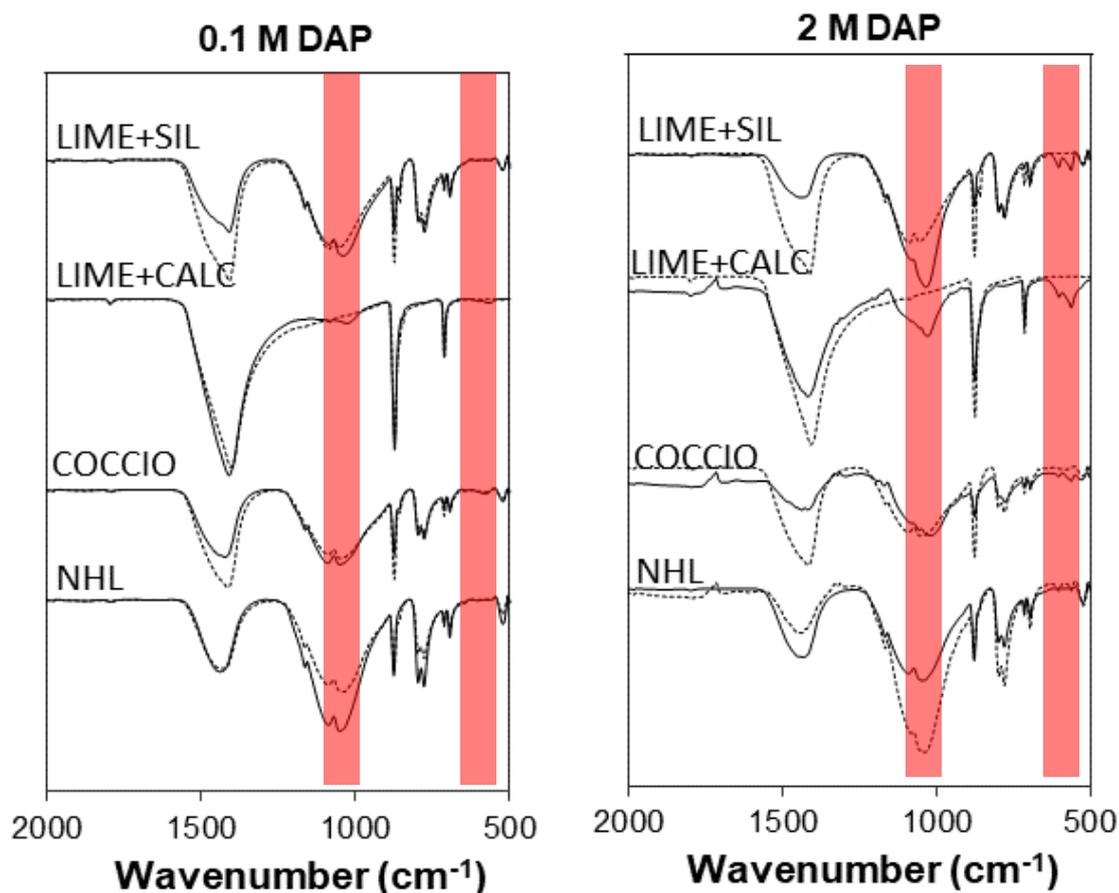
Figure 2. FT-IR spectra of untreated samples (dashed lines) and samples treated for 24 hours (solid lines). The position where HAP bands are expected is highlighted in red.

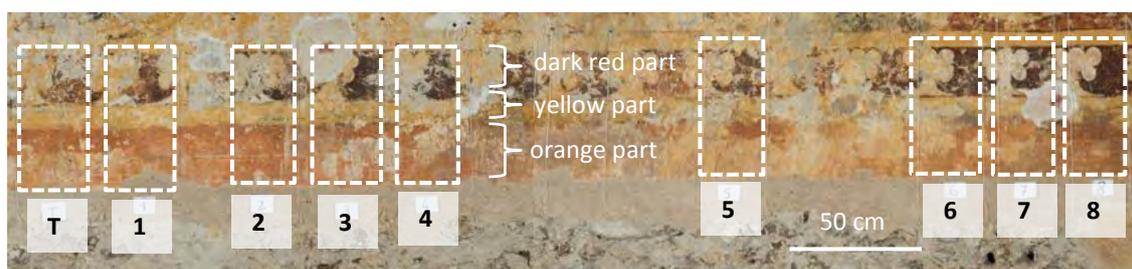
Figure 2. The nine test areas on the east wall with orange, yellow and dark red parts

A part of the east wall painting was granted for consolidation tests. Nine test areas were selected and included a frieze with three main areas of orange, yellow and dark red ochre pigments (Figure 2). The first test area was the reference zone on which no consolidating product was applied. The other eight were dedicated for the application of a series of consolidation tests. Silres BS OH 100 and Primal E330S were applied respectively in areas No.3 and No.5.

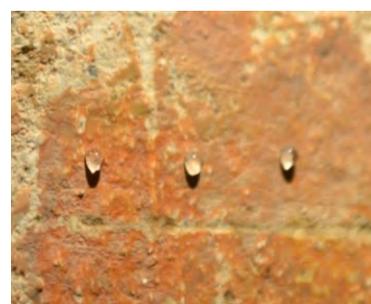
Figure 8. Water drop deposited nine months after consolidation for the test area consolidated with Silres BS OH 100

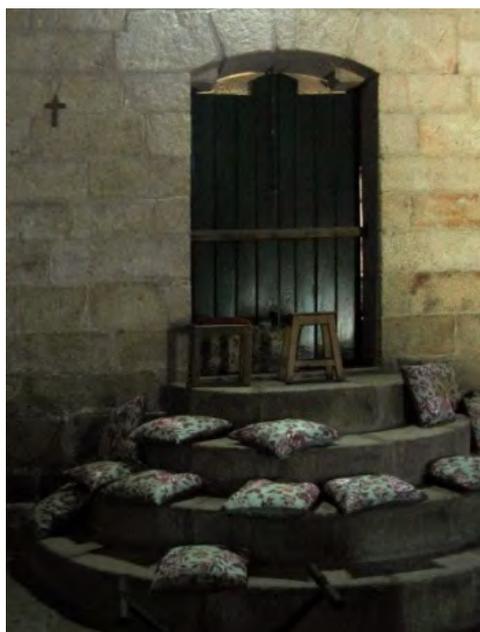
Figure 2. Semi-round stairwell leading to the exit of the South portal

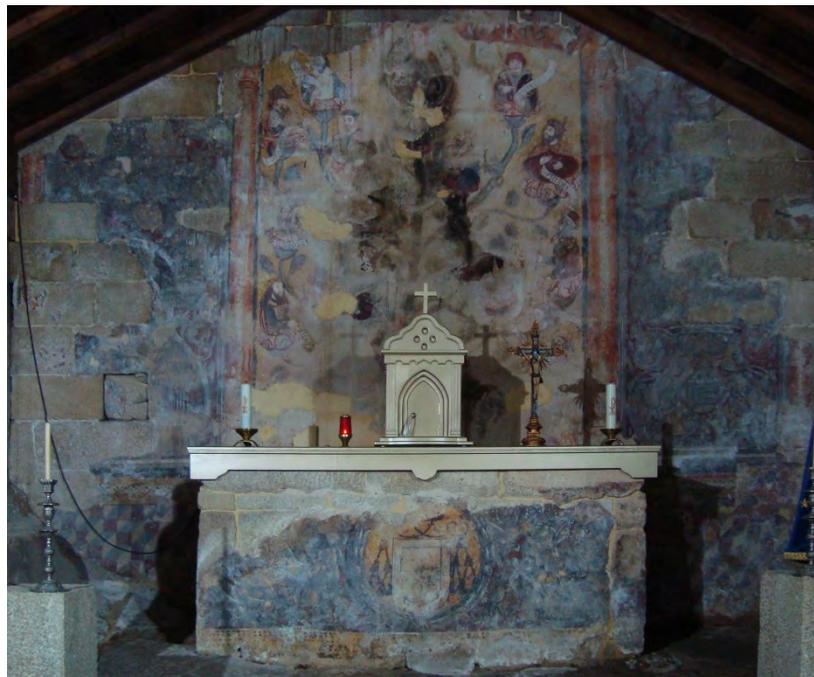
Figure 4. Fresco mural painting from the 16th Century representing the Tree of Jesse on the bottom wall and an episcopal coat of arms attributed to D. Pedro de Castro who commissioned the mural paintings on the altar table of the main chapel

According to Joaquim Caetano [24] the murals are attributed to the painting centre “Oficina III”, operating also in S. Salvador de Travanca Monastery (Amarante), Sta. Marinha Church (Vila Real), S. Brás Chapel (Vila Real), S. Miguel de Tresminas Church (Vila Pouca de Aguiar), Sta. Leocádia Church (Chaves), and S. João Baptista Church (Chaves) [24, 25] (Figure 5).

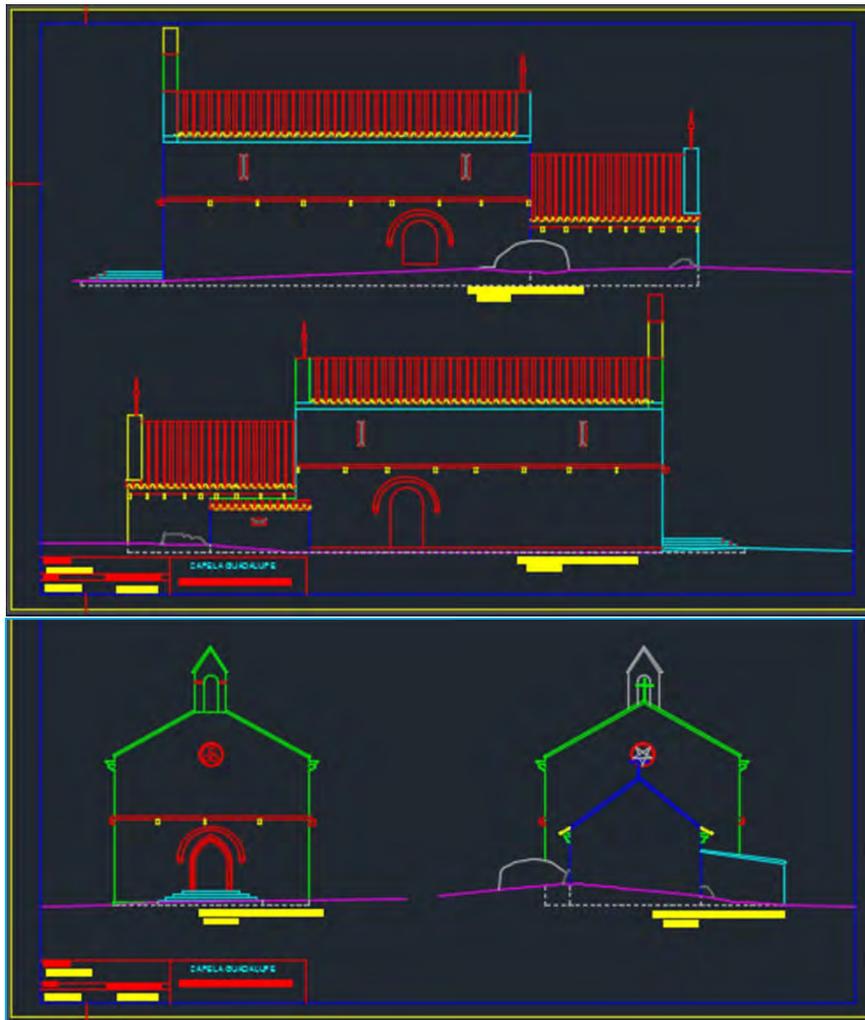
Figure 6. Architectural plants of the 4 facades of Guadalupe Church demonstrating different terrain elevations with lower height on the chapel than on the main entrance. ©João Sandes

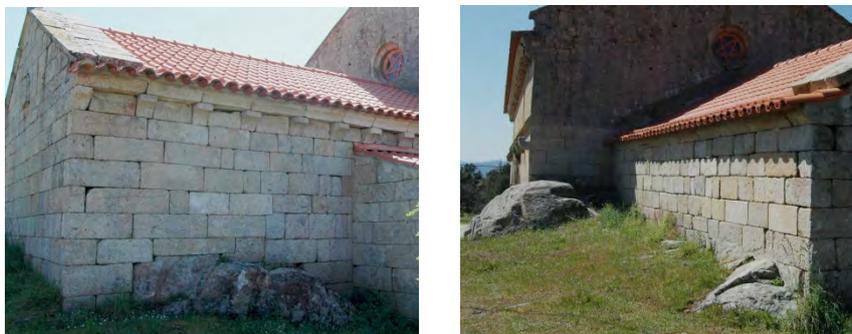
Figure 7. Granite blocks unexcavated, part of the walls: (A) Approximately with three meters on the North façade of the main chapel. (B) One small and the other with a length of approximately three meters on the South facades of the main chapel and nave.

monument it is perceived that the church was excavated on site, in an inclined terrain with a lower height on the east facade and downhill to the main entrance (Figure 6). Three granite blocks unexcavated are embedded on the north and south facades (Figures 7a, 7b). The graves on the floor of the nave still have the bones of the deceased accordingly to the clerical who oversees Vila Real church's heritage for 30 years. In the vicinity of the church, to south, there is a water course for irrigation at 10 meters and a stream at 500 meters west. The church is surrounded by not very dense vegetation, constituted essentially of undergrowth and some bushes leaning on the facades, with fewer trees on the outer perimeter.

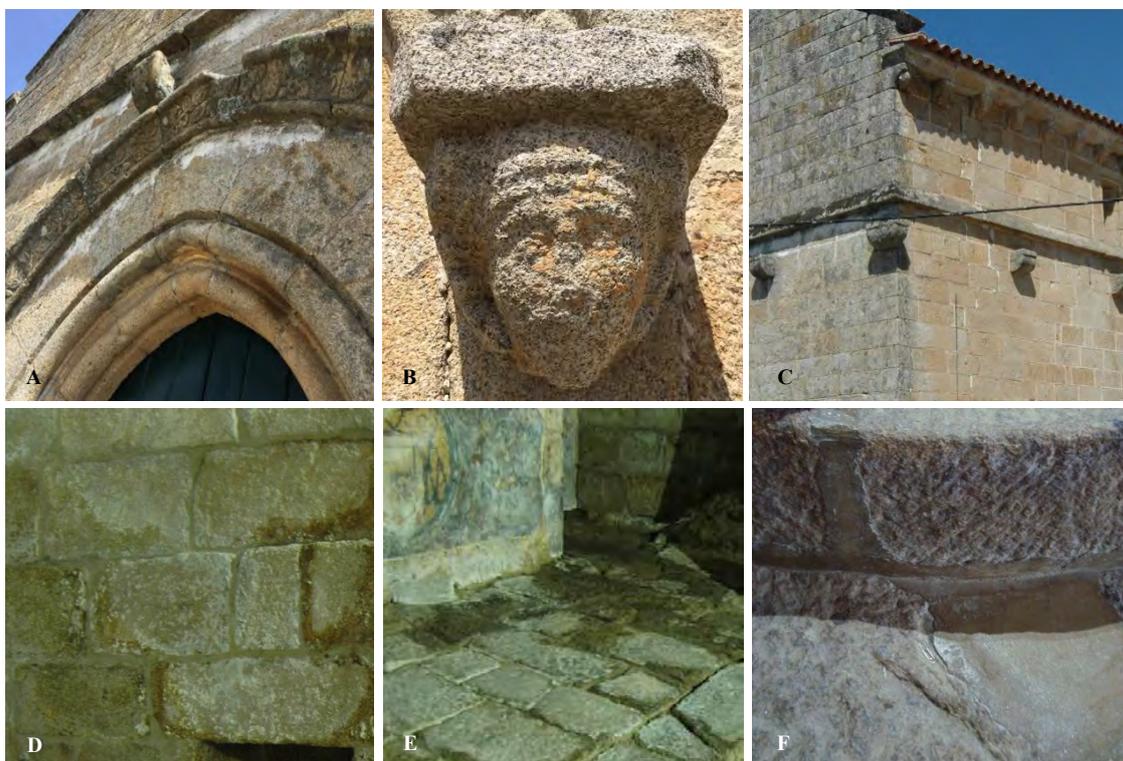
Figure 8. (A) Whitish deposits of mortar leakages probably due to rainwater infiltrations, loss of decorated stone fragment, and biocolonization by different species of lichens (colouring the facades in whitish-grey, yellow, orange, and dark green). (B) Granular disintegration of the granite stone by erosion of the wind and pluvial activity. ©João Sandes. (C) Extremely yellow granite on the South façade of the nave probably a result of a chemical process, and oxidation of some of the minerals that constitute the granite blocks releasing iron oxides. (D) Salt efflorescences and water percolation in the church interior walls. (E) Groundwater capillarity due to open joints. (F) Application of cement mortars in some previous undocumented intervention.

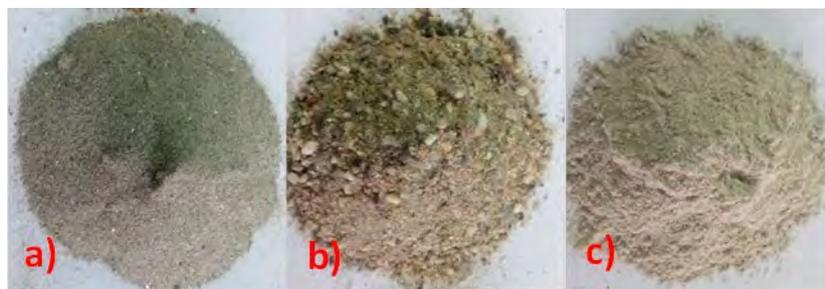
Figure 2. Component materials: a) aggregate F, b) aggregate C, c) natural zeolite

Natural river aggregate originating from Danube river (Serbia) in two different gradations 0/4 mm and 0/0.5 mm was used, designated as C and F, respectively. Bulk density of aggregate F amounted to 1400 kg/m³ and of aggregate C to 1610 kg/m³. The photos of aggregates and zeolite used are presented in Figure 2.

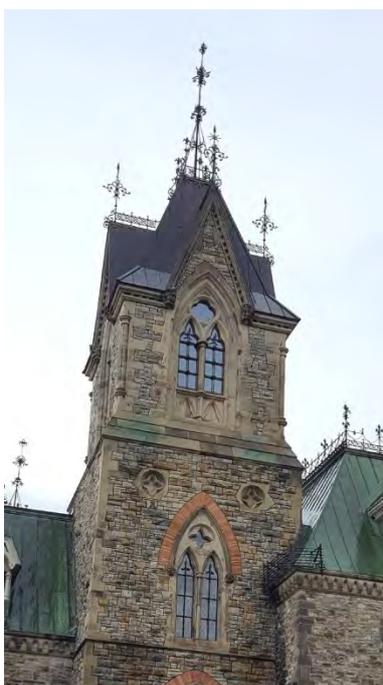
Figure 1. East Block Parliament Hill, Ottawa, Ontario, built 1859-1866, the sloped elements (below the windows) of the northwest tower four years after repointing of the freeze-thaw damaged areas with polymer modified repointing mortar, 2017. Photo by Michael Edison.

The initial impetus to undertake the study of polymer modification of masonry mortar was the premature freeze-thaw failure in early 2013, during the first winter after application, of an air-entrained ASTM C270 Type O repointing mortar on projecting elements of the northwest tower of the East Block on Parliament Hill in Ottawa (Figure 1). The mortar had been proportioned at 1 part ASTM C150 portland cement Type 1, 2.5 parts ASTM C207 hydrated Type SA air-entrained lime, and 8 parts ASTM C144 sand by volume (1:2.5:8). Air content was 12 to 15%. Failures did not occur on vertical surfaces.

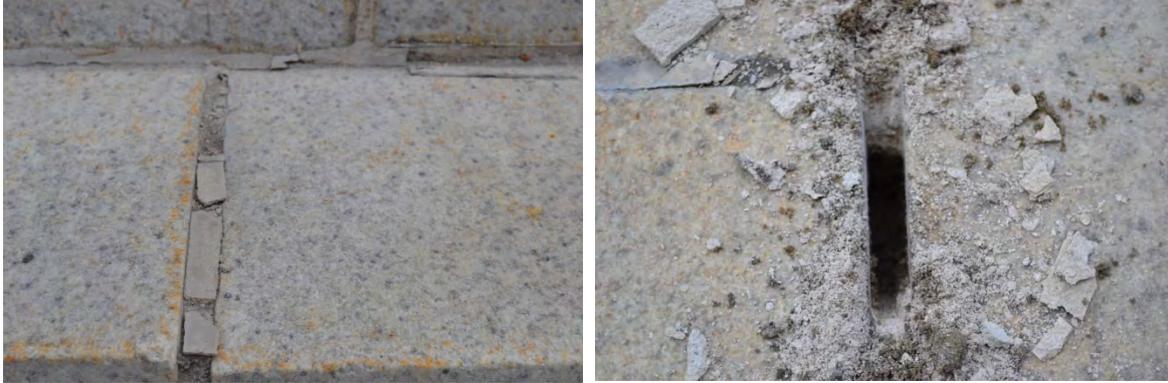
Figure 2. Foley Courthouse, Albany, New York, built 1932 to 1934. Some pavement mortar failures manifested themselves as a thin layer of dry, hardened mortar above a layer of wet, disaggregated mortar, presumably corresponding with the depth within the joint at which mortar was frozen while saturated. Photos by Chad Lausberg
