Proceedings of the 5th Historic Mortars Conference

5th Historic Mortars Conference

19-21 June 2019
Pamplona, Spain

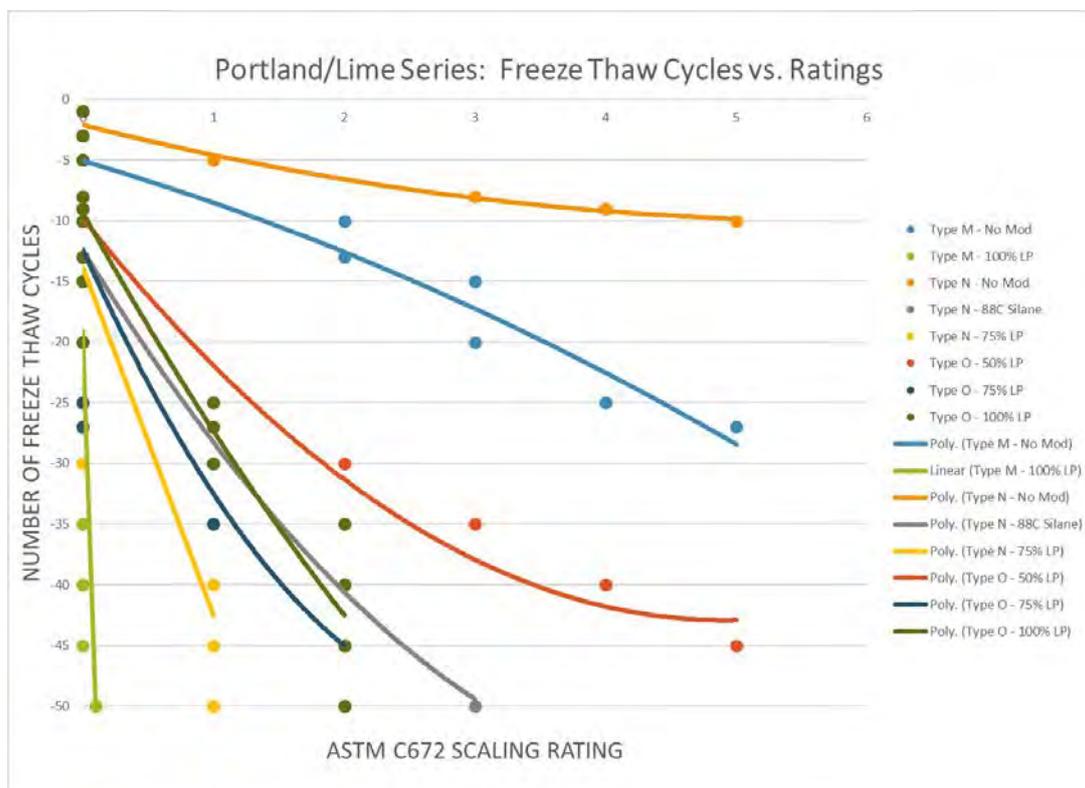
Figure 3. Portland cement/lime series: freeze-thaw cycles vs. scaling ratings

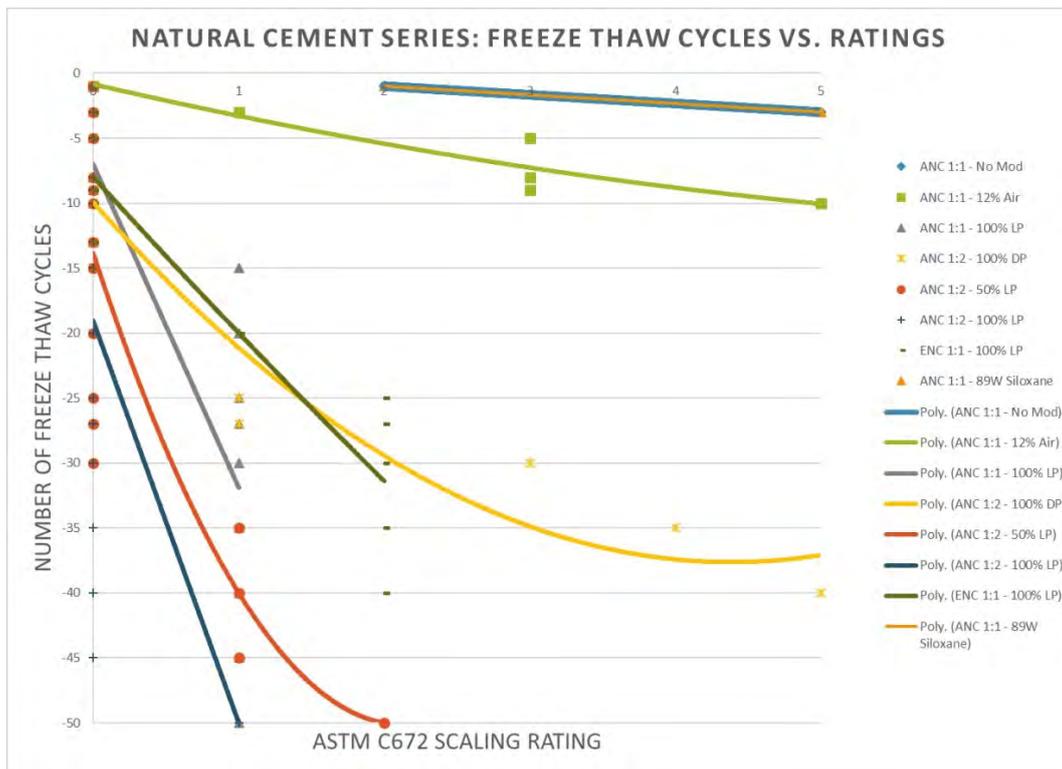
Figure 4. Natural-cement series: freeze-thaw cycles vs. scaling ratings

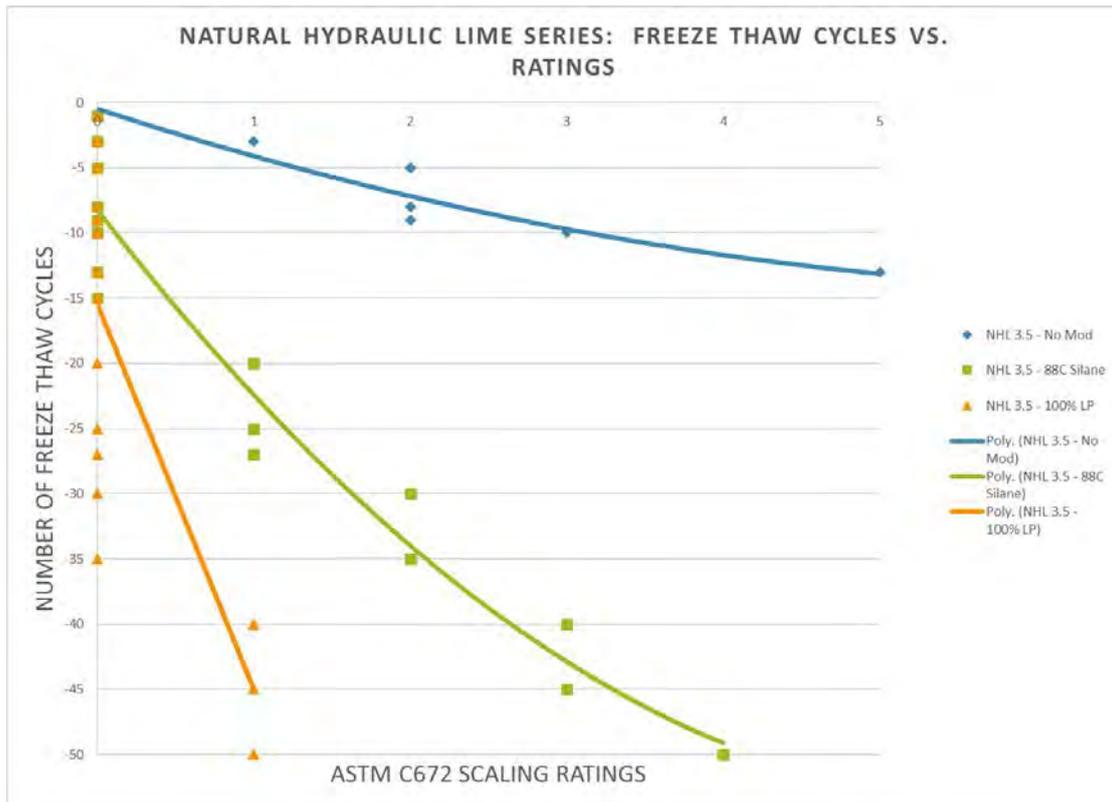
Figure 5. Natural hydraulic lime series: freeze-thaw cycles vs. scaling ratings

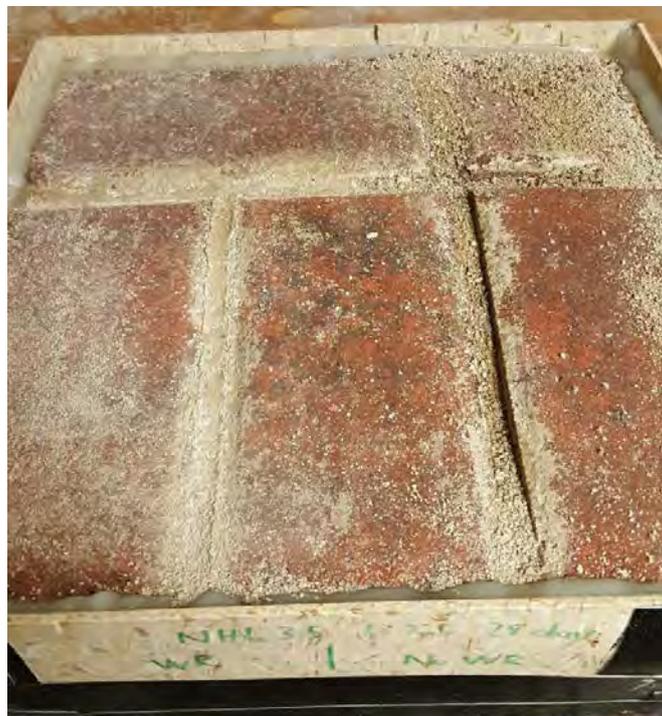
Figure 6. NHL 3.5 mortar with and without silane cream water repellent, after testing of 50 freeze-thaw cycles. The left side is treated with silane cream, the right side is untreated, 2017. Photograph by Chad Lausberg

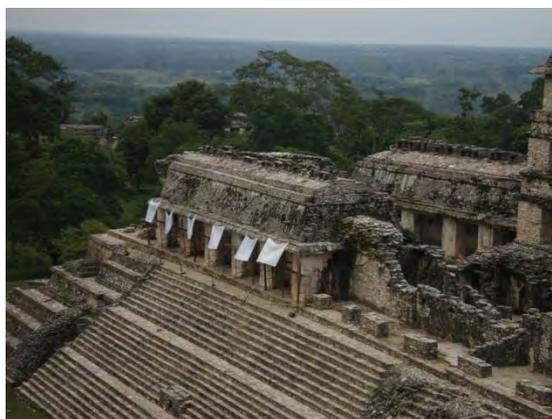
Figure 1. Mayan building. El Palacio from Archaeological site of Palenque, Chiapas. Construction made with limestone, lime mortars, lime plasters and lime decorative elements. STROM 2007.

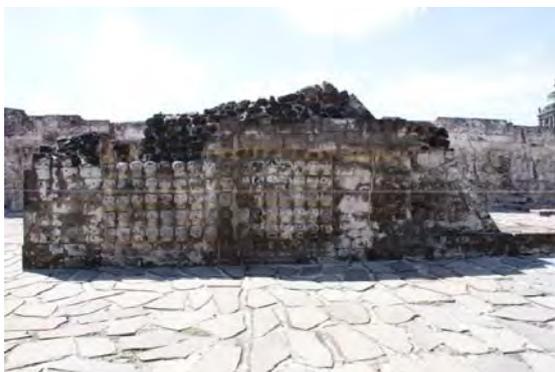
Figure 2. Aztec altar of skulls with restoration joints made of lime/cement mortar. STROM/ INAH 2009.

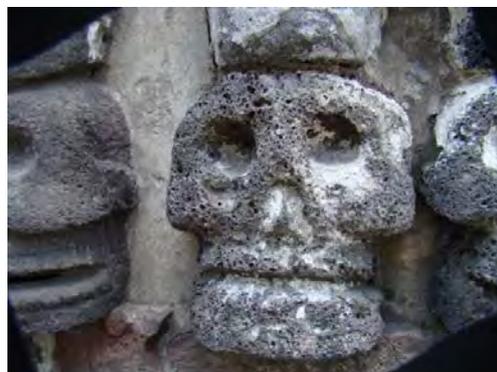
Figure 3. Detail of the Aztec altar of skulls, where original plaster is lost and stone presents decay because of the presence of soluble salts from the lime/cement joints. STROM/INAH 2009.

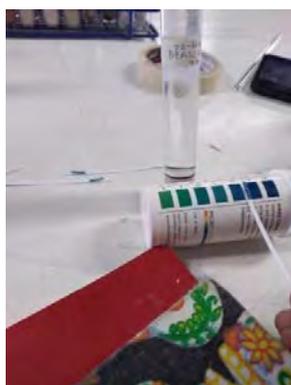
Figure 4. Pozzolan in limewater. Day 1 pH measure 12/13. TECTRAD/ INAH 2019

One test to determine the pozzolanic activity is through the contrast of the pH change in a control solution of limewater and another of limewater with pozzolanic additions. The principle of the qualitative test is that reactive silica (in a pozzolan) will be combined with the lime in a saturated solution and will reduce the alkalinity of the solution. By testing the pH of the solution at regular intervals, the rate of pH reduction and, therefore, the speed of pozzolanic activity can be controlled [19]. This test requires greater refinement, but has allowed comparisons of pozzolanic activity. The results have shown a decrease in pH in an average of 3 points from the day 14 measure.

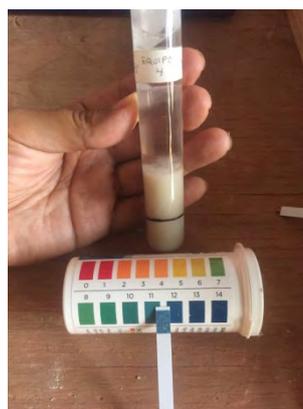
Figure 5. Pozzolan in limewater. Day 7 pH measure 11/12. TECTRAD/ INAH 2019

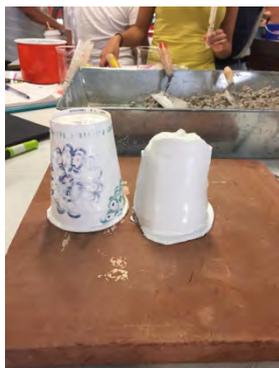
Figure 9 Lime paste test to verify correct texture for mortar mixture. TECTRAD INAH 2019

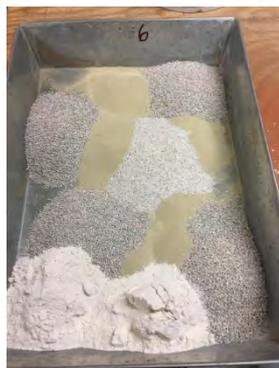
Figure 10 Aggregates selection with different size distribution. TECTRAD INAH 2019

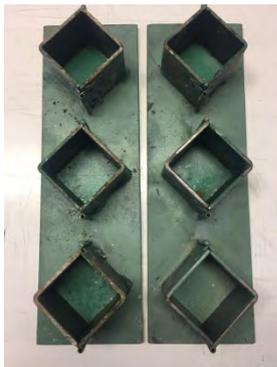
Figure 13 Metal molds for mortars in accordance with ASTM C 1707. TECTRAD INAH 2019

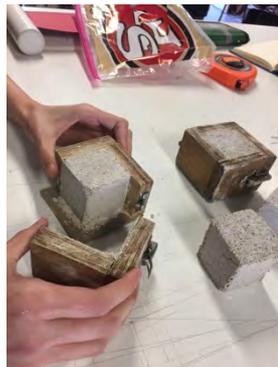
Figure 14 Plywood molds for mortars. TECTRAD INAH 2019

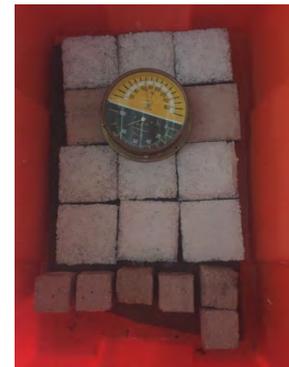
Figure 16 Formulated lime mortars in setting process under a high RH environment in accordance with ASTM C 1707. TECTRAD INAH 2019

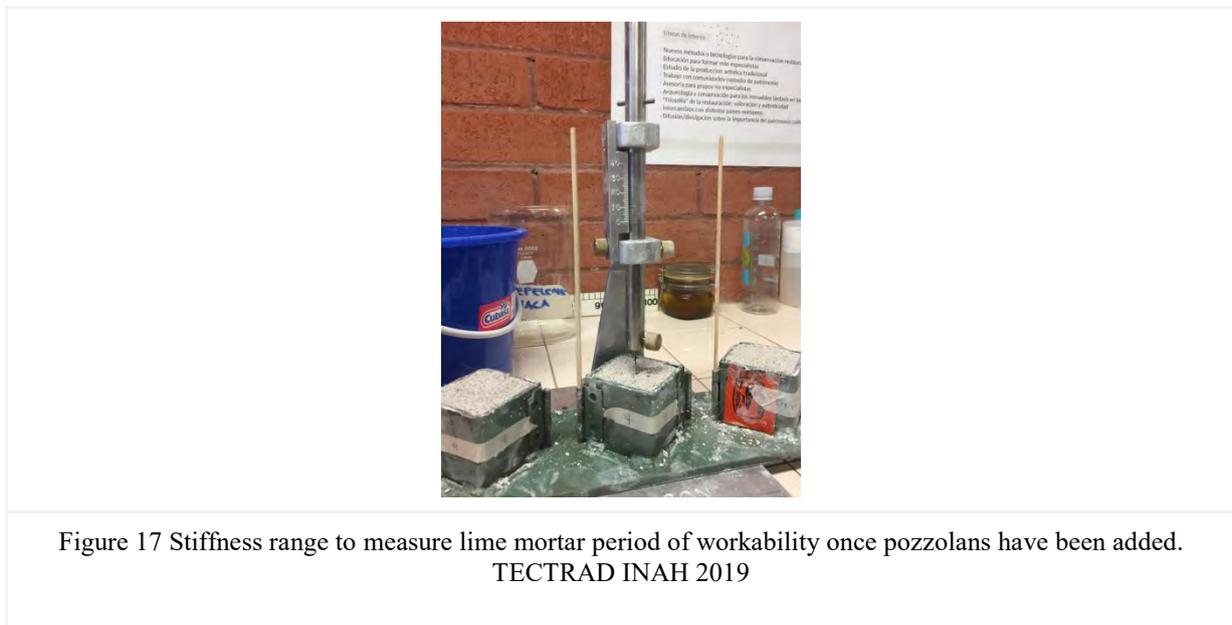
Figure 17 Stiffness range to measure lime mortar period of workability once pozzolans have been added. TECTRAD INAH 2019

the results are not significant for the evaluation of a formulated lime mortar. Other studies suggest pozzolan should be added immediately before the use of the mortar and that there is a margin of approximately two hours for its application [6]. Taking this time as a reference, penetration readings with Vicat apparatus of the original standard (3, 5, 8 and 11 minutes after batch processing) can be adapted spacing the measurements at 30, 60, 90 and 120 minutes. The purpose of this test method is to determine the degree to which a formulated lime mortar develops rigidity that modifies the workability of the mortar. In this way it is possible to establish the working time once the pozzolans have been mixed with the lime mortar.

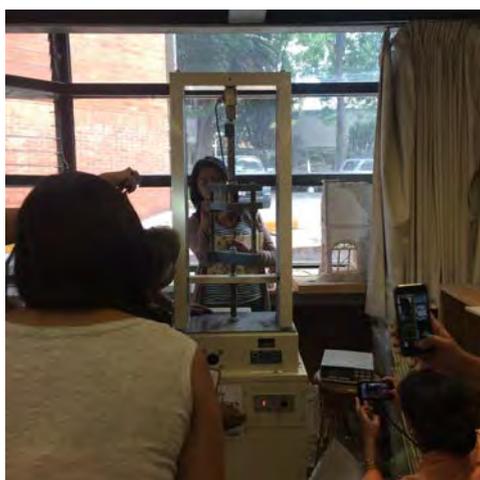
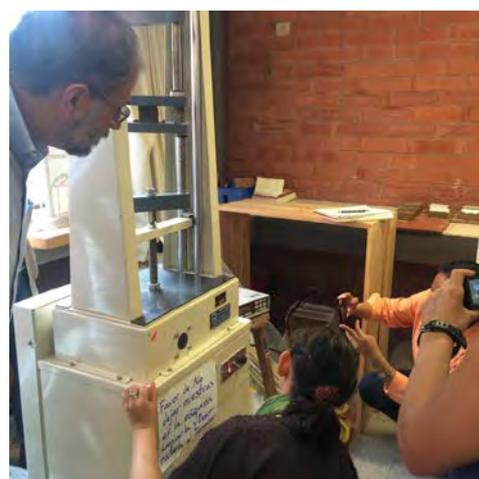
Figures 18 & 19. Compression strength tests as an indicator between lime and formulated lime mortars. TECTRAD INAH 2017.

It is necessary to make some adjustments of the standard ASTM C109 Standard Test Method for Compressive Strength of Hydraulic Cement Mortars, since it is designed to evaluate cement mortars and not formulated lime mortars [26]. The adaptations consist mainly in allowing a longer setting time. The time ranges are taken from previous lime mortar studies, where compression tests are established at 28, 56 and 90 days [11].

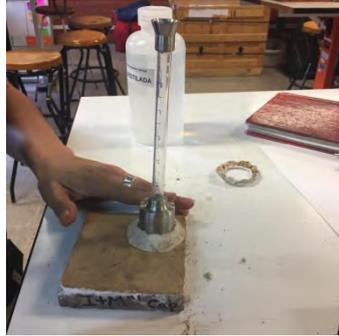
Figure 20. Water absorption test with Karsten tube. TECTRAD / INAH 2018

The permeability of a material is the ability it has to transmit a fluid, in this case water. A material will be more permeable when it is porous and the pores are large and connected. The use of pozzolan additions decrease the porosity [28] creating a less permeable mortar. It

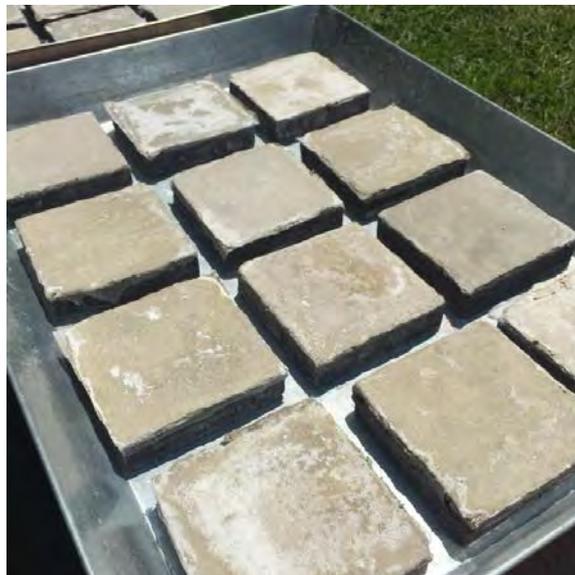
Figure 21. Salts crystallization resistance. Carmona TECTRAD INAH 2018

The standard UNE-EN 12370 evaluates the relative resistance of mortars to the alterations caused by the crystallization of the salts [29]. After drying to constant mass, the test piece is immersed in a sodium sulphate solution, then dried and allowed to cool to room temperature. This cycle is repeated 15 times and the variation of the mass in percentage is determined. The use of pozzolan additions lessens the probability of salts efflorescence at reducing the porosity in the mortar [28], so comparative tests can be held between air lime mortars and formulated lime mortars, to verify the pozzolanic effectiveness.

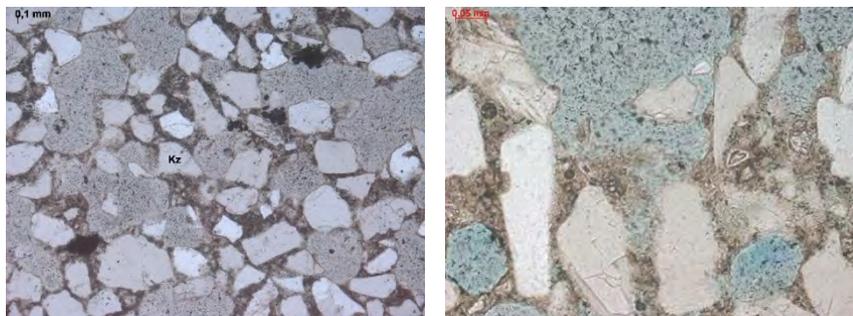
Figure 4. Left: Microphotograph of the aggregate (Kz = quartz sand) in mortar MS (after 28 days curing under outdoor conditions; parallel polarized light). Right: Microphotograph of a detail of mortar MS: in the binder C_2S and C_3S can be identified (after 28 days curing under outdoor conditions; parallel polarized light).

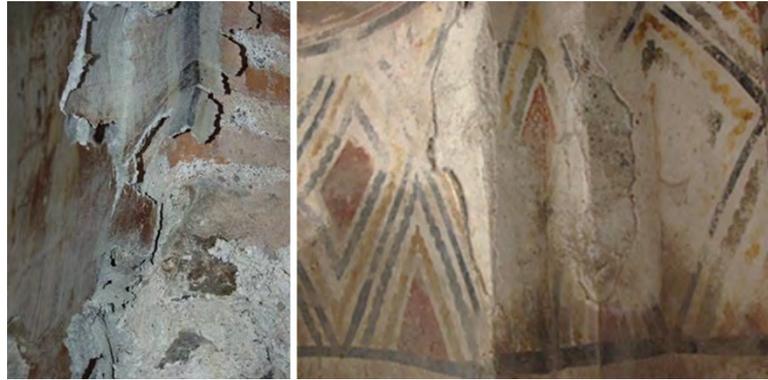
Figure 1. Detachments and loosening of the mortar layers from murals' substrate

The most often pathology symptoms that may be encountered in the architectural elements' substrate can be related to lacunas, discontinuities, as well as cracks or detachments (Figure 1) [9-10]. These can be either detected in the interface of the mortar layers or between the mortar layers and the masonry subground (Figure 2). The degradation rate may vary, according to a synergy of factors, such as differential movements due to accidental loads,

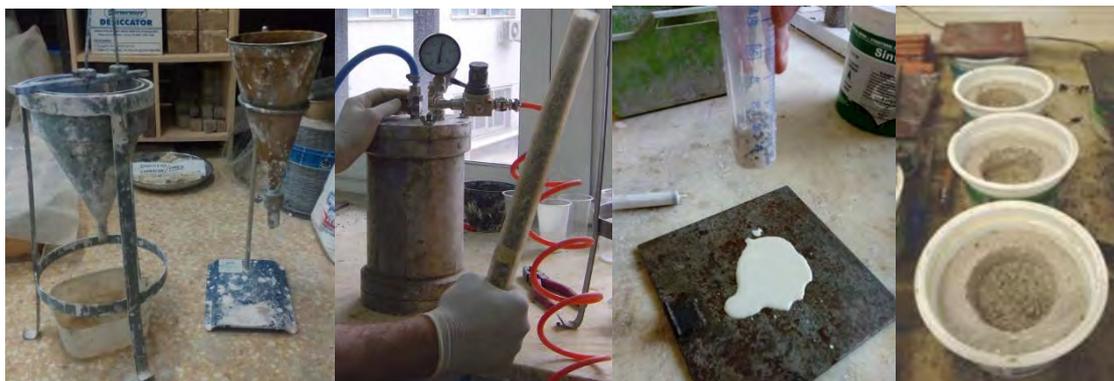
Figure 3. Fresh state properties of the grouts. Marsh cones, column sand test, syringe test, drying shrinkage with mortar cups (from the left to the right)

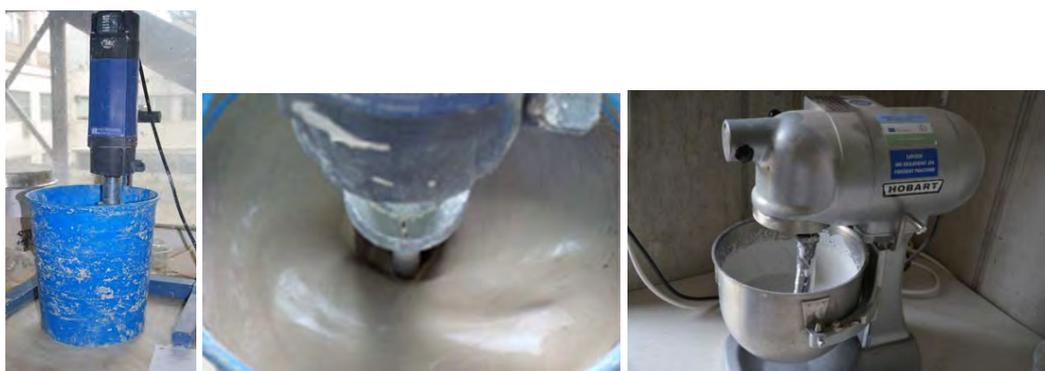
Figure 1. Mixing apparatus of grouts. High-speed mixer (left), Hobart mixer (right).

In the second case (implemented by POLIMI and ITAM), a premeasured amount of water was put into the Hobart mixer and the commercial ready-mixed grouts (TB1 and PLM-A) were gradually added within 1 minute while mixing at speed level 1 (140 rpm). The speed was then increased to level 2 (285 rpm) for a period of 5 to 6 minutes.

Two additional grouts were implemented by ITAM. Roman cement: air lime and citric acid were premixed dry in a mixing bowl and a premeasured amount of water was added during 30s while mixing. The mixing then continued at the speed level 1 (125 rpm) for a period of 4 minutes. Experimentally, also a grout made of finely milled unslaked NHL 3.5 was prepared. The binder was mixed with 3/5 of earlier predetermined total amount of water needed for slaking and achieving the right consistency. After the first minute, the rest of water (2/5) was added gradually while continuously mixing at the speed lever 1 (125 rpm) for another 10 minutes.

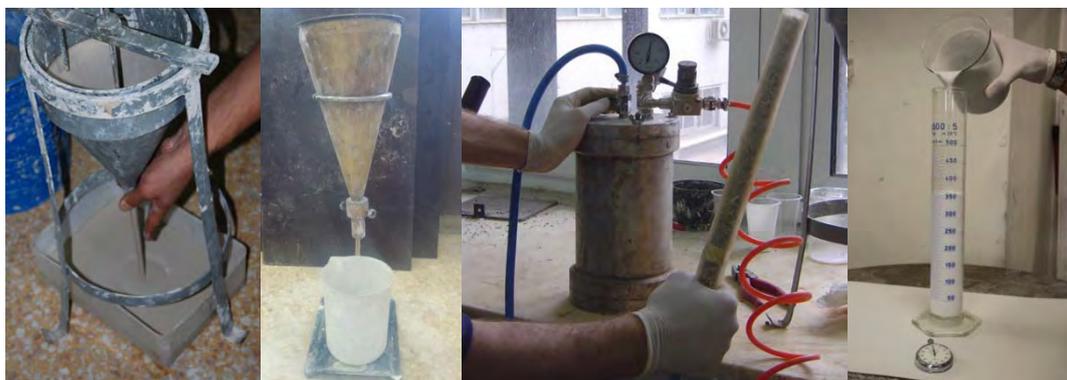
Figure 2. Fresh state properties testing. ASTM and EN flow cones (left), sand column test (middle), volume stability test (right).

- Penetrability, according to the sand-column test (EN 1771:2004) (Figure 2). Plexiglas cylinders (height: 39 cm, diameter: 2.22 cm), filled with natural, siliceous sand of granulometry 2-4 mm were used. Such gradation simulates voids and discontinuities of approximate width 0.3-0.6 mm, as has been pointed out at literature [3, 5, 6].

- Volume stability, according to ASTM C 940-98A (adjusted to a reduced grout volume of 500 ml) (Figure 2). The grout was put in a graduated glass cylinder and covered to prevent evaporation. Twenty-four hours later, the volume of the grout as well as of the bleed water was measured, and the volume change (expansion or reduction) and bleeding were calculated (according to the equations mentioned in the Standard method). The upper limit of 5%, as defined by the relevant studies [5, 9], was taken into consideration.

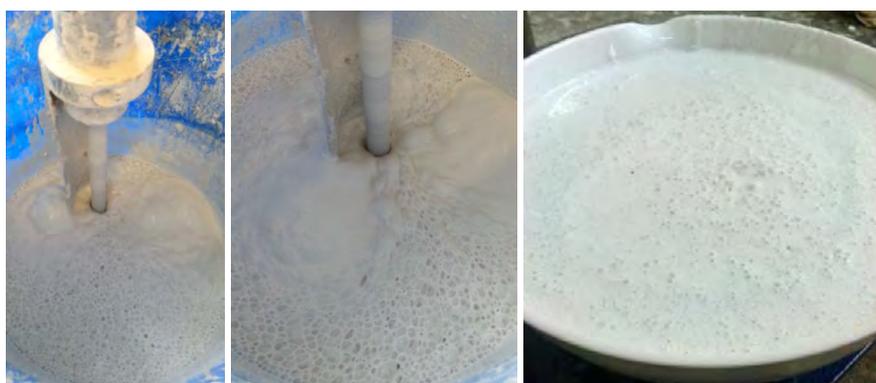
Figure 3. Extreme foaming of ready-mixed grouts (Ledan TB1) in the high speed mixer (left and middle image) and after Hobart mixing of standard grout quantity (image on the right).

On the other hand, commercial grouts (i.e. Ledan TB1) seemed to performed better at low mixing speed that could be achieved by the Hobart mixer and commonly 1+6min mixing time. When they were mixed with high speed mixer, extreme foaming was observed (i.e. Ledan) (Figure 3), which led to extreme water evaporation (W/B increase) and difficulty in applying the flow cone test. The quantity of grout also influenced the mixing results, as significant foaming was observed also during Hobart mixing of Ledan TB1 when standard amounts were employed (Figure 3). Mixing a reduced quantity of the grout following the same mixing procedure provided a more homogenous and foam-free result compared to the full amount. It was noticed that the technical guidelines of the relevant products do not give much details regarding the type and time of mixing, referring only to hand mixing.

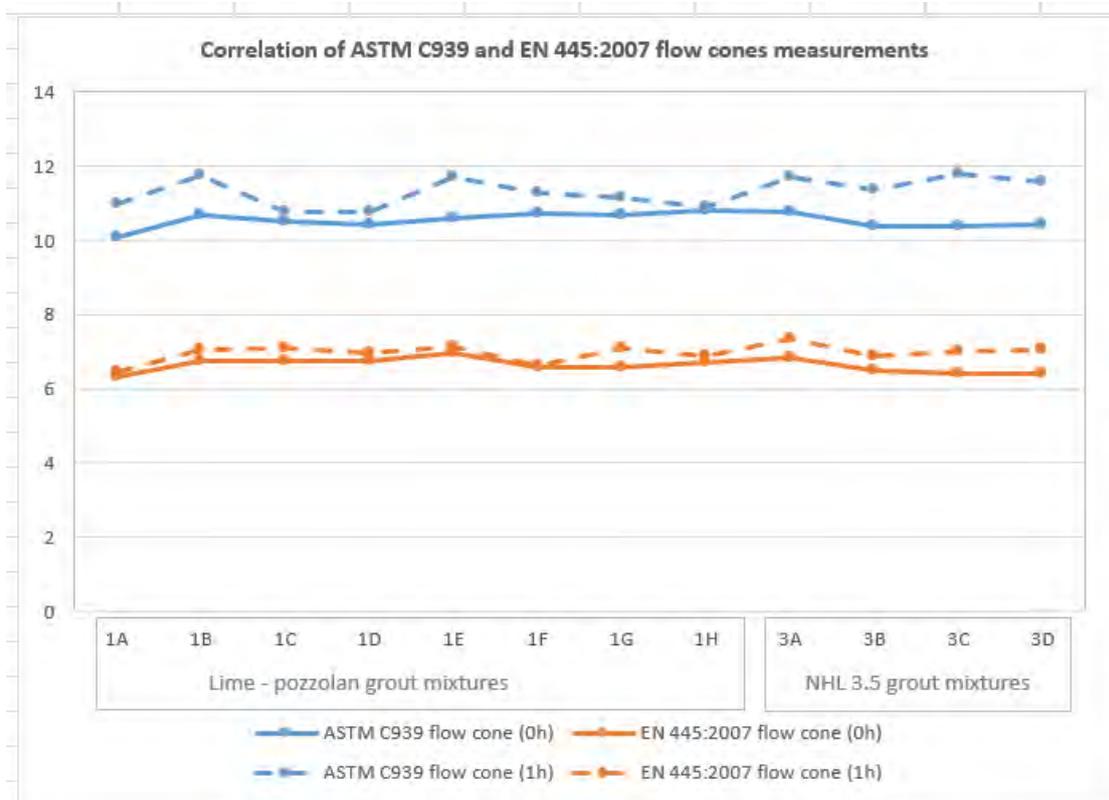
Figure 4. Correlation of ASTM C939 and EN 445:2007 flow cones measurements in the lime-pozzolan and NHL 3.5 grout mixtures.

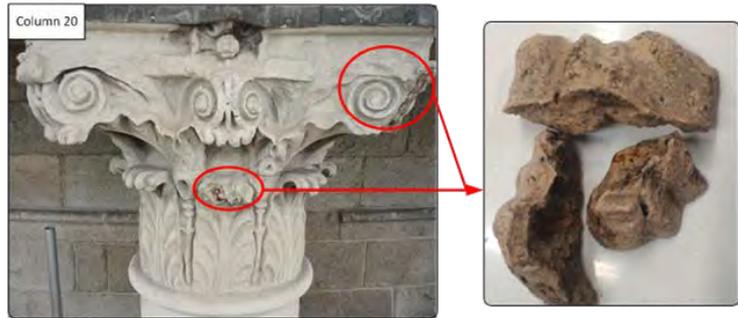
Figure 2. Portland stone at The Four Courts showing old mortar repairs made with crushed Portland stone - Figure 3.

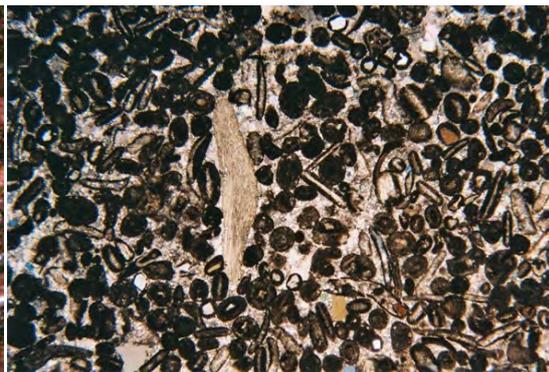
Figure 4. Petrographic image of the Portland stone consisting of ooliths and shells of microcrystalline carbonate cemented with coarser crystalline carbonate. 2X polarised light. Field of view c. 7 mm

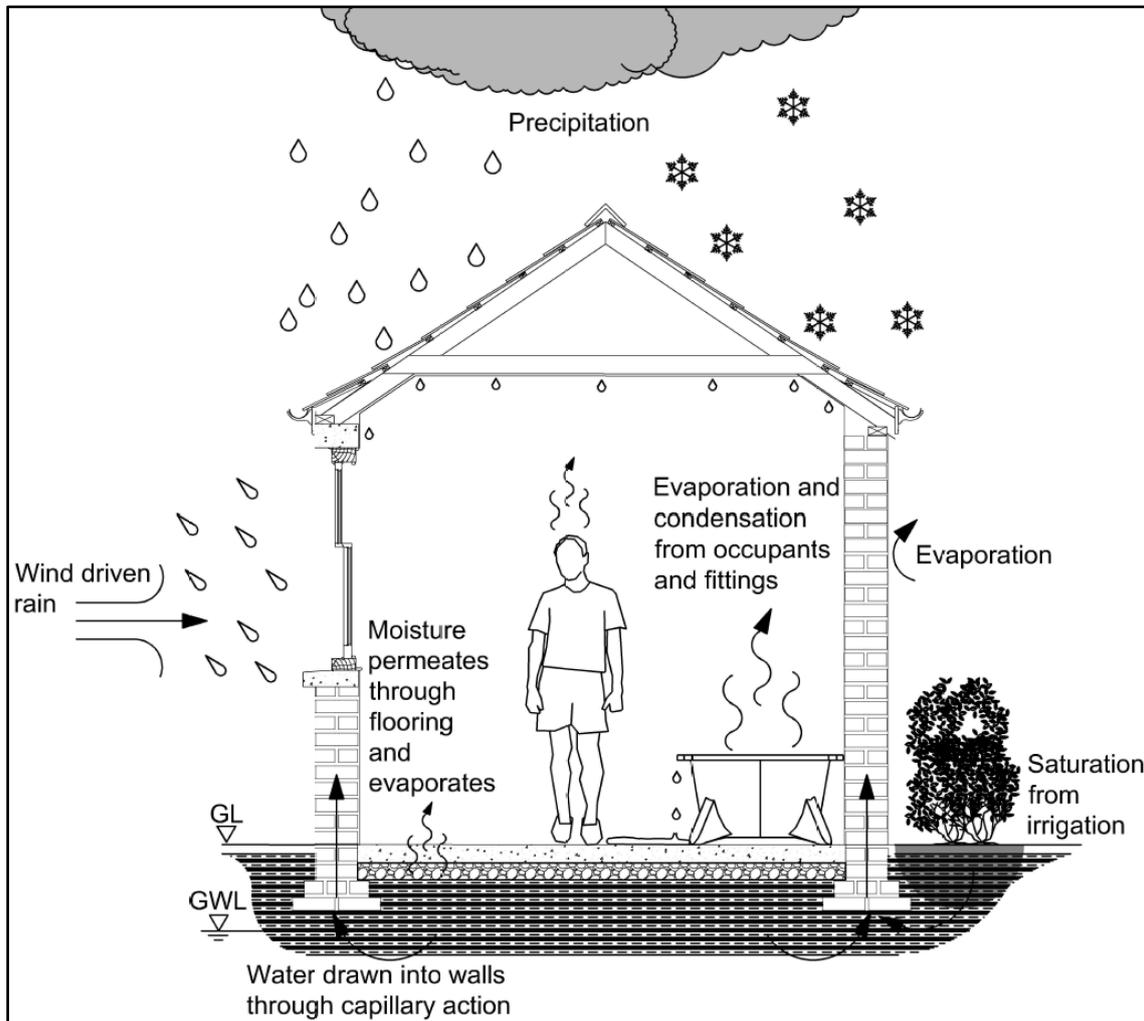
Figure 1. Moisture movement in and around buildings.

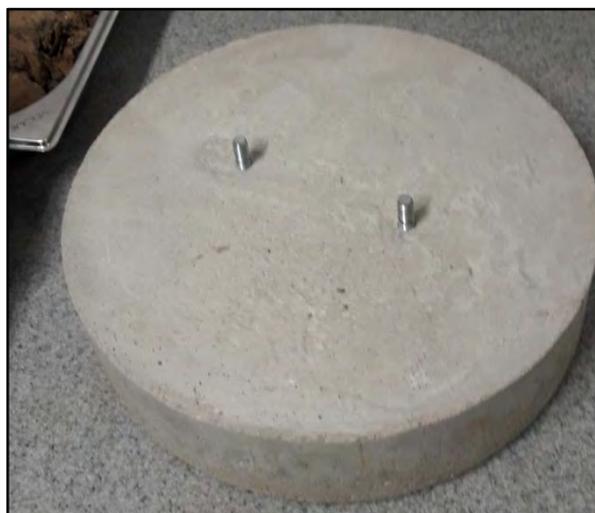
Figure 2. Cast concrete slab prior to use in the modular slab experiment.

The concrete and limecrete were cast as circular slabs, as shown in Figure 2, to fit the modular set-up. Two bolts were cast into the slab to facilitate installation and removal. The concrete and limecrete slabs were of thickness 84mm and 86mm \pm 2mm respectively. They were cast to fit the apparatus, which had an internal diameter of 355mm \pm 1mm with a gap around the perimeter of approximately 10mm. Slabs were installed within 2-4 weeks of casting and had not completely cured.

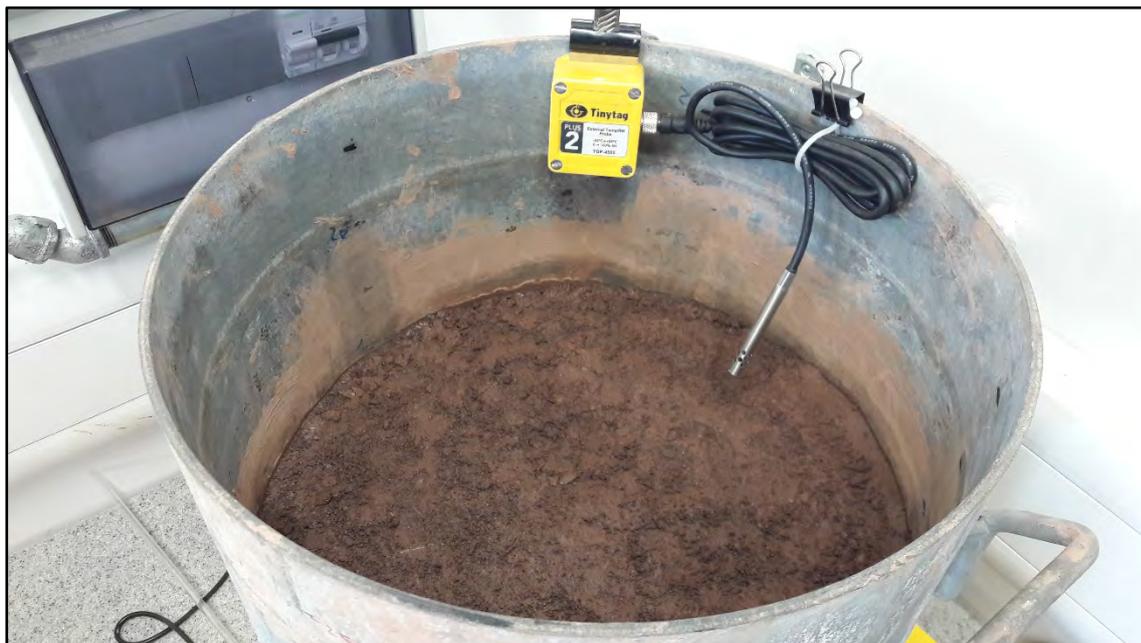
Figure 4. Initial saturation of the bare soil surface.

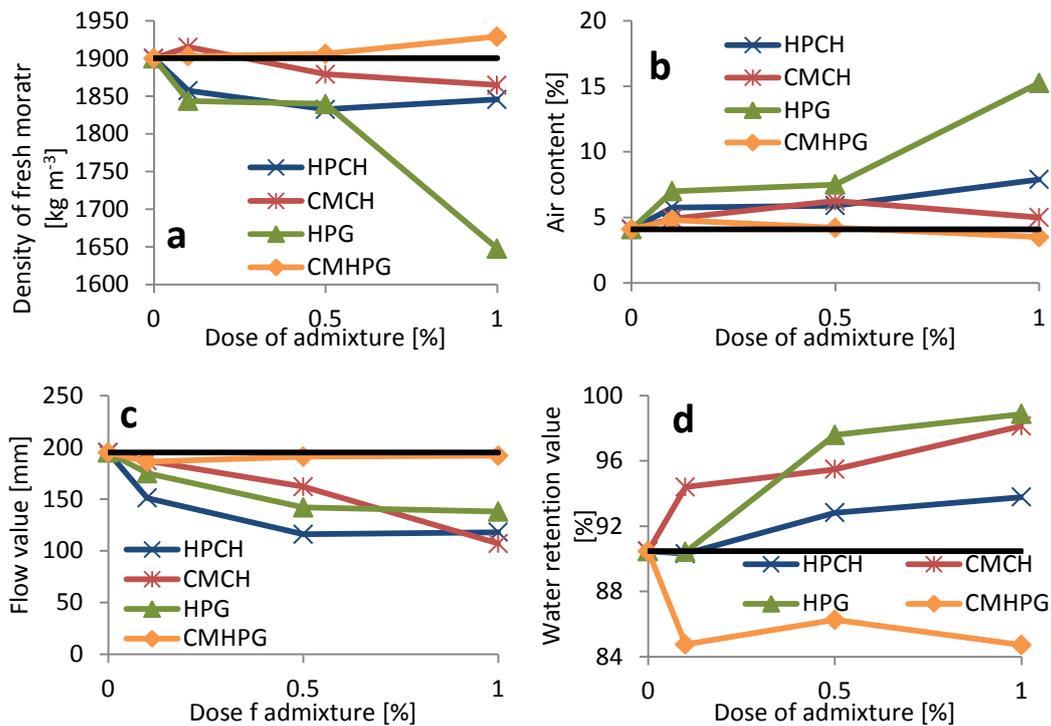
Figure 1. Fresh state properties of the NHL 3.5 mortars with admixtures.

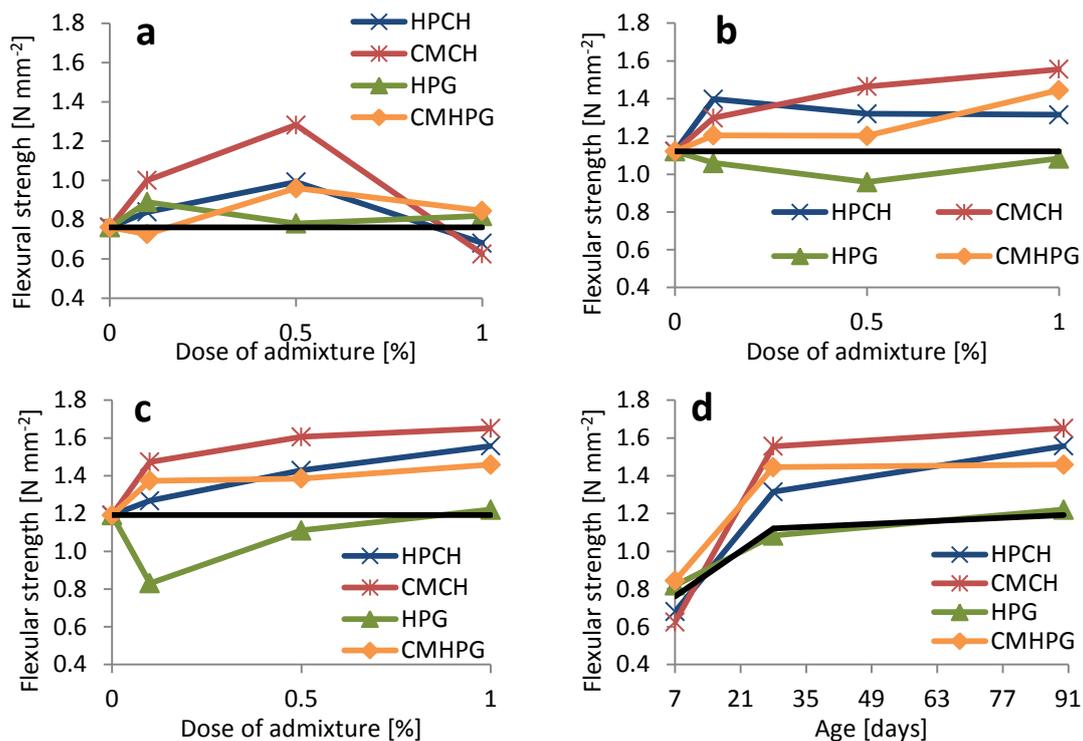
Figure 3. Flexural strength of studied specimens in the age of 7 days (a), 28 days (b), and 90 days (c) and time evolution of strength of samples with 1% of admixture (d).

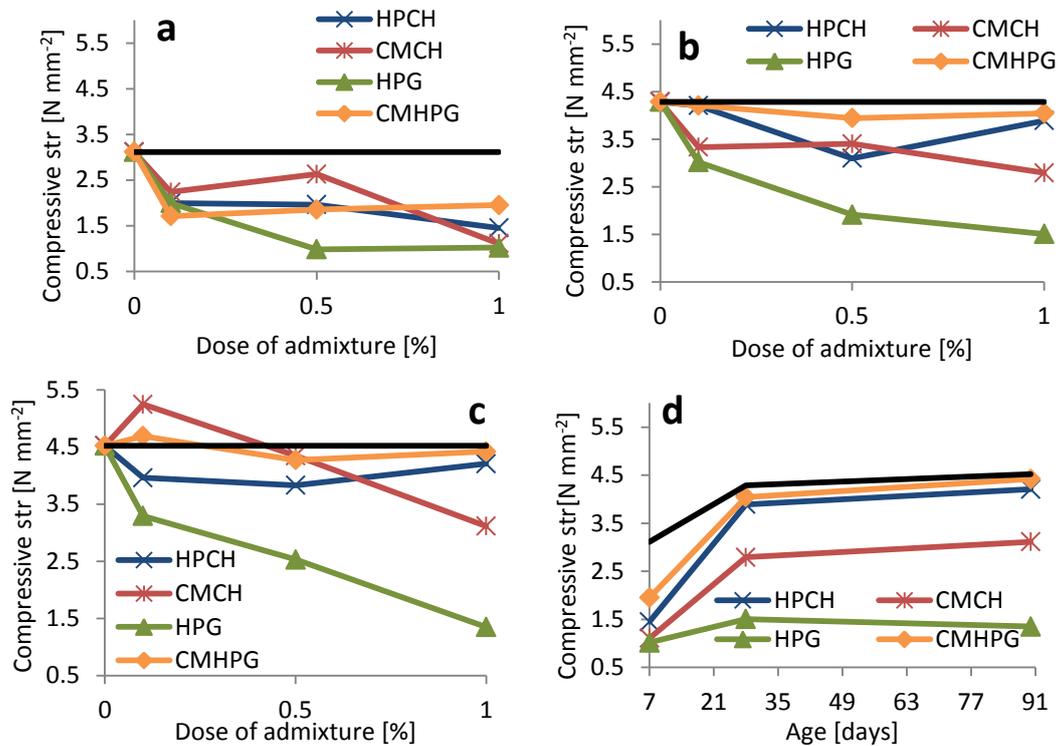
Figure 4. Compressive strength of studied specimens in the age of 7 days (a), 28 days (b), and 90 days (c) and time evolution of strength of samples with 1% of admixture (d).

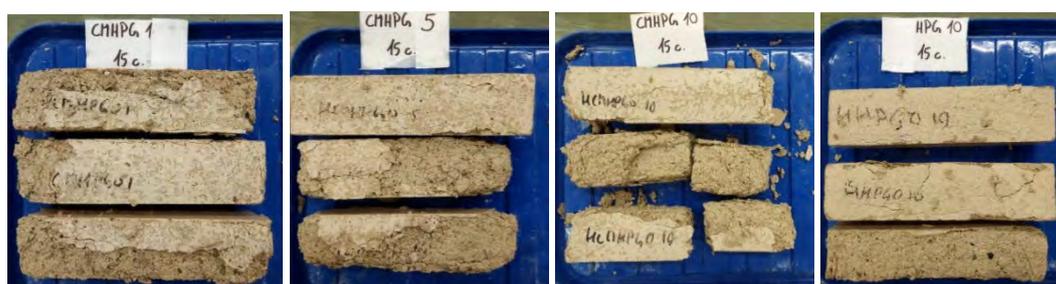
Figure 7. Highly altered samples after 15 freezing-thawing cycles (numbers represent admixture dosage in %).

The highly decayed samples with CMHPG are shown in the Figure 7 alongside with HPG 1 samples, which showed some longitudinal cracks, and in one case, about 1 mm of surface layer had been separated. Other samples, except for the reference ones, were in same or better conditions than the HPG 1 samples, with some longitudinal cracks and several smaller defects predominantly seen on the edges. The best performing admixture was HPG, which notably increased durability even in the lowest dose, but further addition did not lead to improvement. The durability of the mortars is improved by the air pores in the matrix, which

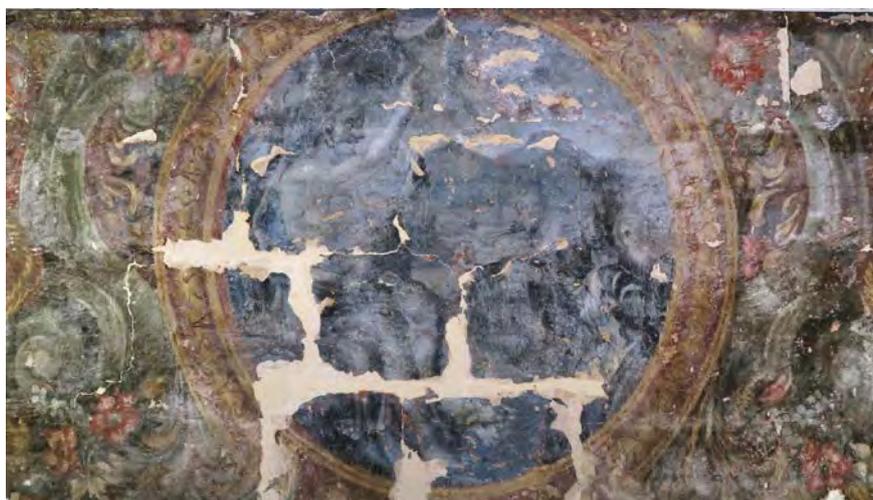
Figure 1. Detail of Baroque painting on east wall of the Chapel at Palazzo de la Salle. Note the characteristic pattern of painted plaster detachment and loss along the joints between ashlar support (Department of Conservation and Built Heritage, University of Malta, 2018).

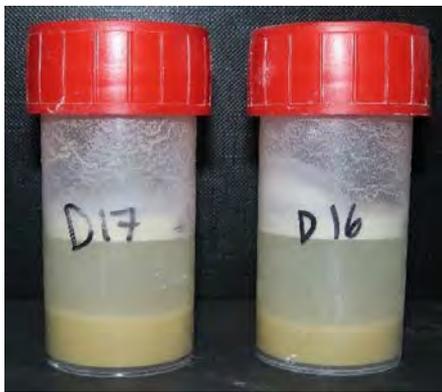
Figure 3: Separation of solid and liquid microgrout components after mixing (Department of Conservation and Built Heritage, University of Malta, 2017).

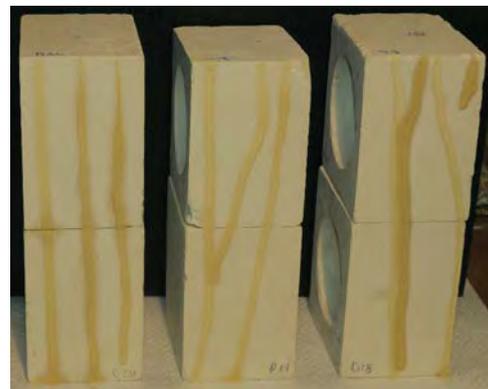
Figure 4: Flow testing (Department of Conservation and Built Heritage, University of Malta, 2017).

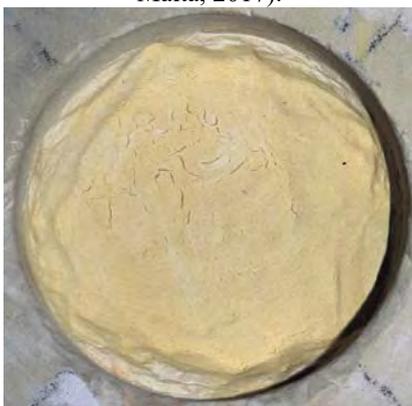
Figure 5: Shrinkage testing. A CaLoSiL-based microgrout exhibiting cracking after application and setting in a Globigerina cup (Department of Conservation and Built Heritage, University of Malta, 2017).

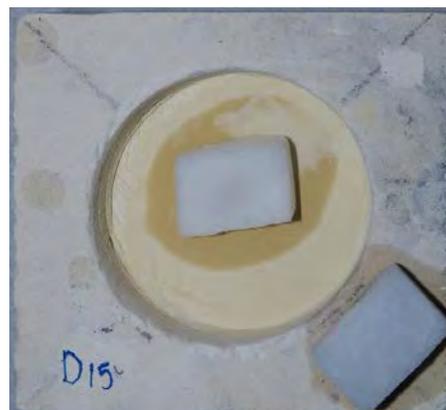
Figure 6: Comparison of DiOx microgrout and Globigerina liquid water absorption. The DiOx sample was applied and set in a Globigerina cup (Department of Conservation and Built Heritage, University of Malta, 2017).

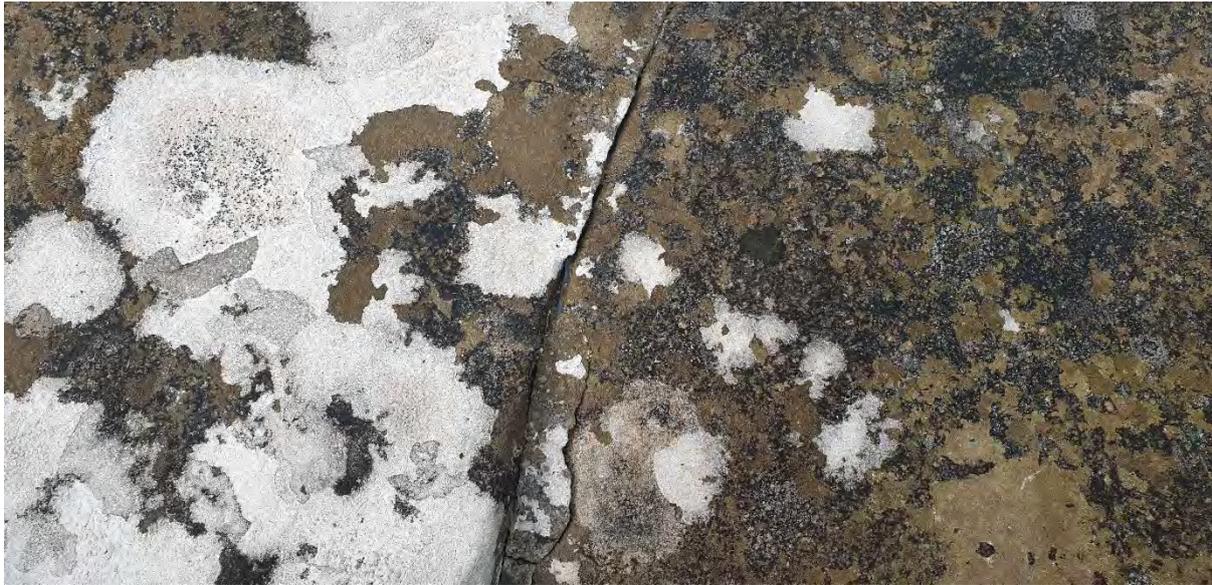
Figure 2. Ethyl silicate mortar repairs carried out to a broken stone in 1996. This image, taken 23 years later in 2019, shows the stone still wet after rain. The mortar repair, now detaching due to movements in the joined stone, achieves both requirements of having good wet colour and a balanced recolonization of biota, in this case two forms of crustose lichen.

Colour stability is achieved not only by the mortar deriving its colour substantially from the larger aggregates with minimal addition of fine pigments, but to achieve wet and dry compatibility the repair must be as porous as the parent surface. Hand in hand with this the repair must provide a nutrient suite similar to that of the parent. No matter how well matched a repair is upon completion, its ultimate colour stability will be determined by how closely it tracks the bio-colonization of the parent stone through changing seasons (Figure 2). Portland cement repairs on outdoor sandstones literally bristle with mosses and other higher species due to the very high nutrient supply in the Portland cement. The same can be said for the use of lime mortars on non-calcareous stones. Calcitic stones provide the same challenges but in this case the presence of calcium carbonate is desirable, as is a reasonable matching of surface texture.

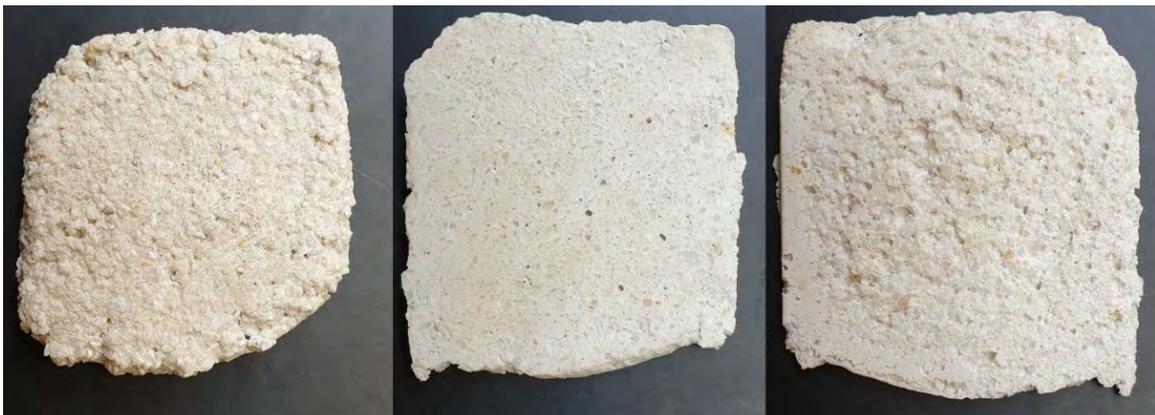
Figure 3. Three views of a mortar composed of marble passed through a 3 mm sieve (not intended to match Carrara marble). Left - the surface as applied off the spatula with rudimentary levelling. Centre – the same batch with all but the upper left corner polished. Right – the underside of one sample showing the coarse texture. It is noted that Carrara marble has grains in the range 300-500 microns, not those used here. No quartz flour was added to these mortars.

One of the features of lithium silicate mortars, more relevant to recent works, is the ability to polish the surface after set. This allows for very precise gloss matching. The central sample of Figure 3 has been polished to a low sheen and in other recent works, highly polished black marble and grey granites have been gloss matched through a combination of polishing and lithium silicate glazing (paper in preparation).

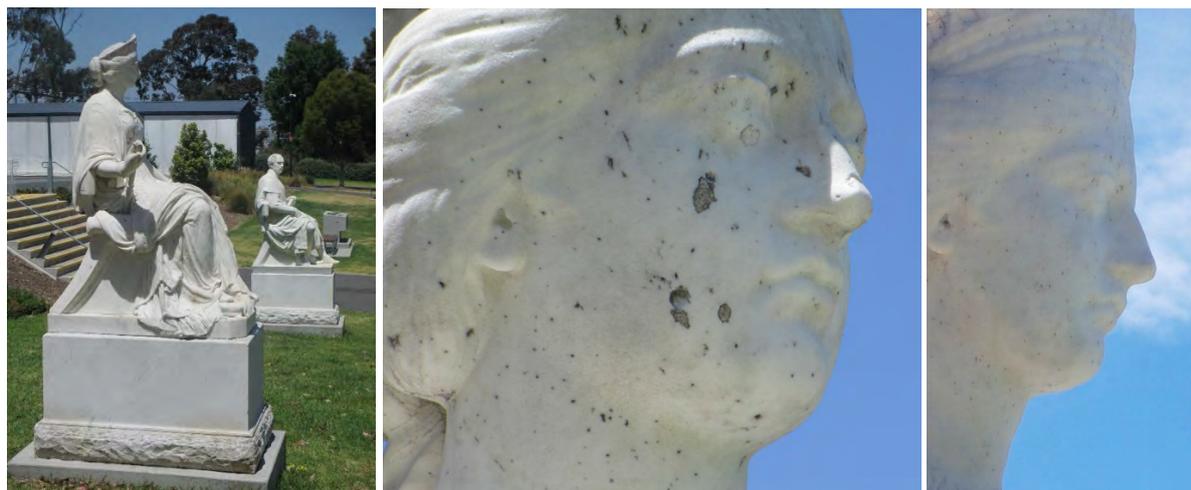
Figure 4. Victoria And Albert at left. A detail of the disfiguring pitting on Victoria's face after cleaning and just prior to lithium silicate mortar repairs in 2012, centre, and the filled surface after 6 years in 2018.

When first encountered both figures were situated under Moreton Bay fig trees, a particularly polluting species that drops sticky residues and attracts a myriad of fruit devouring birds, most of whom depart the trees weighing roughly the same as when they arrived. The depth and extent of the pitting on the face of Victoria became fully apparent when the sculpture was first cleaned in 2006. The first sight was of a heavily graffitied face, and this together with the accumulations from the trees and birds were removed with ammonium bicarbonate poultice cleaning. The cleaned face, typical of many parts of both figures, fully exposed the disfiguring pits that were clearly inherent defects in the marble, together with some additional impact damages such as the bridge of the nose in Figure 4.

At that time the surface was rebuilt using slaked lime, quartz flour and marble dust with 5% acrylic emulsion used as the diluent. The fill began to fail within 18 months in a typical fashion for weak mortars; friable loss around the contact edges before complete separation. The inability of lime to form strong adhesive bonds is well known and masons prefer to cut a deep sharp edge for any form of plastic repair. The previously quoted treatment of the Arch of Septimus Severus¹ required the filling of very large losses but does not describe instances of shallow filling requirements. Nardi does describe the incorporation of acrylic emulsion for fine crack filling and it is assumed that a transition between straight lime and acrylic addition was made. This author has also used acrylic augmented lime fills to repair highly decorative marble that remain effective after 21 years. Acrylic is not a natural partner for lime mortars as it causes stretching and cracking not encountered in straight lime putty fills.

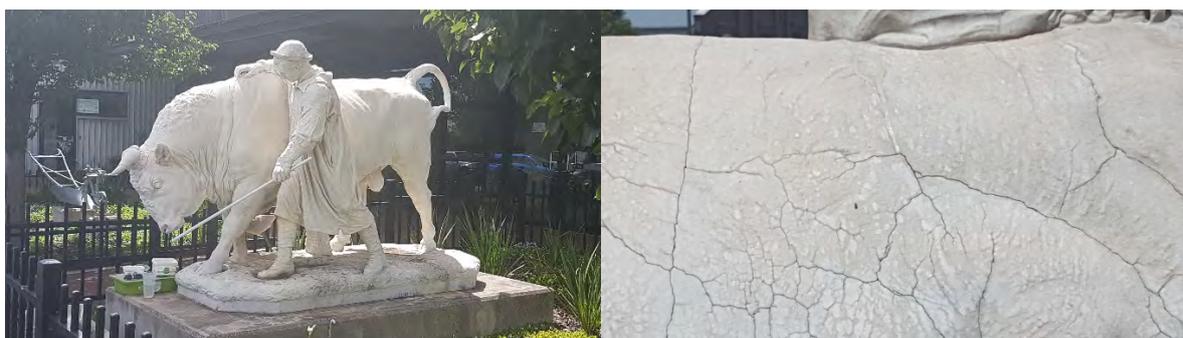
Figure 5. Young Bull and Handler, showing a detail of the overall crack pattern across the upper back of the bull.

The pattern of fine cracks in the upper marble (Figure 1, Figure 5) are not considered a structural issue, despite the deepest and most visible one appearing to suggest the head may detach at any moment.
