Proceedings of the 5th Historic Mortars Conference

5th Historic Mortars Conference

19-21 June 2019
Pamplona, Spain

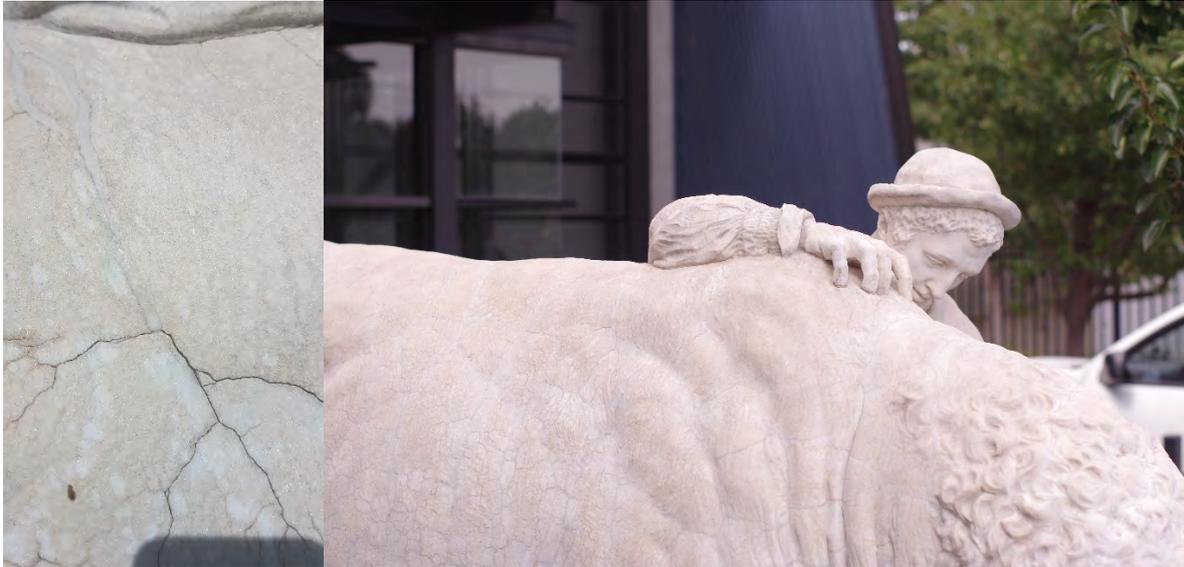
Figure 6. Detail of the filling process on left with the upper crack over-filled prior to finishing. The completed surface on right after 18 months.

The final application of 65:100 liquid:aggregate was allowed to over-fill the surface. This over-fill was removed with diamond discs attached to a Dremel drill. The ability to work the cured mortar in this manner is critical to achieving a gloss match but also serves as testament to the cohesive strength of the grout. The ground surface was dense but more water absorptive than the parent marble, thus lithium silicate has been applied during all stages of the application, including the final grinding. Further application of lithium silicate

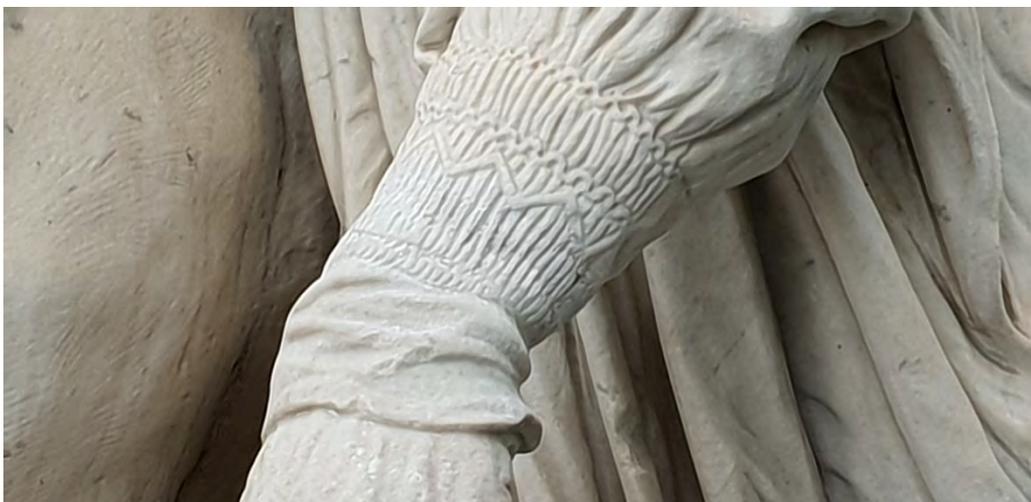
Figure 7. The drapery above the Handler's wrist required extensive mortar repairs, testing the modelling abilities of the mortar.

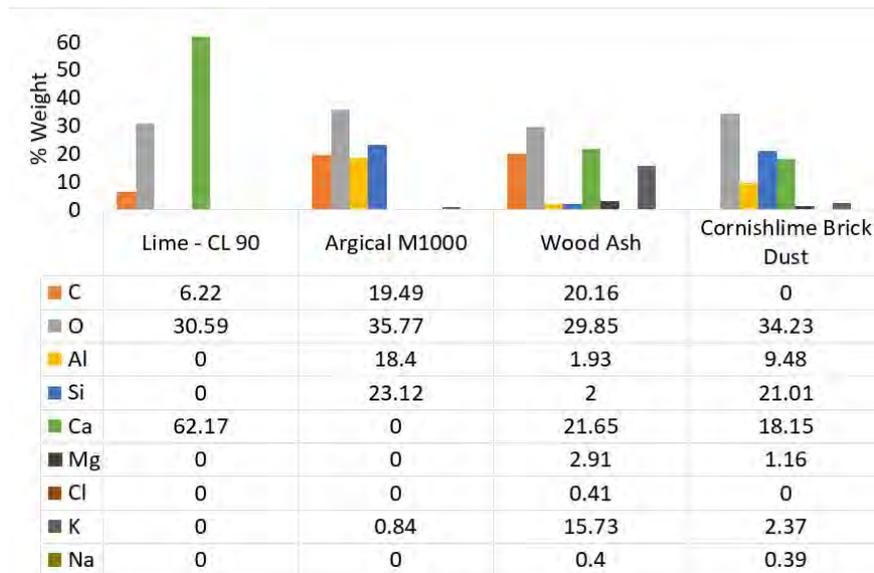
Figure 1: Elemental composition of the raw materials (Weight %)

Argical M1000, Wood ash and brick dust are produced at temperatures of $600\text{--}800^\circ\text{C}$, above 850°C and above 1000°C respectively. The elemental analysis (EDX) confirmed that CL90 is a pure hydrated lime which does not contain silicon (Si), aluminium (Al) or magnesium (Mg). The highest quantity of Si was observed in Argical M1000 which was 23.12% by weight. Cornish Lime brick dust (21.01%) had a comparatively lower Si weight percentage than Argical M1000. Wood ash showed the lowest Si and Al content which are important for promoting pozzolanic reactions with lime (CL90). The amount of aluminium oxide impacts the strength, setting characteristics, microstructure, acid resistance of the properties and metakaolin includes 40% aluminum oxide while other pozzolan, slag has 10% aluminum oxide content [13]. Walker and Pavia reported that the initial setting time of pozzolan-lime pastes are increased by the presence of silica and alumina phases, while the content of calcium and magnesium oxides decrease it [14]. Contrarily, $\text{Mg}(\text{OH})_2$ is not associated with the strength of samples in terms of the studies of Edwards [15]. In terms of this study, Argical M1000 has the highest initial setting time while wood ash has the lowest regarding their silica and alumina contents. This is shown in Figure 6 where the lowest initial reaction delayed Argical M1000 and brick dust initiated. The presence of Ca as not detected for Argical M1000 while Cornish Lime brick dust and wood ash had levels of 18.15% and 21.65% respectively. Quantities of chlorine (Cl) were detected in the wood ash along with a high proportion of potassium (K). Small amounts of K and sodium (Na) were detected in the wood ash and brick dust, Figure 1.

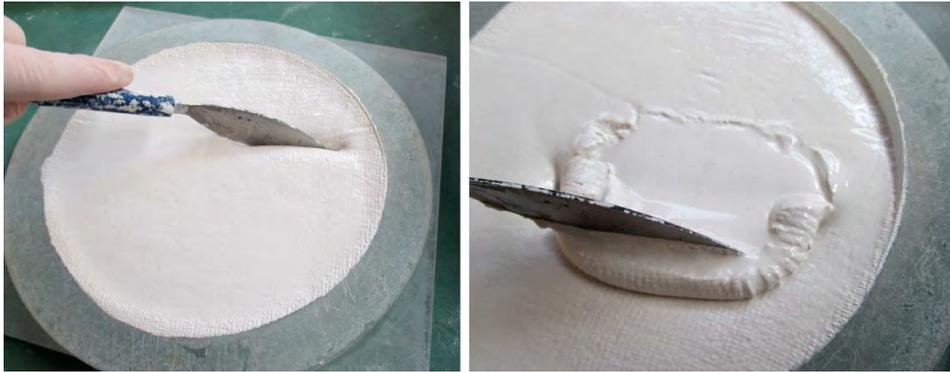
Figure 2. Checking the thickness of compact layer.

Water retention and release test was used to determine the ability of the fresh grout to retain water when subjected to suction. Water retention capacity was determined by the adapted standard procedure prEN 1015-8:1999. The grout is placed in a standard mould, with the upper diameter of 150 mm, lower diameter of 140 mm and a height of 15 mm. The grout surface is covered with a thin sheet of a nonwoven tissue and filter paper plates and immediately inverted onto a smooth levelled non-absorbent surface. A 2 kg weight is placed on the back of the mould and the grout is subjected to suction for 5 minutes. After 5 minutes, the filled mould is inverted again and the filter papers at the top of the grout surface are removed. The thickness of compact grout layer in contact with the filter papers is checked by cutting the grout with a knife or spatula (Figure 2). The water retentivity of the grout is classified as: good (G_D) – if the thickness of the compact layer is less than or equal to 5 mm and the grout is still fluid under the compact layer; medium (M_D) – if the thickness of the compact layer is between 5 and 10 mm and the grout is still fluid under the compact layer; or bad (B) – if the thickness of the compact layer is more than 10 mm. The thickness of the compact layer, measured from the top of the grout layer, is recorded as D in millimetres.

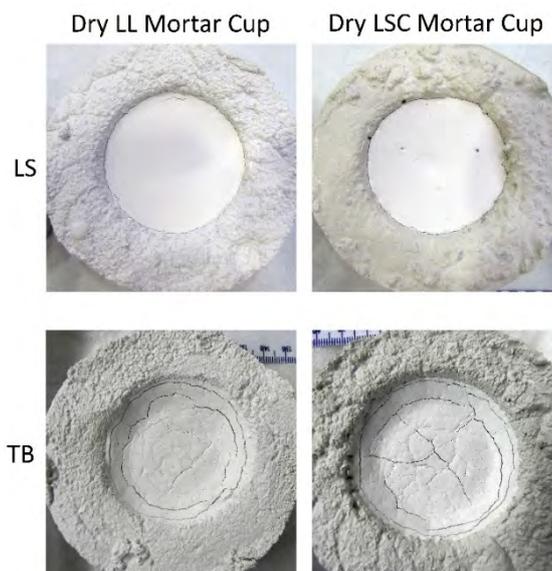
Figure 4. Reference mixtures LS and TB after drying in lime (LL) and lime-cement (LSC) mortar cups.

Situation is quite different for the TB grout, where different thicknesses of separation rings were observed in tested samples, ranging from 0.30 to 1.00 mm for the LL mortar cups, and from 0.40 to 1.00 for the LSC mortar cups. At the same time, cracks were formed also inside of each sample, with thicknesses between 0.10 to 1.5 mm for the LL and LSC mortar cups. Therefore, all but one TB samples can be classified as grout with high drying shrinkage (HS). The only exception is sample TB6 with the MS classification.

The mortar cups simulate the absorptive effect of porous plaster and demonstrate the extent of the grout volume stability when exposed to drying. Low volume stability of the grout leads to the formation of cracks inside the grout. By comparing the behaviour of the grouts in mortar cups, it is possible to obtain information about long term (24 hour or more) ability of particular grout to retain moisture inside its structure. We can see that the LS grout behaved much better, compared to the TB grout. Separation ring between mortar cup and grout and/or cracks inside the grout can also indicate excessive water content in the grout mixture, which could reduce the strength of the grout mixture [1].
