ERASMUS MUNDUS MASTER IN ARCHaeological MATerials
Science

Unveiling the mural art of Almada Negreiros at the Maritime Stations of
Lisbon: *diagnosis research of paint layers as a guide for its future
conservation*

Mila Cvetković

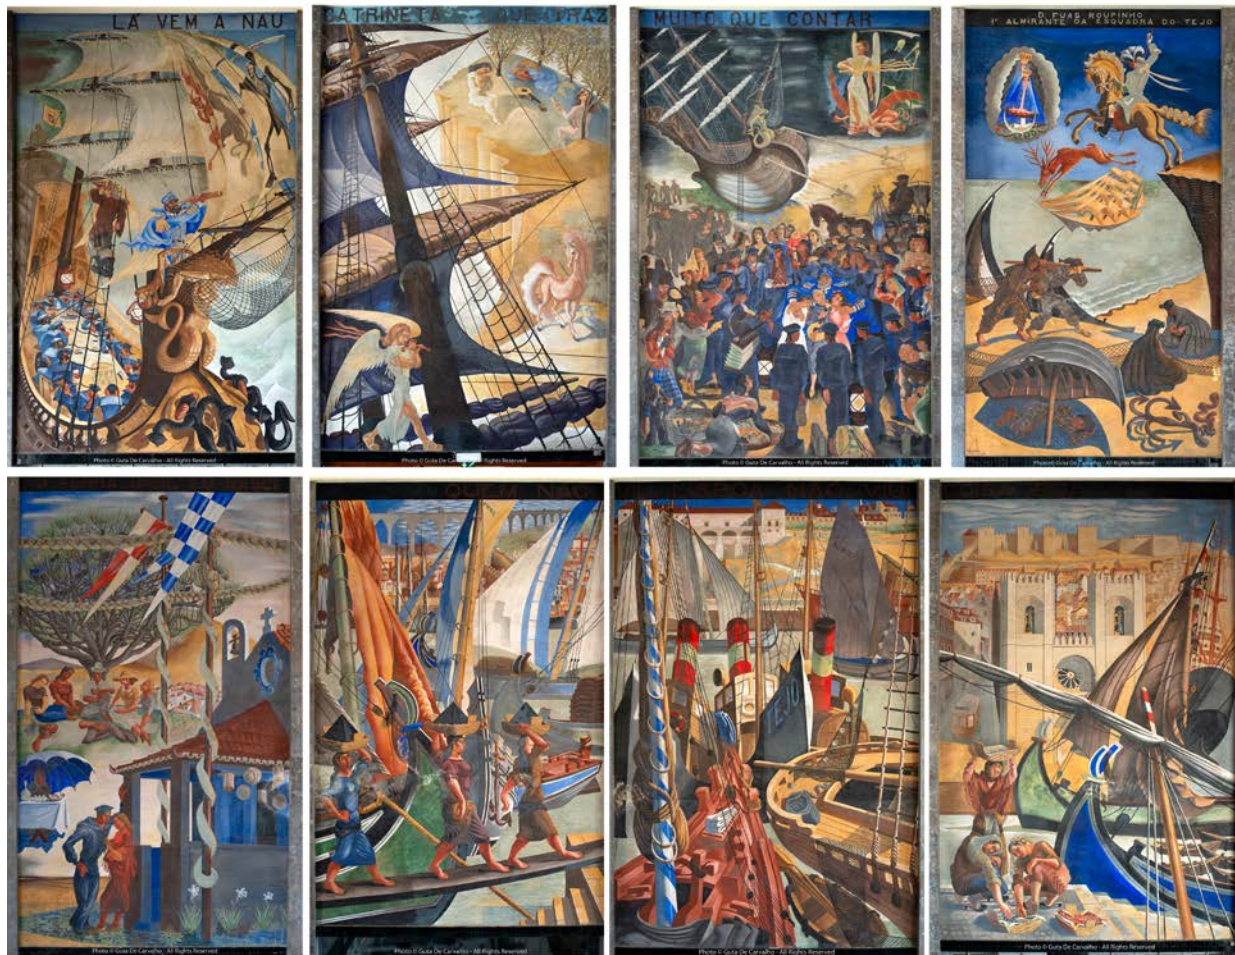
Almada painted the murals of Alcântara Station in a naturalistic way. Eight murals - two triptychs and two individual paintings are presented in the waiting hall of Alcântara. They carry names (sequentially): (P1) *Lá vem a nau*, (P2) *Catrineta que traz*, (P3) *Muito que contar*, (P4) *D. Fua Roupinho*, (P5) *O terra onde eu nasci*, (P6) *Quem não*, (P7) *Viu Lisboa não viu*, (P8) *Coisa boa* (Figure 8).

Figure 8. Murals of Alcântara station in their sequential order as they appear in the hall. Images are taken by Guta Carvalho (6-7th of June 2020 © all rights reserved)

In total eight murals are presented on the east and west wall of Alcântara station: two triptychs and two individual paintings (Chapter II, Figure 8, Appendices I and II). Subject of this research were murals under numbers 2,3 & 6 (Figure 12). They were chosen based on type of deterioration, since each had deteriorated features representative for all eight murals.

Beside the photo documentation survey of eight panels taken in 2020 (Figure 8 of the chapter II), two other sets of images were part of this research. The photographs from APL Archival coming from the late 1990s and the set photographed by José Vicente on 16th of July 2013 (Photographs are presented in the Appendix I). Decay dynamics are evident when photographs of the panel 3 are compared (Figure 18). Many of salt induced phenomena developed in the 30 years that elapsed between the first and last set of photos analysed. Since Almada completed the murals of Alcântara station in 1943, this would mean that main decay phenomena rapidly evolved during the last third of their existence. One of the deteriorated spots affected by salts sub-efflorescence and salt efflorescence is marked in red in the three photographs from 1990, 2013 and 2020 (Figure 18). White veil covering paint layer is clearly visible in last two photographs and yet we can notice that it didn't exist in the first one, taken in late 1990s. Based on the location of the area affected as presented in the figures 12 and 13 of the previous chapter, this white veil can be a consequence of poor isolation and concentration of water vapour formed by installations (pipes) for hot water or heating.

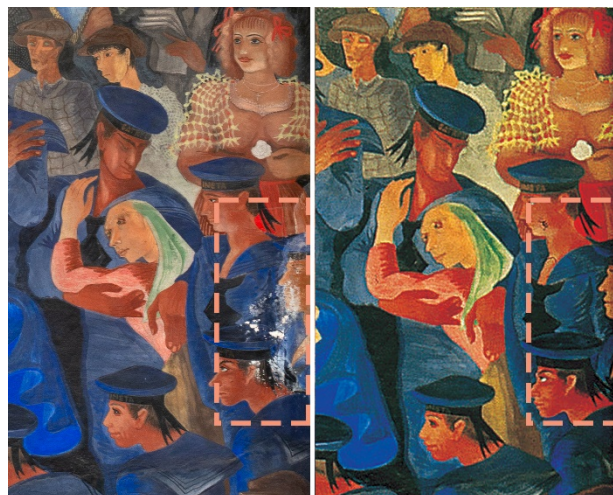
Figure 11. Panel 3. On the left: photograph taken by Guta Carvalho (6-7th of June 2020), on the right: photograph taken in late 1990s (APL Archival). The area chosen for analysis of salts deterioration dynamics is indicated with interrupted line

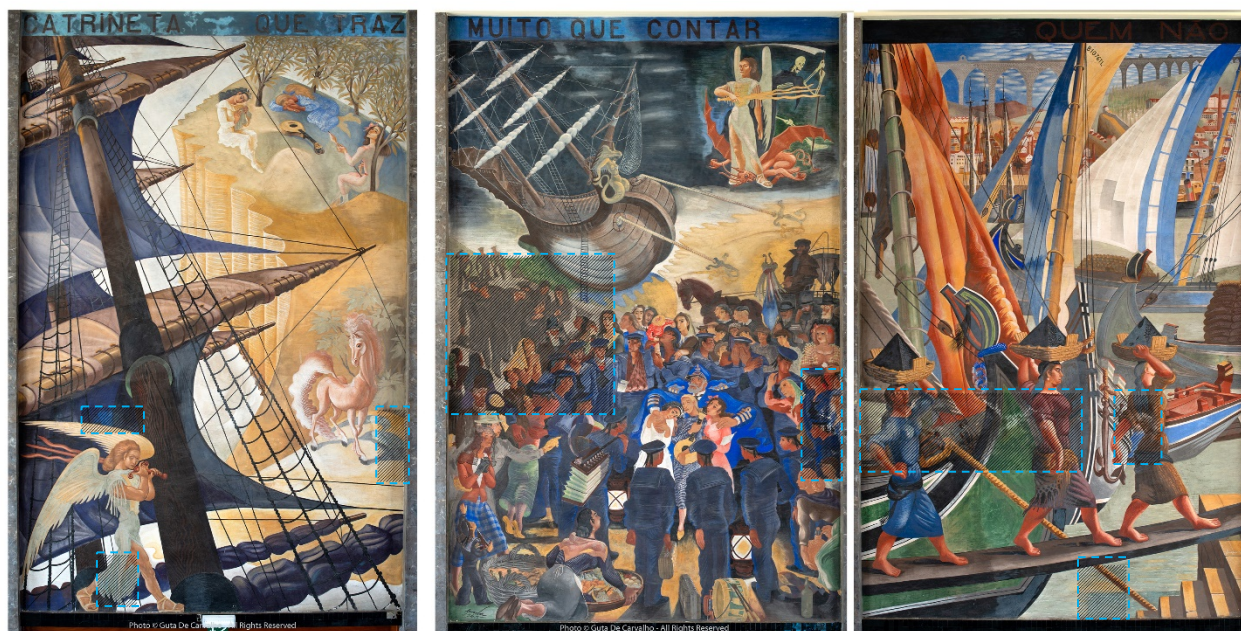
Figure 12. From left to right: Panels 2, 3, and 6, with indicated areas of interest that were analyzed in-situ and laboratory setup (photos by Guta Carvalho 2020 © all rights reserved)

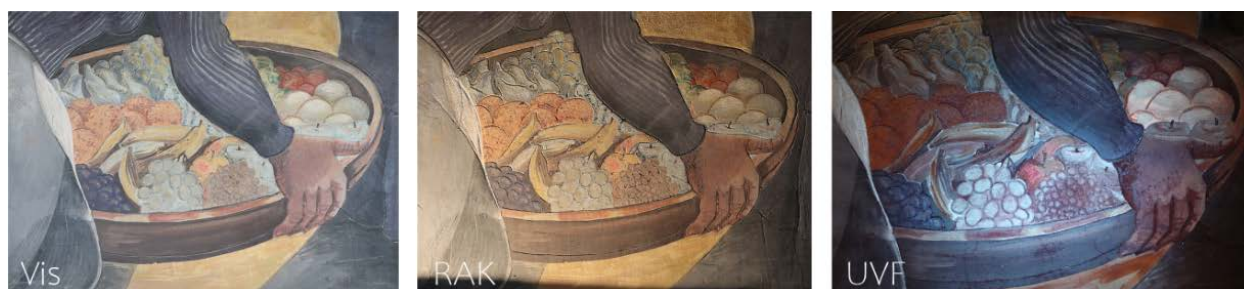
Initial insight into the deterioration and the painting materials was obtained after *in-situ* analyses. The first step was to identify and locate the main deteriorated areas of all eight murals, with later focus on three of them: murals 2,3 and 6 (Figure 11 of previous chapter). As it was explained in *Chapter III*, these murals were chosen based on their representability regarding decay phenomena which are affecting all paintings of Alcântara station. Photographic documentation in visible (Vis), visible raking (Vis-RAK) and UV induced fluorescence (UVF) light allowed us to detect, mark and record all areas of interest. Visible raking light (RAK) highlighted the extent and severity of flaking and lack of cohesion of paint layers, and ultraviolet induced fluorescence (UVF) light showed presence of areas that potentially underwent previous treatments (Figure 16).

Figure 16. Area of the basket with fruits from the panel 3, Photo-documentation taken in Vis, RAK and UVF light during the survey (1st-6th June, 2020)

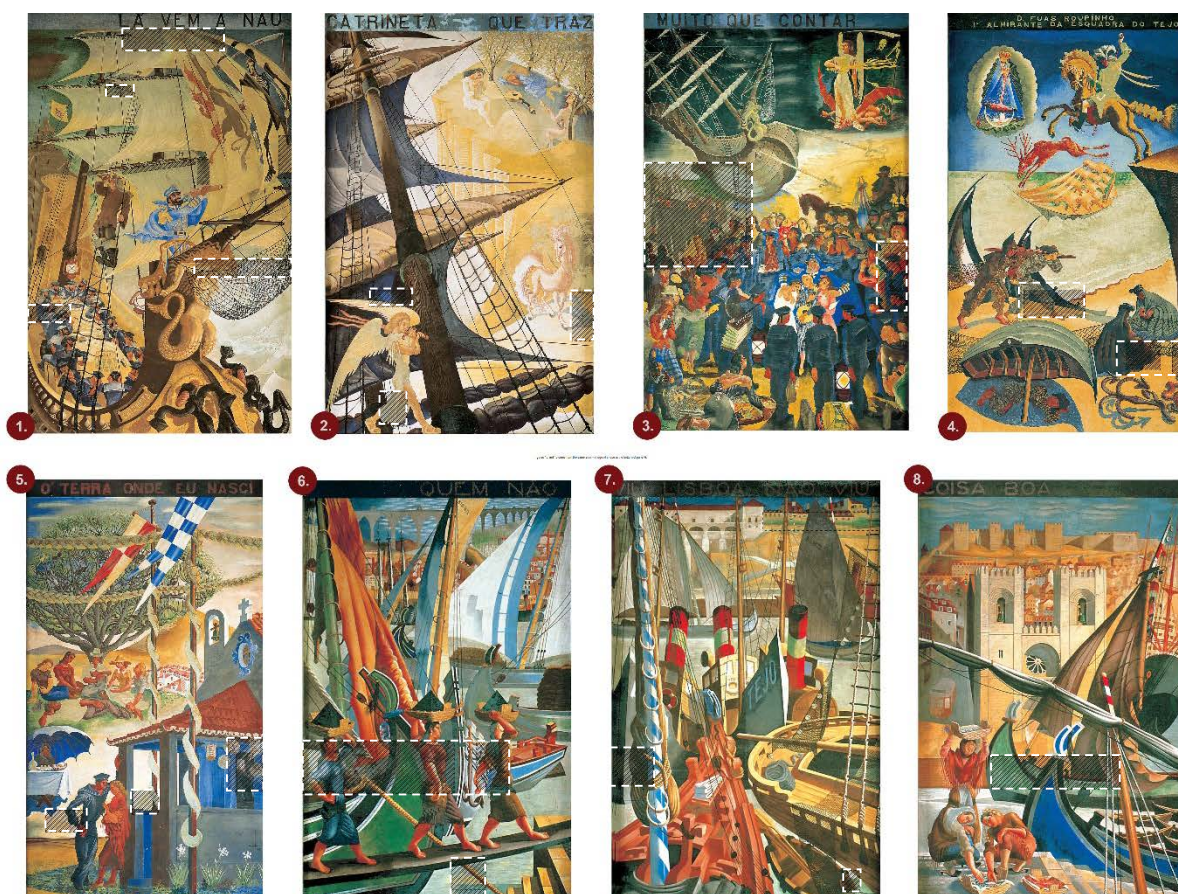
Figure 17. Images of eight panels of Alcântara station. Areas that display deterioration problems such as flaking, lacuna and formation of salts are marked in white

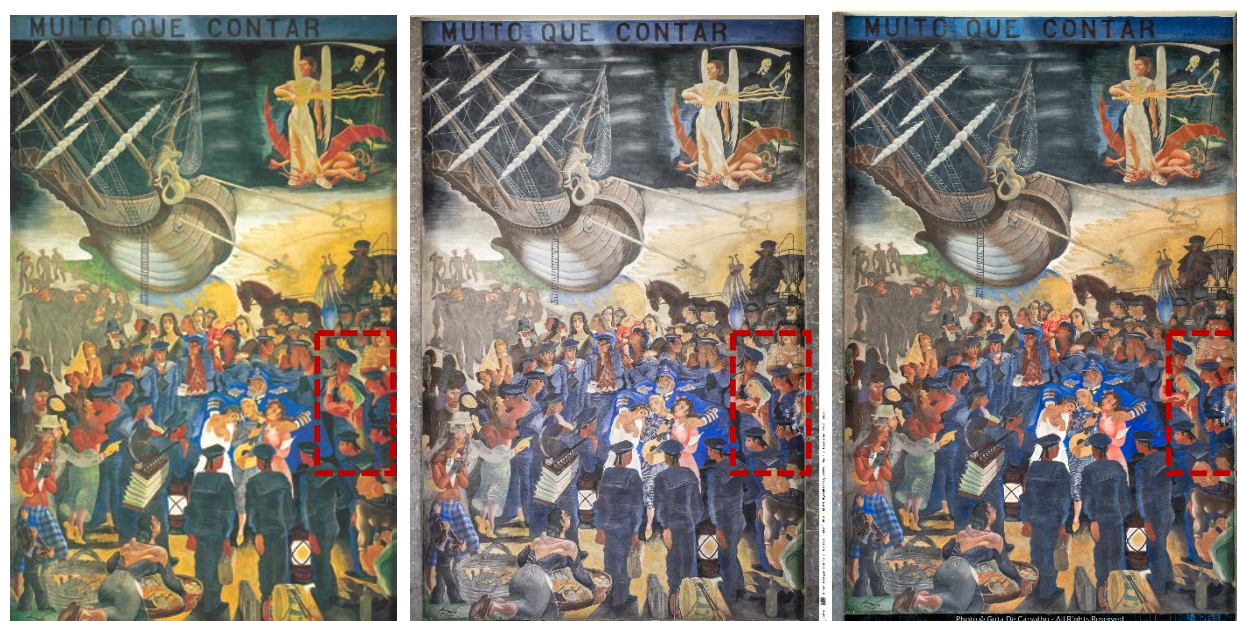
Figure 18. Three images of panel 3 of Alcântara station. From left to right: APL Archival (late 1990s), José Vicente (16th of July 2013), Guta Carvalho (6-7th of June 2020). Deteriorated area marked in red illustrating decay dynamics

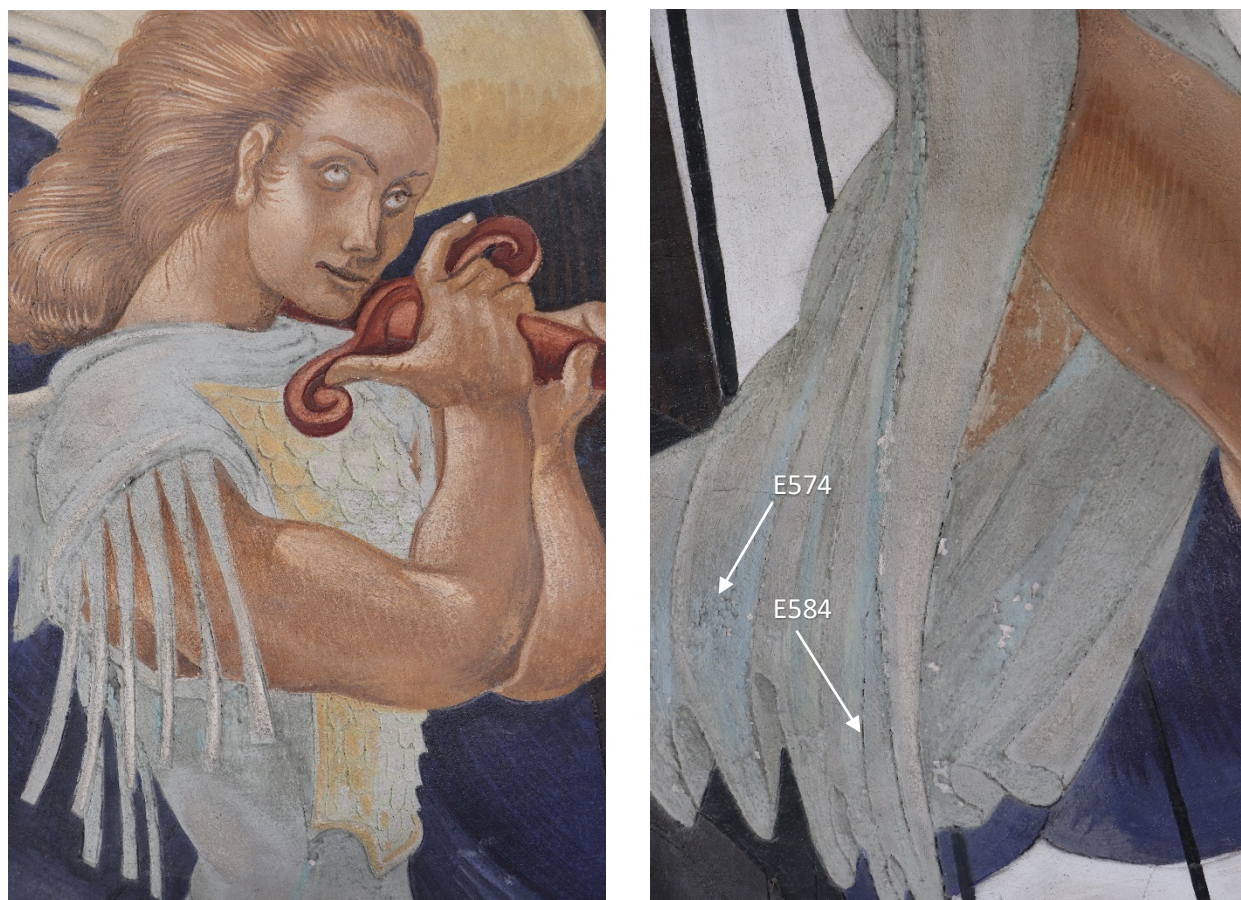
Figure 18. Two zones of interest in Vis light of panel 2 displaying image of Angel and his garment

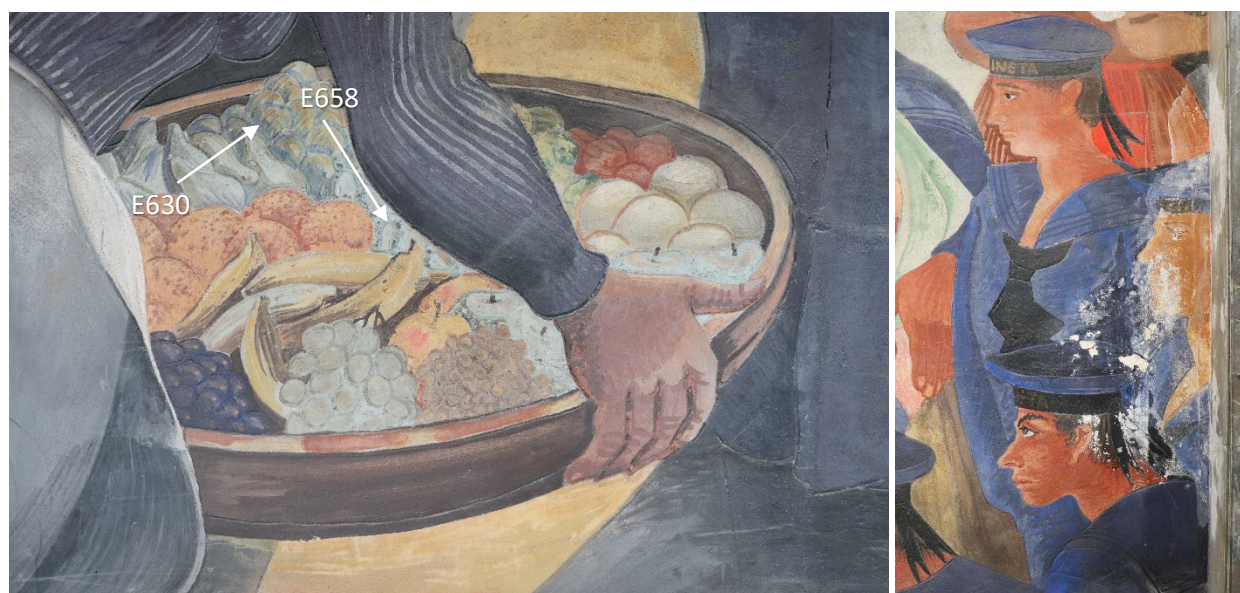
Figure 21. Two zones of interest of panel 3. First one, on the left, displaying the basket with fruits, second one, near the right edge of the panel, presenting figures of sailors

Panel 3 was divided into two zones of interest as presented in the Figure 21 above. They are displayed in Appendices I and II in more detail. The first one is a basket with fruits, that held the largest amount of different colour hues, while the second one, on the right, near the edge of the panel, was previously described as the area displaying severe salts formation in the last 30 years (Figure 18). Regarding the first zone - basket with fruits, the main issue seems to be the lack of cohesion of the paint layers, which caused erosion and lacunae (Figure 22).

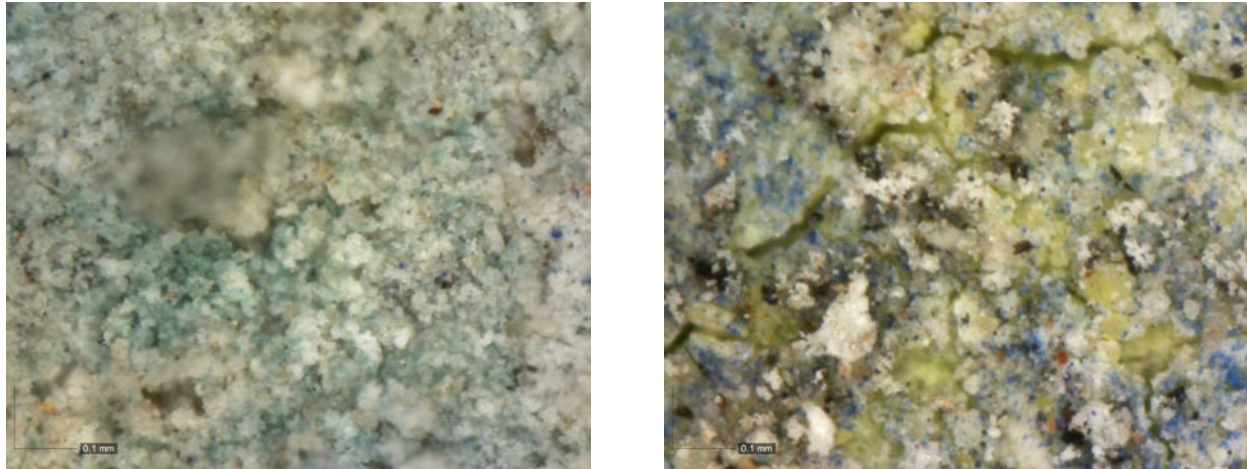
Figure 22. Two portable optical microscope (p-OM) images E658 (on the left) and E630 (on the right) in magnification 434x from the area in the basket of fruits, panel 3. Images are displaying paint layers affected by lack of cohesion

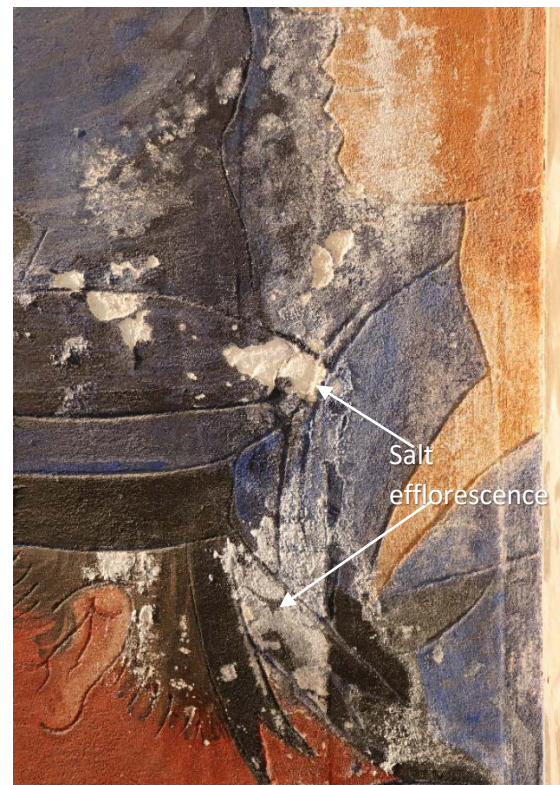
Beside the flaking and lacuna that were formed in this area, formation of a white veil and accumulation of superficial dirt are causing chromatic changes of the paint layer. The most affected pigment seems to be the dark blue shade and its hues as visible in the Figure 23.

Figure 23. Vis-RAK image of deterioration features on the second area of panel 3, affected severely by salts, salt efflorescence and sub-efflorescence

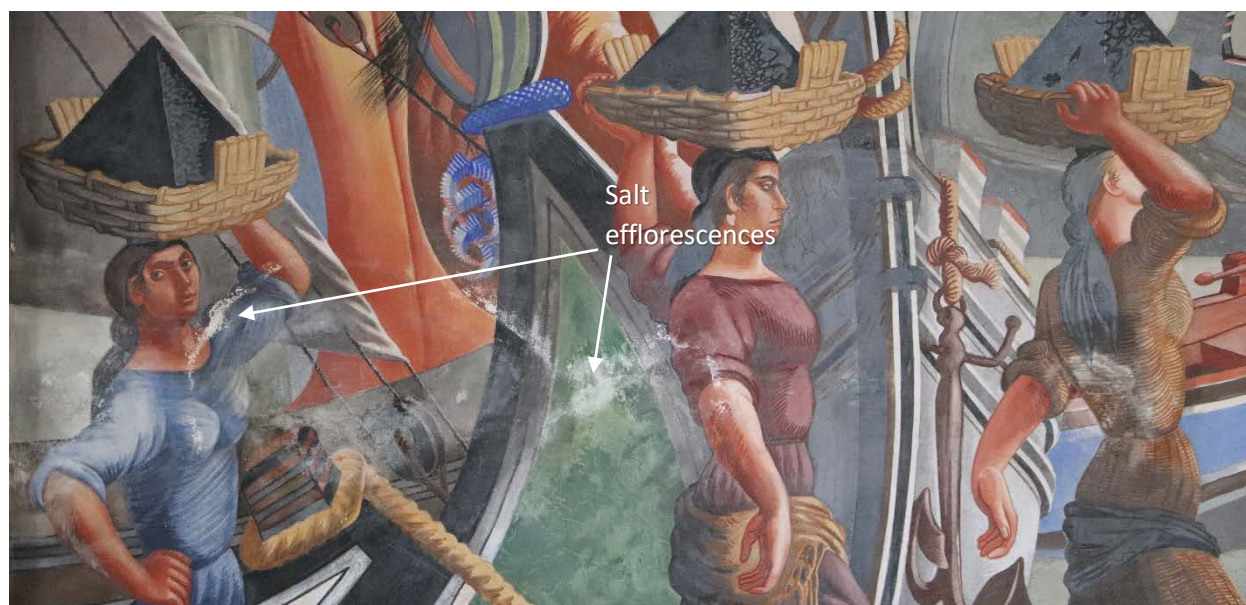
Figure 24. Zone 1 of panel 6, displaying three female figures

Panel 6 was the most complex one. Similarly to the first two panels it was divided into two deterioration zones. Zone 1, an extremely large zone, covering three female figures in the lower part of the panel, starting from the left edge and spreading almost to the right one (Figure 24). Zone 2, is located below Zone 1, and covers the greenish background at large (Figure 25). The main decay phenomena in this panel follows the pattern of the two previous ones: formation of salts, salt efflorescence and sub-efflorescence, flaking, erosion and lacunae. Salts' formation doesn't seem to be linked to a specific pigment. It rather aligns with architectural joints of the hall (similar as in the second area of panel 3) and, based on the photo documentation from last 30 years, it has been actively growing (sets of photographs of panel 6 are presented in the Appendix I). In some places, an opaque white veil is present, covering paint layers (Figure 24).

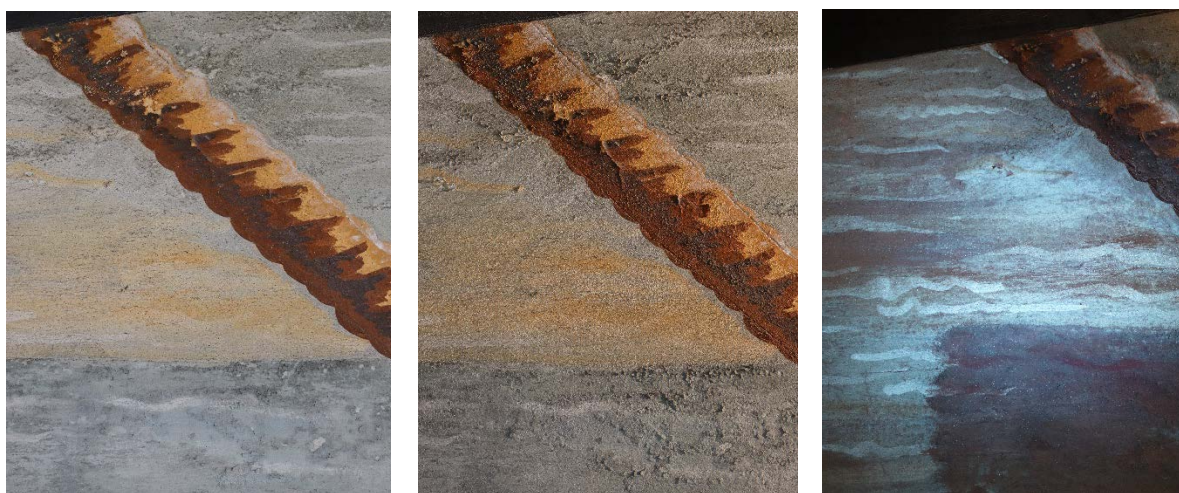
Figure 25. Vis, Vis-RAM and UVF images of flaking area with greenish background, Zone 2 of panel 6

Similarly to the previous two panels, the most degraded layer seems to be greenish blue one, present in the background and displayed in Figure 25 above. Flaking of the paint layer is clearly observed under vis-raking light (RAK) and under portable optical microscope (p-OM) in magnification 20x (Figure 29).

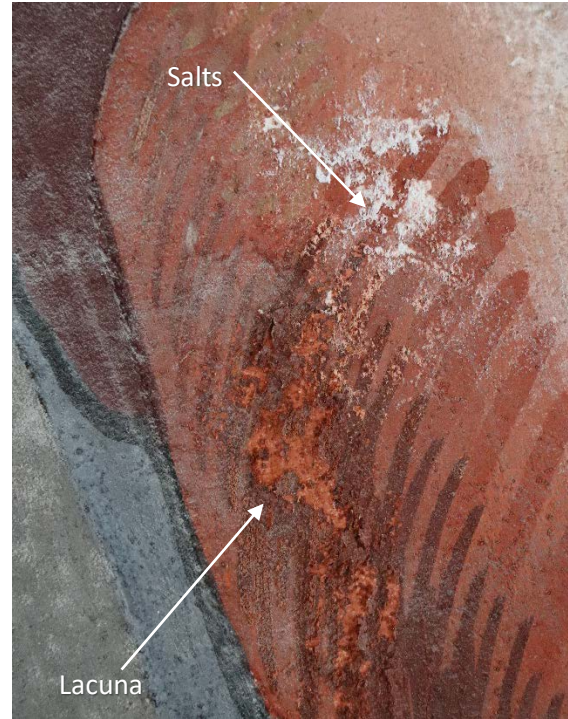
Figure 26. Flaking of the top reddish brushstrokes. The underneath pinkish background is also affected by pigments' lack of cohesion (detail of the female arm, panel 6)

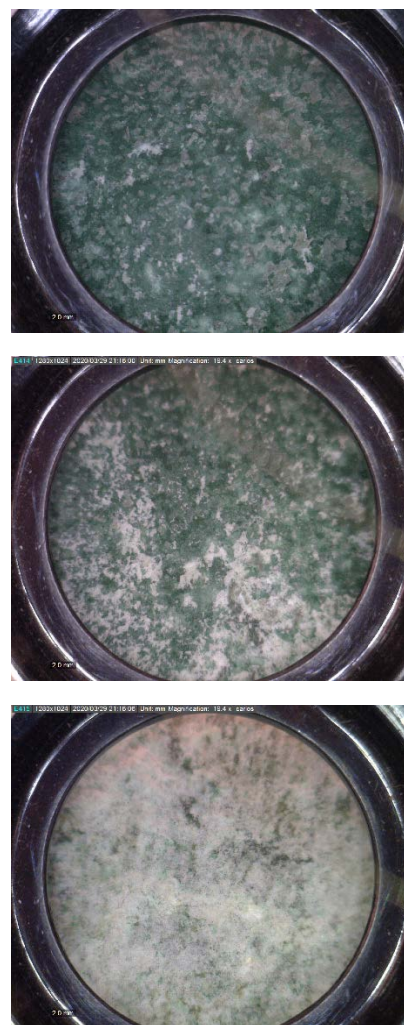
Figure 28. OM images E412, E413 and E415 (upper to lower) of different stages in the formation of white veil caused by salts mechanism. Magnification: 20x

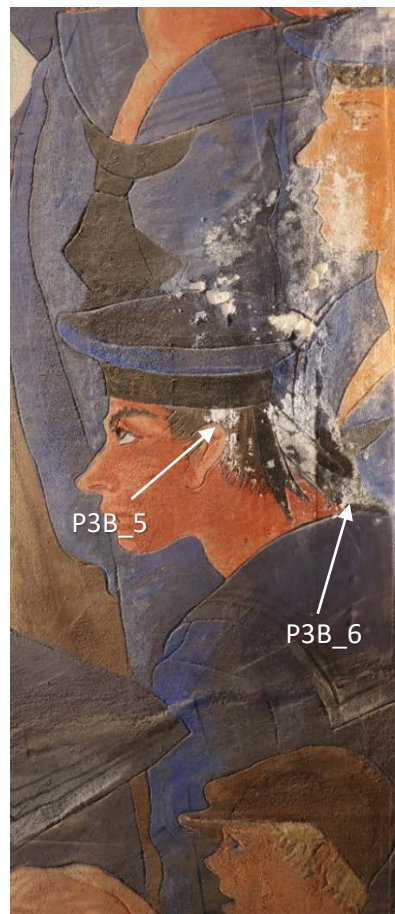
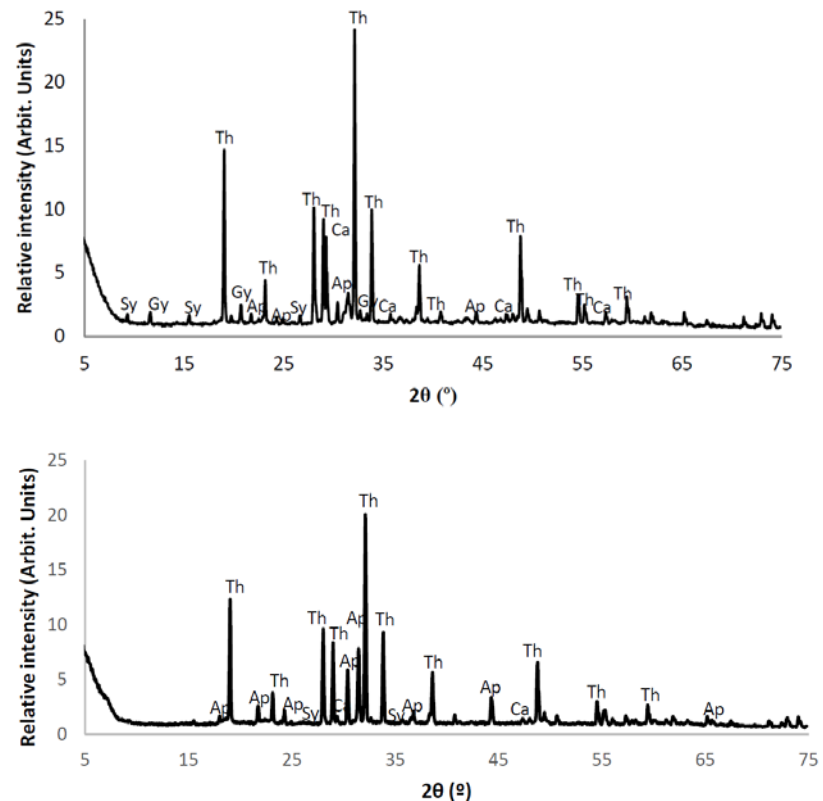
Figure 30. Left: locations of sample extraction, panel 3. Right top: μ -XRD diffractogram of sample P3B_5, right bottom: μ -XRD diffractogram of sample P3B_6. (Ca – Calcite, Th – Thenardite, Sy – Syngenite, Ap – Aphthitalite, Gy – Gypsum)

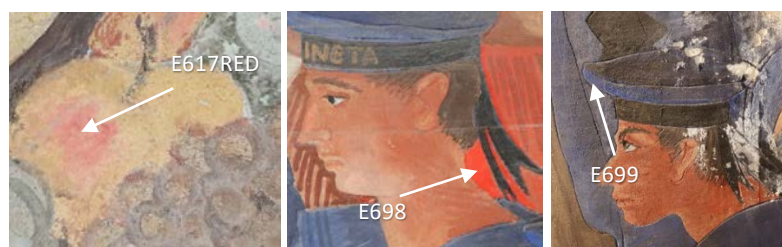
Figures 36 and 37. Area of sample E617RED, rose hue, panel 3 (on the left), area of the sample E698, vibrant red hue, panel 3 (on the right)

Handled X-ray fluorescence analyses of red, brown and flesh coloured hues, showed two types of reddish pigments. First group of point analyses seem to be enriched in iron and aluminium (Figure 35), which suggests the use of ochre-based pigments. The other one – a group of two samples from panel 3, E698 and E617RED, likely corresponds to the use of artificial cadmium pigments (Figure 35). However, it is important to note that the measurement E698 appears to have a higher amount of cadmium than measurement E617RED. Given the rose-coloured hue of measurement E617RED (Figures 36 and 37), it is possible that the cadmium pigment was mixed with lighter hue pigment in order to achieve the desired shade. One hypothesis is that E617RED might have been obtained with the mixture of cadmium and ochre pigments.

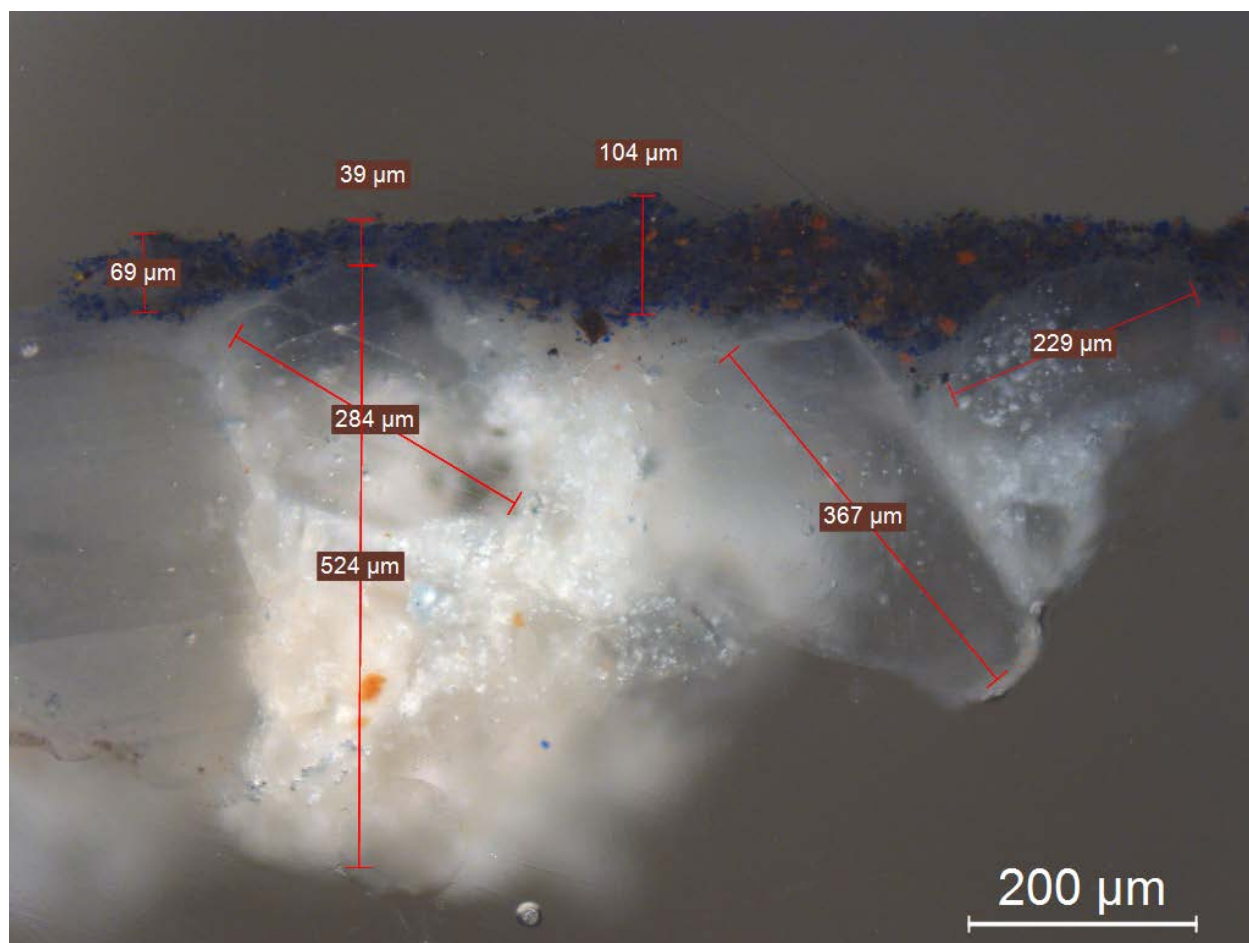
Figure 42. Microscope image of sample P3B_2 in magnification 100x showing admixture of pigments' particles in the paint layer and a lower layer of intonaco with large grains of aggregate identified as CaCO_3 by SEM-EDS

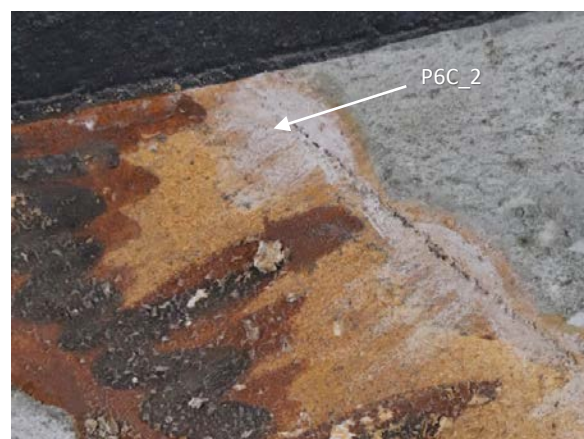
Figure 44. Area of the rope in panel 6 with marked extraction point of sample P6C_2

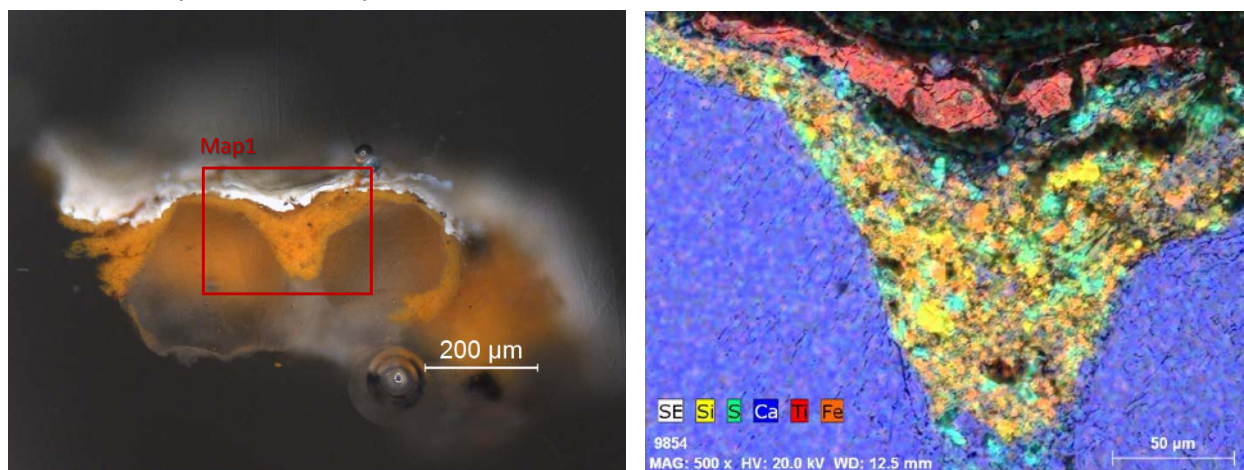
Figure 45. On the left: Microscope image of sample P6C_2 in magnification 100x with representation of paint layers and marked area of the Map, on the right: SEM image – Map1 in backscattering more in magnification 500x with representation of distribution of chemical elements within painting layers

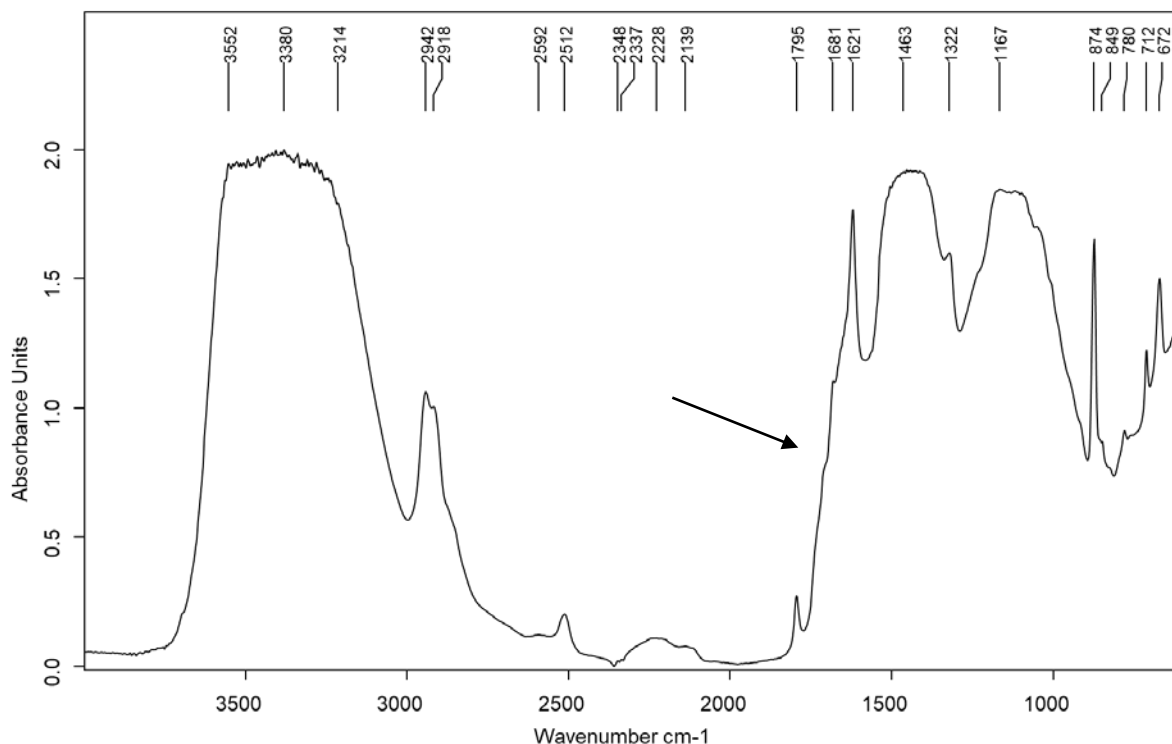
Figure 46. FT-IR spectra of the sample P6C_4 extracted from the greenish background in the panel 6. Characteristic band at 1735cm^{-1} is corresponded to vinyl polymer

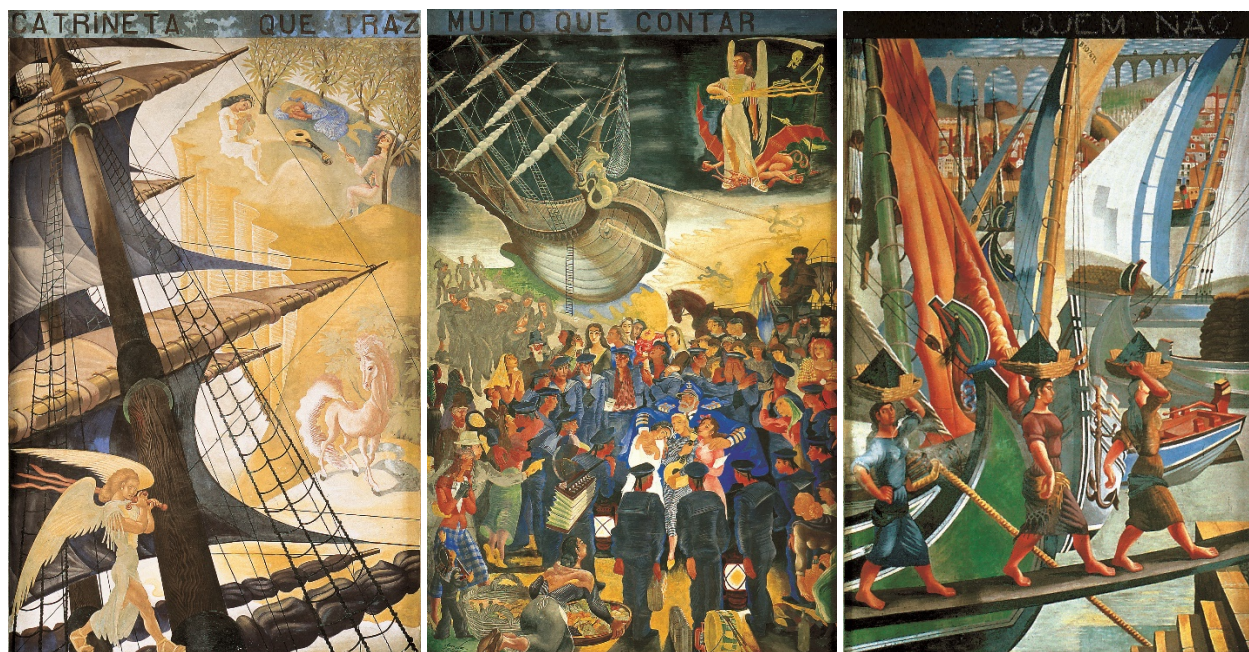
Photo-documentation of the panels 2,3 and 6 taken in the late 1990s by APL Archival:

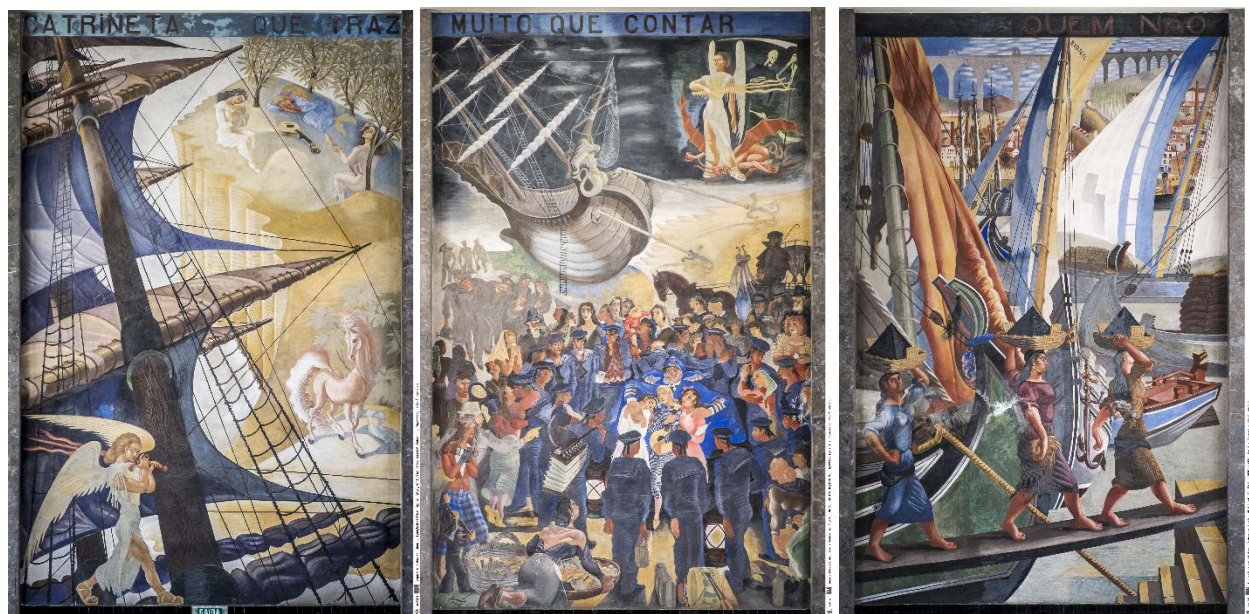
Photo-documentation of the panels 2,3 and 6 taken by José Vicente on the 16th of July 2013:

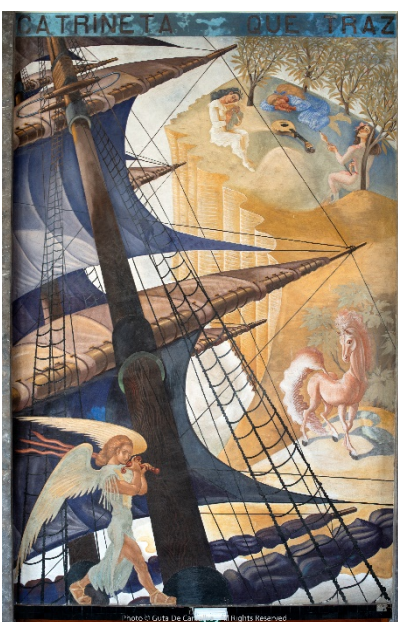
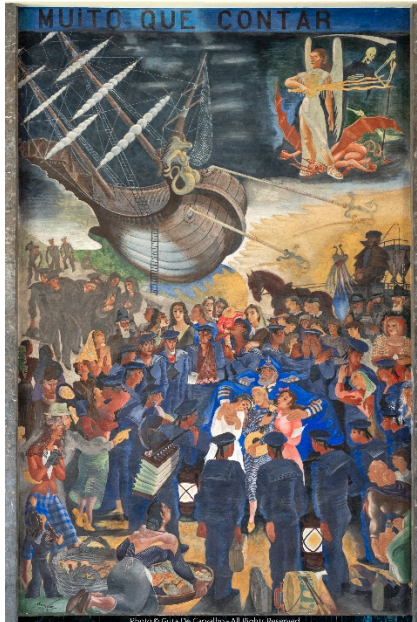
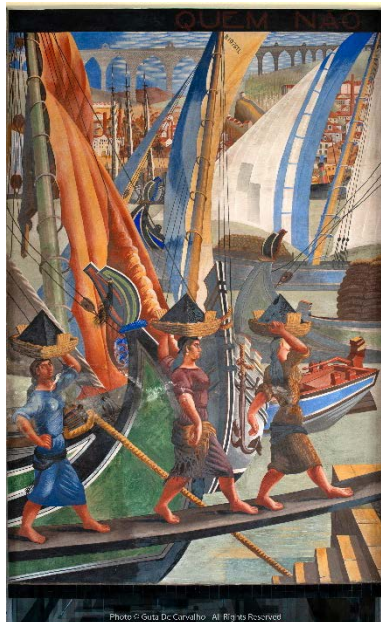
Photo-documentation of the panels 2,3 and 6 taken by Guta Carvalho on the 6th and 7th of June 2020:

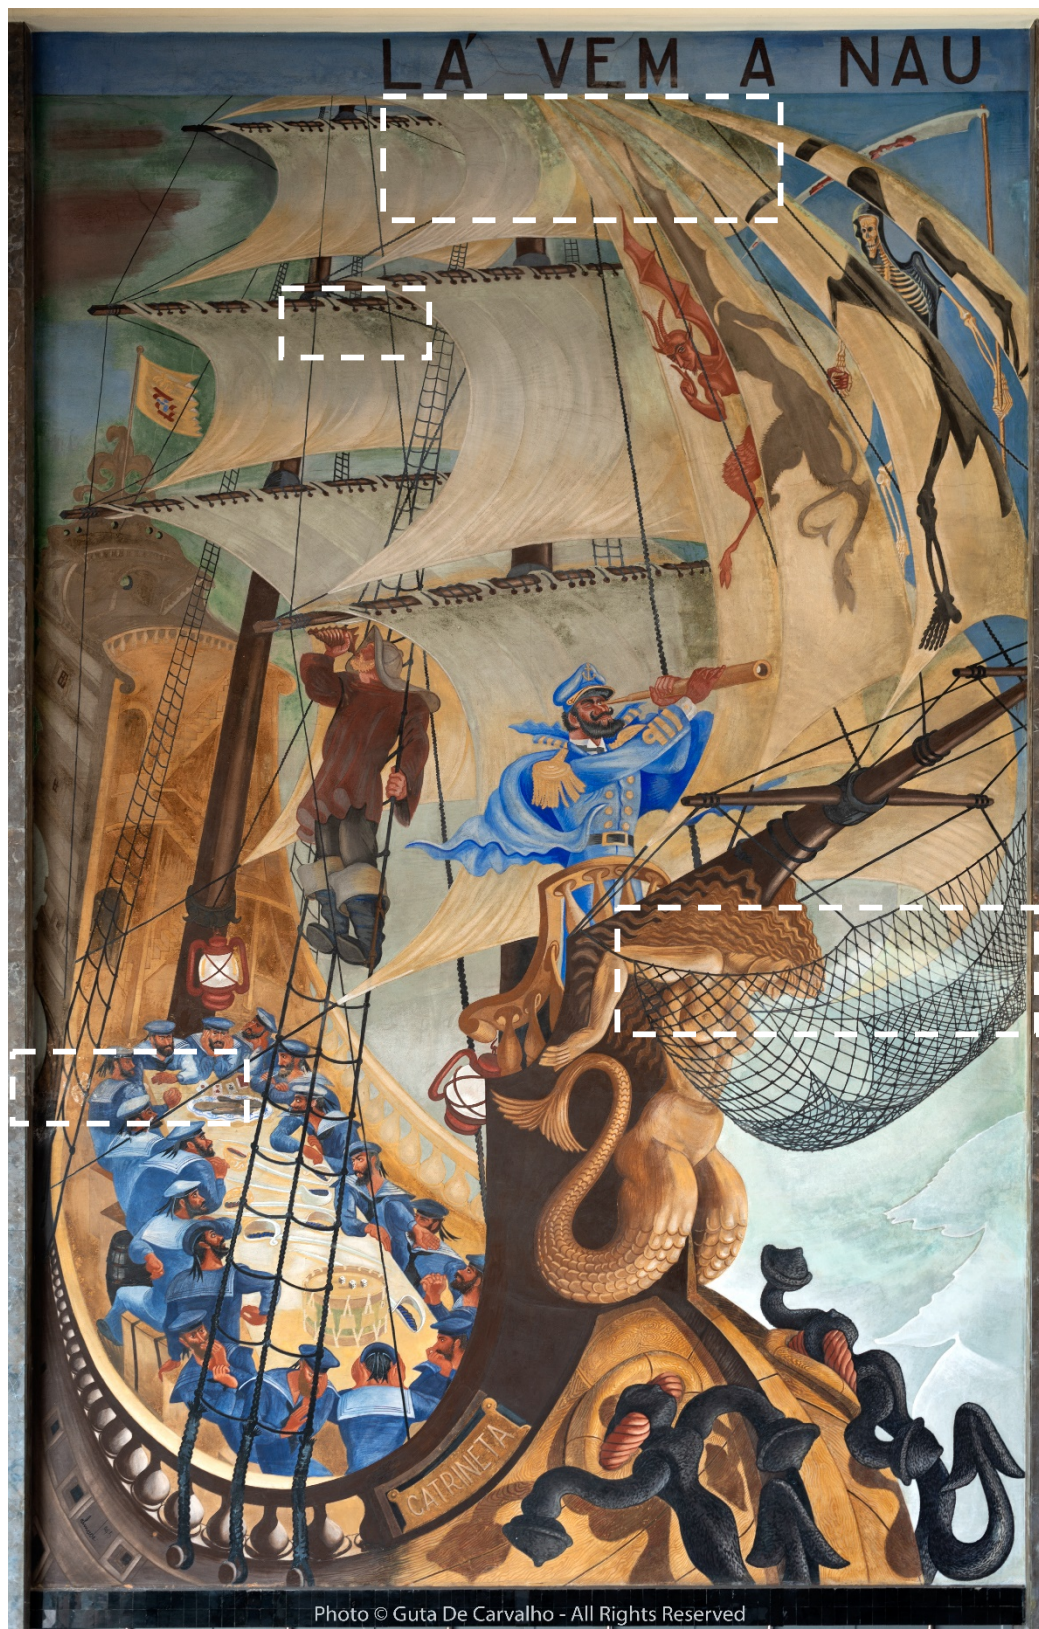
Individual presentation of panel 1, areas that display deterioration are marked in white. Photograph is taken by Guta Carvalho (6-7th of June 2020 © all rights reserved):

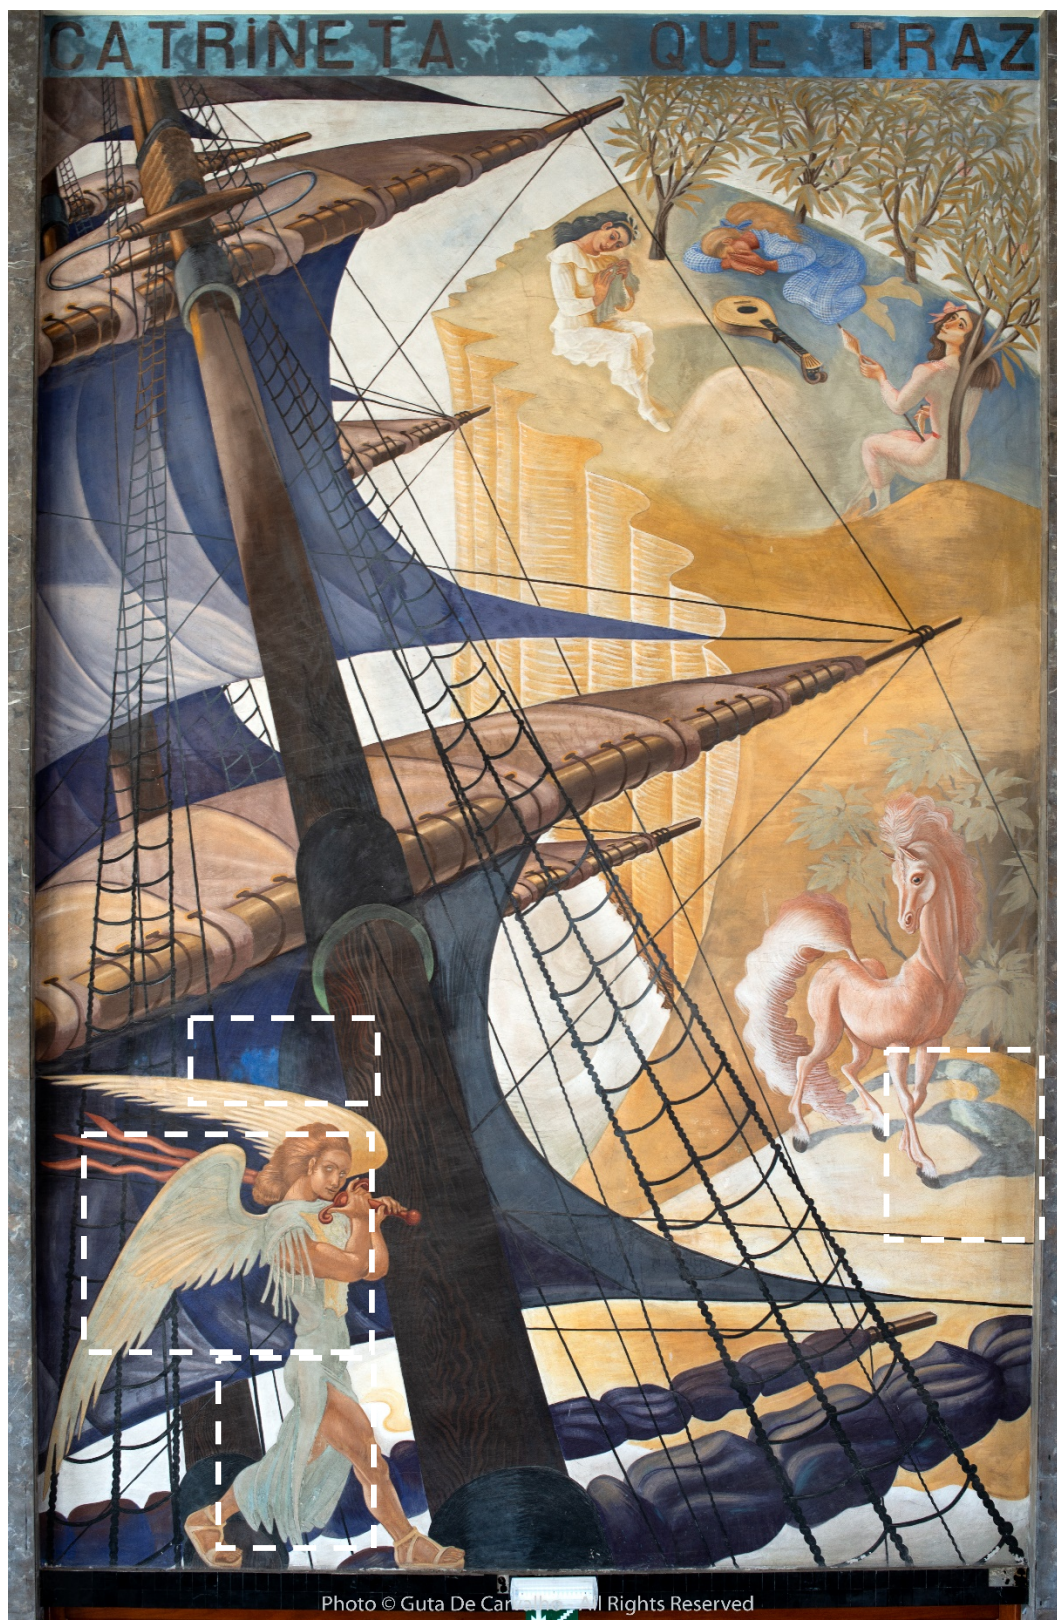
Individual presentation of panel 1, areas that display deterioration are marked in white. Photograph is taken by Guta Carvalho (6-7th of June 2020 © all rights reserved):
