ERASMUS MUNDUS MASTER IN ARCHaeological MATerials
Science

Unveiling the mural art of Almada Negreiros at the Maritime Stations of
Lisbon: *diagnosis research of paint layers as a guide for its future
conservation*

Mila Cvetković

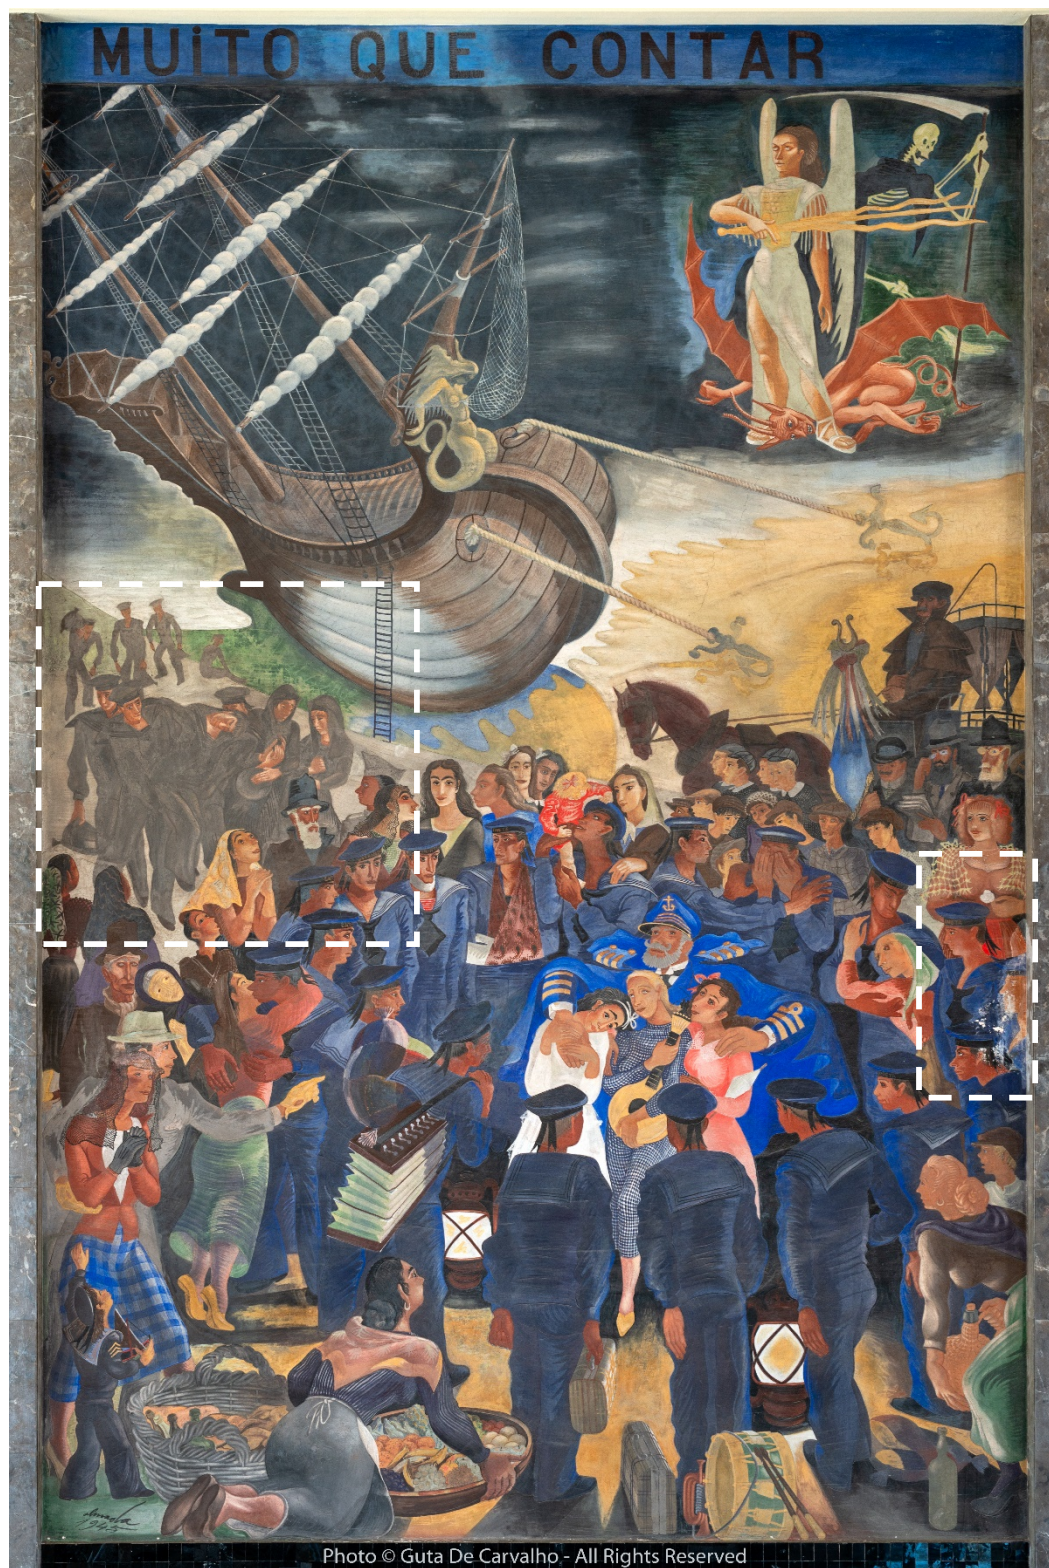
Individual presentation of panel 3, areas that display deterioration are marked in white. Photograph is taken by Guta Carvalho (6-7th of June 2020 © all rights reserved):

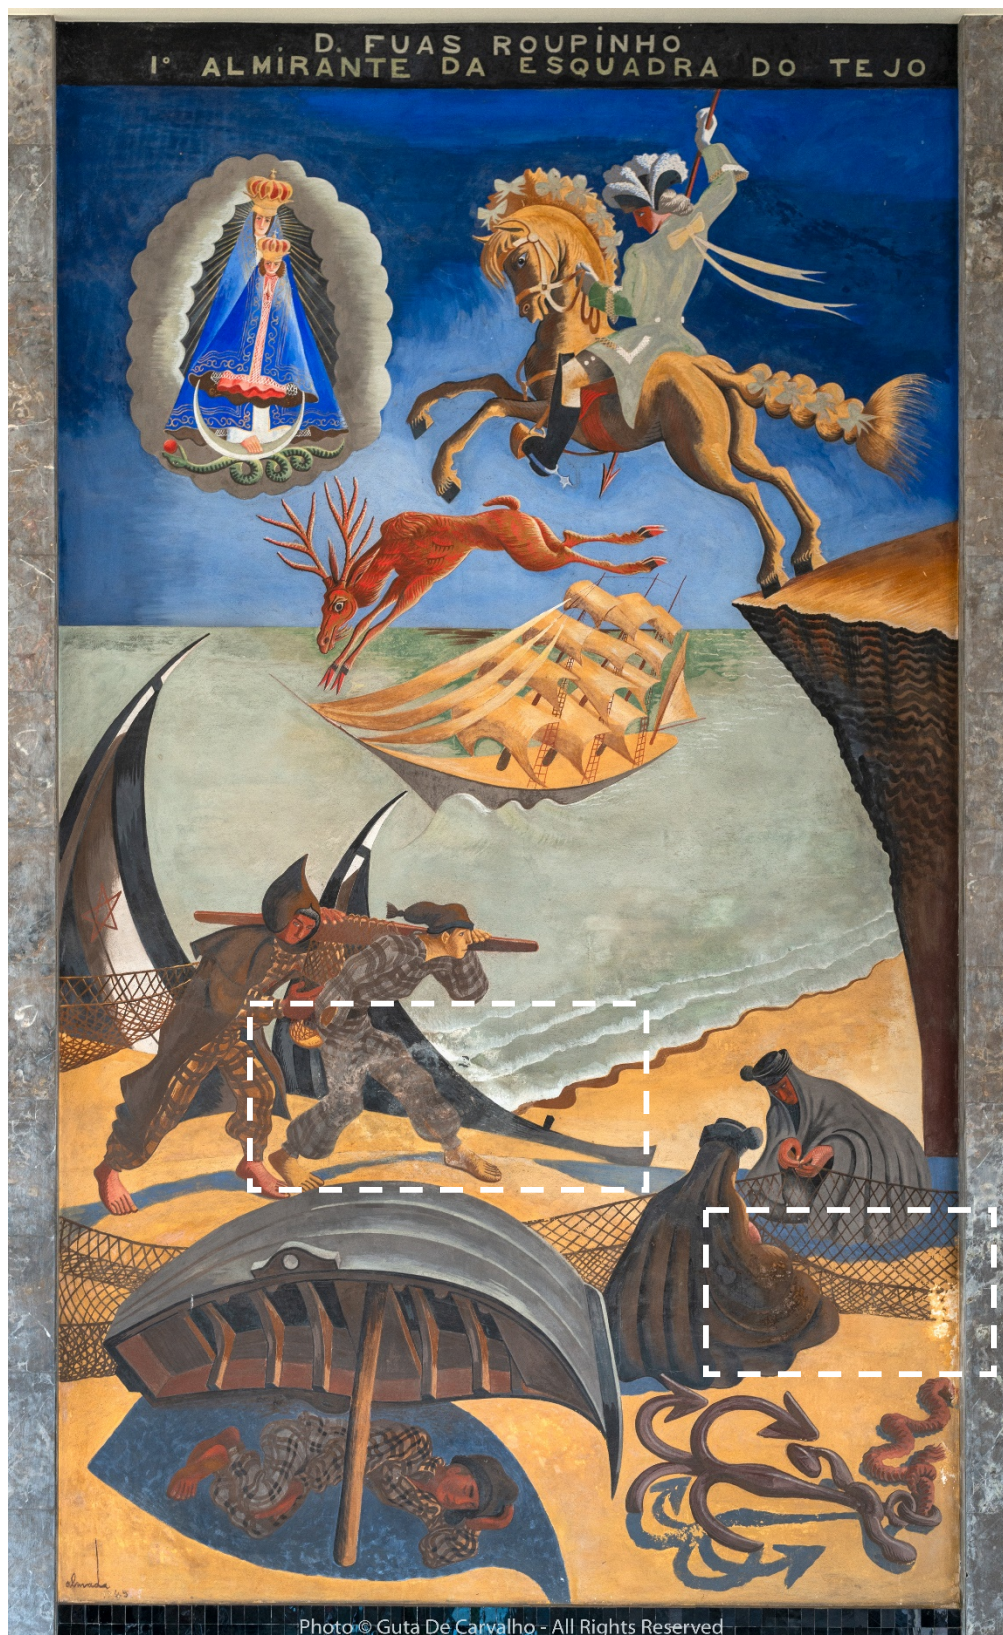
Individual presentation of panel 4, areas that display deterioration are marked in white. Photograph is taken by Guta Carvalho (6-7th of June 2020 © all rights reserved):

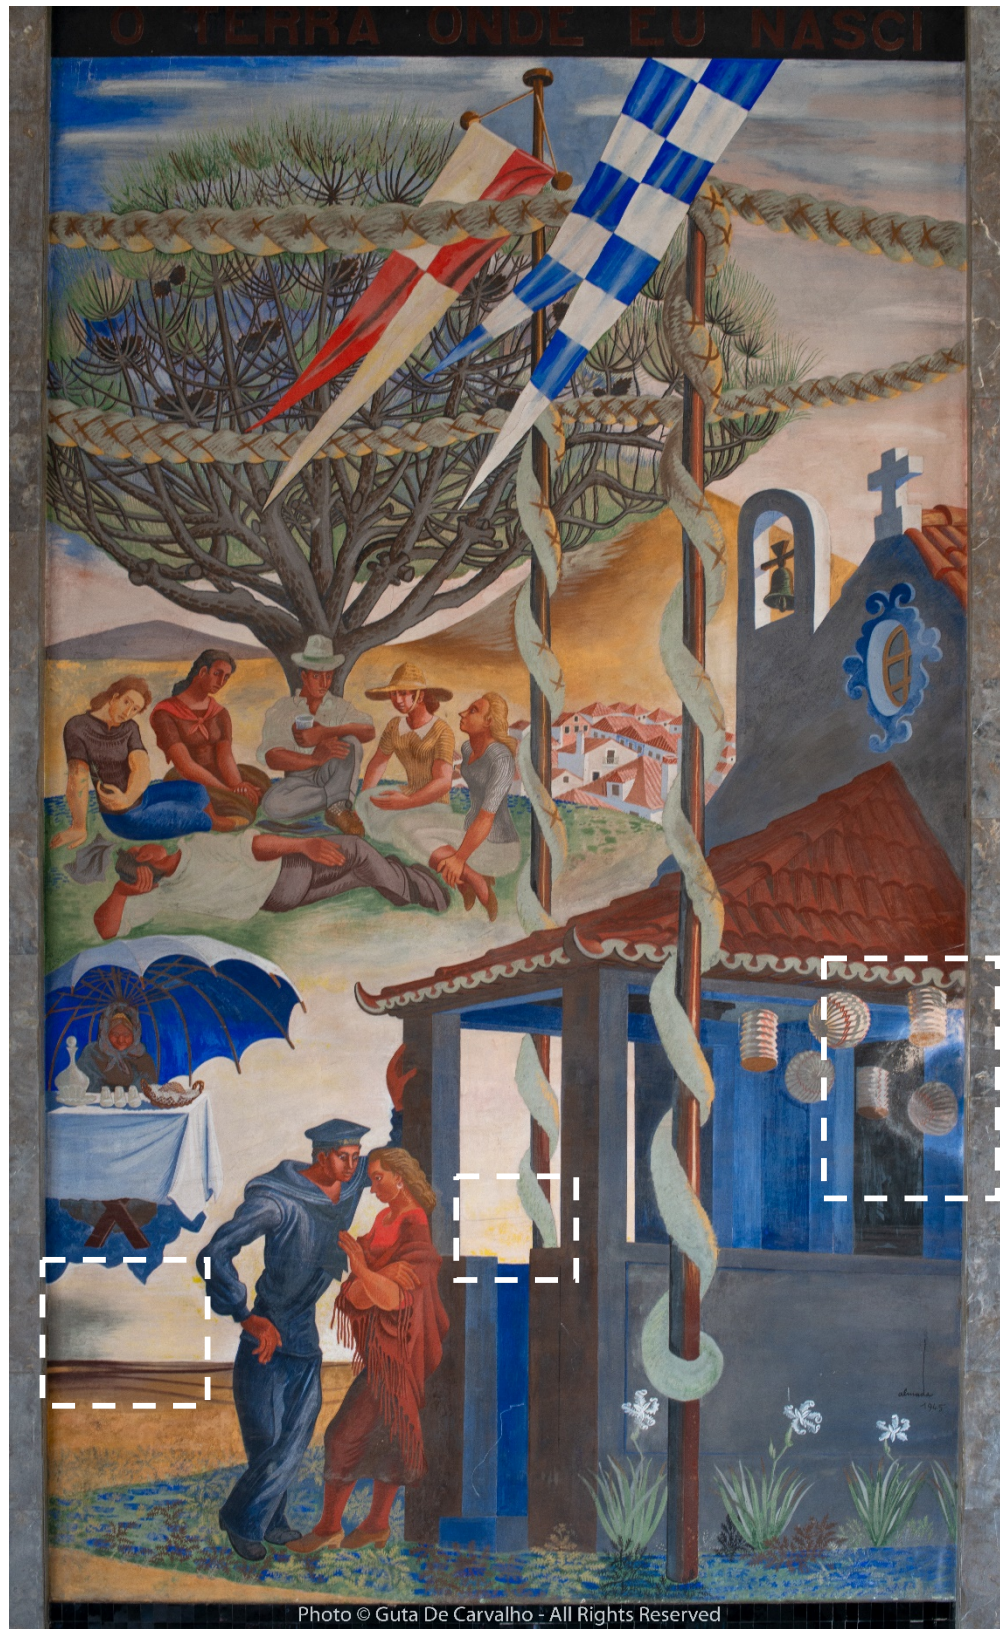
Individual presentation of panel 5, areas that display deterioration are marked in white. Photograph is taken by Guta Carvalho (6-7th of June 2020 © all rights reserved):

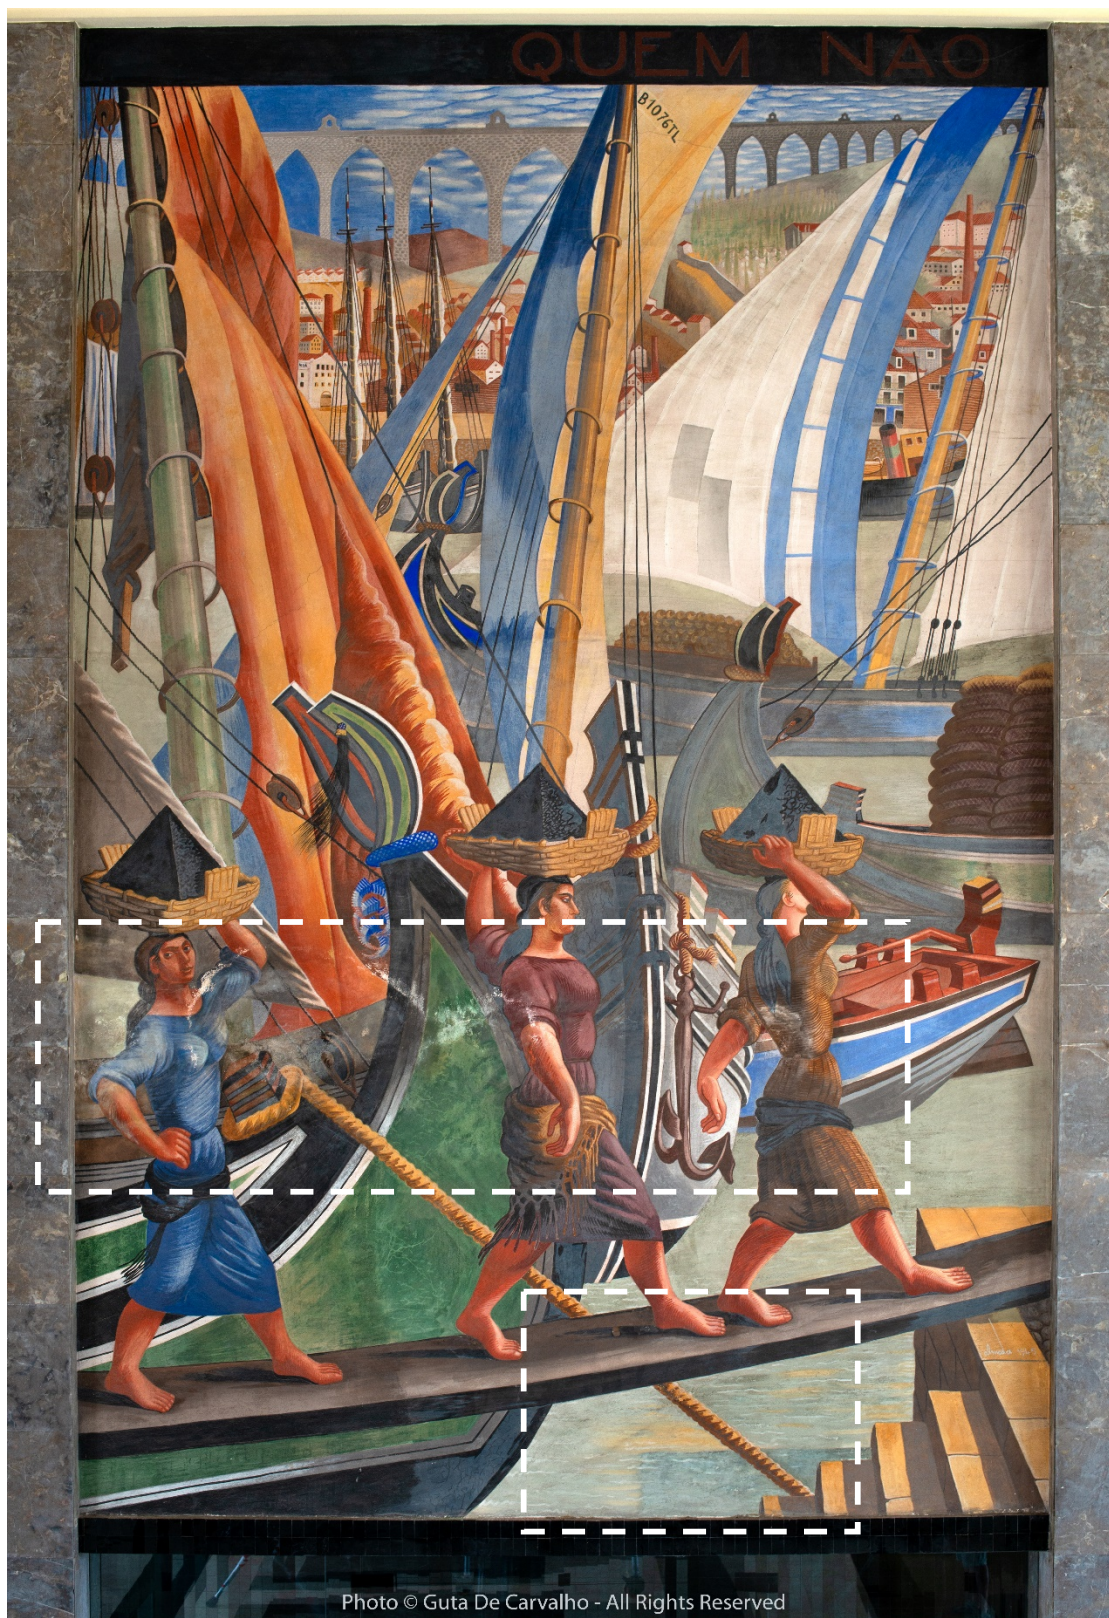
Individual presentation of panel 6, areas that display deterioration are marked in white. Photograph is taken by Guta Carvalho (6-7th of June 2020 © all rights reserved):

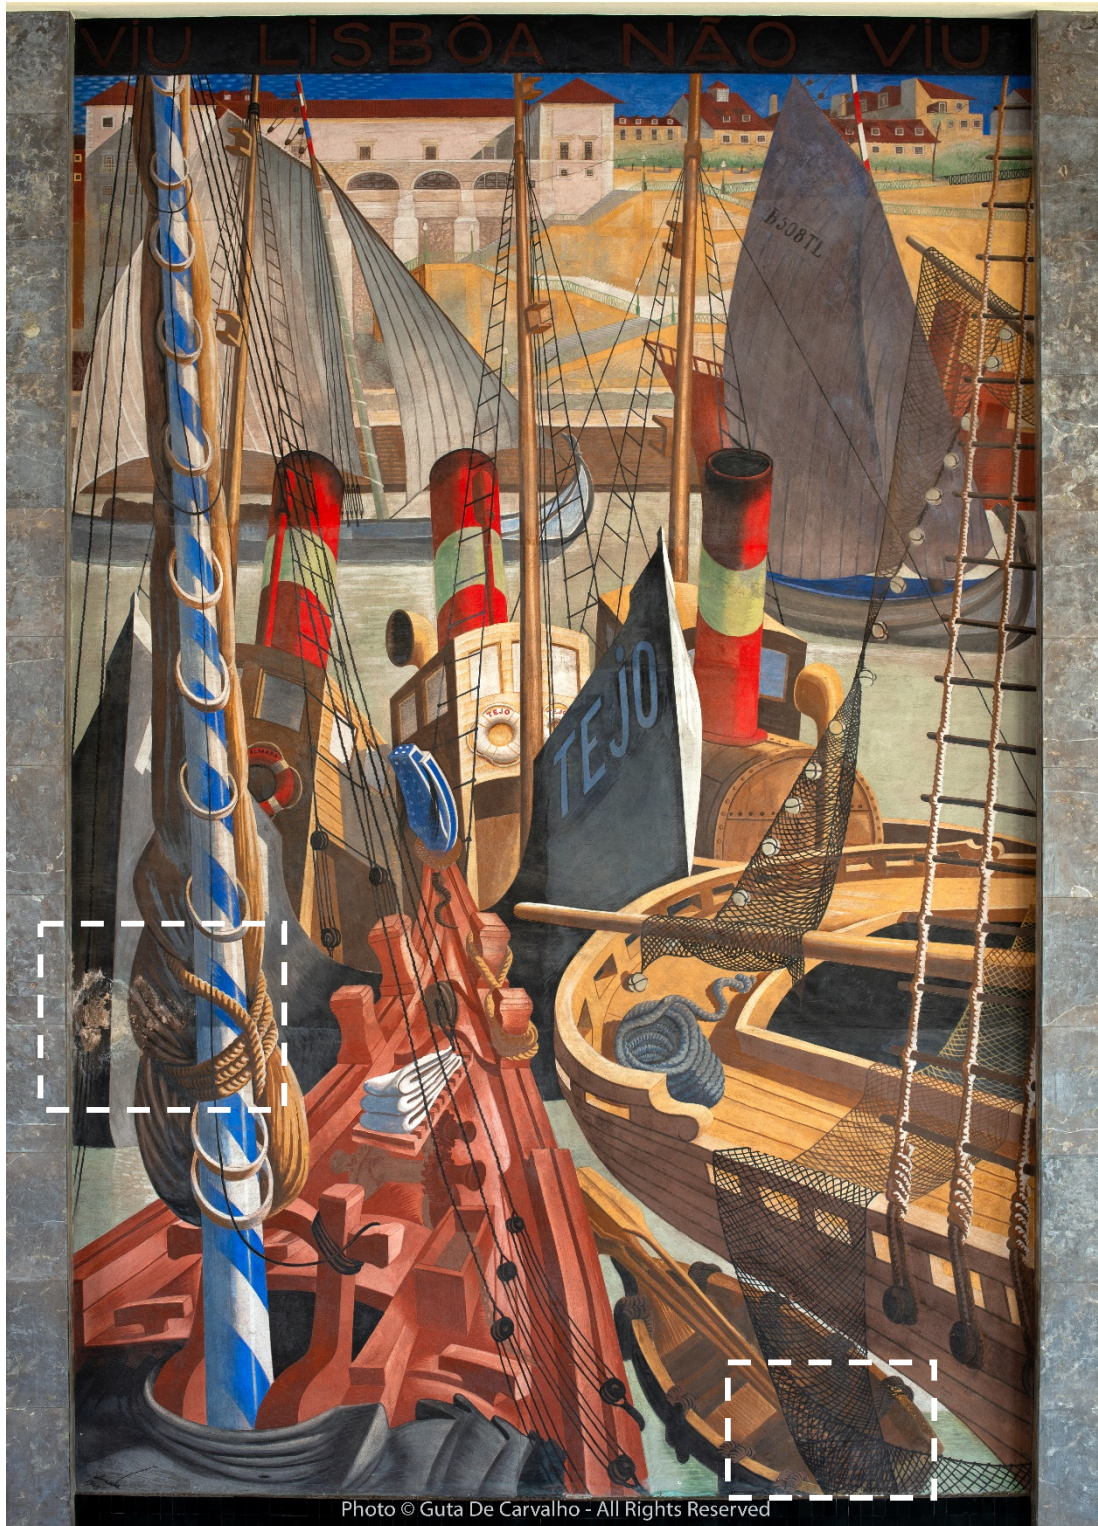
Individual presentation of panel 7, areas that display deterioration are marked in white. Photograph is taken by Guta Carvalho (6-7th of June 2020 © all rights reserved):

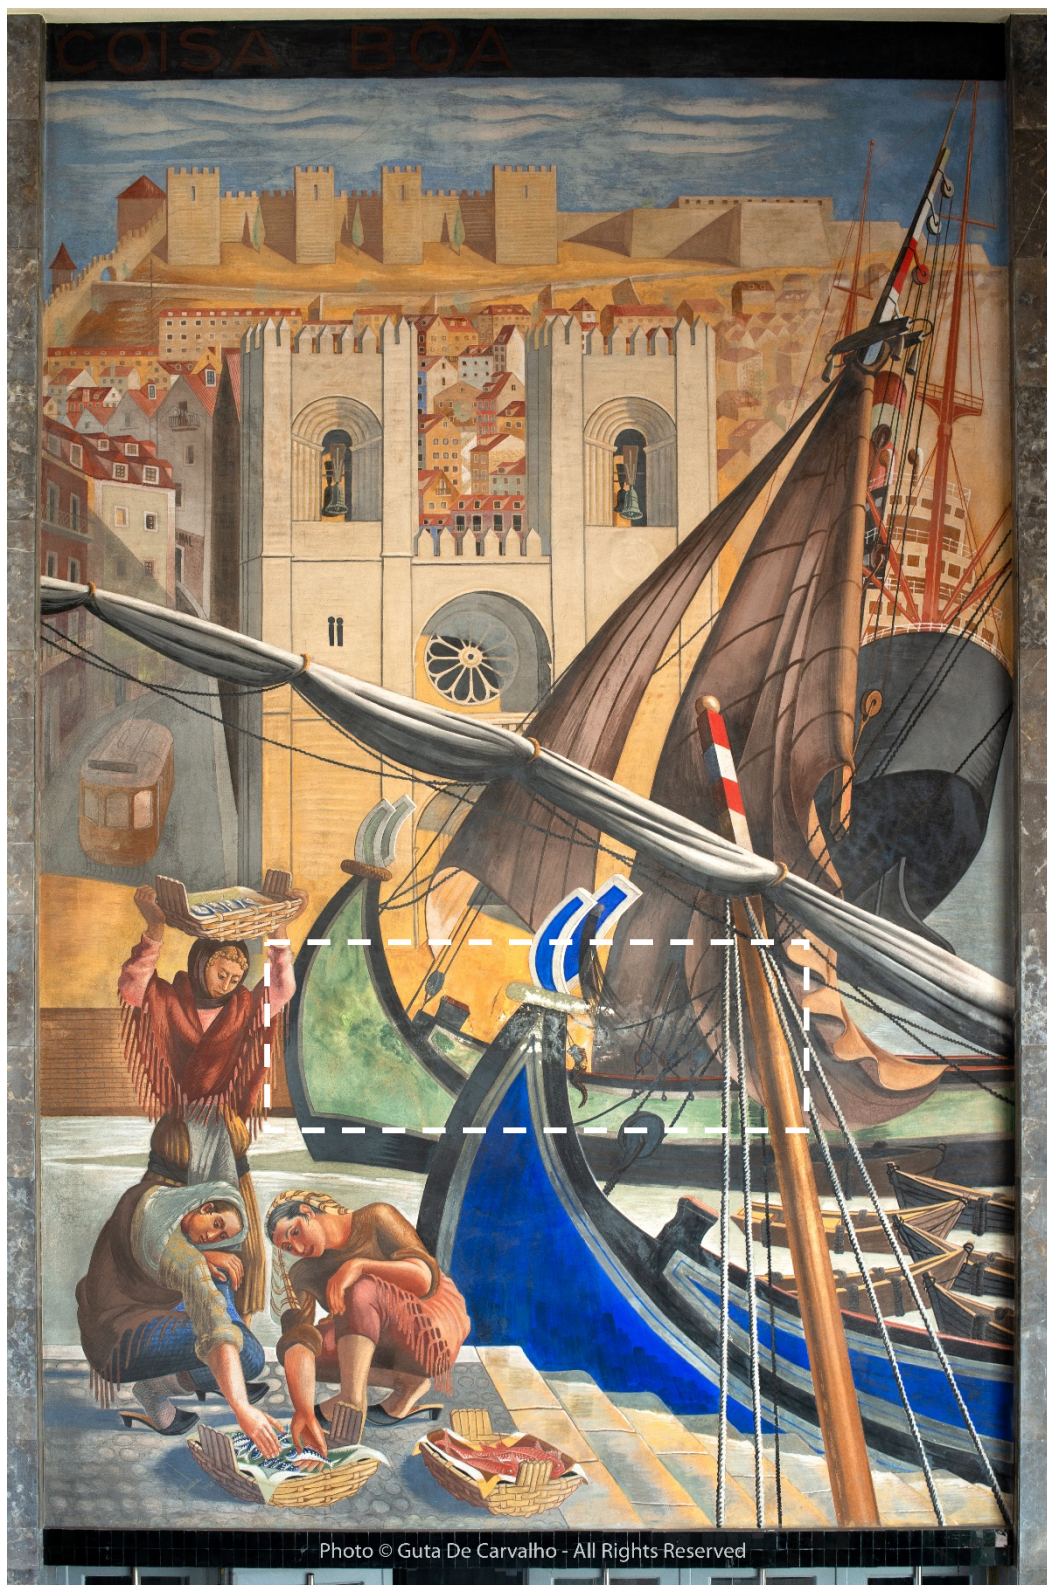
Individual presentation of panel 8, areas that display deterioration are marked in white. Photograph is taken by Guta Carvalho (6-7th of June 2020 © all rights reserved):

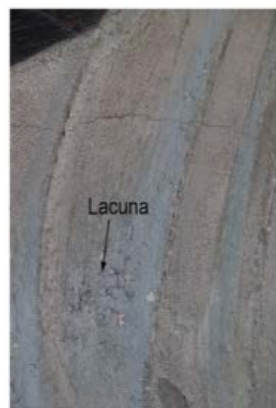
Zone 1
Areas 1&2

Portable optical microscope image E550
displaying lacuna of greenish paint layer
magnification 20x

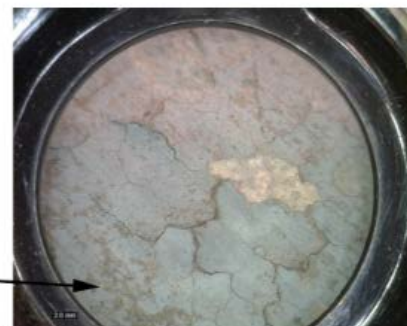
Zone 2

Portable optical microscope image E574
displaying formation of lacunae
magnification 20x

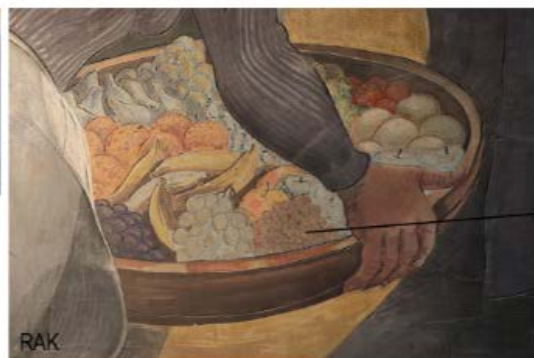
Zone 1

Portable optical microscope image E675 displaying brownish paint layer affected by the lack of cohesion and fissures, magnification 434x

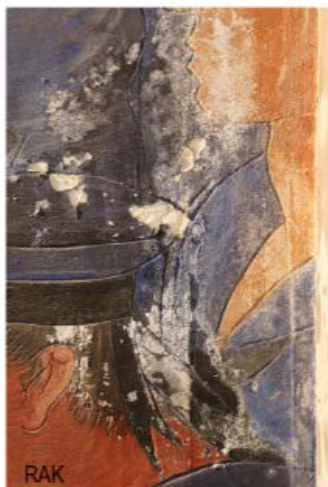
Zone 2

Portable optical microscope image E713 displaying brownish paint layer from the area of sailor's nose, affected by the lack of cohesion magnification 434x

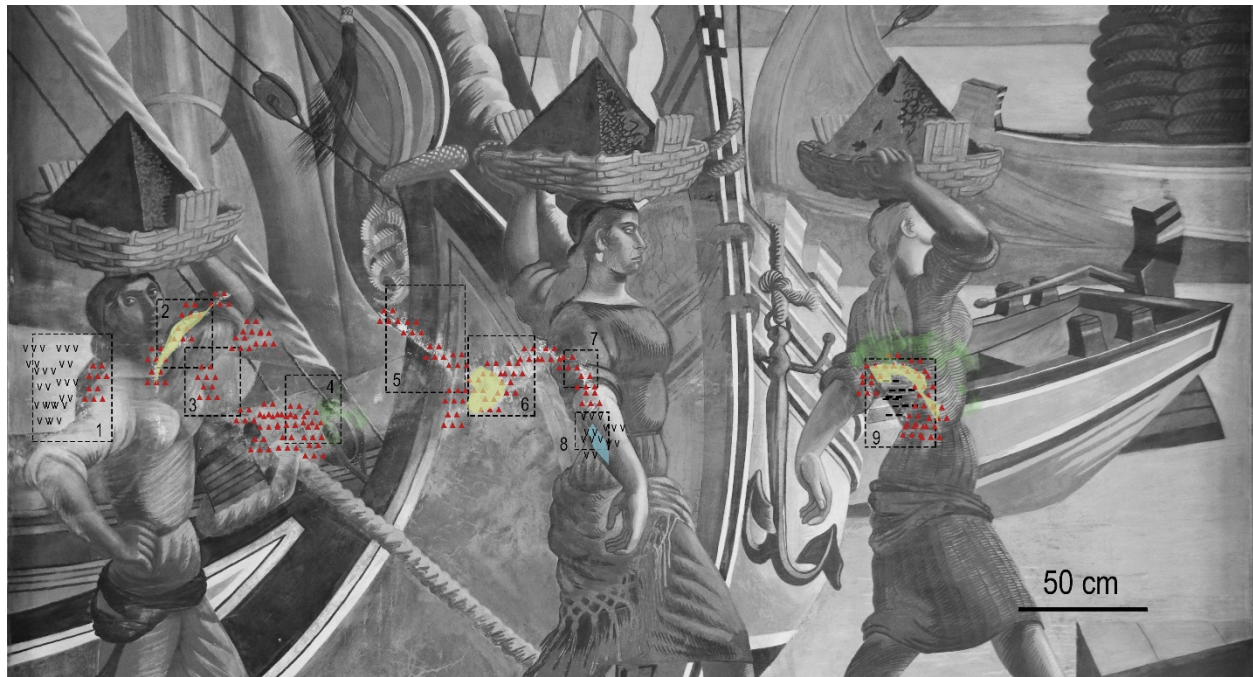
Analysed zones of panel 6 with the display of deterioration features:

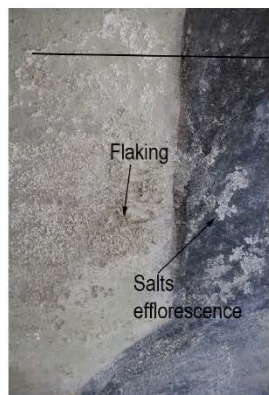
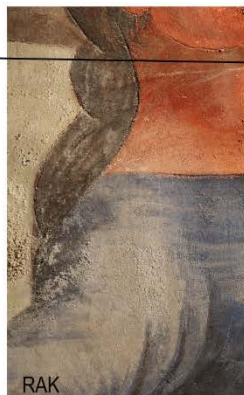
Portable optical microscope image E735 of greenish paintlayer in the background affected by flaking and salts, magnification 434x

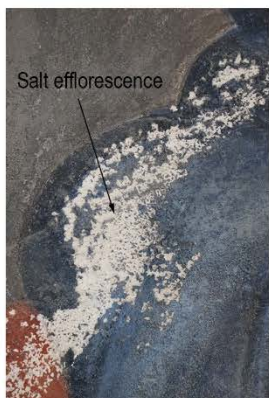
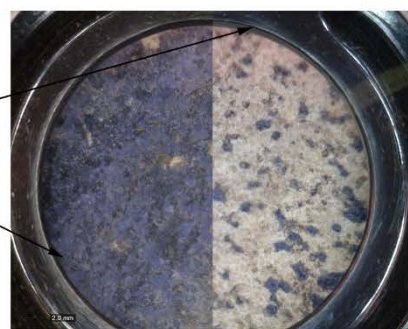
Zone 1, Area 1

Portable optical microscope images E367 (on the left) and E365 (on the right) displaying different stages of salts' formation, magnification 20x

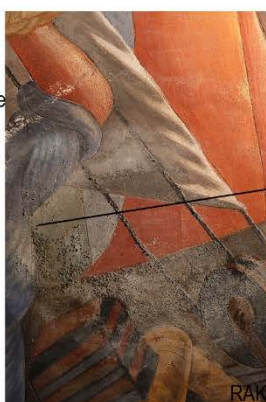
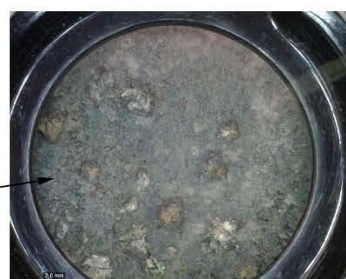
Zone 1, Area 2

Portable optical microscope image E378 displaying green paint layer affected by salts' formation, magnification 20x

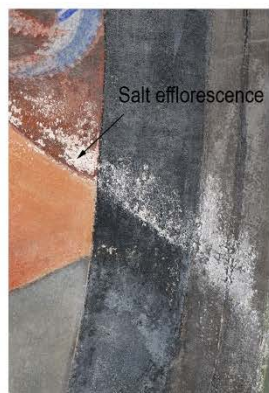
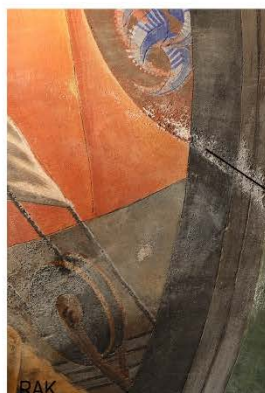
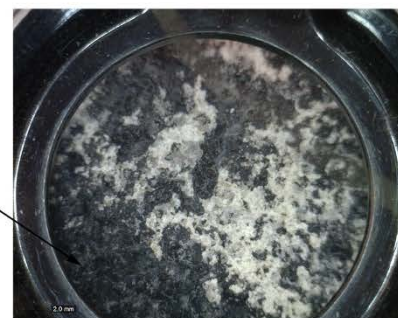
Zone 1
Areaa 3&4

Portable optical microscope image E3418 displaying black paint layer affected by salts' efflorescence, magnification 20x

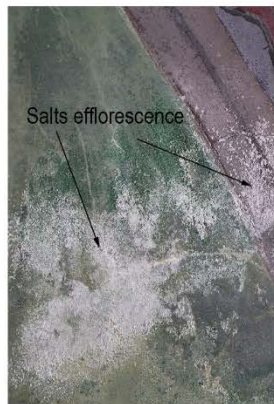
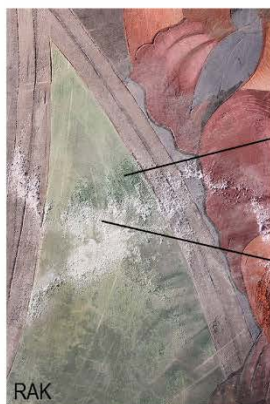
Zone 1, Area 5

Portable optical microscope images E412 (left) and E415 (right) displaying different stages of salts' efflorescence magnification 20x

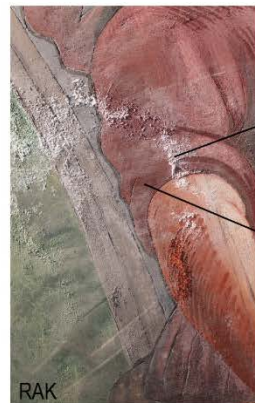
Zone 1
Areas 7&8

Portable optical microscope images E427 (left) and E426 (right) displaying different stages of salts' efflorescence, magnification 20x

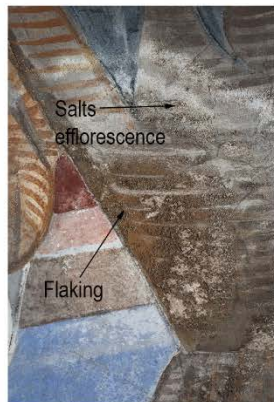
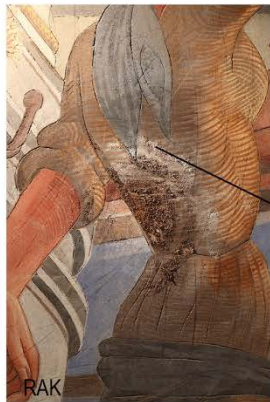
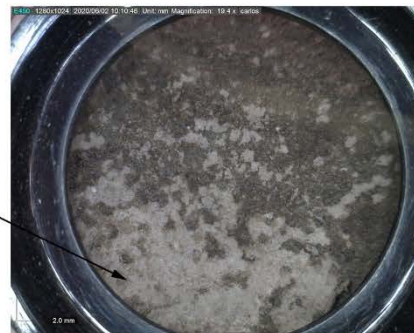
Zone 1, Area 9

Portable optical microscope image E450 displaying brownish paint layer affected by salts' efflorescence magnification 20x

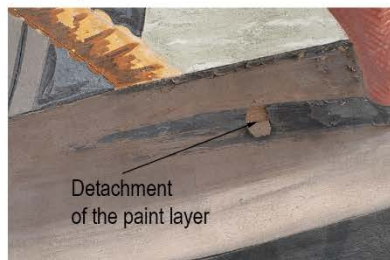
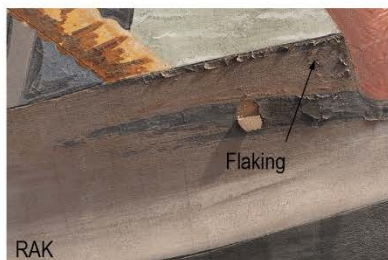
Portable optical microscope image E496
displaying the flaking brownish paint layer
magnification 20x

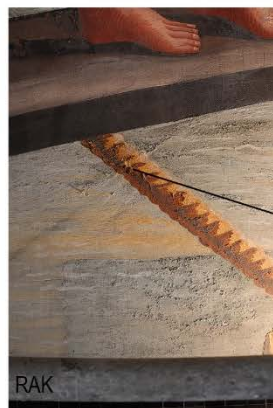
Zone 2, Area 1

Portable optical microscope image E517
displaying the brownish paint layer affected
by lacunae, magnification 20x

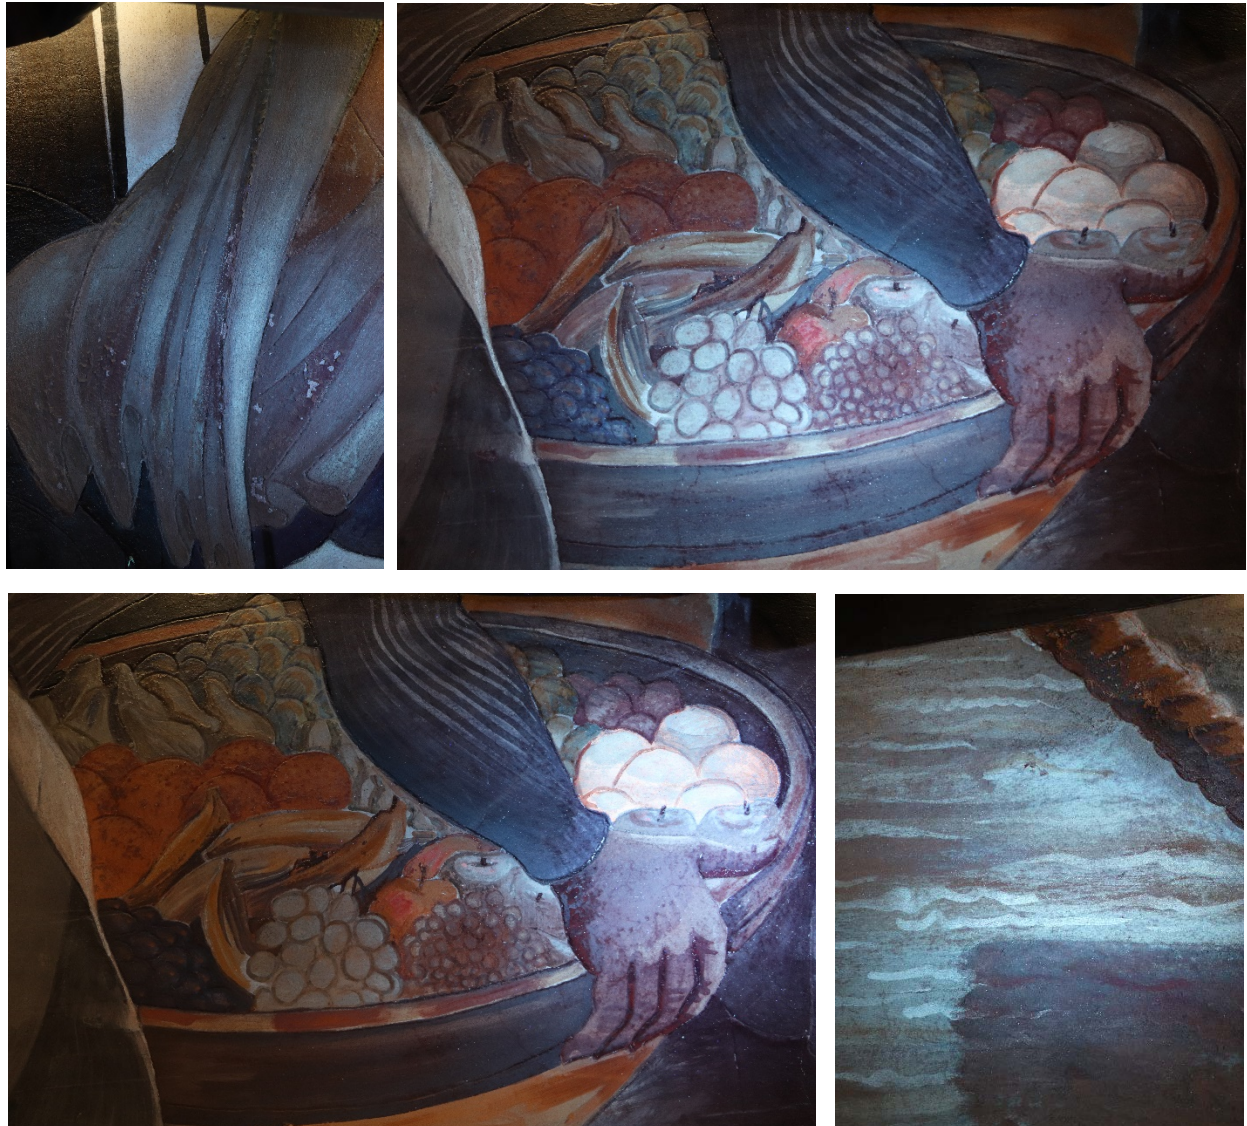
Photo-documentation in ultraviolet light (UVF), in following order:

Angel's garment from panel 2, two images of basket with fruits from panel 3 and area of the background in the panel 6:

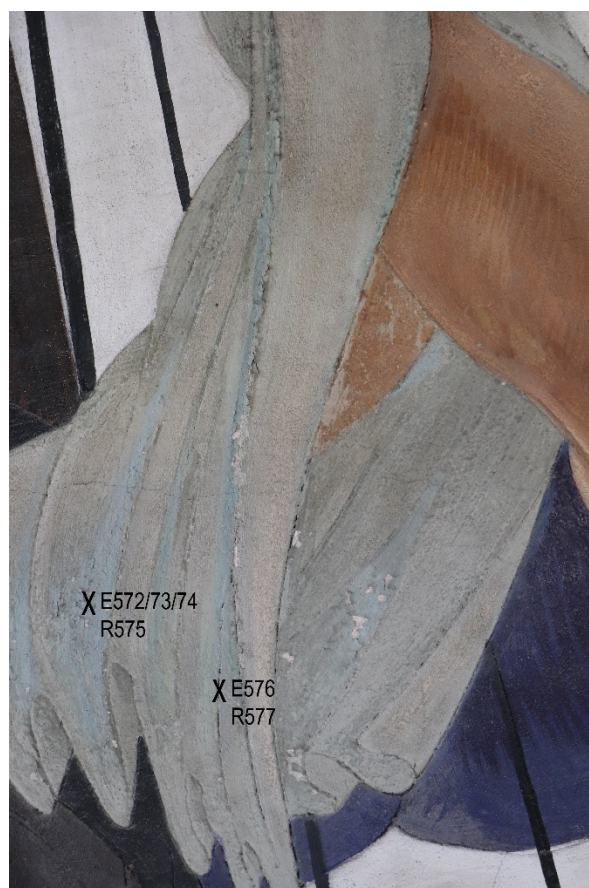
Locations of handled X-ray fluorescence analyses (h-EDXRF), panel 2:

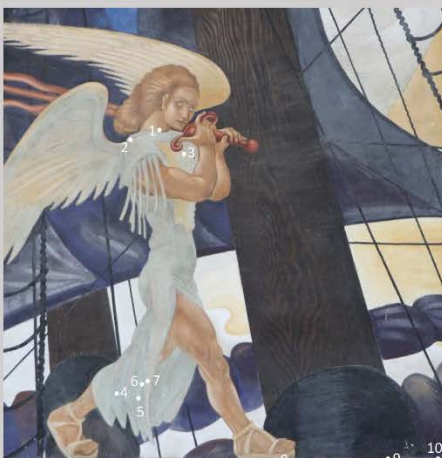
MICROSAMPLING LOCATION - PANEL 2	Detail	Description	Goal
    <p>Building: Shipping station of Alcântara Painting. Ref. Guardian angel protects the 'nau' Painting author: Almada Negreiros Date of the paintings: 1943-1945 Dimensions: 6.20x3.50m Date of the microsampling: 5 June 2020 Collector: Milene Gil</p>	 	1-angel's neck (flesh tone-brown shadow)	1-identify painting technique/pigment
	 	2-angel's dress (flaking light greenish blue)	2-identify painting technique/pigment
	 	3- angel's dress (traces of yellowish green)	3 -identify painting technique/pigment
	 	4- angel's dress (flaking light greenish blue)	4-identify painting technique/pigment

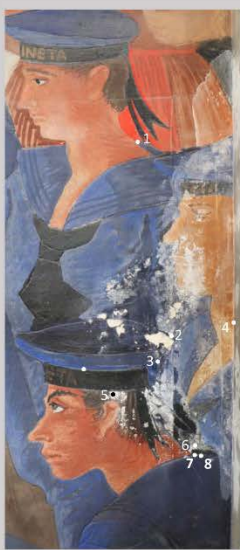
MICROSAMPLING LOCATION - PANEL 3	Detail	Description	Goal

<p>Building: Shipping station of Alcântara Painting. Ref.: Arrival of the 'nau' (ship) with the Captain embracing his three daughters, surrounded by sailors Painting author: Almada Negreiros Date of the paintings: 1943-1945 Dimensions: 6.20x3.50m Date of the microsampling: 5 June 2020 Collector: Milene Gil</p>

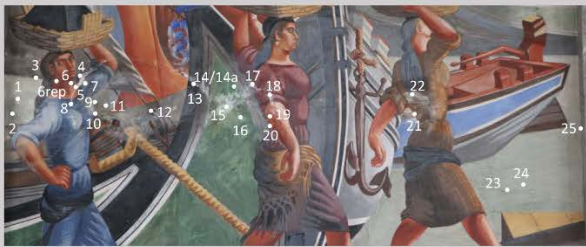
MICROSAMPLING LOCATION - PANEL 6	Detail	Description	Goal

<p>Building: Shipping station of Alcântara Painting. Ref.: Barefoot fishwives at the offloading of the coal Painting author: Almada Negreiros Date of the paintings: 1943-1945 Dimensions: 6.20x3.50 m Date of the microsampling: 5 June 2020 Collector: Milene Gil</p>

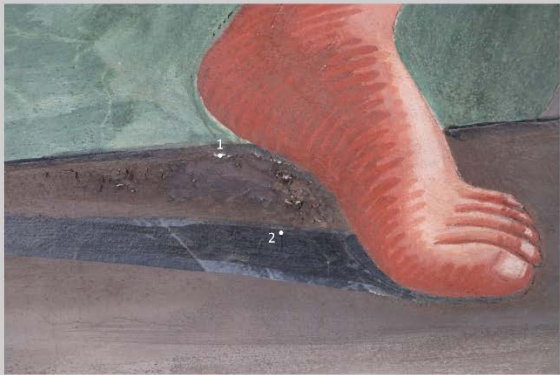
MICROSAMPLING LOCATION - PANEL 6	Detail	Description	Goal

<p>Building: Shipping station of Alcântara Painting. Ref.: Barefoot fishwives at the offloading of the coal Painting author: Almada Negreiros Date of the paintings: 1943-1945 Dimensions: 6.20x3.50 m Date of the microsampling: 5 June 2020 Collector: Milene Gil</p>

2-platform (flaking glossy black/what is the glossing material?)	24-identify painting technique/pigment / intervention material?

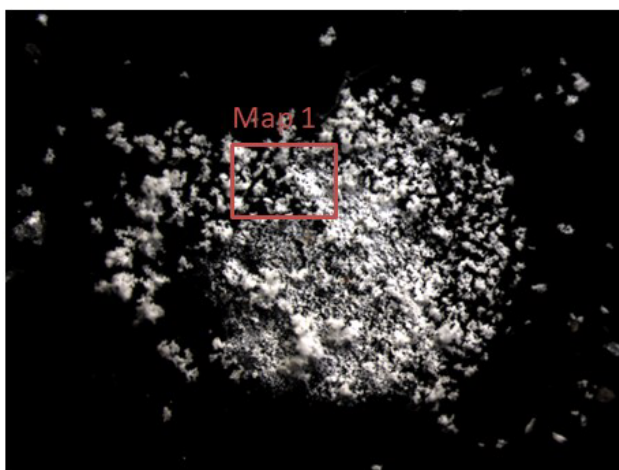
P3B_5 –salt efflorescence

Area 1 (matrix): C, O, Na, Al, Si, S, K
 Area 2 (matrix): C, O, Na, Al, Si, S, K, Ca, Fe
 Area 3 (matrix): C, O, Na, Al, Si, S, K, Ca
 Area 4 (elongated grain): C, O, Na, Al, Si, S, K, Ca

Presence of salts detected, including K and Na. It might be Aphthalite ($(K, Na)_3Na(SO_4)_2$)
