ARCHMAT

**Characterization of Mortars from
Aqueduct of Água da Prata (Évora, Portugal)**

Évora, Portugal, December 2020

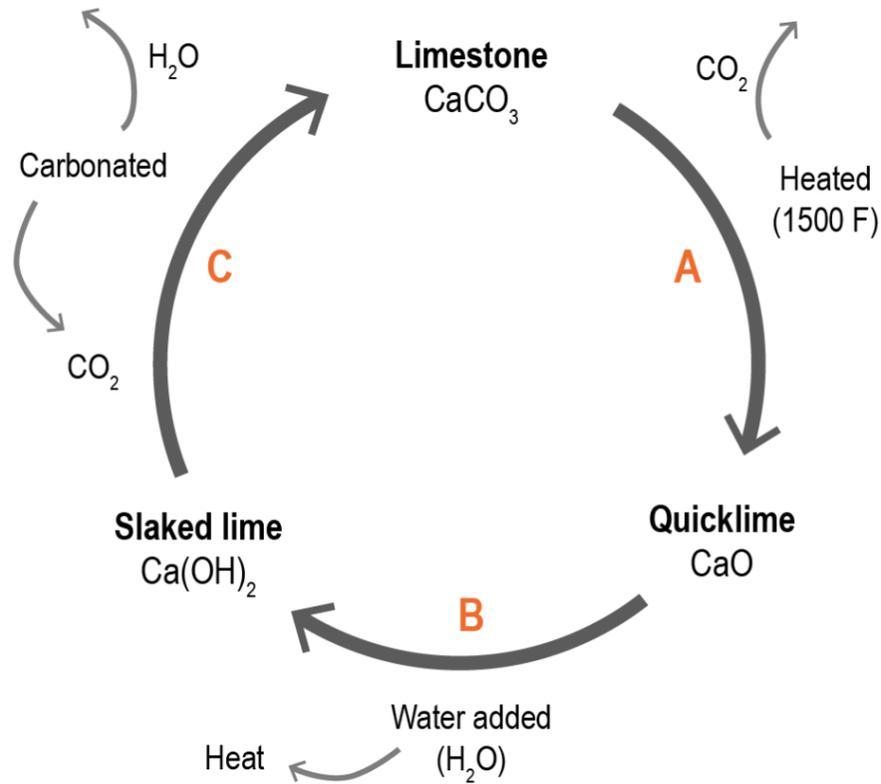
Figure 1-1. Lime Cycle.

Among the Roman mortars, lime has been considered the most common mortar binder in the historical context (Schnabel, 2008). It is produced through a series of processes that occur in three stages starting with calcination, followed by hydration and finalized by carbonation which is called a Lime Cycle (Fig. 1-1).

During the stage of calcination, the calcite (CaCO_3) in the limestone decomposes at high temperature (900 - 1000°C) forming calcium oxide (CaO) also named as quicklime and releasing carbon dioxide (CO_2) as shown in the equation (1). This burning process occurs in a kiln in which the limestone from a quarry was put and the final product is also known as burnt lime or lump lime.

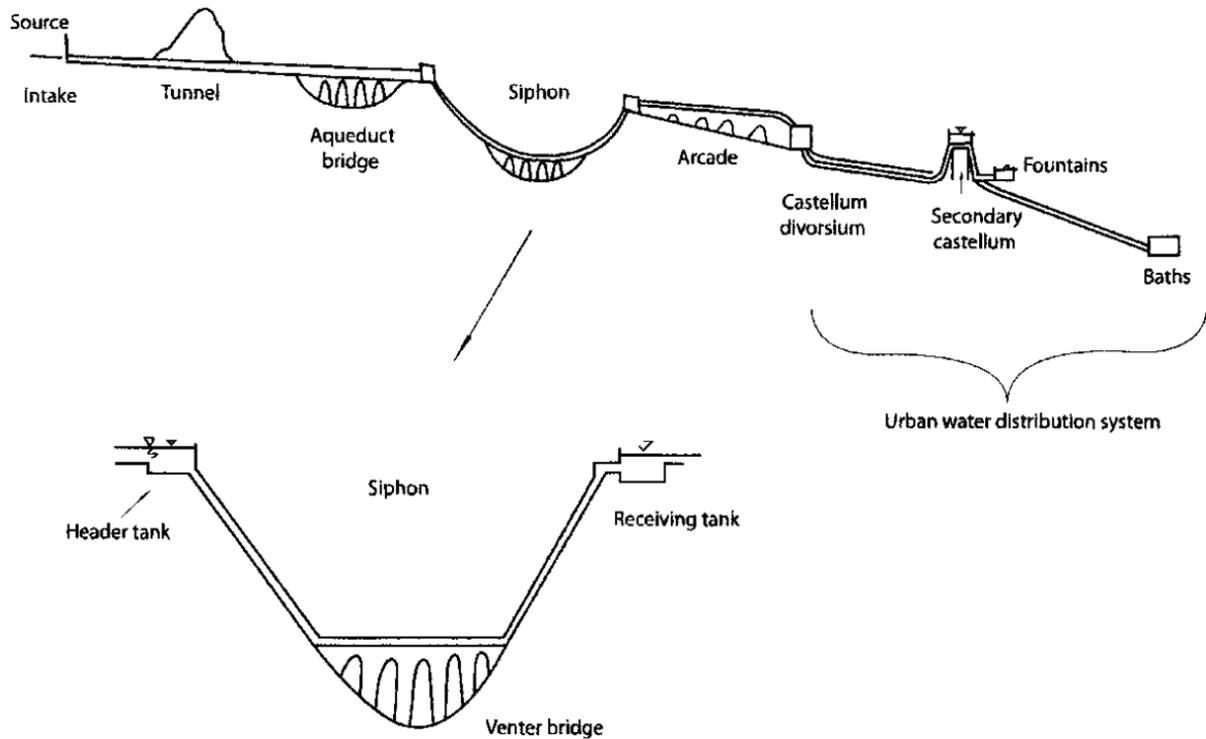
Figure 2-1. Diagram showing the elements of Roman aqueducts in various topographies (Mays, 2010).

The aqueducts were formed of several elements to carry the water in the desired direction like shafts, tanks, tunnels, bridges, siphons, arcades and distribution basins that are designed accordingly with the landscape features. The ancient Roman treatises of Vitruvius and Frontinus provide insight into finding a healthy water source, constructing and maintenance of the aqueducts and distribution of water (Mays, 2010).

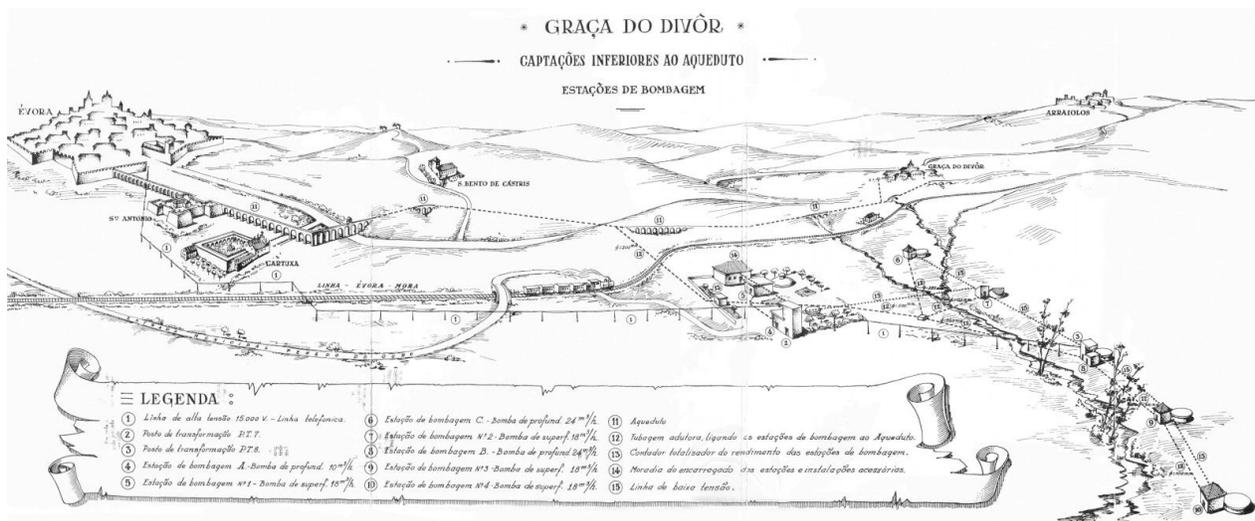
Figure 2-2. Drawing of the aqueduct and the pumping stations by Daniel Sanches, 1951 (Claro, 2019).

The aqueduct of Água da Prata is an 18 km long construction connecting the urban centre of Évora with the springs by passing through both rural and urban landscapes (Fig. 2-2). The aqueduct originates from the springs of Graça do Divor located in the northwest of the city and reaches to the Giraldo Square in the urban centre of the city. From the furthest point of the spring the water flows through a water channel for around 16 km until it reaches São Bento de Cástris convent and continues for around 2 km before bringing the water within the city walls (Monteiro, 2012). During the photogrammetric survey carried out by CME, the last part from São Bento de Cástris to its final destination within the city, the structure has been divided into four sections for a better description which are; Torralva, Cartuxa, Fortress of Santo António and Intramural (CME-DCP, 2019) (Appx. 1).

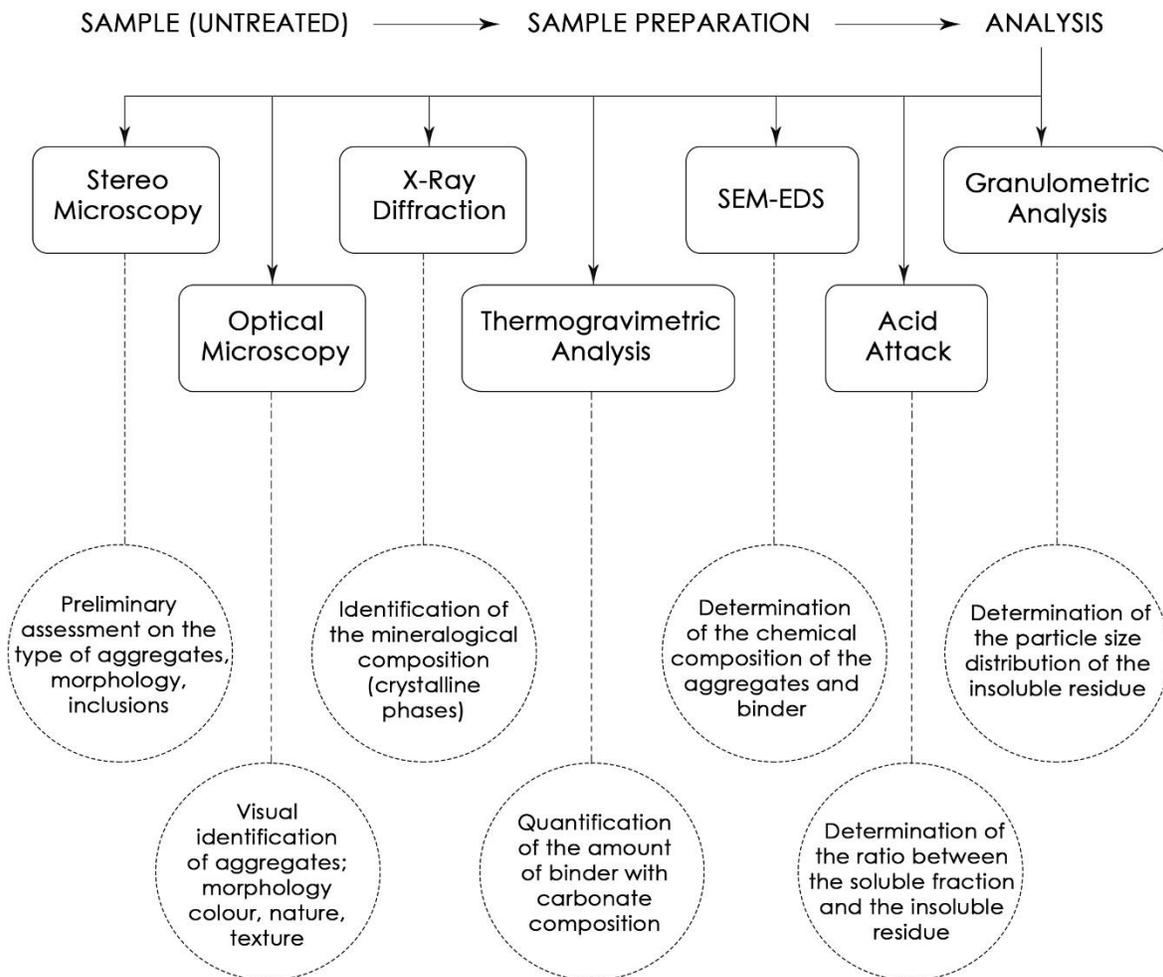
Figure 3-1. Methodology used and the information gathered for the characterization of the mortars.

The methodology used for the characterization of the mortars comprises a diverse set of analytical techniques that complement each other. The work contains several steps starting with the collection of samples from the most representative places of the architectural structure, sample preparation, analysis and data treatment. Sampling and sample preparation procedures will be explained consecutively in sections 3.1 and 3.2. The type of analysis includes microscopic techniques which are Stereo and Optical Microscopy, Scanning Electron Microscopy with Energy Dispersive X-ray Spectrometry (SEM-EDS), X-ray Diffraction (XRD), Thermogravimetric analysis (TGA-DTG), Acid Attack and Granulometric Analysis. The techniques used and the information obtained from them have been described in Fig. 3-1. The experimental conditions of each technique will be explained in Section 3.3.

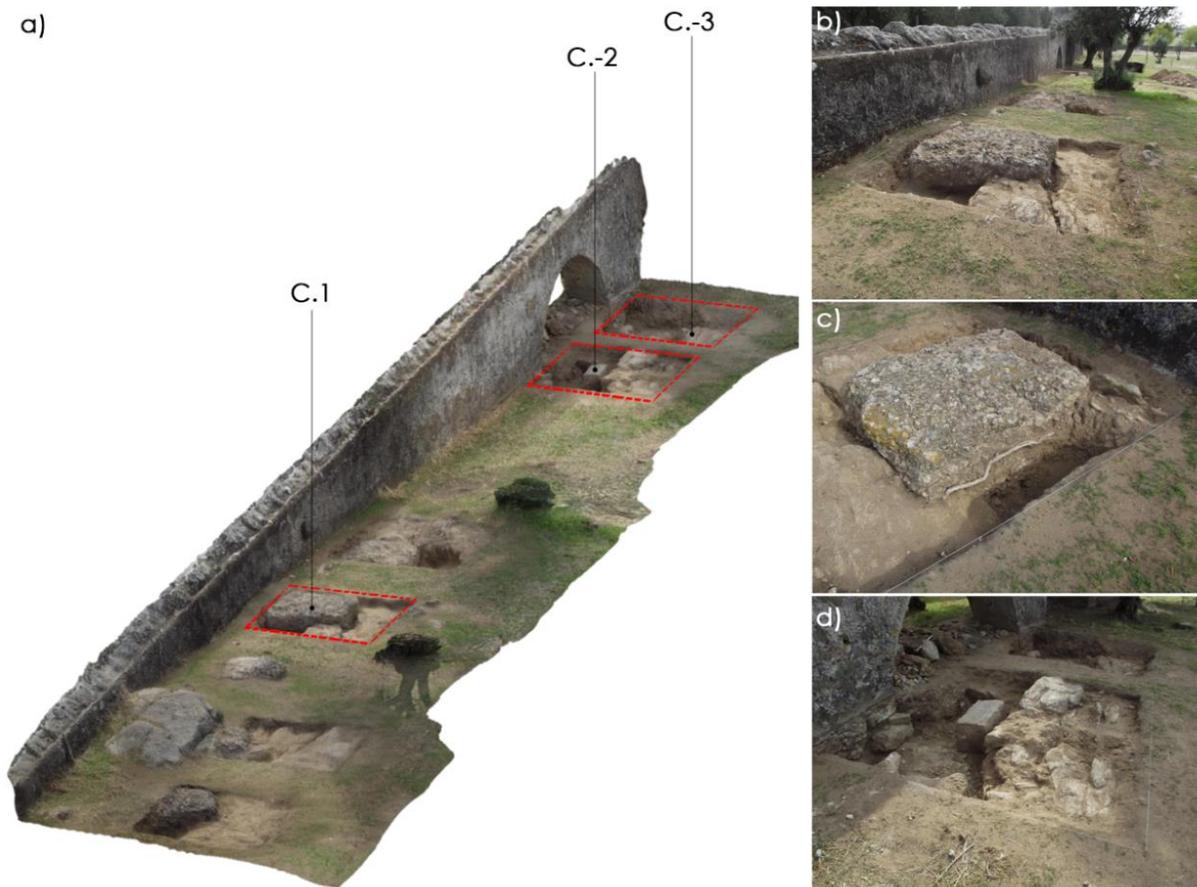
Figure 3-2. a) Photogrammetric image of the sampling pits from Cartuxa b) General view of survey pits, c) Pit C.1, d) Pits C.-2 and C.-3 (All images obtained from CME-DCP, 2018).

From Cartuxa section, samples EVR-1, EVR-2, EVR-3, EVR-4 and EVR-6 were collected. This section is particularly selected as the remains of the foundation of the Roman aqueduct is discovered right next to the still standing XVI century aqueduct. As the foundations of the Roman and the XVI century constructions are visibly separate, it allowed the sampling of the filler mortars of both periods. Sampling was carried out from the survey pits C.1, C.-2 and C.-3 as described in Figure 3-2.

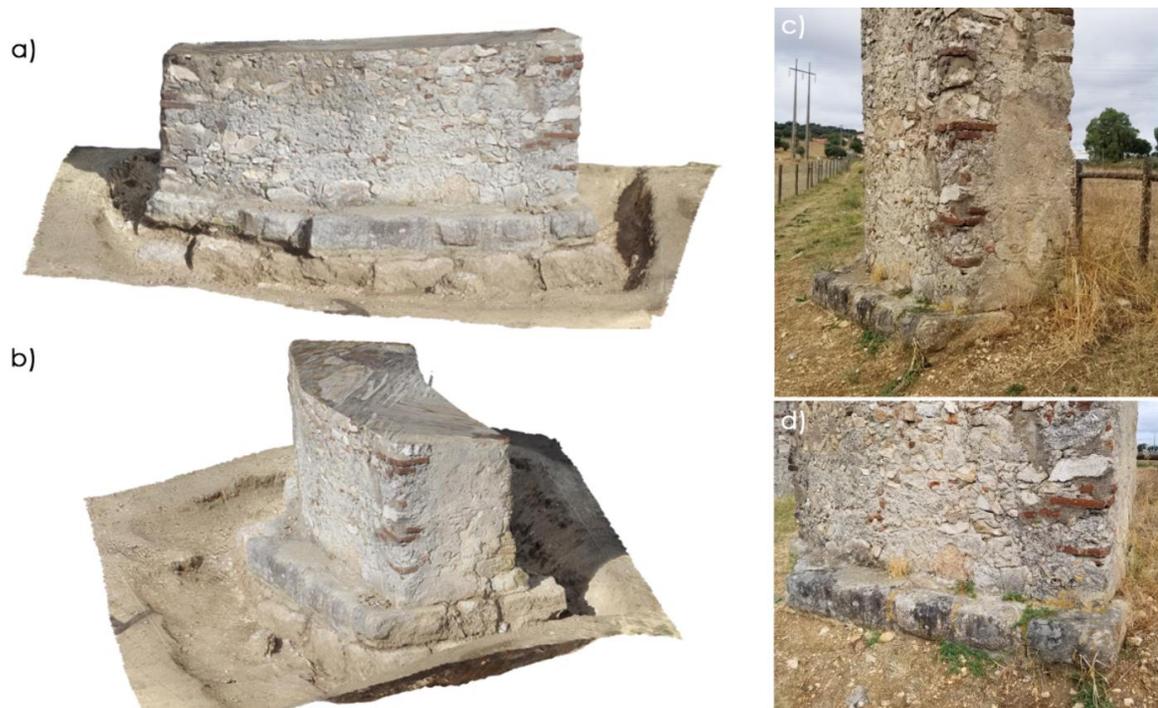
Figure 3-3. a-b) Photogrammetric images of Torralva survey pit, c-d) Photos of XVI century pillar and Roman base. (Photogrammetric images obtained from CME-DCP, 2018, photos taken by author in September 2020).

From the Torralva section, samples EVR-05, EVR-07 and EVR-08 were collected. Torralva survey pit which is located at the area of pillar 42 was chosen as a sampling spot since it contains characteristics of both Roman and XVI century constructions. As described in the technical report of the archaeological surveys, the pillars of the Torralva section indicate characteristics of XVI century construction which are supported by several inscriptions of dates 1534 and 1535 carved on the wet mortar still visible on site. Whereas the base of the pillars, demonstrate Roman characteristics of building manufacture regarding the type of blocks used for construction (*opus quadratum*) typically showing the rustic surface on the face of the ashlar stones as seen in Figure 3-3 (CME-DCP, 2018). The samples extracted from the Torralva survey pit represent filler mortars from both periods.

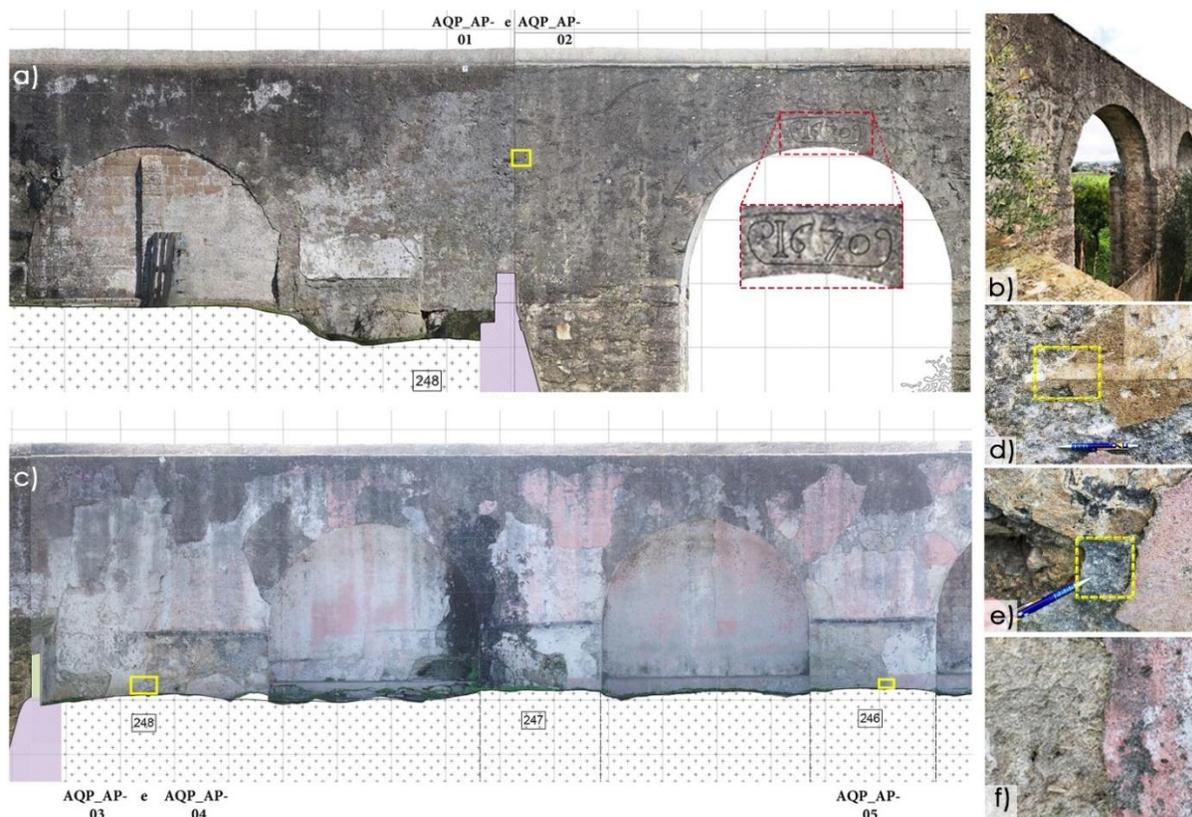
Figure 3-4. a-b) Orthophoto and digital photo of sampling spots AP-01 and AP-02, c) Orthophoto of sampling spots AP-03, AP-04 and AP-05, d-e-f) Photos of the sampling spots AP-03, AP-04 and AP-05 respectively.

From the section of Fortress of Santo António, 5 samples were collected (AP-01, AP-02, AP-03, AP-04 and AP-05). Samples AP-01 and AP-02 were obtained from the same spot in which sample AP-02 represents the inner part of AP-01 (Fig. 3-4a-b). The sampling spot was located on the southern façade of pillar 248 that is situated next to the inscription '1670' and representing most probably the period of the renovations carried out by Francisco Ferreira after the Spanish siege in 1663 (CME-DCP, 2019). Samples AP-03 and AP-04 were also obtained from the same spot in which sample AP-04 represents the inner part of AP-03. The sampling spot was located on the northern façade of pillar 248 (Fig. 3-4c-d-e). Sample AP-05 was located on pillar 246, having a pinkish chromatic layer probably belonging to later interventions of the XIX century (Fig. 3-4c-f).

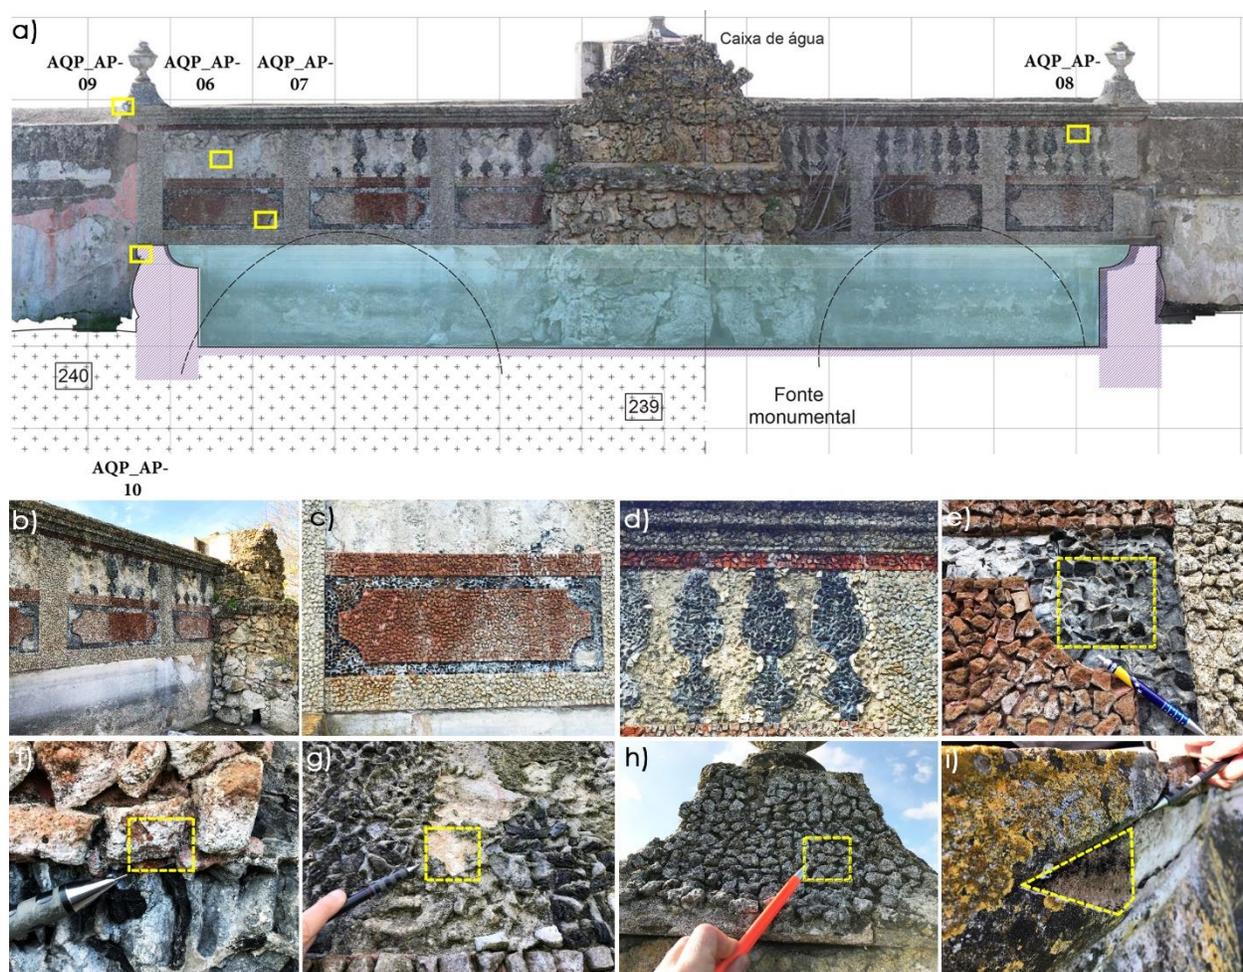
Figure 3-5. a) Orthophoto of sampling spots AP-06 – AP-10, b-c-d) Photos of the monumental fountain's decoration, e-f-g-h-i) Sampling spots of AP-06, AP-07, AP-08, AP-09 and AP-10 respectively.

Another group of 5 samples (AP-06, AP-07, AP-08, AP-09, AP-10) were collected from the monumental fountain which is also located inside the fortress of Santo António. The fountain is positioned between the pillars 238-240. The water tank is found in the central part of pillar 239 that resembles a cave in which the spring flows. Both sides are decorated with mortars given colors by immersing fragments of stones, ceramics and coal. The assemblage of the mortar decoration simulates white pilasters connected together with black balusters over a white surface and below is a reddish surface framed with a black colored decoration mortar. The whole composition is enclosed with two vases on both sides together with a cornice around the top edge and a large pool on the ground (Fig. 3-5a-b-c-d). It is considered that the entire configuration of the fountain is a later intervention dating back to the XIX century. The mortar samples collected were selected to be representative of the use of different colors which are black (AP-06) acquired from the balusters, red (AP-07) a ceramic fragment from the lower panel and white (AP-08) from the background. Also, two other samples were obtained from the base of the vases on sides (AP-09) and from the exterior surface of the pool (AP-10) as shown in Fig. 3-5.

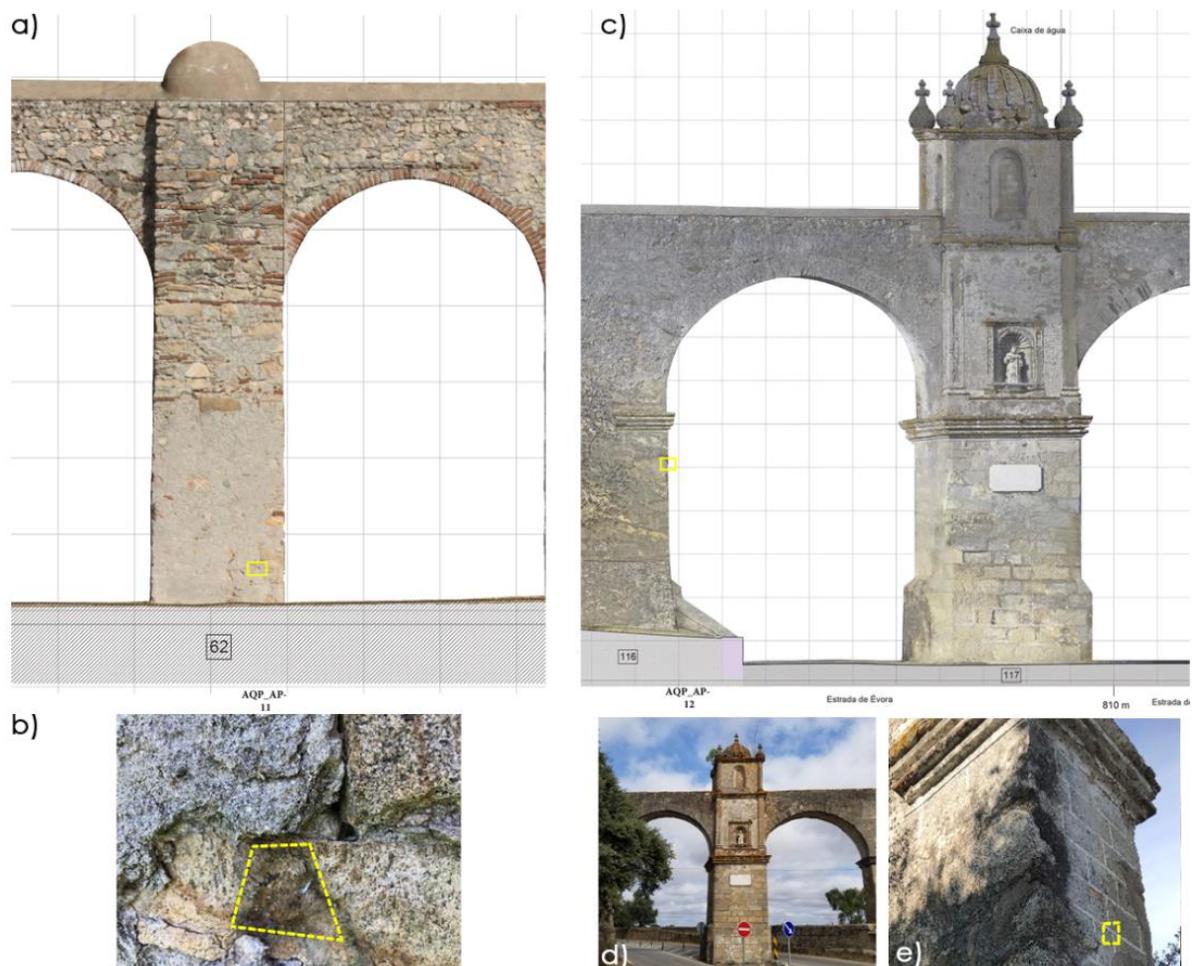
Figure 3-6. a-b) Orthophoto and digital photo of sampling spot AP-11, c-d-e) Orthophoto and digital photos of sampling spot AP-12.

From the Torralva section, sample AP-11 was collected. The render mortar was obtained from the lower part of pillar 62 (Fig. 3-6a-b). Due to the inscriptions of dates and figures found in this section of the aqueduct, it is considered that AP-11 could be a render mortar originating from the XVI century construction.

The last sample of the study (AP-12) was acquired from the monumental arch located in the Cartuxa section of the aqueduct. The sampling spot was the elevated archway that is situated on the Arraiolos- Évora road (Fig. 3-6c-d-e). As known by the inscriptions, the monumental arch was erected in the XVI century and it has been considered as a fine example of its time with its decorative style of Manueline expression (CME-DCP, 2019). The water tank is located on pillar 117 and it is connected by arches to pillars 116 and 118 on both sides of the road. Starting from the ground level until the decorative cornices, all 3 pillars have fake stone masonry with pronounced joints in white plaster which is a mural decoration technique known as *sgraffito* (Salema, 2008). The sampling was carried out on the *sgraffito* decoration on pillar 116.

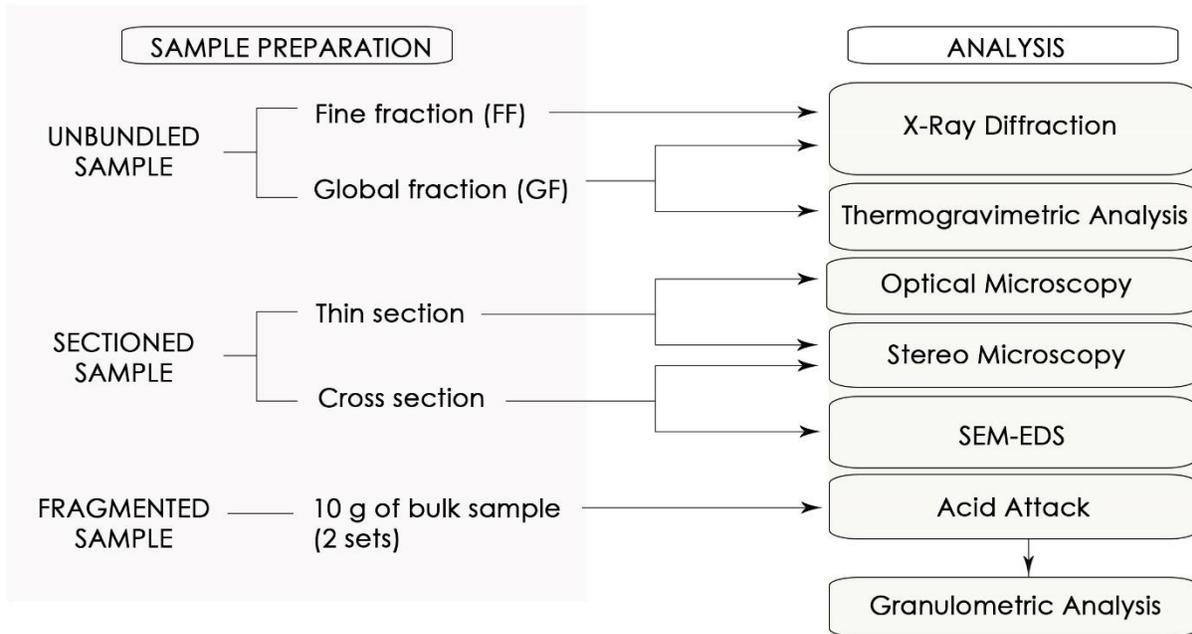
Figure 3-7. Sample preparation diagram.

Before initiating any preparation procedures, all samples were left to dry in a ventilated oven overnight at 40 °C. Later, they were cleaned with a brush, chisel and scalpel to remove the dirt, dust and any kind of biological colonization like lichens, molds and insects. Cleaned samples were once again dried in the oven overnight to guarantee a well-cleaned surface without any moisture. After the cleaning process is completed, all samples were photographed and observed for the record of their macroscopic characteristics such as color, texture, stratigraphy, type of aggregates and additives (fragments of ceramics, coal, etc.).

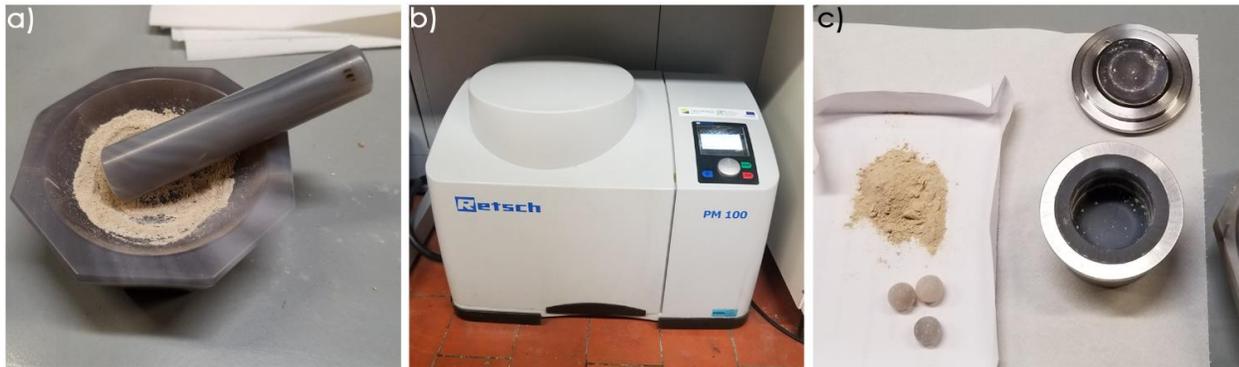
Figure 3-8. Tools used for the preparation of the powdered samples: a) Disaggregation by mortar and pestle, b) Powdering equipment PM 100 Planetary Ball Mill (Retsch), c) Agate grinding jar and grinding balls

The preparations started firstly by obtaining approximately 10 g of the samples using a hammer and chisel. The separated fragments were then disaggregated by hand into smaller fractions using a mortar and a pestle (Fig. 3-8a). Each sample was later grounded into a fine powder using a PM 100 Planetary Ball Mill (Retsch) (Fig. 3-8b). For this procedure, an agate grinding jar with 3 grinding balls (<1cm Ø) were used (Fig. 3-8c). The dry grinding was done at 500 rpm for a run of 10 minutes. The process was repeated in cases where larger grains of quartz were still present. The final product of the process was a homogeneous fine powder representing the bulk of the sample (GF). For the fine fractions (FF), the powder obtained from the segregated sample during the disaggregation by hand using a mortar and a pestle was sieved with a stainless steel test sieve (ASTM E11, 100 mm x 40 mm, Retsch) with a mesh size of 63 µm.

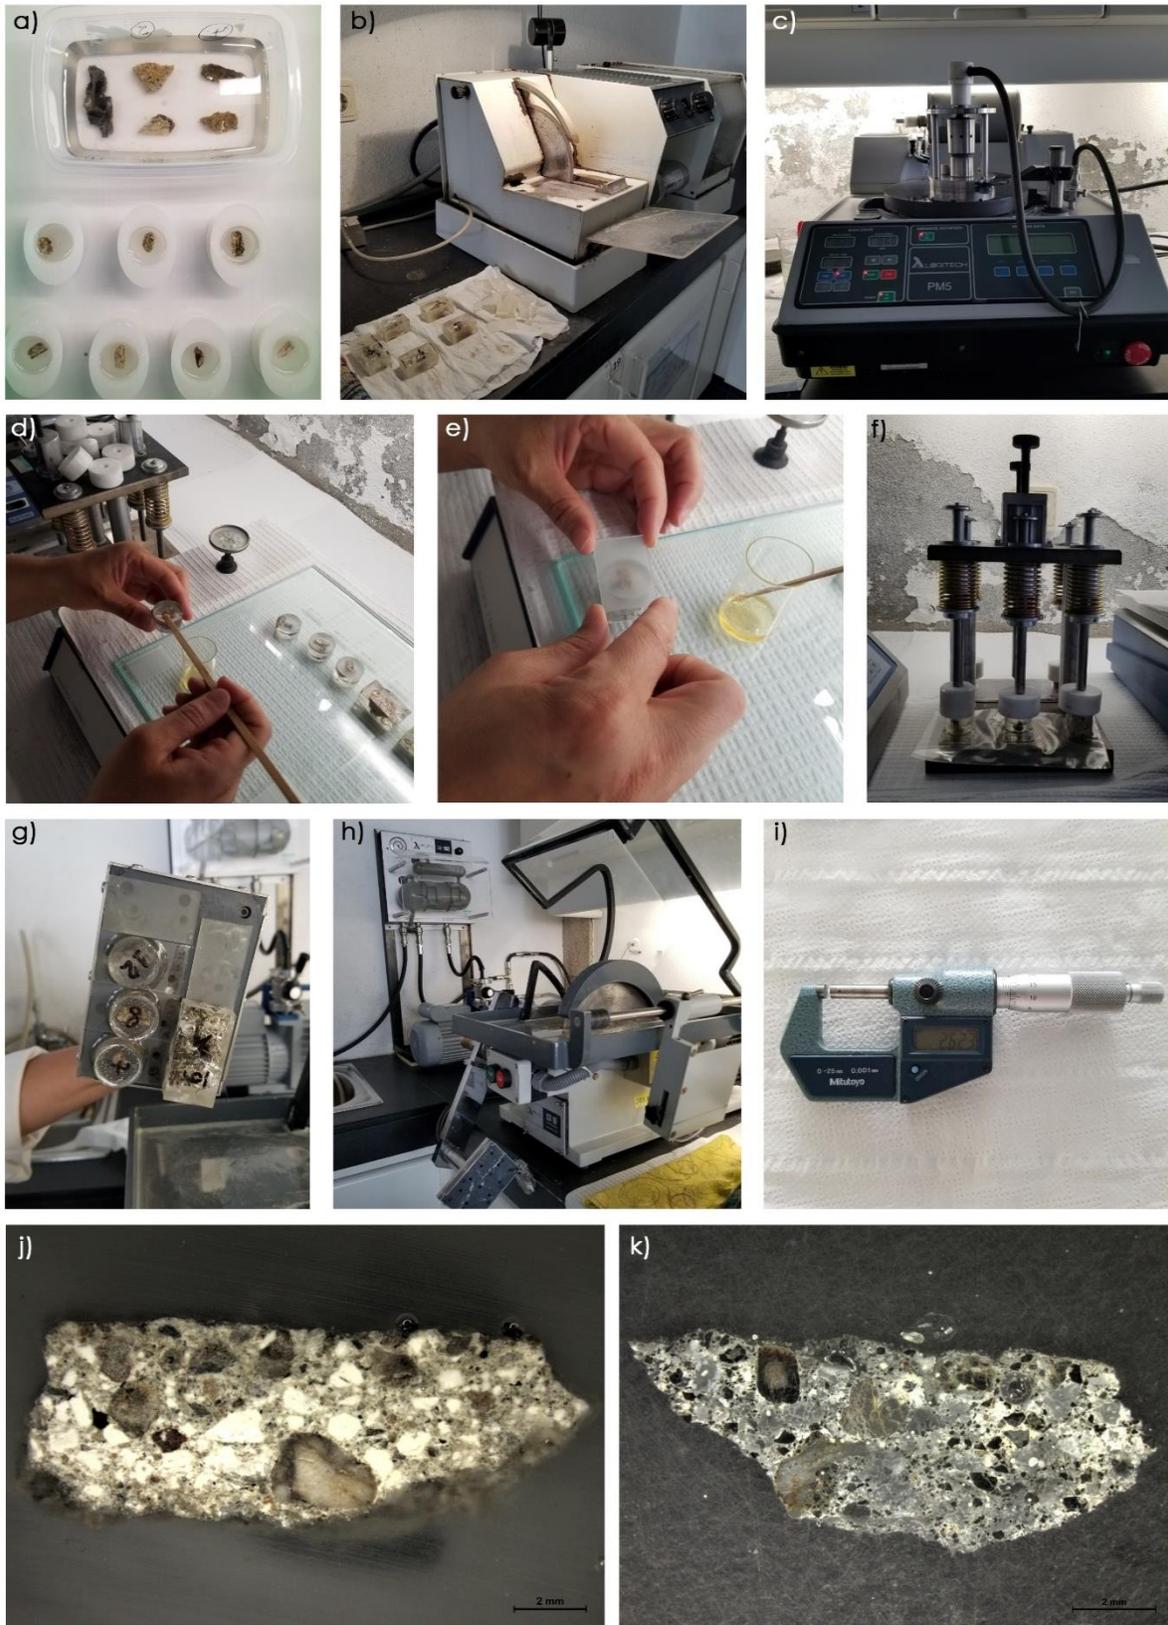
Figure 3-9. Thin section preparation: a) Samples in epoxy resin for cross sections, b) Cutting using Discolplan-TS, c) Grinding by Logitech PM5, d-e) Gluing the glass slides on cross sections, application of epoxy resin (e), f) System Abele press, g-h) Cutting out the thin sections under vacuum using a Logitech CS10 Thin Section Cut Off Saw (h), i) Mitutoyo digital micrometer, j-k) Results of AP-03, cross section (j) and thin section (k) under microscope.

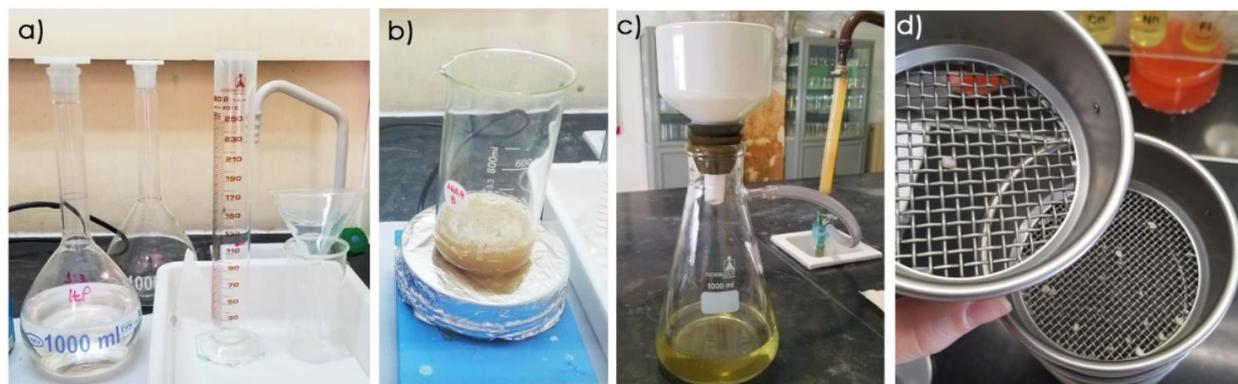
Figure 3-10. Experimentation of the analysis: a) Preparation of HCl aqueous solution, b) Heating up the sample + HCl aqueous solution on hot plate up to boiling temperature, c) Filtration under vacuum using a Büchner funnel + filter paper, d) Sieving using ASTM E11 test sieves.

hot plate and the mixture was heated up to boiling temperature and left for 10 more minutes while stirring (Fig. 3-10b). The mixture was then cooled down by adding distilled water. After it reached room temperature, it was filtered under vacuum using a Büchner funnel and VWR grade 413 qualitative filter paper (Fig. 3-10c). During this process, the insoluble residues were washed at least twice with distilled water. After the filtration, they were left in the oven for at least 48 h at around 60°C to ensure the moisture is completely removed. The dry insoluble residues were once again weighed and recorded. The initial and the final values were plotted (Appx. 10) for the determination of the soluble fraction:insoluble residue ratio for each set of samples.

The granulometric analysis was performed for the determination of the particle size distribution of the insoluble residue that is representing the silicious aggregates within the samples. It was carried out on the resultants of the acid attack by sieving them through stainless steel test sieves ASTM E11 with a diameter of 100 mm x 40 mm by RETSCH (Fig. 3-10d). The sieves used for the analysis had mesh sizes of 4, 2, 1, 0.500, 0.250, 0.125 and 0.063 mm. To capture the granulometric distributions of the samples, the insoluble residue obtained by each sieve was weighed and recorded. Each fraction was observed under a Leica M205 C Stereoscopic Microscope and photographed by a Leica DFC 295 digital camera. The results were presented in plots and diagrams. The data was used as a complementary to the results achieved by the thermogravimetric analysis. Together they were used to determine the production of the historical mortars of the Água da Prata according to the method introduced by Hanna Jedrzejewska (Jedrzejewska, 1960).

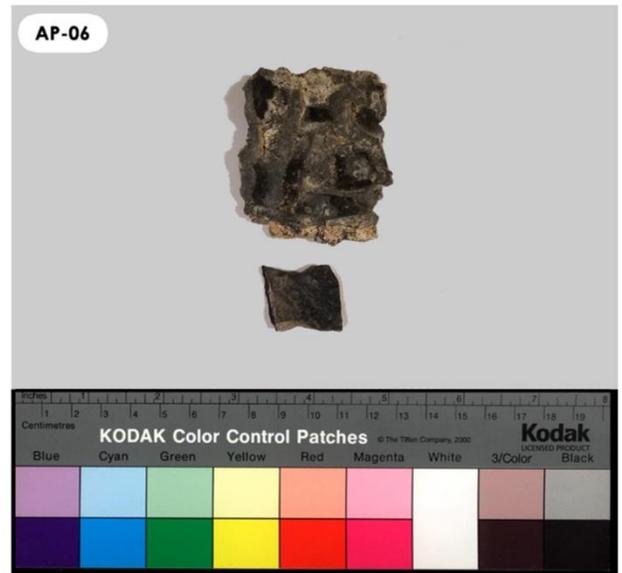
Figure 4-1. Photographic documentation of the samples before disaggregation.

The resistance of samples was also observed during the disaggregation. The samples showing less mechanical strength were the lighter coloured samples having decorative functions (AP-03, AP-08 and both layers of AP-12). Whereas the hardest mortar samples were AP-06 and AP-09D which are the darkest coloured (black and dark grey) samples. All the rest showed a medium mechanical strength. The inclusions visible to the naked eye were the lime nodules that appeared in all samples however, no ceramic additives were observed. In sample AP-06, fragments of coal were present embedded on its surface (Fig. 4-1). After the documentation, the coal fragments were removed from the sample before analysis.

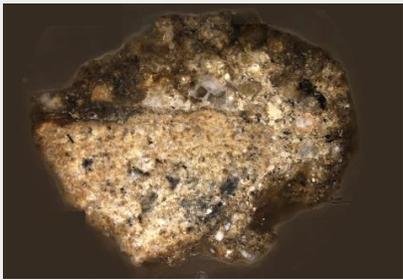
Sample	Function	Colour	Description	Cross section
EVR-01	Filler mortar from the XVI c. foundation	Brown	Aggregates sub-angular and angular, around 1 mm. Presence of large granitic fragments (15-20 mm). Small nodules of round lime lumps less than 1 mm in diameter.

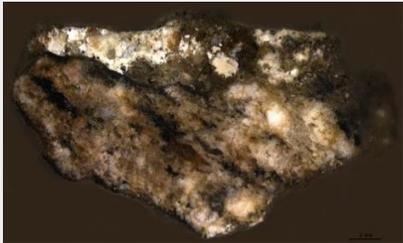
EVR-02	Filler mortar from the Roman foundation	Dark brown	Aggregates sub-angular, smaller than 1 mm. Small nodules of round lime lumps less than 1 mm in diameter. Presence of black elongated inclusions.

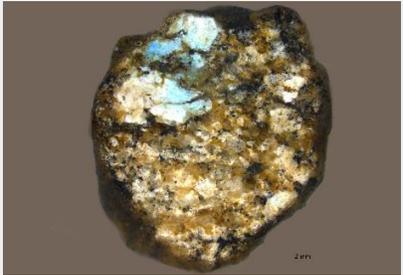
EVR-03	Filler mortar from the Roman foundation	Brown	Aggregates sub-angular and angular, around 1 mm. Large nodules of lime lumps, 4 to 6 mm in diameter.

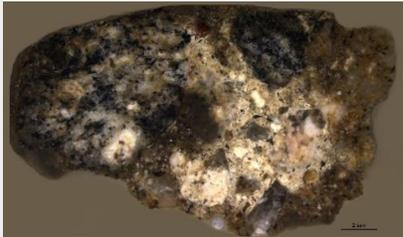
EVR-04	Filler mortar from Roman foundation <i>Opus caementicium</i>	Dark brown	Aggregates sub-angular and angular, around 1 mm. Small nodules of lime lumps less than 1 mm in diameter. Presence of dark coloured lithic fragments.

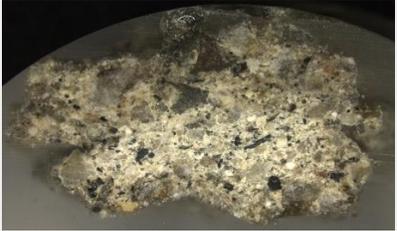
AP-02	Render mortar from XVII c. restoration	Grey	Aggregates sub-angular and angular, around 1 mm. Small nodules of lime lumps. Presence of black elongated inclusions. Has medium mechanical strength.

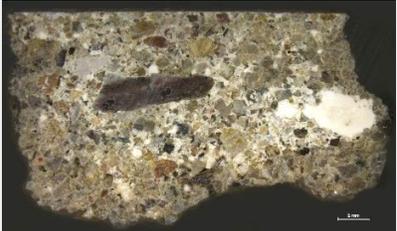
AP-06	Decoration mortar from the XIX c. fountain	Black	Aggregates sub-angular and angular, smaller than 1 mm. Large nodules of lime lumps up to 3 mm. Presence of a large coal fragment (6 mm). Visible cracks in the binder. Has high mechanical strength.

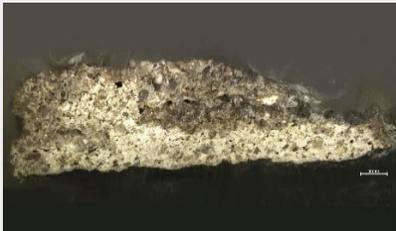
AP-10	Render mortar from the external façade of the pool from XIX c. fountain	AP-10D Grey	Aggregates sub-angular and angular, less than 1 mm. Has medium mechanical strength.

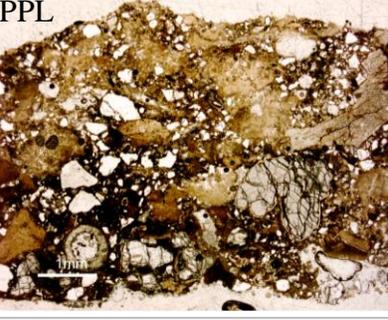
Table 4-4. Images of the isolated minerals observed under XPL (cross polarized light) and PPL (plane polarized light).

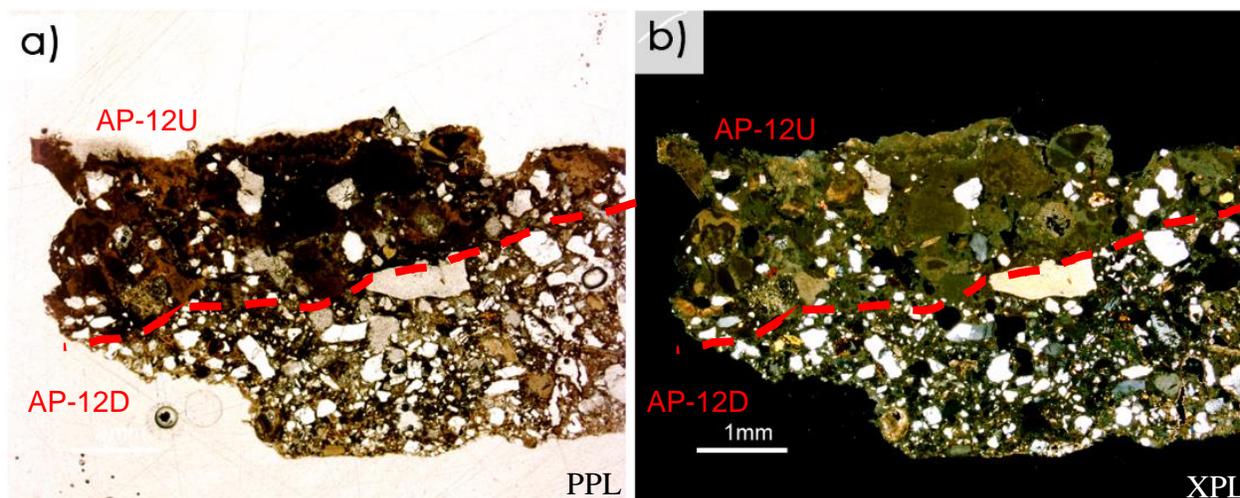
Figure 4-3. Representative petrographic images of AP-12, PPL(a) and XPL(b); AP-12U (referring the whiter layer); presence of carbonated grains within the binder forming a more homogenous appearance, AP-12D (referring the darker layer); has more aggregates and less binder.

Lime lumps were observed in all samples confirming the preliminary assessments by stereo microscopy. Within the binder of the decorative mortars (AP-03, AP-06, AP-08, AP-09 and AP-12) it was possible to observe carbonated grains which were not as distinguishable as they share a similar composition with the binder itself and did not define a very clear shape (Fig. 4-3). Such inclusions gave the binder a continuous and homogenous appearance. These grains could also be observed in the samples that had stratigraphy (AP-09, AP-10 and AP-12). Their lighter coloured layers (AP-09U, AP-10U and AP-12U) were more enriched with carbonated grains and had fewer aggregates. Their binder was more continuous. Whereas, the darker layers of these samples (AP-09D, AP-10D, AP-12D) were composed of more aggregates mostly smaller in sizes (< 0,5 mm) and had less amount of binder (Fig. 4-3).

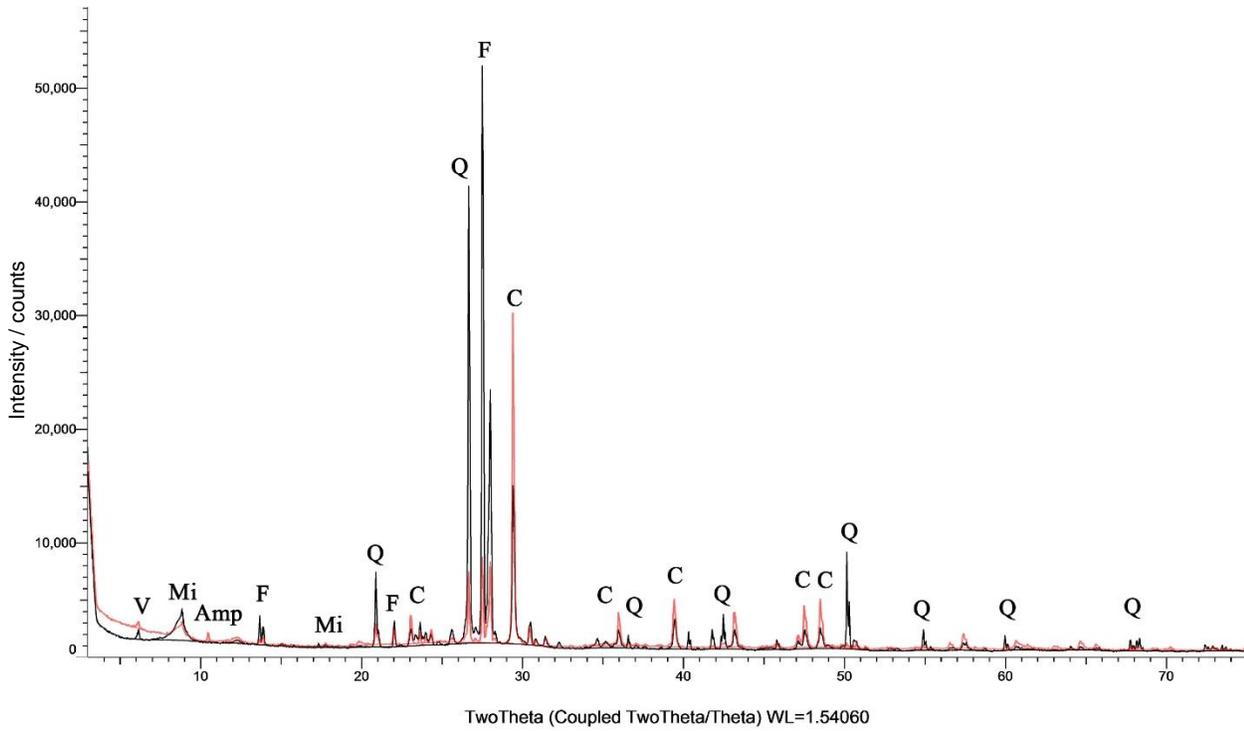
Figure 4-4. Representative XRD pattern of the XVI century filling mortar; diffractogram of EVR-01 GF (black), FF (red), (Q: quartz, C: calcite, F: feldspar, Mi: mica, Amp: amphibole, V: vermiculite)

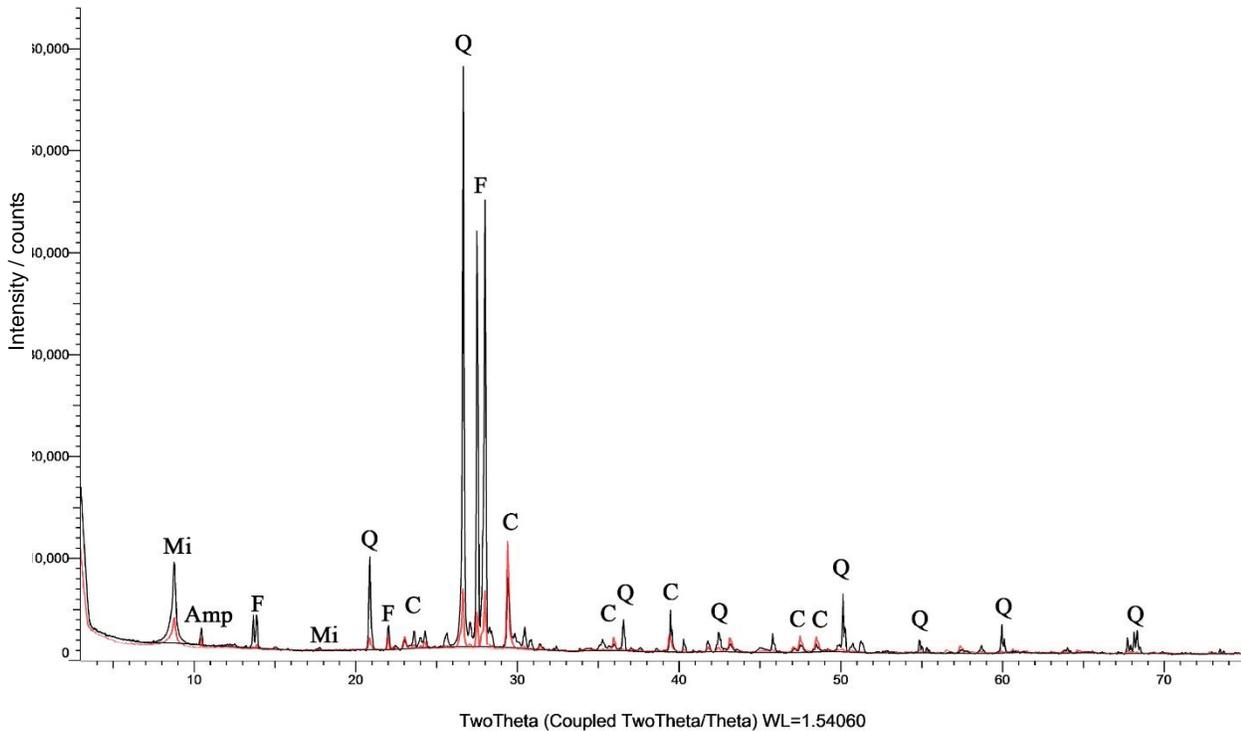
Figure 4-5. Representative XRD pattern of the Roman filling mortar; diffractogram of EVR-04 GF (black), FF (red), (Q: quartz, C: calcite, F: feldspar, Mi: mica, Amp: amphibole, V: vermiculite)

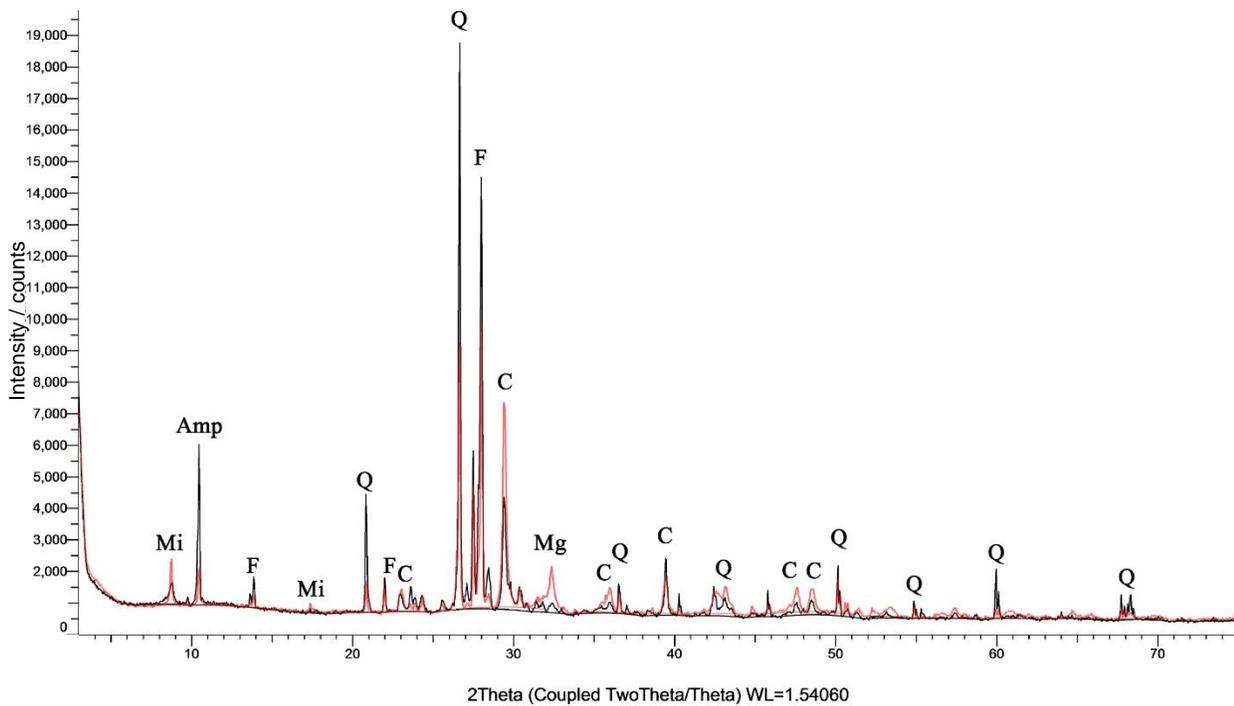
Figure 4-6. XRD Patterns of the stratigraphic layers of decorative mortar AP-12; Light coloured layer AP-12U (red), darker coloured layer AP-12D (black), (Q: quartz, C: calcite, F: feldspar, Mi: mica, Amp: amphibole, Mg: magnesite).

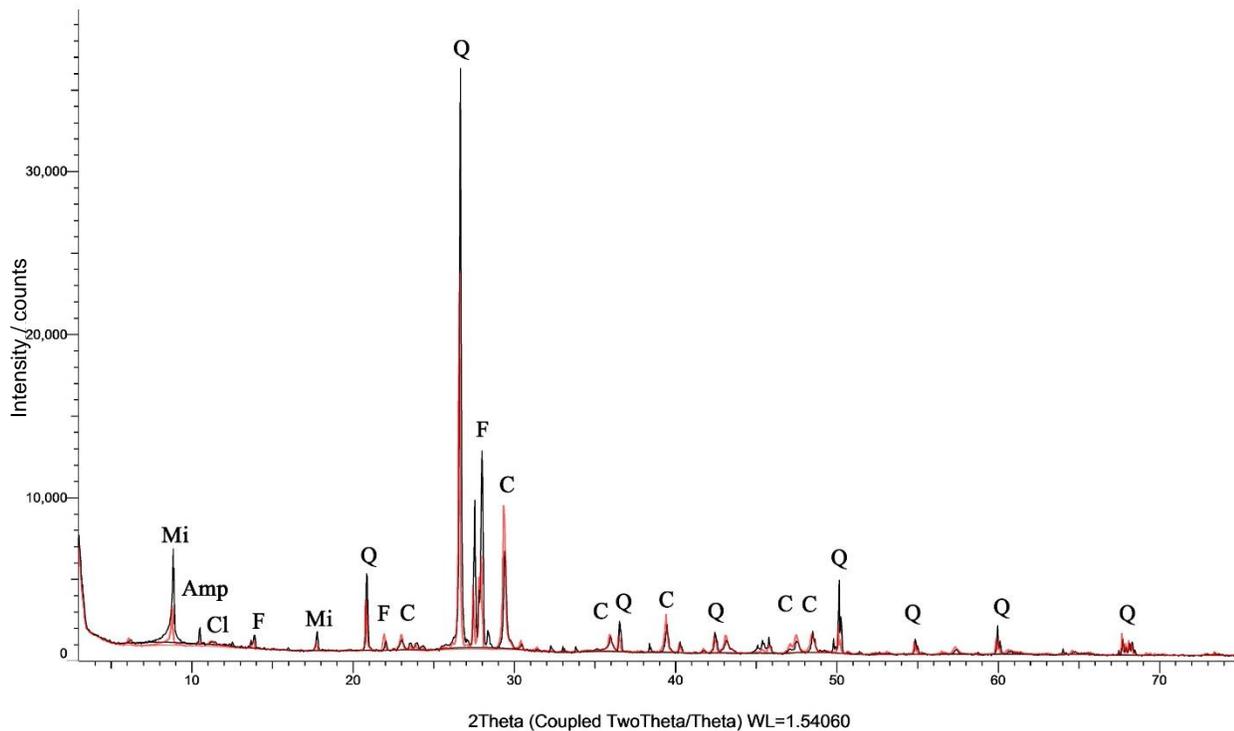
Figure 4-7. Patterns of the stratigraphic layers of the render mortar AP-10; Light coloured layer AP-10U (red), darker coloured layer AP-10D (black), (Q: quartz, C: calcite, F: feldspar, Mi: mica, Amp: amphibole, Cl: chlorite).
