ARCHMAT

**Characterization of Mortars from
Aqueduct of Água da Prata (Évora, Portugal)**

Évora, Portugal, December 2020

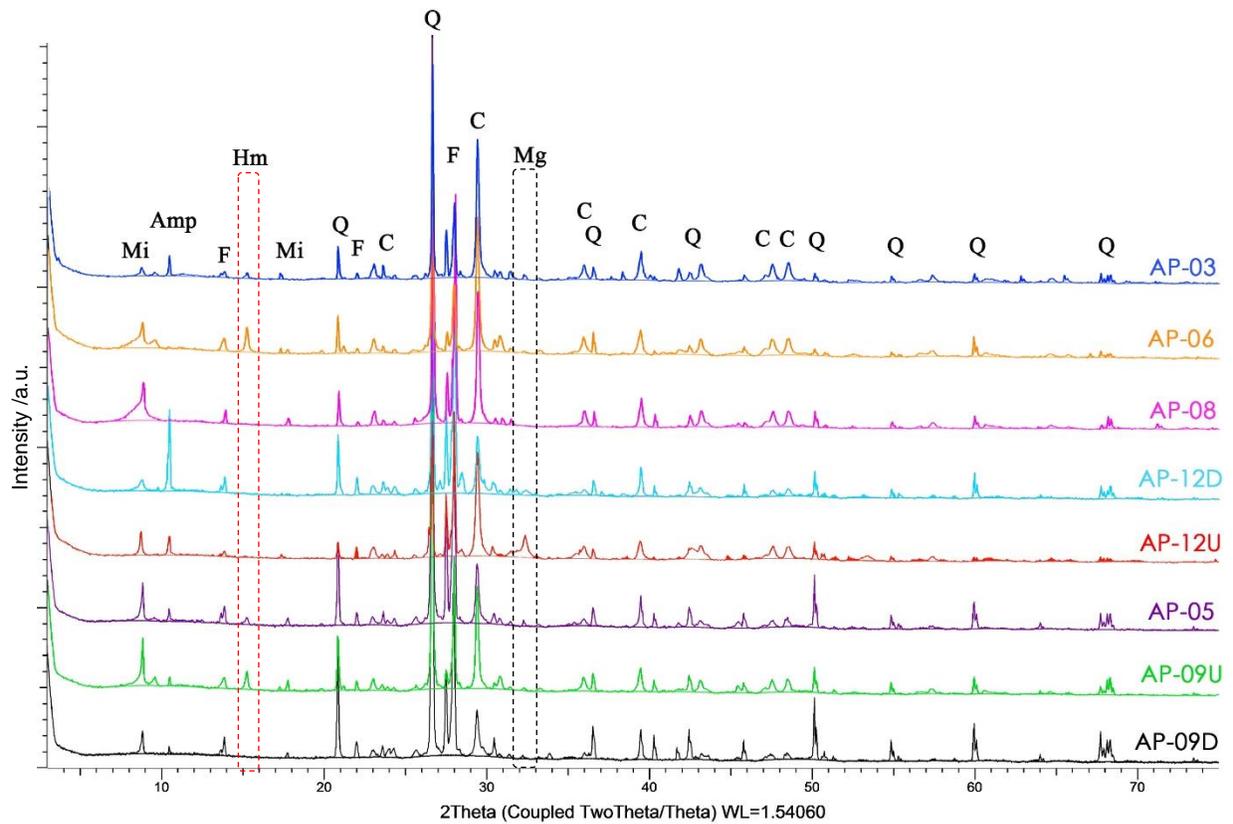
Figure 4-8. XRD Patterns of the samples with decorative use and AP-05 (Q: quartz, C: calcite, F: feldspar, Mi: mica, Amp: amphibole, Hm: hydromagnesite) (marked with red box), Mg: magnesite (marked with black box).

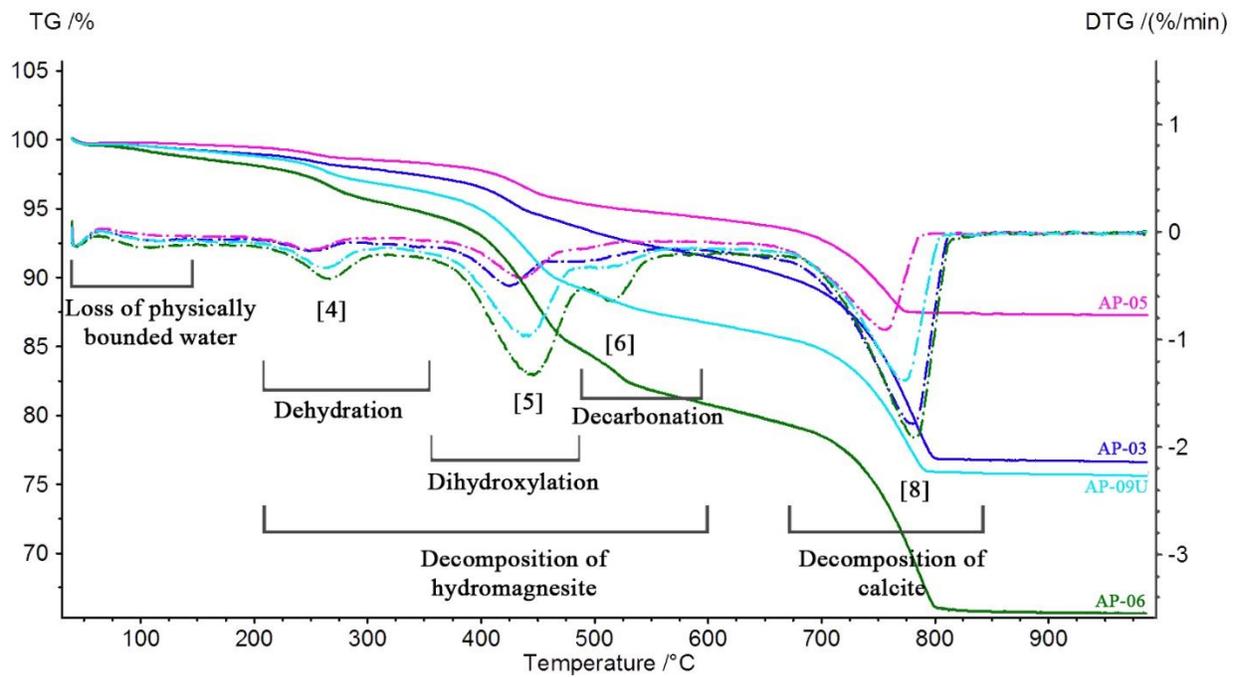
Figure 4-9. TG/DTG curves of samples AP-03 (blue), AP-05 (magenta), AP-06 (green) and AP-09U (cyan), continuous curves representing TG and dashed curve representing DTG data

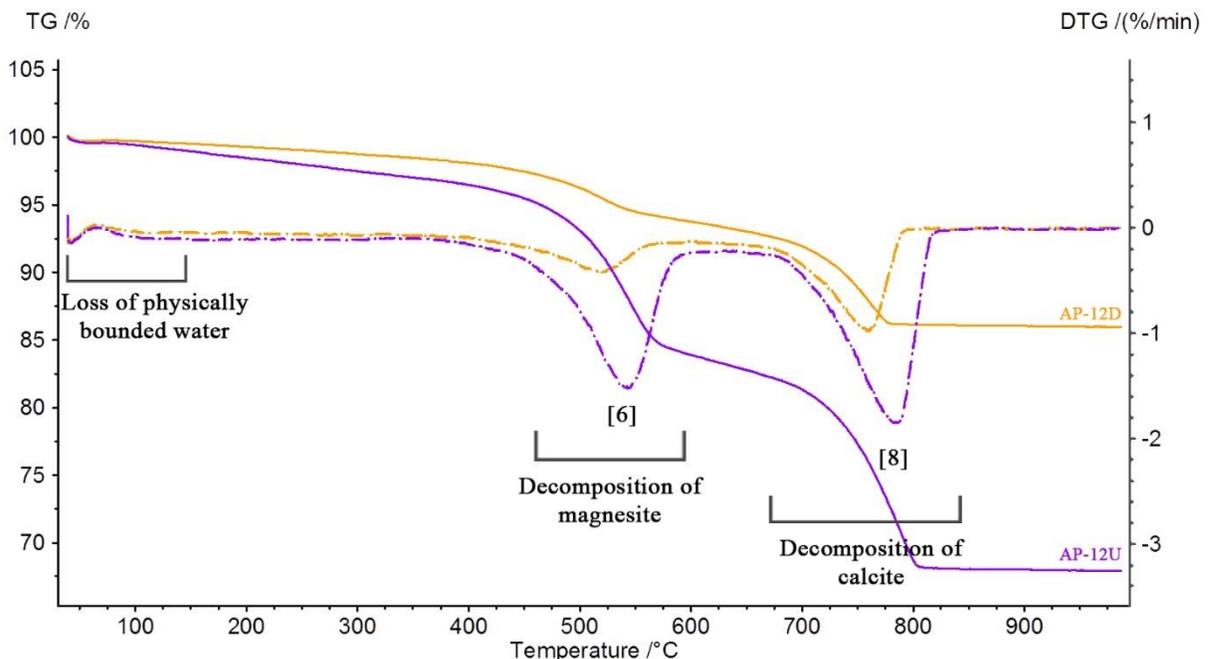
Figure 4-10. TG/DTG curves of samples AP-12U (purple), AP-12D (orange), continuous curves representing TG and dashed curve representing DTG data.

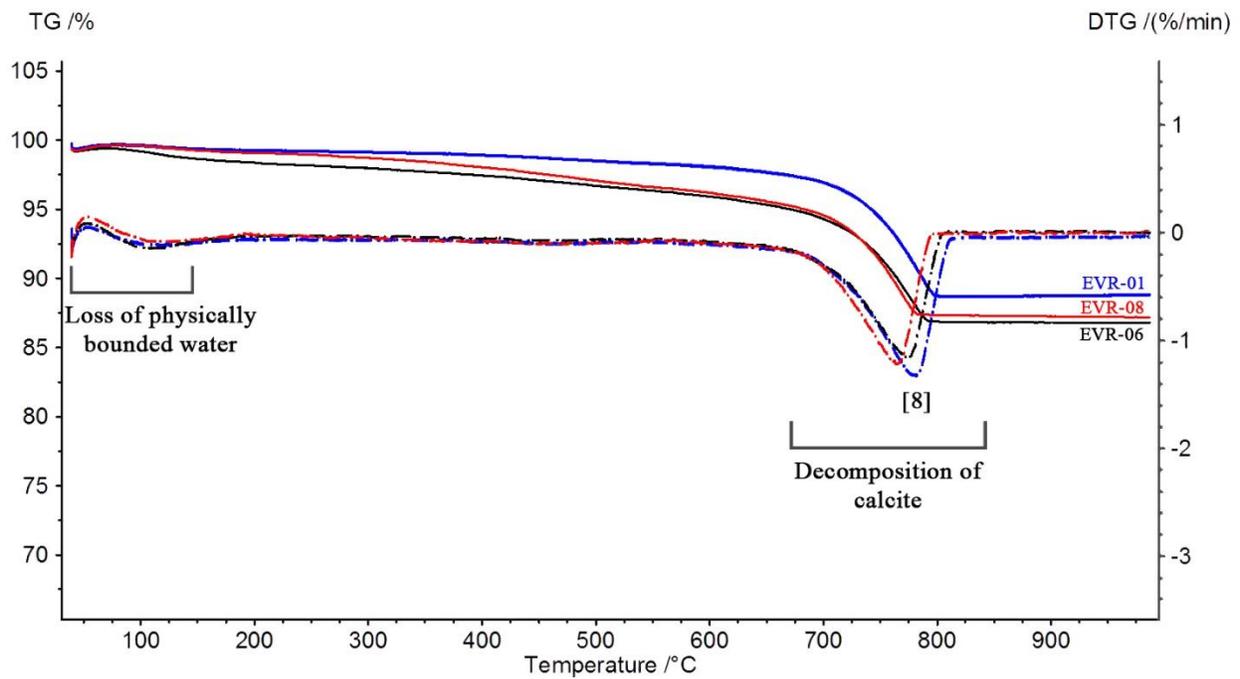
Figure 4-11. TG/DTG curves of XVI c. filling mortars; EVR-01 (blue), EVR-06 (black), EVR-08 (red); continuous curves representing TG and dashed curve representing DTG data.

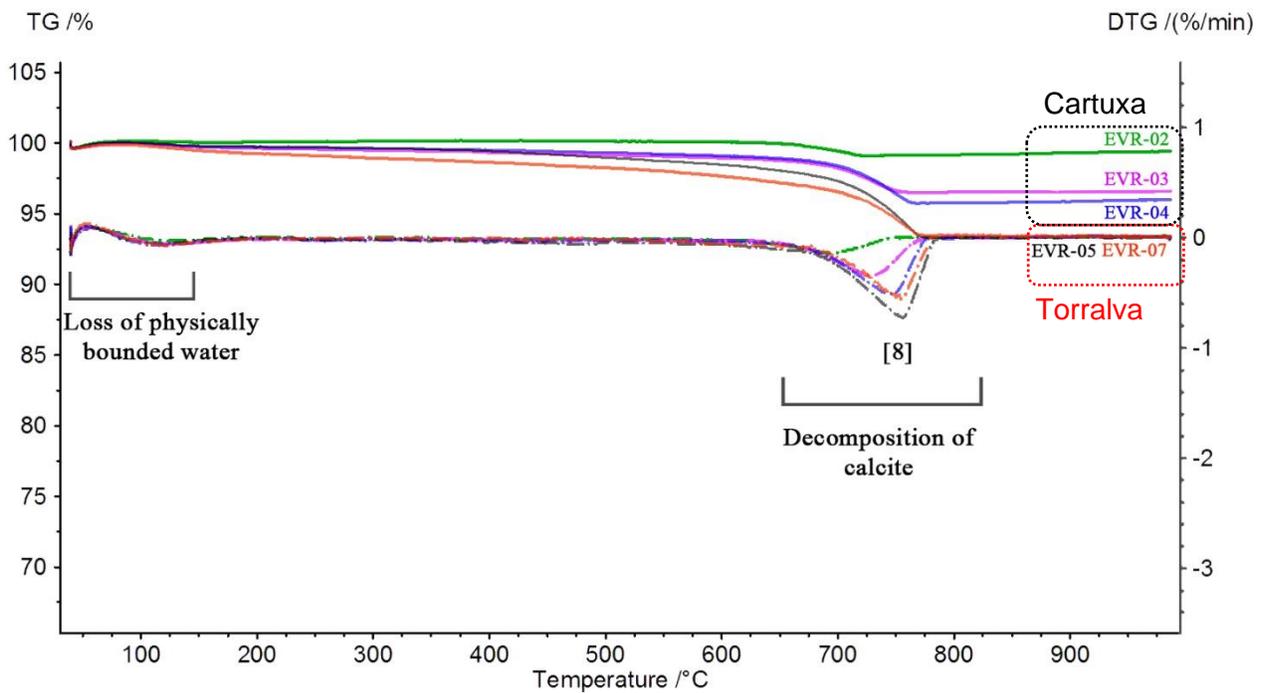
Figure 4-12. TG/DTG curves of the Roman filling mortars; EVR-02 (green), EVR-03 (magenta), EVR-04 (blue), EVR-05 (black), EVR-07 (red); continuous curves representing TG and dashed curve representing DTG data.

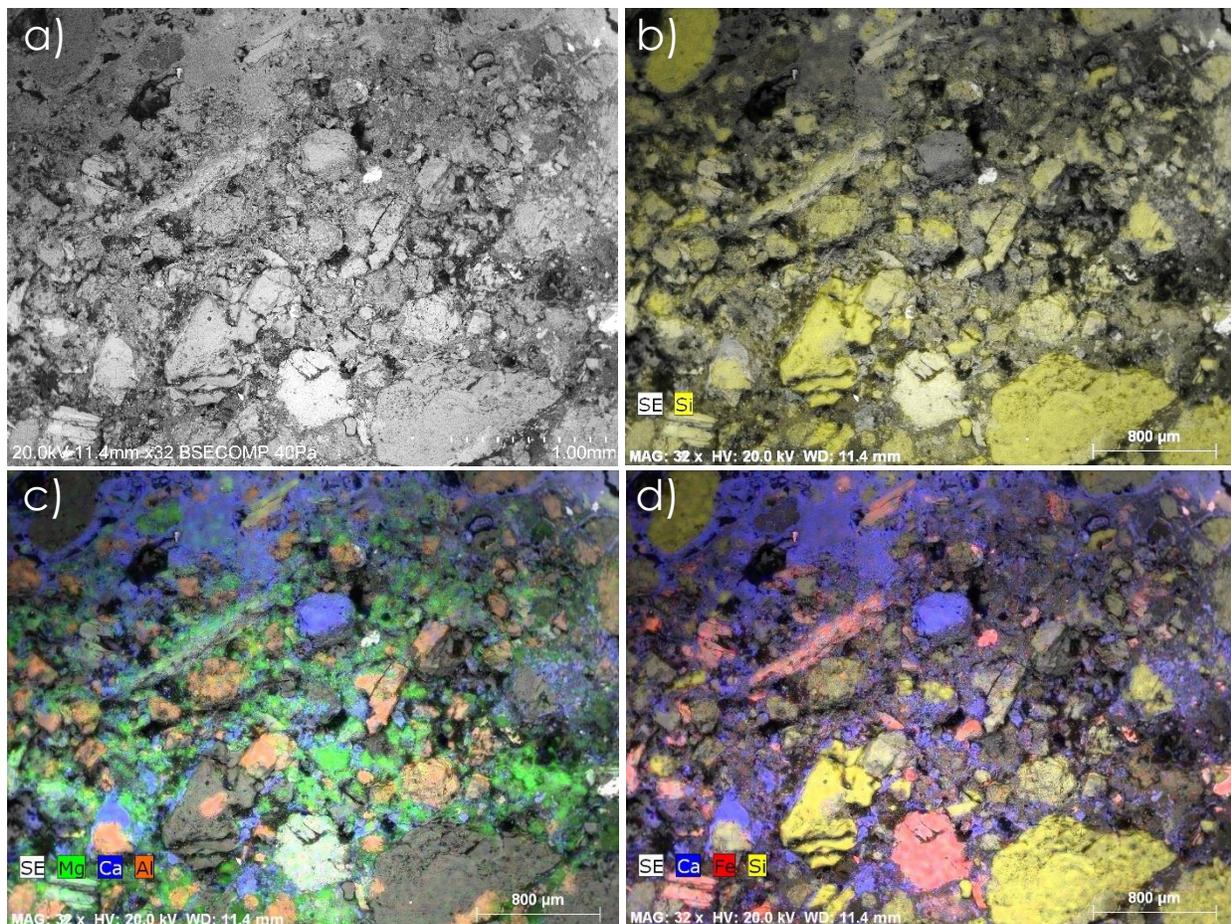
Figure 4-13. Elemental maps of AP-02; a) BSE image of the general composition, b) Siliceous aggregates within the composition c) Mg, Ca, Al elemental map, Al related to feldspars d) Ca, Fe, Si elemental map, Fe related to biotite. Yellow: Si, blue: Ca, green: Mg, orange: Al, red: Fe.

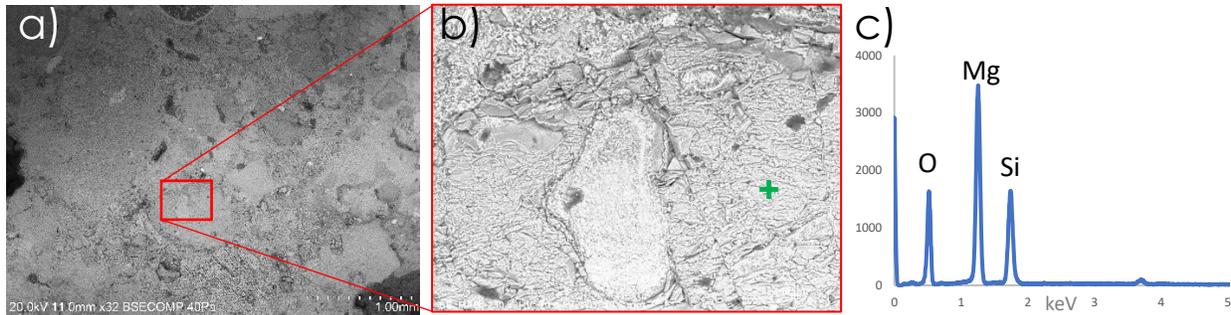
Figure 4-14. a-b) BSE image of AP-03, c) EDS spectra of the point analysis marked in (b).

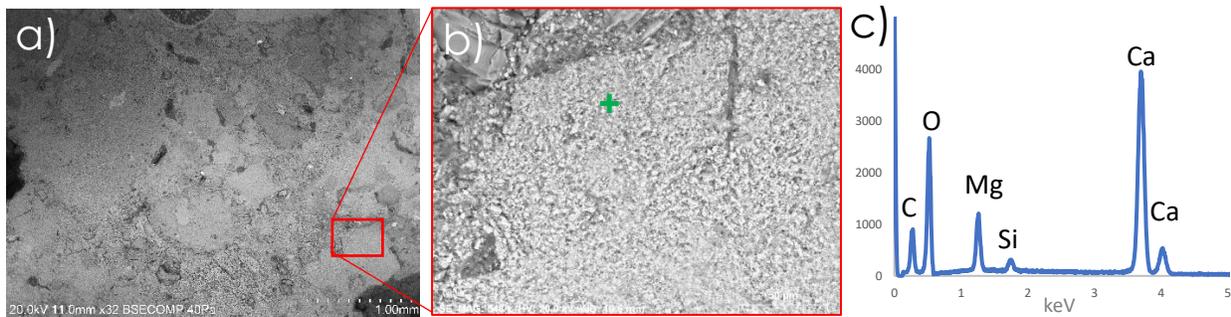
Figure 4-15. a-b) BSE image of AP-03, c) EDS spectra of the point analysis marked in (b).

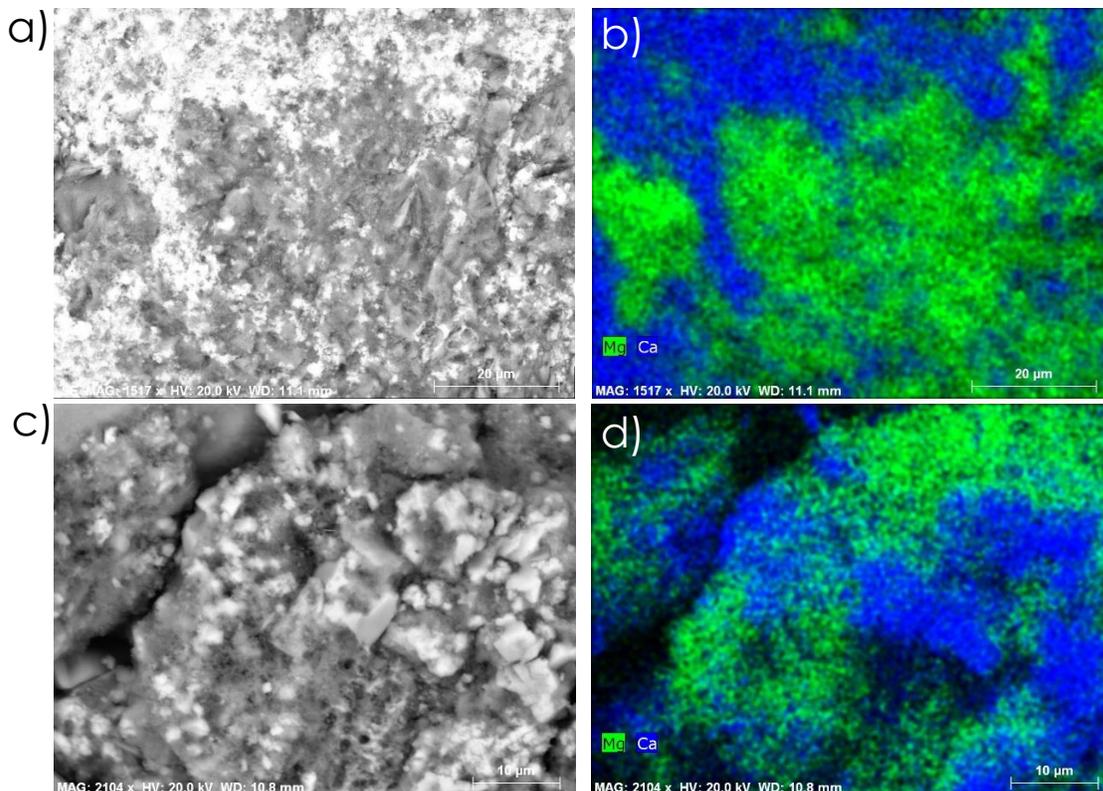
Figure 4-17. Representative image of binder microstructure; a-b) Sample AP-09U, c-d) Sample AP-01; BSE images on the left and elemental distribution maps of calcium (blue) and magnesium (green) on the right, respectively.

Figure 4-17. Representative image of binder microstructure; a-b) Sample AP-09U, c-d) Sample AP-01; BSE images on the left and elemental distribution maps of calcium (blue) and magnesium (green) on the right, respectively. 51

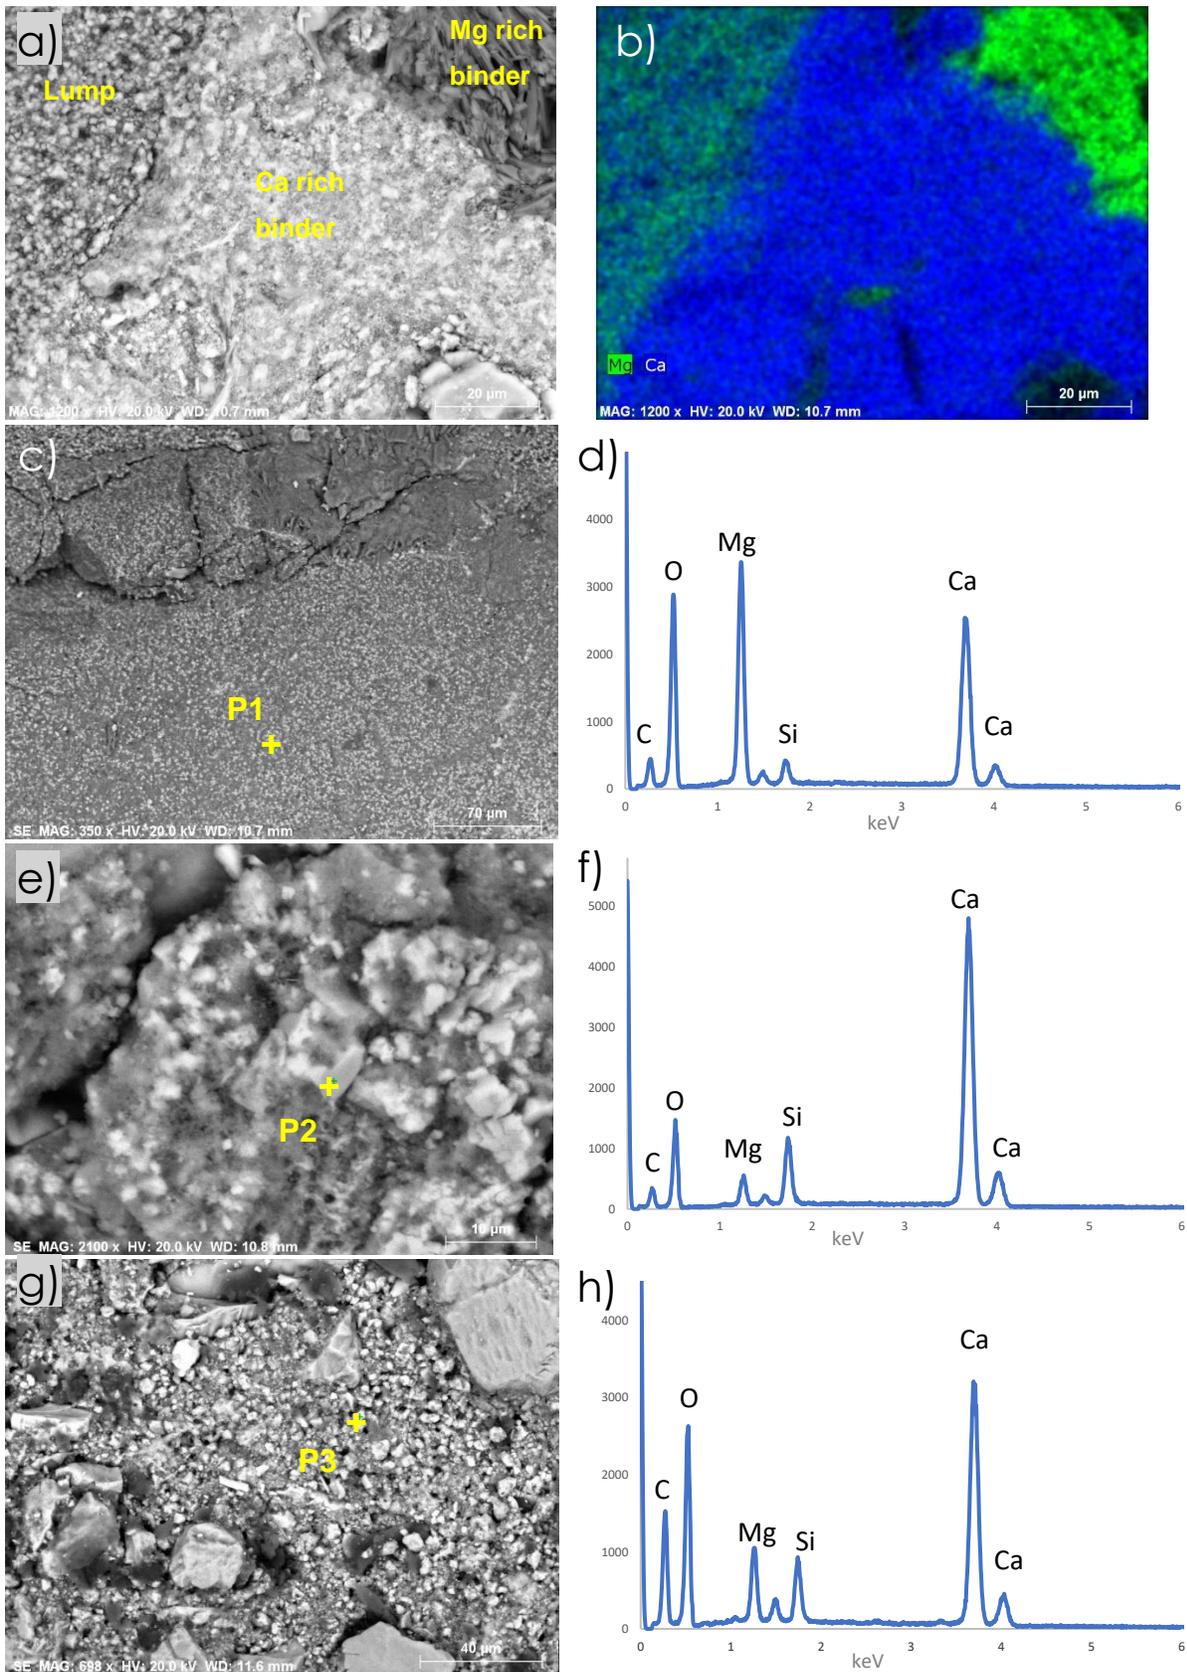
Figure 4-18. a) General aspect of lime lump and binder of AP-01; b) Elemental map of (a), c-h) Point analysis and corresponding EDS spectrum of lump (P1) in AP-01, Ca rich (P2) in AP-01 and Ca rich (P3) in AP-12, respectively.

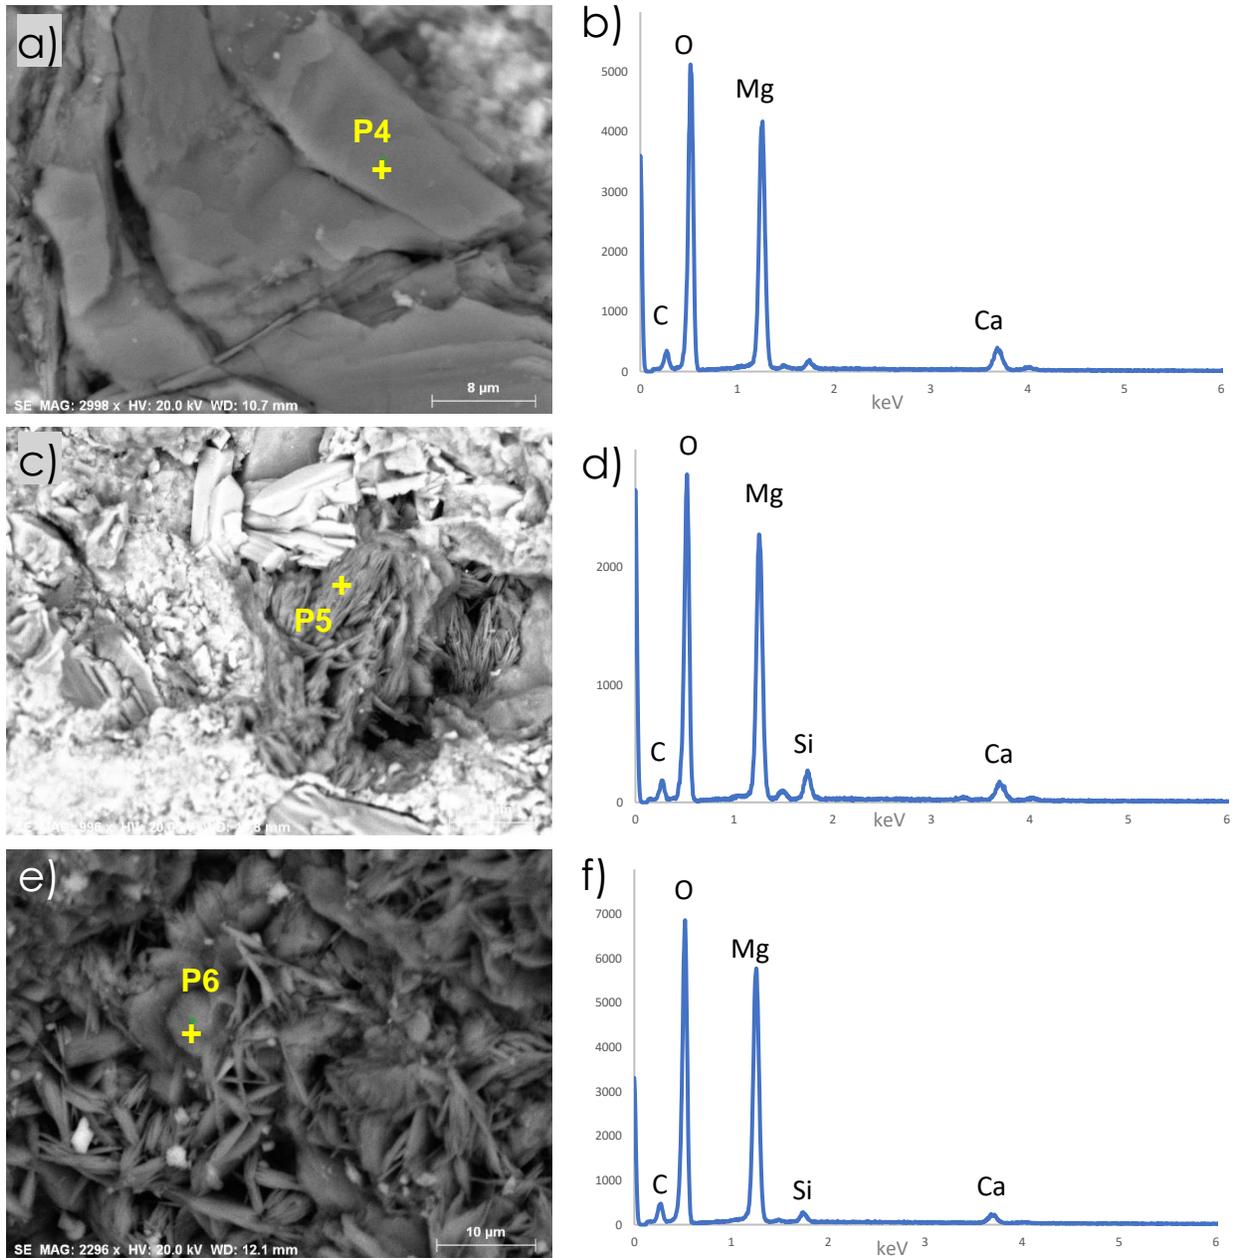
Figure 4-19. BSE image of the point analysis and corresponding EDS spectrums of the magnesite crystals within the binder matrix; a-b) AP-01, c-d) AP-03 and e-f) AP-05.

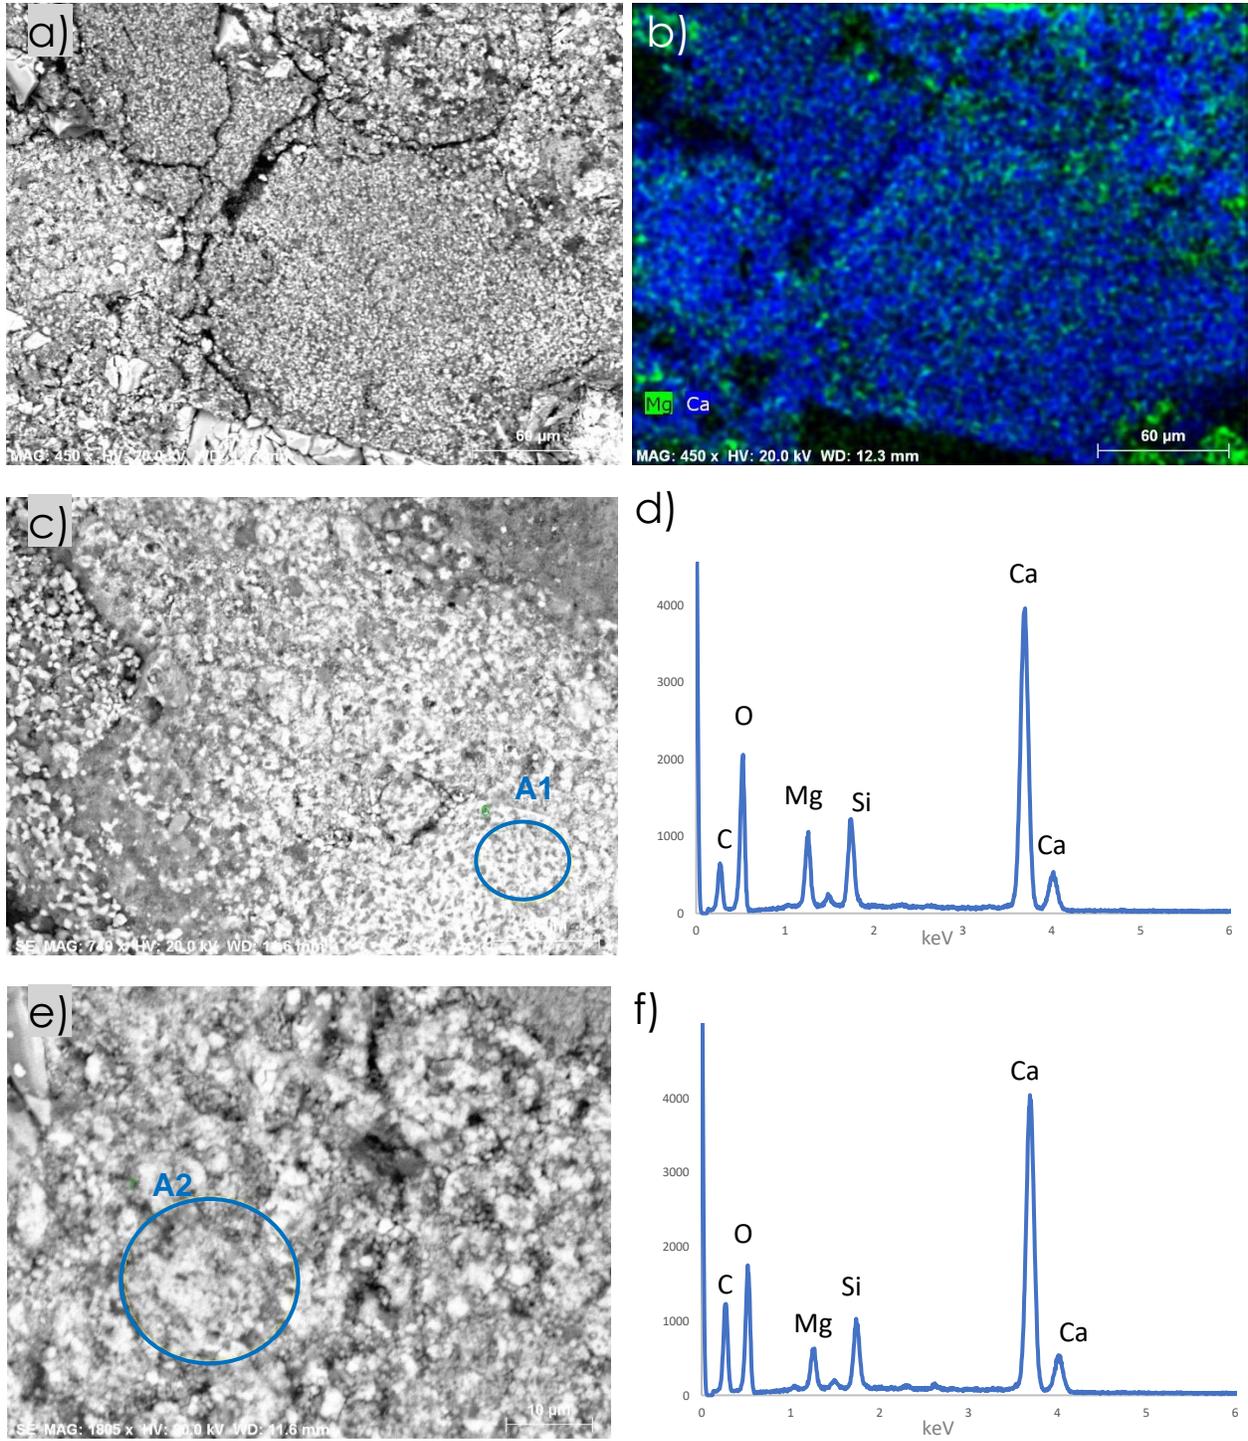
Figure 4-20. a) Representative image of binder microstructure of AP-11, b) Elemental map of (a) Ca and Mg, c-f) BSE image of the multipoint analysis in the binder of AP-04 and corresponding EDS spectrums of the (A1) Mg bearing area and (A2) Ca bearing area.

Figure 4-20. a) Representative image of binder microstructure of AP-11, b) Elemental map of (a) Ca and Mg, c-f) BSE image of the multipoint analysis in the binder of AP-04 and corresponding EDS spectrums of the (A1) Mg bearing area and (A2) Ca bearing area. 54

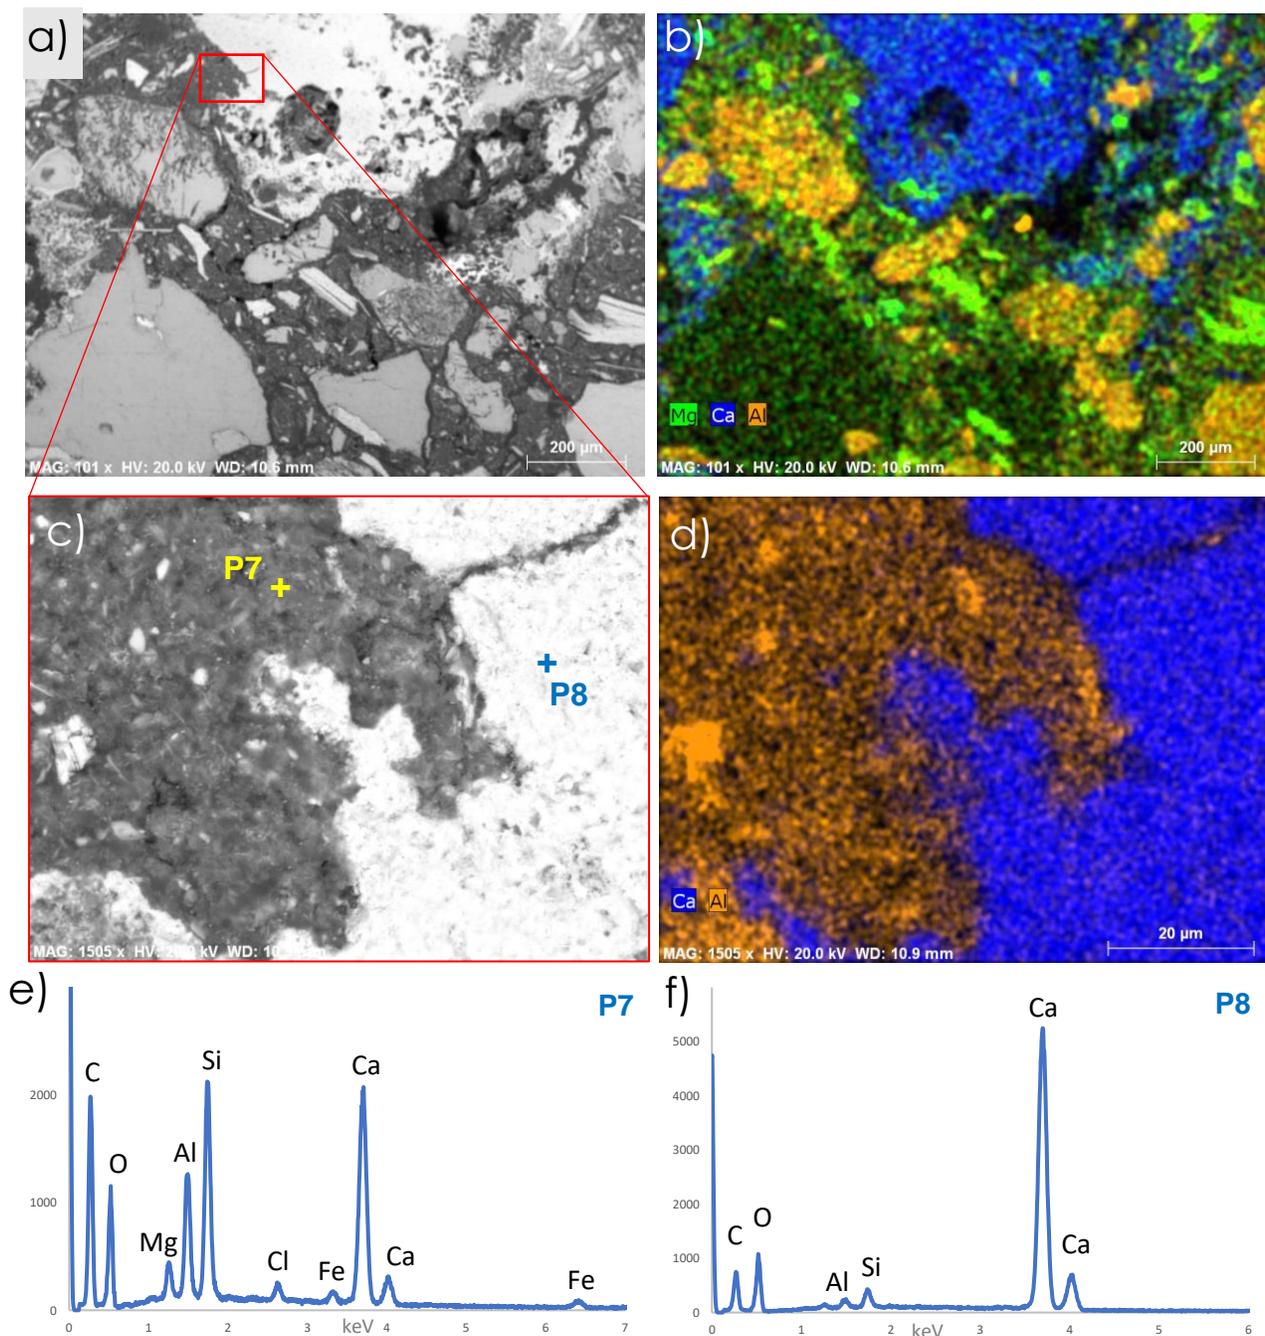
Figure 4-21. a) BSE image of the general composition of EVR-04 (Roman sample), b) Elemental map of (a) with Mg, Ca and Al, c) BSE image of a more focused on the binder area with calcitic lime on the right, d) Elemental map of (c) with Ca and Al, e-f) Point analysis P7 on the binder (e) and P8 on the calcitic lime binder (f).

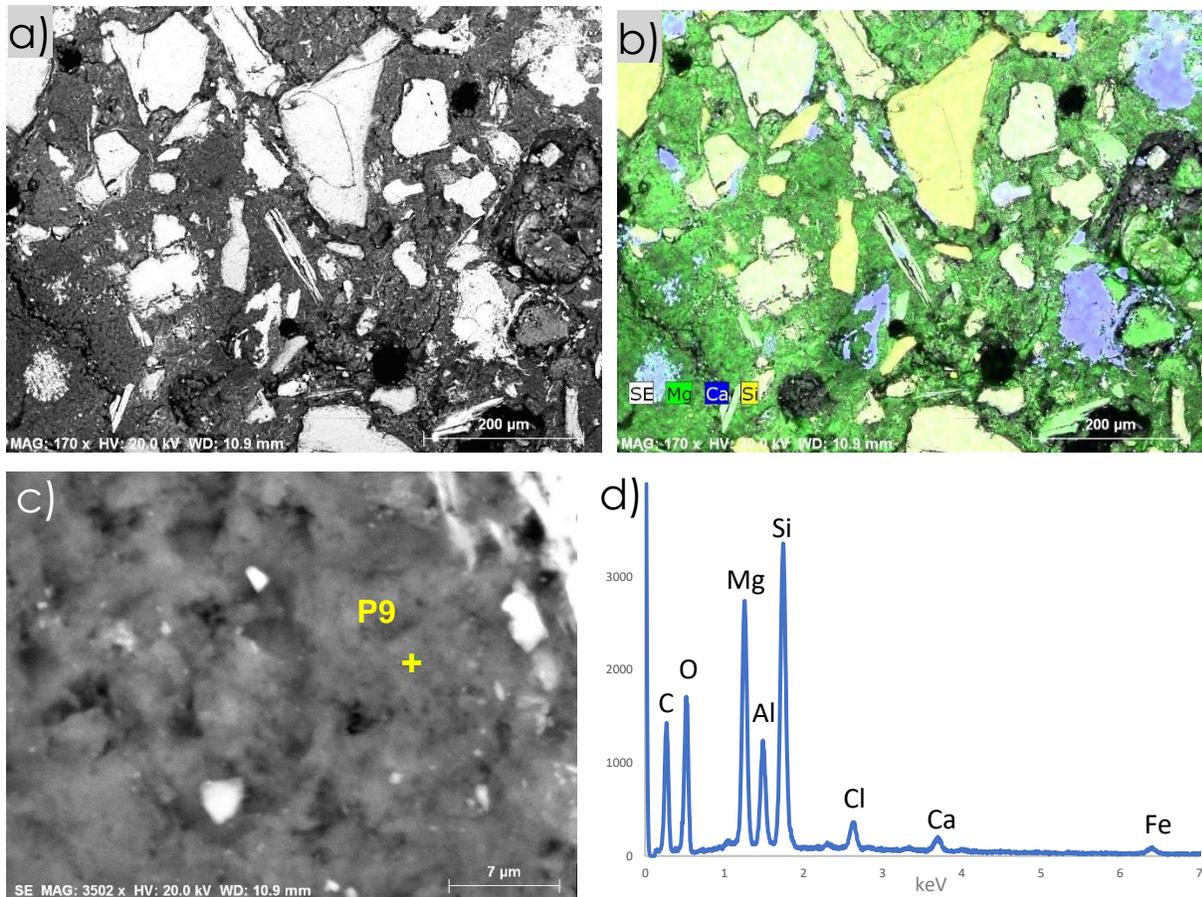
Figure 4-22. a) BSE image of the general composition of EVR-06 (XVI century sample), b) Elemental map of (a) with Mg, Ca and Si, c) BSE image of a more focused on the binder area, d) Point analysis P9 on the binder (c).

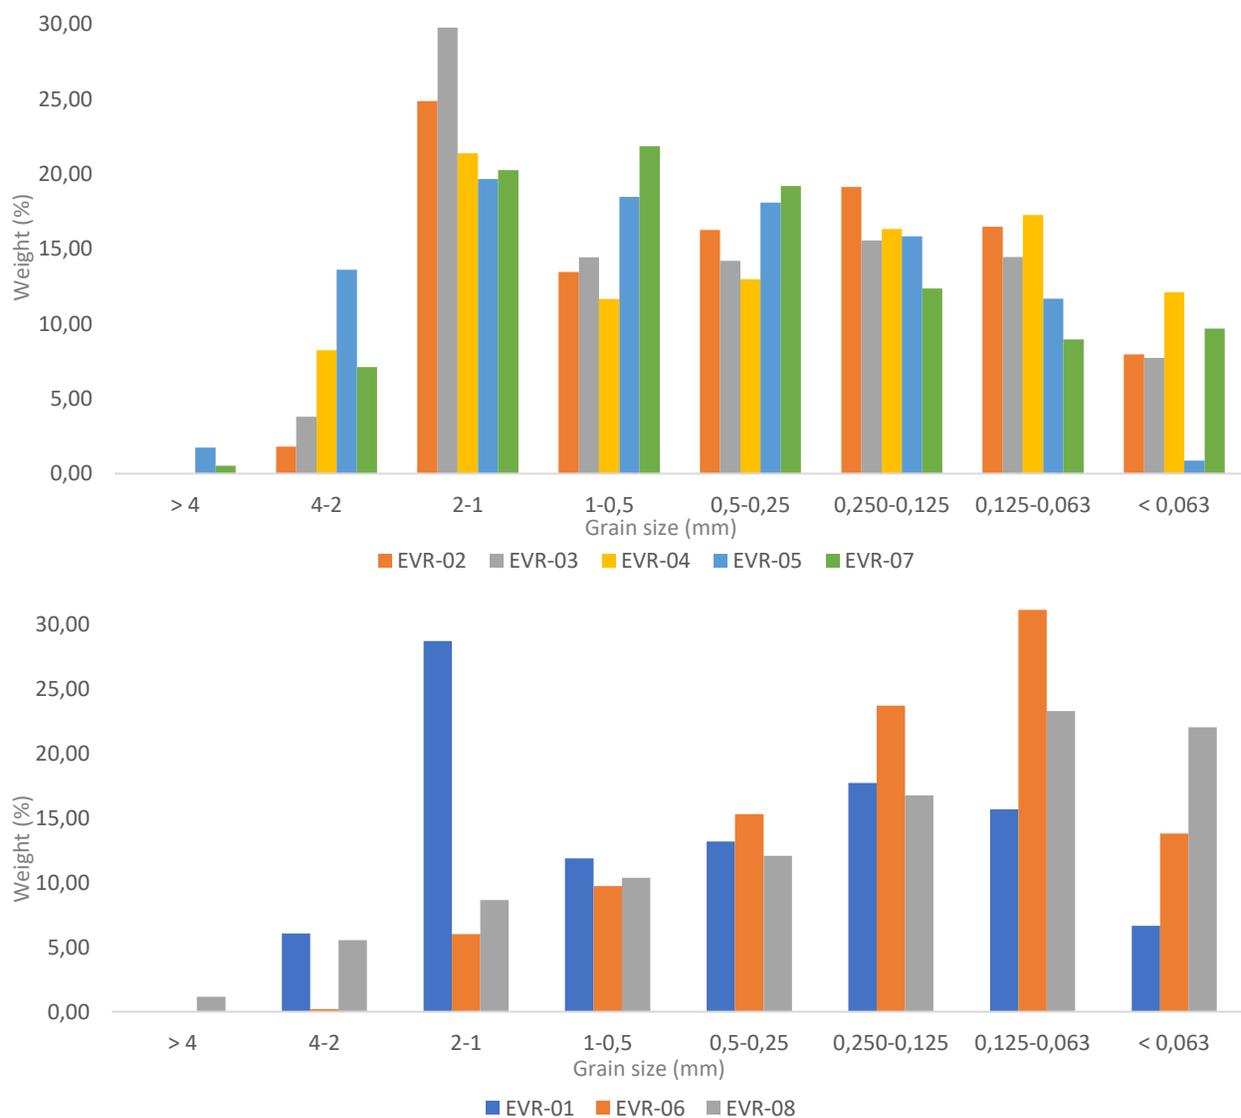
Figure 4-23. Grain size distributions of filler mortars from Roman period (upper) and XVI century (lower).

The sieving of the insoluble residues allowed to determine the grain size distributions of the aggregates as plotted in Appx.11. It was possible to identify the predominant fraction for each sample by their distribution patterns. Filler mortars from the Roman period (EVR-02, EVR-03, EVR-04, EVR-05 and EVR-07) had the highest amount of fraction between 2,0 and 1,0 mm which is categorized as very coarse sand by Wentworth, 1922 (Fig. 4-23). Even though having the highest fraction at the same range, the Roman mortars from Torralva pit (EVR-05 and EVR-07) displayed a different distribution pattern, allowing them to be grouped together as in the previous observations. Filler mortars of XVI century (EVR-06 and EVR-08) displayed a finer grain pattern by having the highest fraction between 0,125 and 0,063 mm categorized as very fine sand (Blott and Pye, 2001). Distinctively, EVR-01 which is also a filler mortar from the XVI century presented a very similar distribution pattern to the Roman samples.

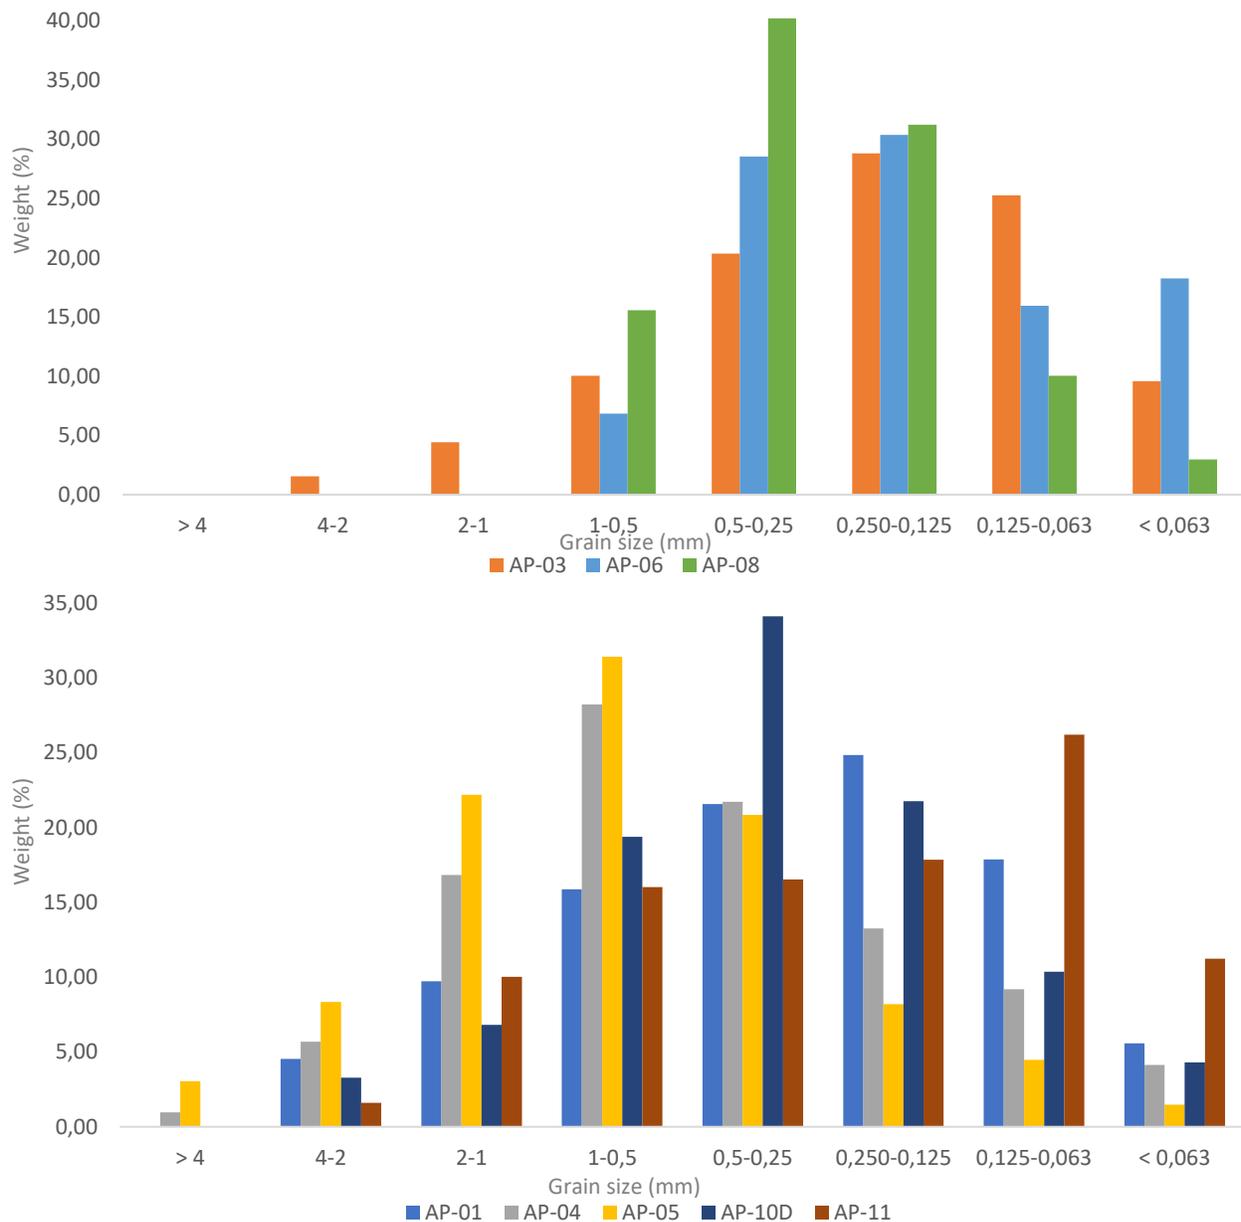
Figure 4-24. Grain size distribution curves of render mortars; decorative mortars (upper) and render mortars (lower).

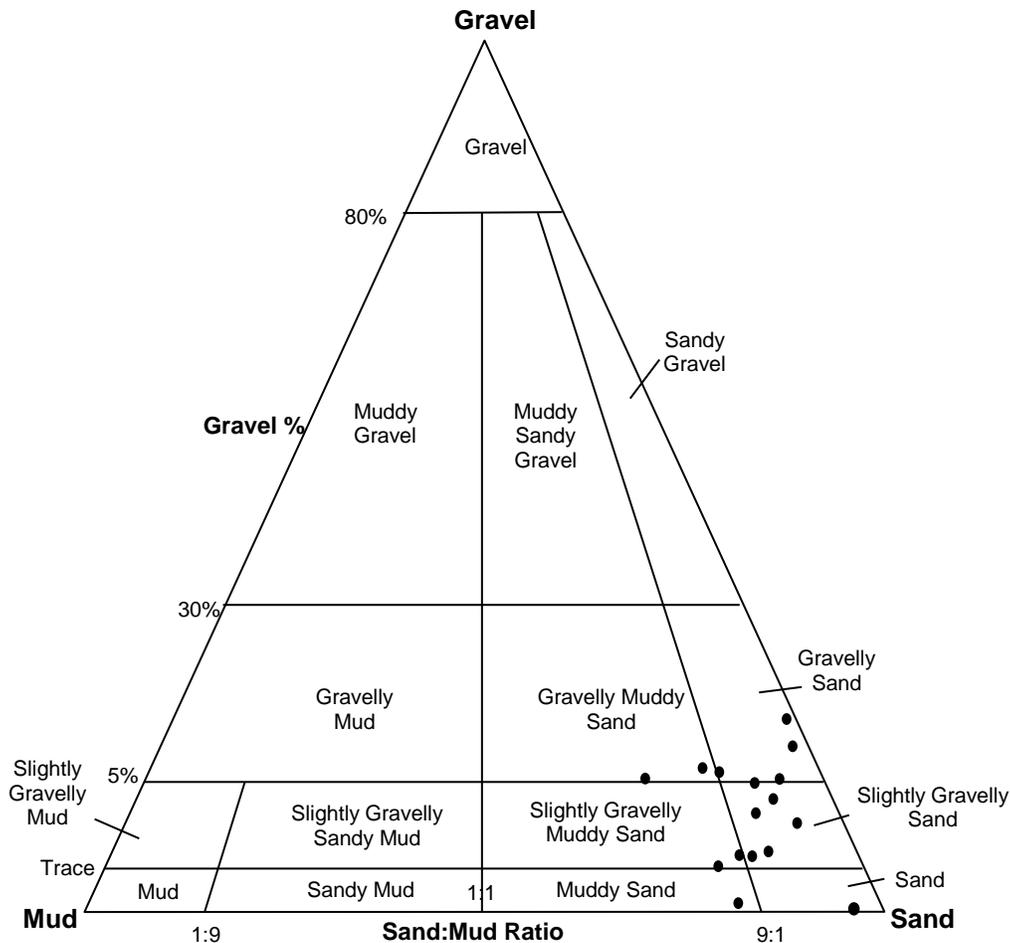
Figure 4-25. Gravel:mud:sand diagram from GRADISTAT.

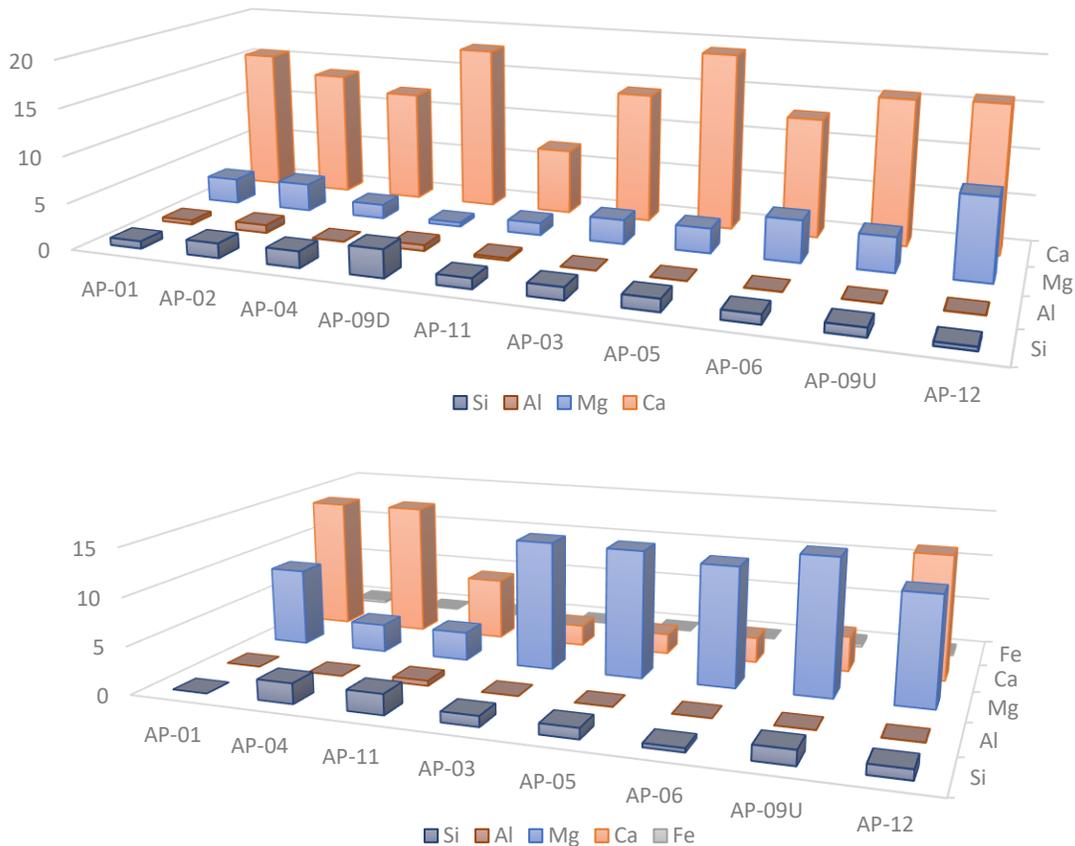
Figure 5-1. EDS analysis of Ca rich (upper) and Mg rich (lower) points within the binder of the samples (%).

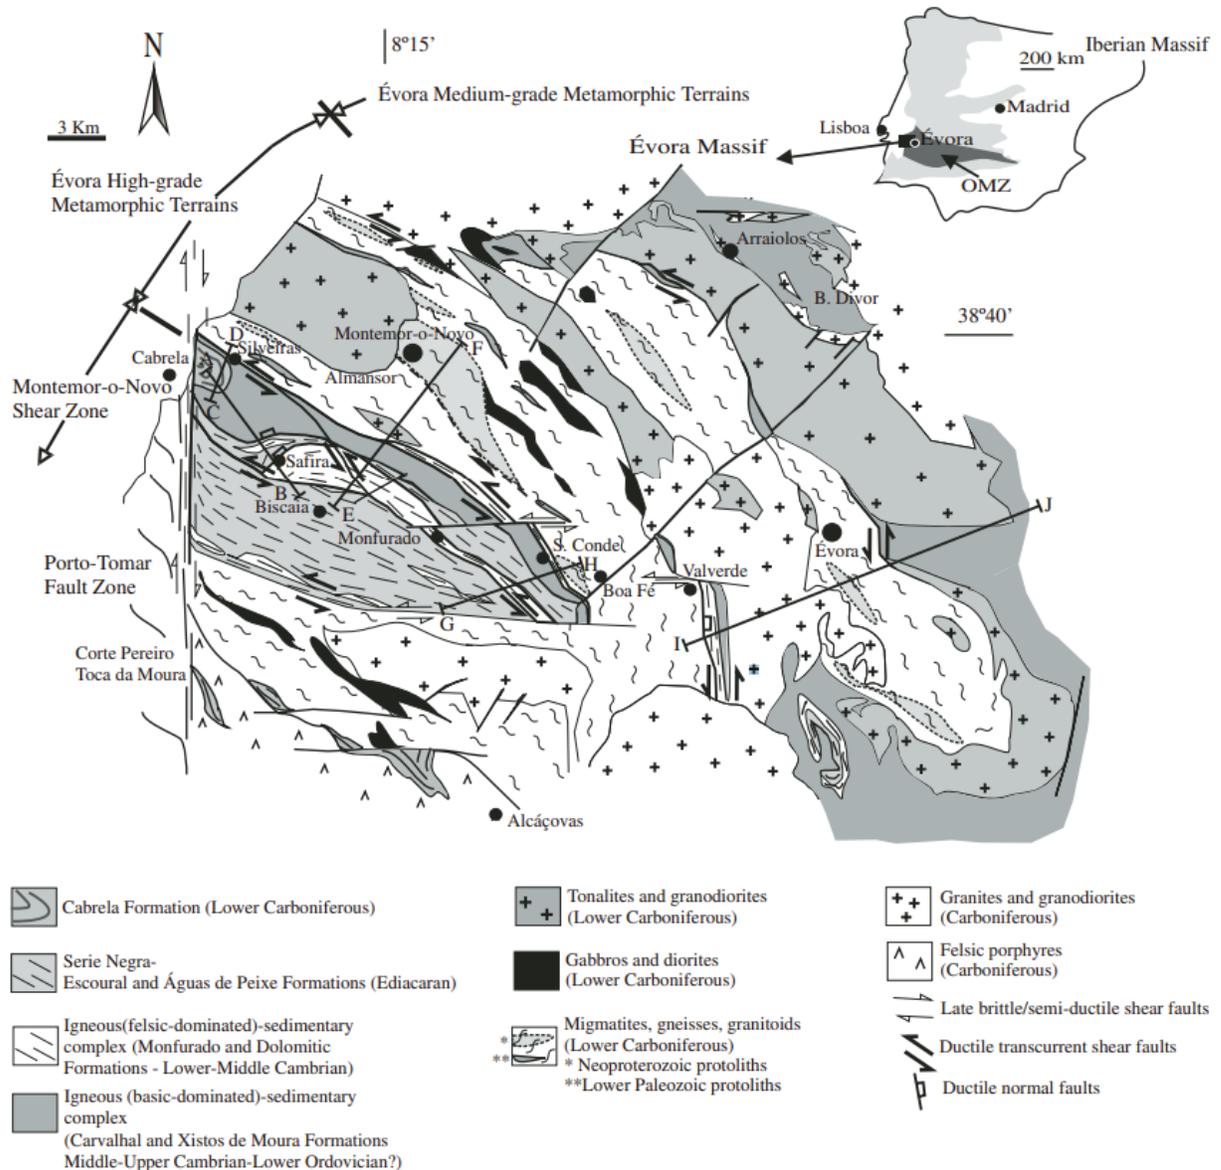
Figure 5-2. Geological map of Évora and its surroundings (Moita *et al.*, 2009)
