ARCHMAT

**Characterization of Mortars from
Aqueduct of Água da Prata (Évora, Portugal)**

Évora, Portugal, December 2020

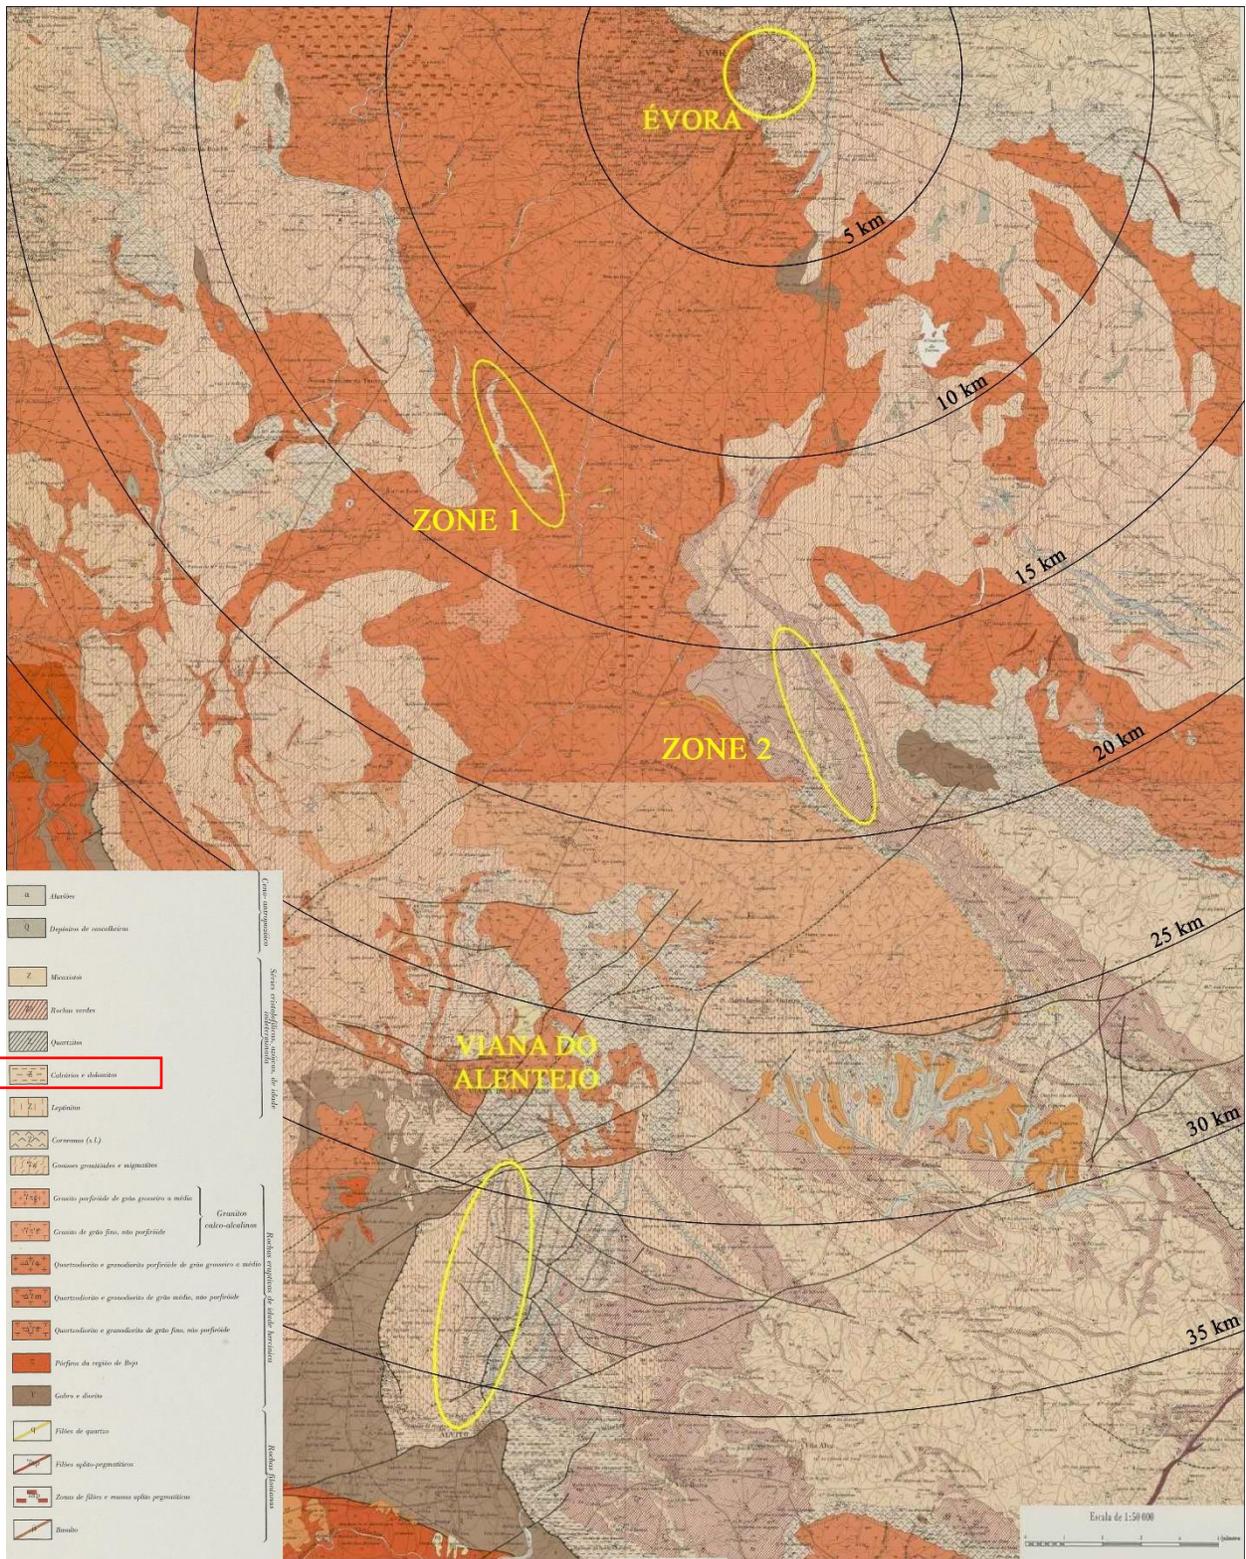
Figure 5-3. Geological scheme from Évora (40-A) and Viana do Alentejo (40-C) geological maps in 35 km of radius between Évora and Viana do Alentejo , scale of 1/50000 (taken and adapted from Laboratório Nacional de Energia e Geologia (LNEG), <http://geoportal.lneg.pt/geoportal/mapas/index.html>).

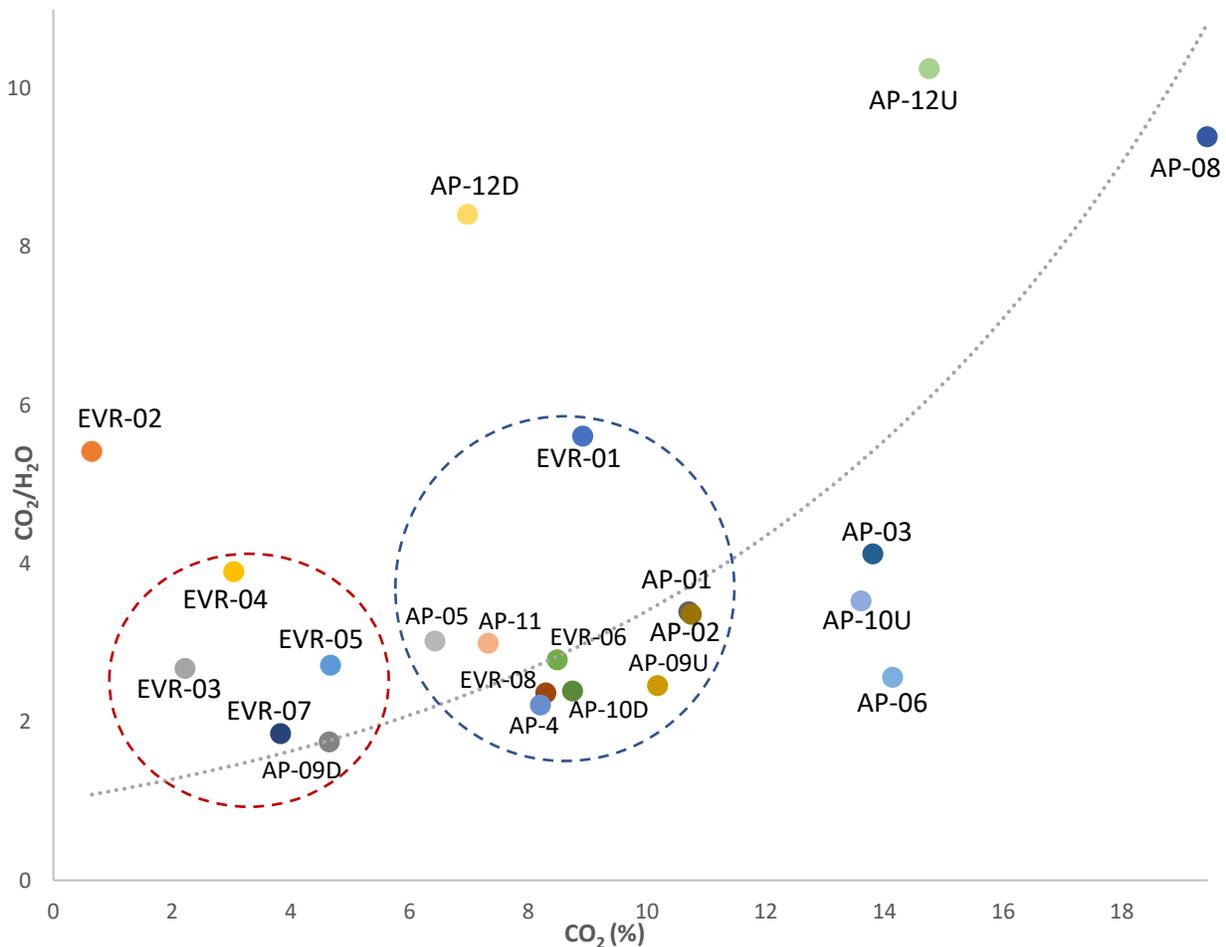
Figure 5-4. Carbon Dioxide / Structurally Bound Water versus Carbon Dioxide (%).
