# Compatibility Tests Between High Temperature Concrete and Molten Salts to be Used for a Thermal Energy Storage

**Abstract.** Solar Energy is an abundant resource and can be stored for use at any time of the day. One of the most efficient methods of storage is the thermal process at high temperature (> 400 °C) usual for solar concentrators using molten salts stored in two tanks. In order to reduce total storage costs, an alternative solution would be to store in a solid medium using concrete with thermal properties optimized as a storage medium. The present paper focuses on performing a compatibility evaluation, by analyzing at a laboratory scale, small concrete cubes uncoated and concrete cubes covered with protective refractory coatings that were put in contact with molten salts subject to a heating cycle up to 500°C. In this investigation, thermal cycles between 290 °C and 500 °C were tested by placing cubic samples (40x40x40 cm) in a bath with a ternary mixture of molten salts in a furnace to simulate loading and unloading cycles. The results show that a good concrete mix (suitable binder, suitable aggregates, admixtures) is critical for good thermal performance and adequate

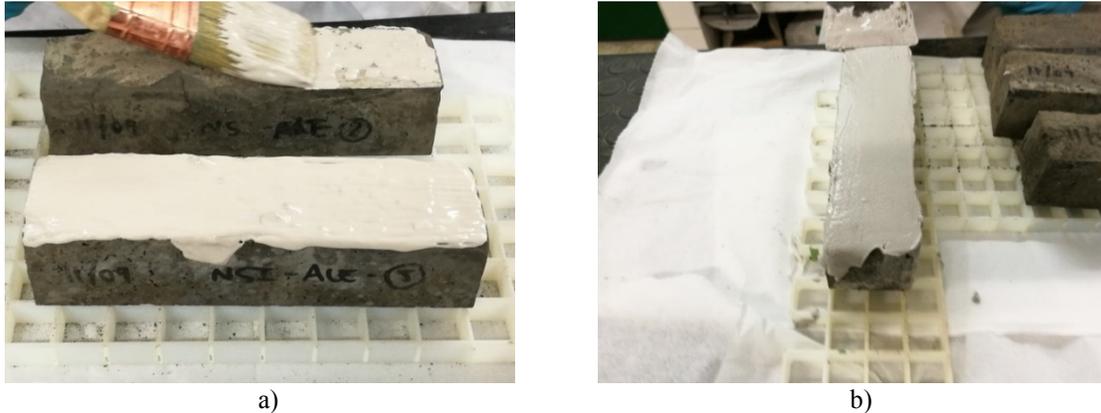
**FIGURE 2.** a) Application of the paint with a brush. b) Application of the mortar with a spatula.

After a pre-selection of possible commercial products, two products for testing were selected. One zircon based paint and one high alumina content refractory mortar. The selected products have characteristics such as a bulk density of  $1800 \text{ kg/m}^3$  for the zircon paint and  $2500 \text{ kg/m}^3$  for the vitset mortar. Some characteristics of these products are, for example, the grain size (in the case of zircon paint it is less than  $0.1 \text{ mm}$ , while in the vitset it is less than  $0.5 \text{ mm}$ ). The method of application of the selected coatings, is displayed in Figure 2, for the case of zircon paint (Fig. 2-a) the application is done using a brush, in the case of vitset mortar, it is done with a spatula.

After application and drying, the zircon paint presented small cracks, while the refractory mortar had visually no defects. Therefore, the vitset mortar is the preferred material for the detailed interaction tests, additionally the paint shows a smoother surface due to its much easier application for the size of the samples.

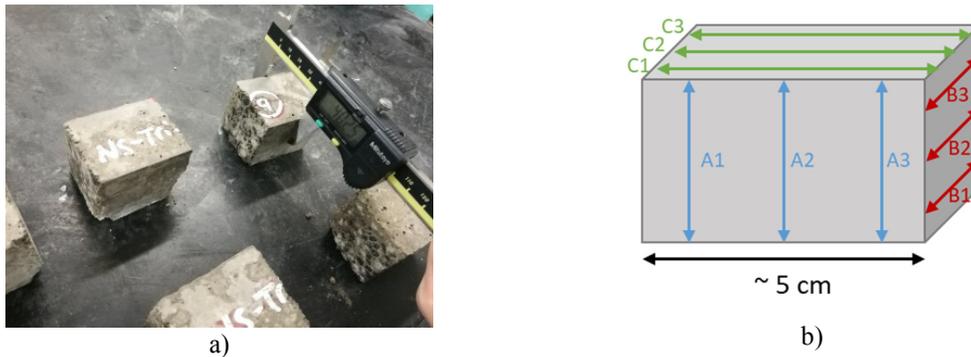
**FIGURE 3.** a) Measure of the thickness of the cubes before the application of the coating. b) Three directions of the measurements performed on the prisms.

The thickness of the samples was measured (Figure 3) before and after applying the protective layer (coatings), the measurement of the thickness was made three times (1,2 and 3) in the same face (faces A, B and C) (Fig. 3-b).

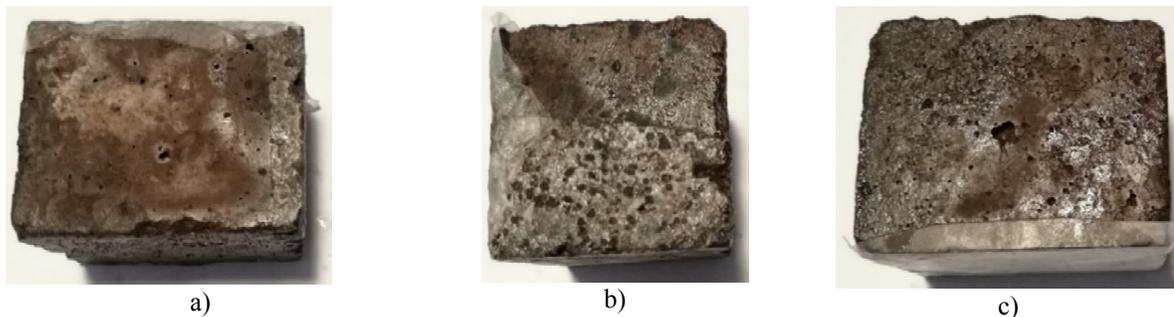
**FIGURE 4.** Visual appearance of an uncoated cube after 1500 hours in contact with the molten salts in surface A, B and C.

Figure 4 to Figure 6 present images taken in two surfaces of the three areas (A, B and C) measured, showing a visual registration of the degradation. Figure 4 shows a sample cube without coating that suffered thermal cycles of 290 to 500°C during 1500h in contact with a ternary mixture. Its visual appearance of the surface A and C shows only slight degradation of the surface, but no visible cracks.

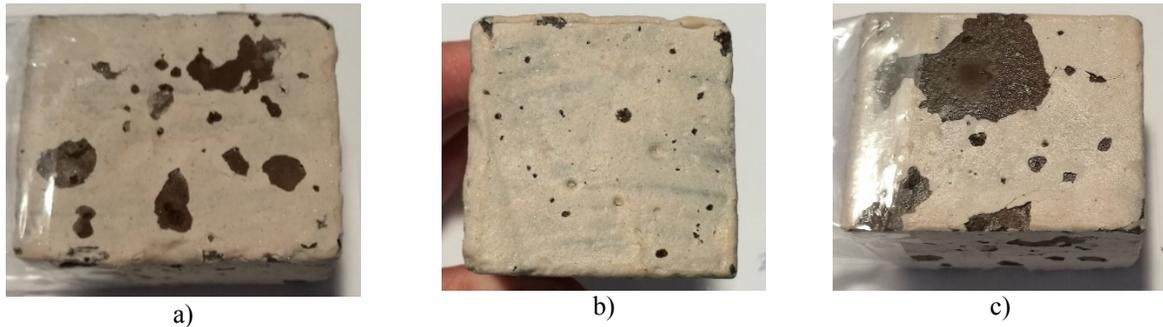
**FIGURE 5.** Visual appearance of the cube sample 23 coated with zircon paint after 1500 hours in contact with the molten salts in surface A, B and C.

The surface degradation of coated samples is important to evaluate the protection layer. The cube sample 23 coating with the zircon paint has been analyzed after the thermal cycles for 1500h in contact with a ternary mixture of molten salt. Its visual appearance shows clear degradation of the coating (Figure 5), especially in surface A and C.

The surface degradation of the samples with zircon paint were calculated and are as high as 30% of the exposed surface. The process followed is summarized in Figure 7. The degraded area was selected as the area with a specific color range (Adobe Photoshop CS6 feature), using as reference the concrete color. This area was colored in red for clarity, and this area was evaluated (in pixels) and compared with the number of pixels in the whole section.

- Zircon Paint A: 17.2% - Surface area 20 cm<sup>2</sup>
- Zircon Paint B: 1.7% - Surface area 16 cm<sup>2</sup>
- Zircon Paint C: 28.4% - Surface area 20 cm<sup>2</sup>
- Vitset A, B, C, no visual degradation (0%)

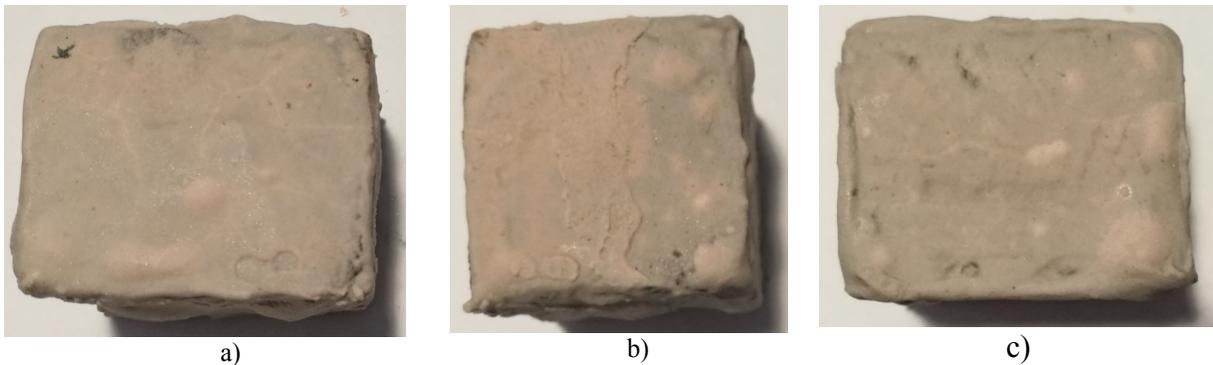
**FIGURE 6.** Visual appearance of the cube sample 35 coated with vitset mortar after 1500 hours in contact with the molten salts in surface A, B and C.

The same analysis was performed for samples coated with vitset mortar, after suffering the abovementioned cycling conditions. The results (Figure 6) show good integrity of the mortar but with a slight start of cracking in some faces.

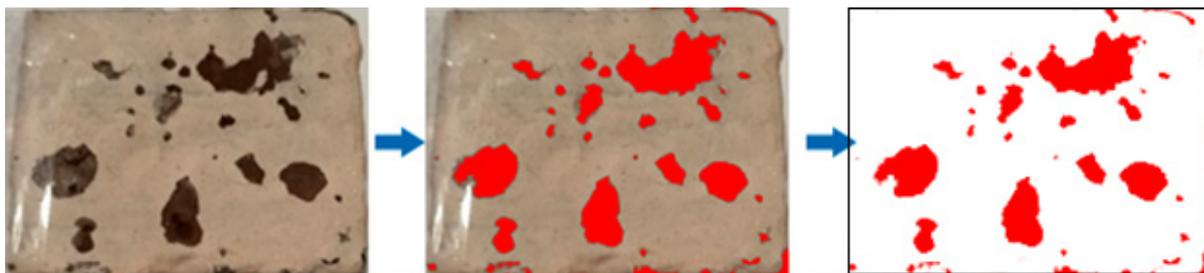
**FIGURE 7.** Image processing for the evaluation of the percentage of area degraded from surface “A” exposed to molten salt.

The values of the amount of surface where the coating disappeared calculated with this method are:

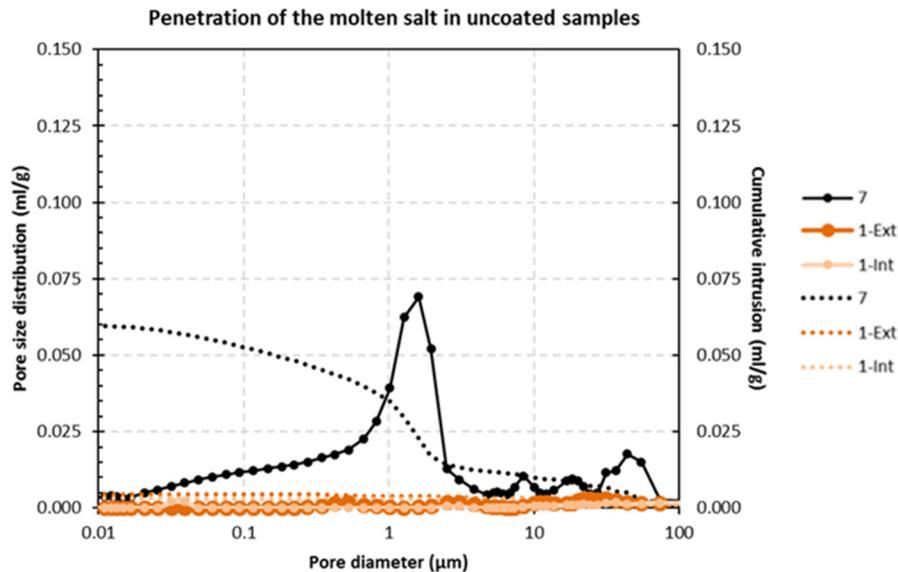
**FIGURE 8.** Pore size distribution for a reference concrete sample (7) and two zones of a sample after suffering the contact with ternary mixture after 1500 hours. (note: solid lines show the pore size distribution curves, principal axis, and dashed lines cumulative intrusion curve, secondary axis)

In order to evaluate this penetration capacity, one sample that was never in contact with molten salts neither thermal cycles (7) was used as a reference. From the samples that suffered thermal cycles and contact with the molten salts, two positions were compared, one in the external part of the sample (where higher penetration was expected) and another in the interior of the sample, at a distance of approximately 2 cm from the surface. Using this method, the presence of pores will indicate the effectiveness of the coating.

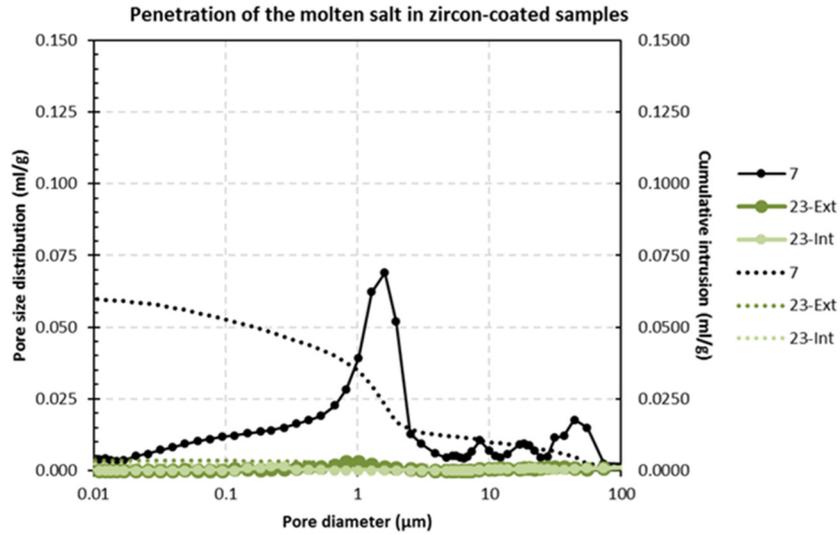
**FIGURE 9.** Pore size distribution for a reference concrete sample (7) and two zones of a sample coated with zircon paint after interacting with Ternary mixture under thermal cycles for 1500 hours. (note: solid lines show the pore size distribution curves, principal axis, and dashed lines cumulative intrusion curve, secondary axis)

The results obtained when using zircon paint and vitset mortar are displayed in Figure 9 and Figure 10, respectively, showing that for the external points, after the contact all the pores were completely filled by the molten salt, despite the presence of the coating. However, in the interior of the sample, vitset mortar achieved certain protection of the concrete, which can be deduced by the presence of pores of the size over 25  $\mu\text{m}$ . The pore size distribution indicates that finer pores will be completely filled.

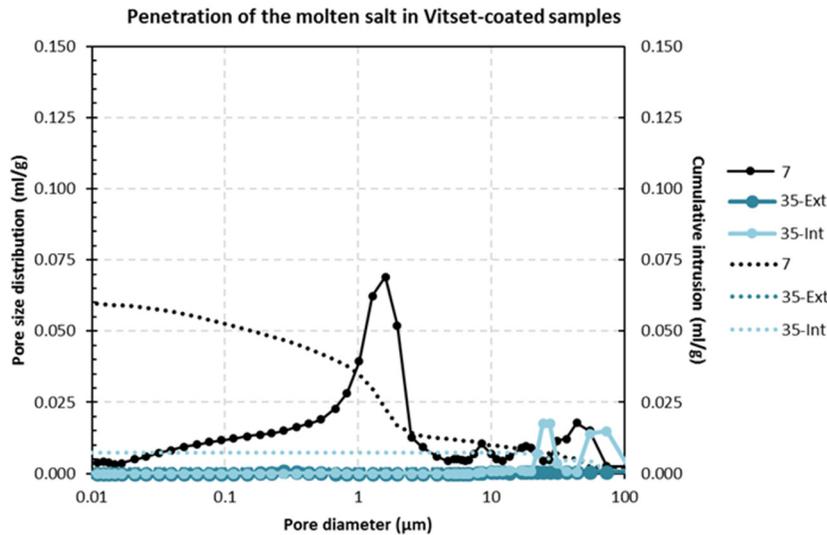
**FIGURE 10.** Pore size distribution for a reference concrete sample (7) and two zones of a sample coated with vitset mortar after interacting with Ternary mixture under thermal cycles for 1500 hours. (note: solid lines show the pore size distribution curves, principal axis, and dashed lines cumulative intrusion curve, secondary axis)

Results presented indicate that the alumina mortar showed better resistance (2.1% of porosity) than the zircon paint, being able to delay the penetration of the molten salts to the interior of concrete. However, in accordance to the analysis performed in [3], since the salt was able to penetrate inside the concrete to some extent, to guarantee concrete durability for a long-term direct contact, it will be necessary to protect it with a different coating or another protection method, such as a steel liner. These are preliminary results of on-going work within an extensive Project on Materials for Energy Storage [5] and thus further results are expected in the framework of the project.
