VSI: TECHNART 2023 selected papers

# The “Black Panther”: A multi-analytical study on the statue of the football player Eusébio da Silva Ferreira

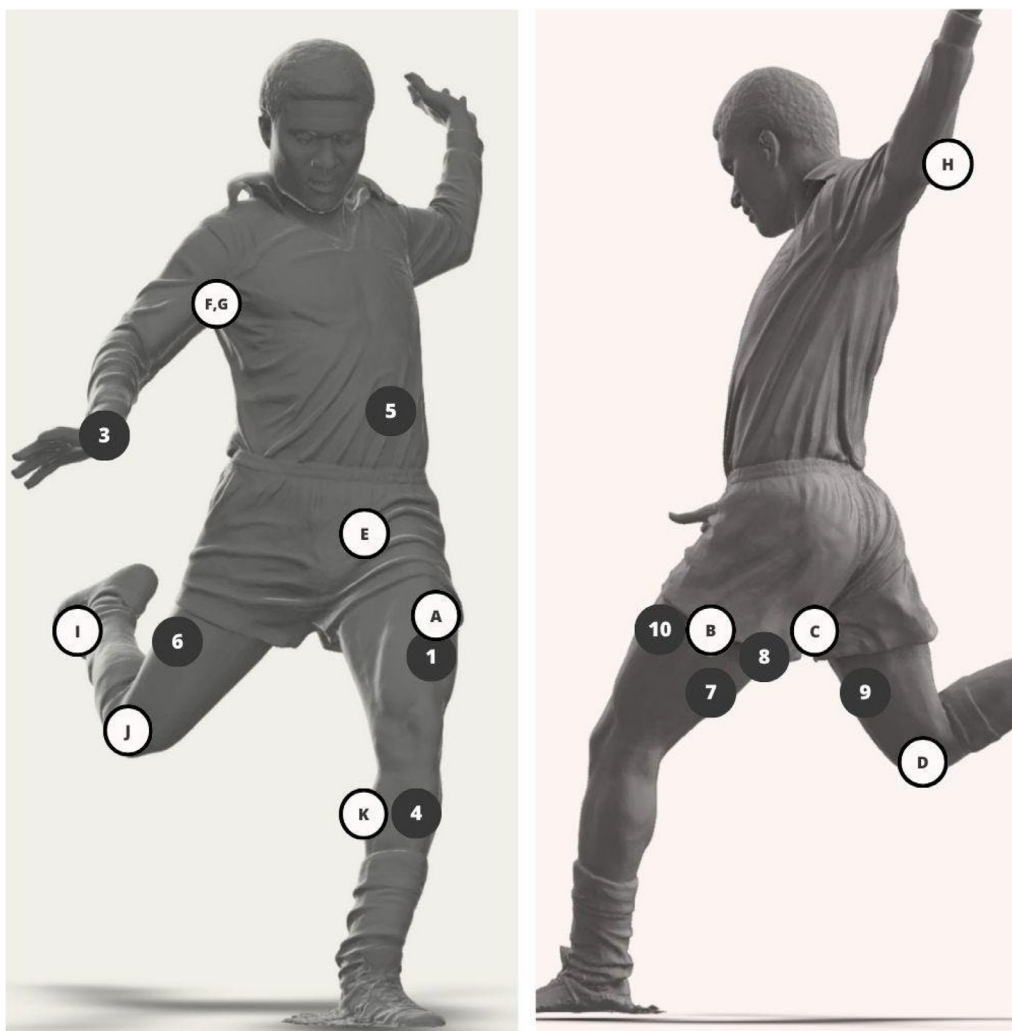
**Fig. 4.** 3D model of the statue of Eusebio da Silva Ferreira. The numbers (1–10) correspond to the locations where the h-XRF was used. Sample number 2 was taken on the football surface, not represented here. The letters (A–K) represent the location where micro-samples were removed for observation under XRD and SEM-EDS (see 2.2.3 and 2.2.4.). Locations A and I refer also to image 2a and 2b, respectively.

the patina was visually absent, providing better access to the underlying alloy (as shown in Fig. 1). Additionally, analyses were performed on regions with dark patina to gather information on the patinated surface. The numbers (1 to 10) in Fig. 4 indicate the locations where this methodology was applied.

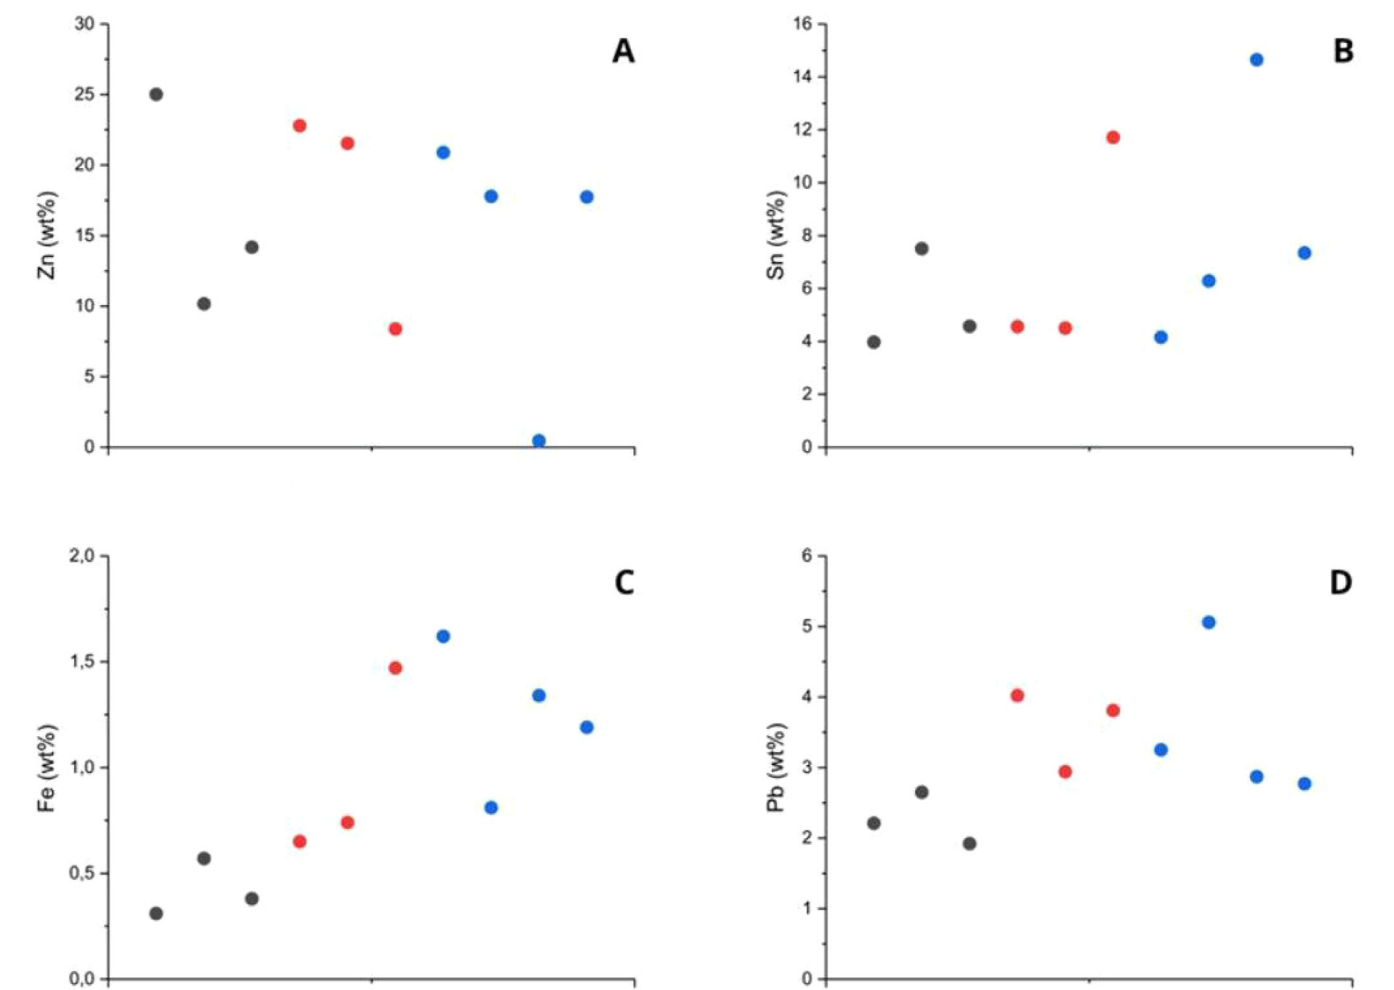
For the major elements, significant variations were observed across the analysed points. Notably, Zn displayed considerable variability, particularly in the patinated areas, where two points—Points 6 and 9—recorded levels below 10 %. Due to the non-destructive and surface-based methodology employed in this study, we cannot definitively confirm that these variations represent the actual composition of the alloy. Instead, it is more plausible that, in specific regions, these findings reflect a process of Zn depletion resulting from prolonged environmental exposure (Fig. 6A), particularly if Zn is added above about 15 wt. [14].

For Sn, eight out of the 10 points analysed show concentrations below 10 %. Within this subset, no significant differences were observed between unpatinated, patinated exposed and patinated unexposed areas. It is noteworthy that the two points with the highest Sn concentrations coincide with the patinated areas. This observation suggests a surface enrichment of Sn, consistent with the selective leaching phenomenon whereby Cu and Zn corrode more readily than Sn, resulting in surface layers enriched in Sn (Fig. 6B).

**Fig. 6.** Plot illustrating (A), Sn (B), Fe (C), and Pb (D) variability across different surface conditions: free-patina areas (black dots), patinated exposed areas (red dots), and patinated non-exposed areas (blue dots). (For interpretation of the references to color in this figure legend, the reader is referred to the web version of this article.)

The potential influence of corrosion, formed because of the statue's interaction with pollutants, moisture, and other environmental factors, is further highlighted by the behaviour of Fe and Pb. Iron content is notably higher in patinated areas, particularly in exposed zones, reaching up to 1.47 % at point 6, which suggests the formation of iron oxides or other corrosion products due to environmental exposure (Fig. 6C). Similarly, Pb is present in higher concentrations in the patinated points (2.87–5.06 %) compared to clearer surfaces (Fig. 6D).
